Structural Survey

Top House Farm, Arowry,
Wrexham, SY13 3EQ.

- h) Other Matters: This report has been commissioned to ascertain the general structural condition of the cattle shed and its suitability and adequacy for conversion and re-use.

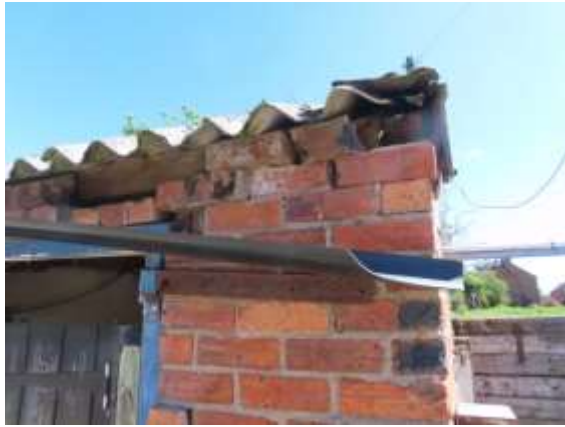
Disconnected gutter

3. Rainwater Fittings	The rainwater fittings, where present, are formed in plastic gutter sections.	Poor. The gutters are in a neglected state and are detaching at the connections.	Installation of new rainwater gutters and downpipes; to be connected to the existing drainage system.

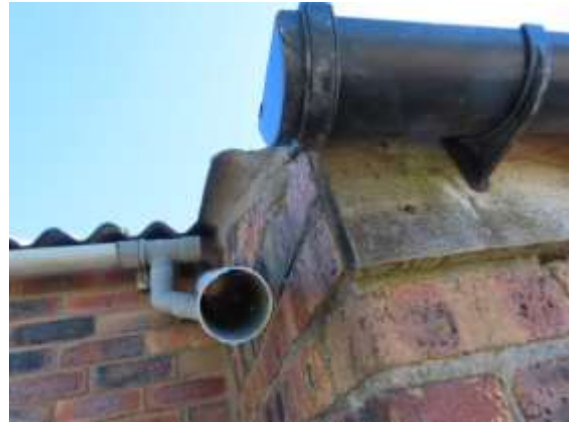
Downpipe missing from front left corner

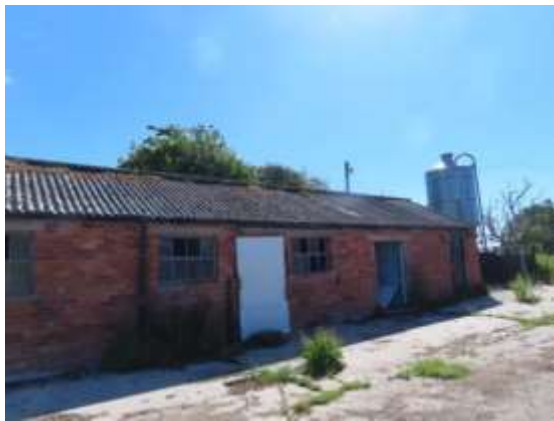
Front elevation wall

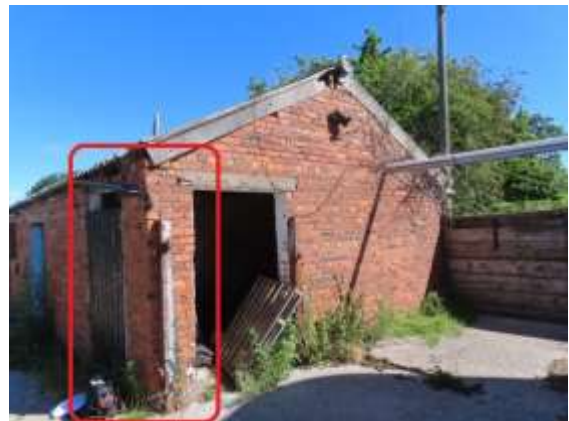
4. Main Walls	The main walls are constructed with solid brick (220mm) incorporating a bitumen DPC.	Structural failure and rotational movement evident to front right corner of the building. Possible	Inspection of the underground drain required. Relevant structural repair required to front right corner,

Damage and rotational movement to front right corner

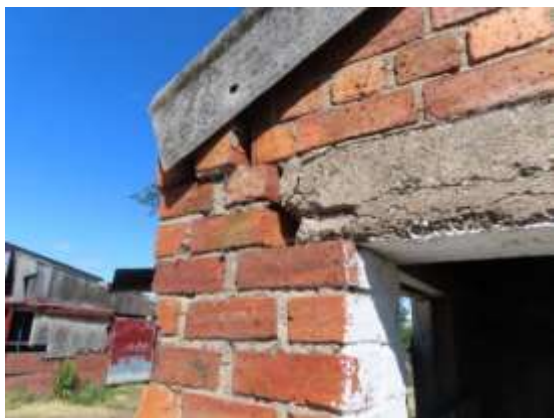
Dislodging brickwork

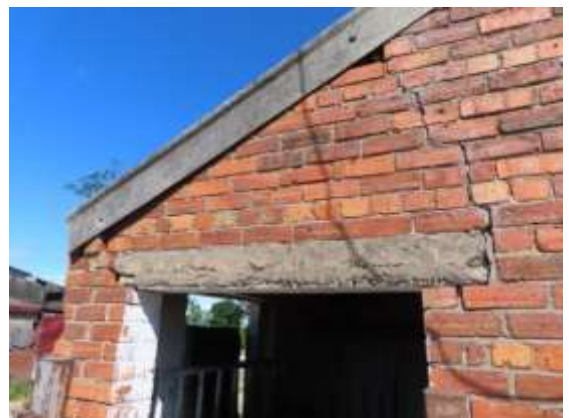
Large crack stemming from lintel to verge
