Fire Safety Report V 4 20.11.22  
The National Trust  
Erddig Hall, Wrexham

Author: Steve Emery CMIFireE  
Heritage Fire Consultancy Limited

24<sup>th</sup> October 2022

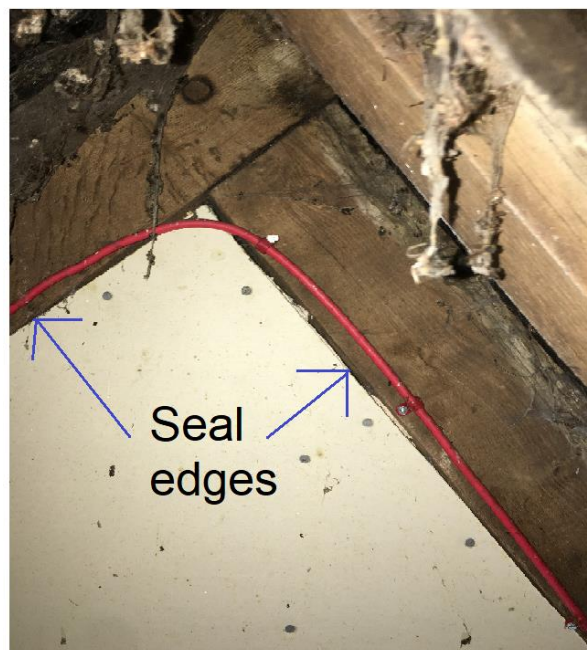
- 1.1. Barrier B** should be sealed around the top edges with an intumescent mastic.

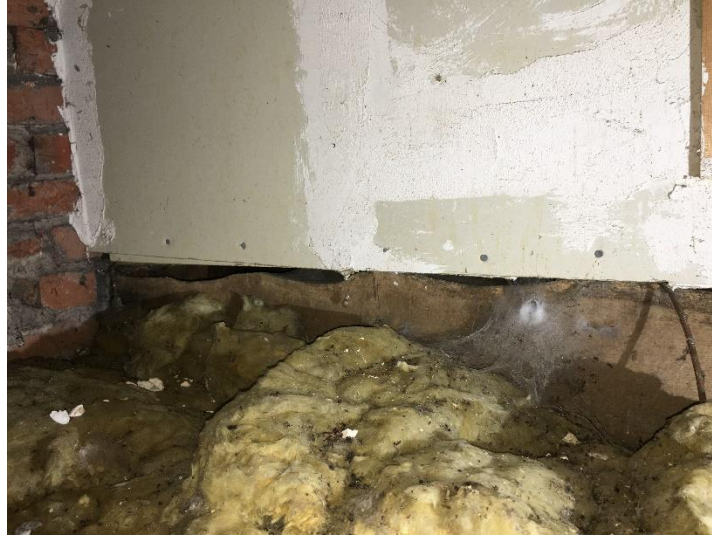
*Underside of Barrier not sealed*

Adjacent to the South side of partition B, the underside of the plasterboard has not been sealed. This should be filled with compressed mineral wool. This also applies to other barriers with similar holes.

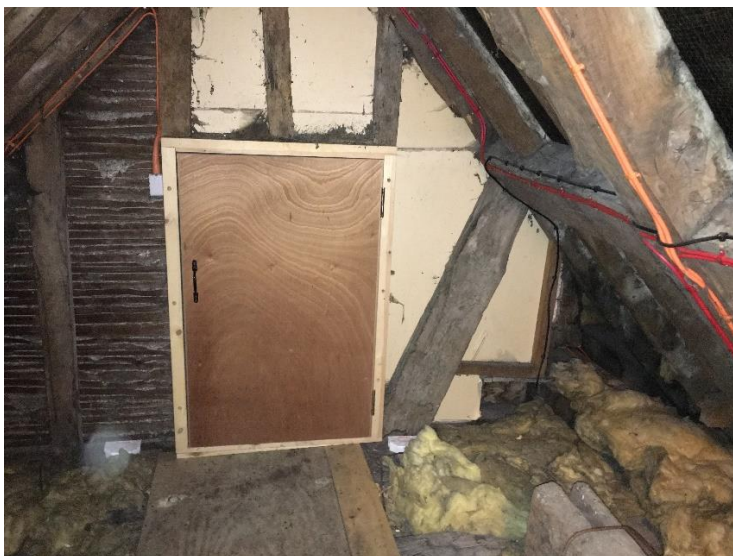
*Barrier D lath and plaster*

- 1.2. Partition D** is around the staircase and is one of the more critical protective barriers because the underside of the stair and the door at the base of the stair provides insufficient fire protection.

South of the barrier has a mixture of lath and lime plaster and plasterboard. The laths are a bit too close together at mid-height, so the plaster is not keyed sufficiently, and is likely to fail if attacked by fire. If the fire were already in the loft, the laths would burn rapidly, and the partition would also fail.

The keying of the plaster is fine at the top and bottom of the partition, where the laths are wide enough for the plaster to be pushed through but is not satisfactory mid-level at the height of the door handle.

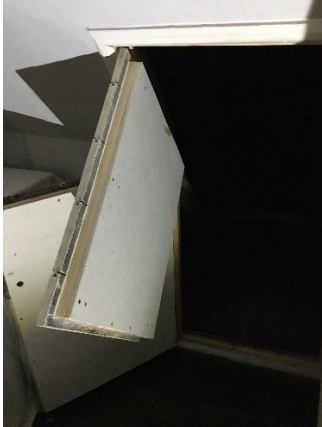
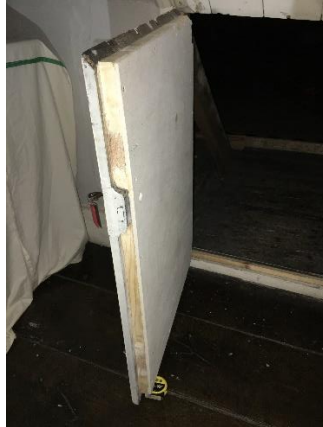
The door and hatch in the South wing is recorded in the fire door schedule but is repeated here for completeness. Hatch T15 is made of two plank doors, similar to miniature stable doors, faced with Masterboard or Supalux. The bottom door is vertical and the top one is in line with the sloping ceiling.

*Top leaf*

*Bottom leaf*

The top leaf is damaging the edge of the fireline board on the bottom leaf when opening the hatch. I recommend it is protected with a thin baton of wood about 10mm thick and 25mm wide screwed to the face of the fireline board level with the top.

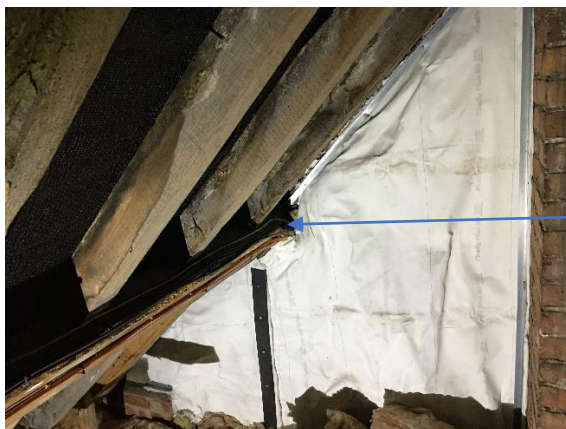
The fire barrier in the South wing has been constructed with a 60 minute fire blanket (Firefly Stamper), reinforced on one side with planks of wood. A breach is evident where cables and a purlin run through it. This hole can be sealed with compressed Rockwool pushed into the cavity.

Hole in fire barrier for passage of cables and purlin

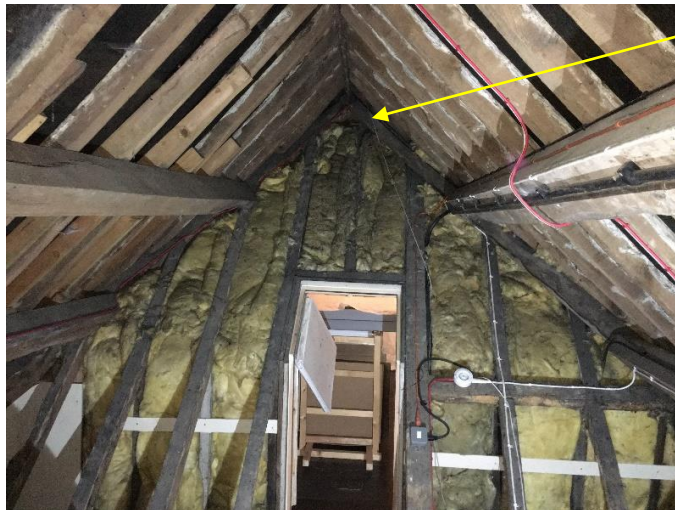
The mineral wool covering the partition between the loft and room T03 provides some fire resistance but has slipped at the top. The presence of bats are evident at the apex.

Rockwool is missing at apex.

If possible, the mineral wool should be replaced with 50mm Ablative Rockwool batts between the joists and sealed at the edges with an intumescent mastic.

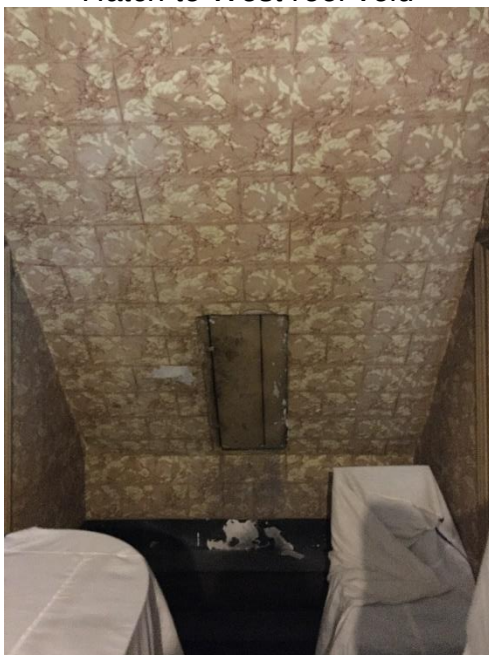
*Hatch to West roof void*

The West roof void is accessed via a sloping hatch at third floor level. This hatch has a fire door blank on the inside so should give 60 minutes fire resistance. The void does not appear to link with the main roof void.

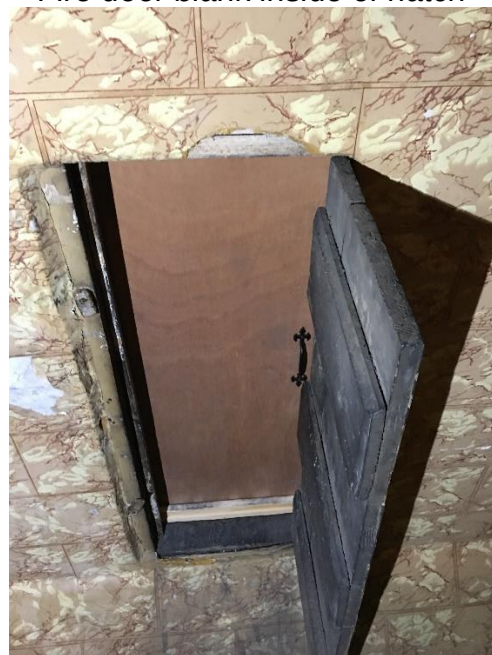
*Fire door blank inside of hatch*

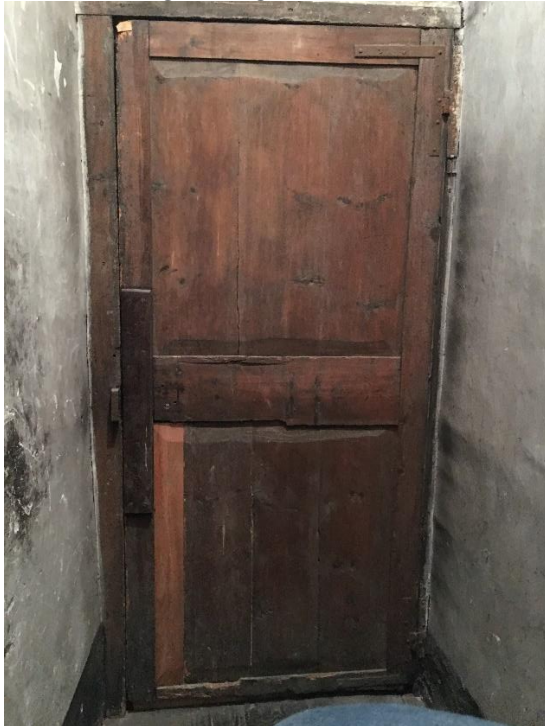
Door T4 which should protect the stair to the loft, is in a very poor condition, with some minor repairs that would be ineffective in the severity of a fire that could be expected in the central corridor. The panels are only 7mm thick at the edges, which would burn through in about 11minutes with a charring rate of 0.63mm/min. Upgrading this door would cause a lot of damage and would be ineffective because the stiles and rails with their tenon joints are not robust enough to prevent distortion in a fire.

*Lightweight door T4*

| T4 | Stair/passage used for storage | 2 | Too small for matrix but would require full upgrade if over 50m <sup>3</sup><br>Door in poor condition, at base of stairs serving roof void. New door recommended. | 29 | 9 | 7 | 11 | 30 | 8mw<br>0.7/m <sup>2</sup> | 0 | N/A |

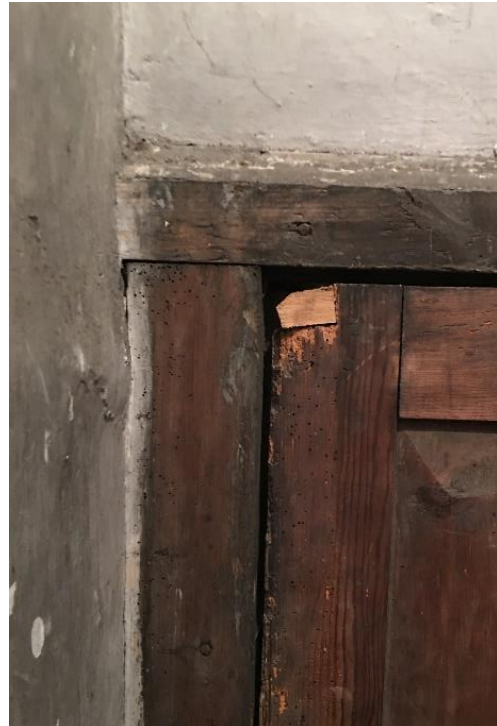
*Poor condition of door T4*

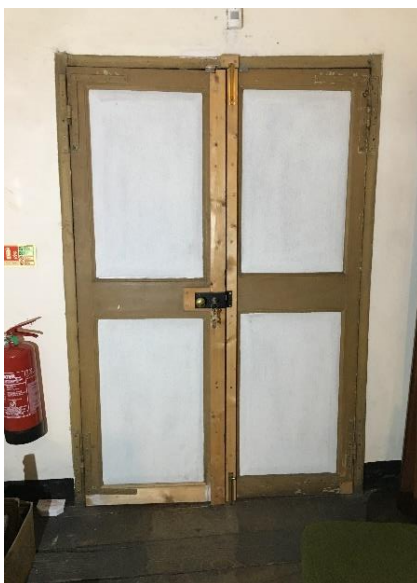
Cross corridor door-set T18 has received some fire protection upgrade works in the form of intumescent paper on the panels. This is a good example of how an upgraded door will not give adequate fire protection, because the stiles and rails are too narrow to avoid distortion and the surrounding frame has gaps through it as can be seen in the photograph below.

*Door T18 with intumescent covering and narrow stiles and rails*

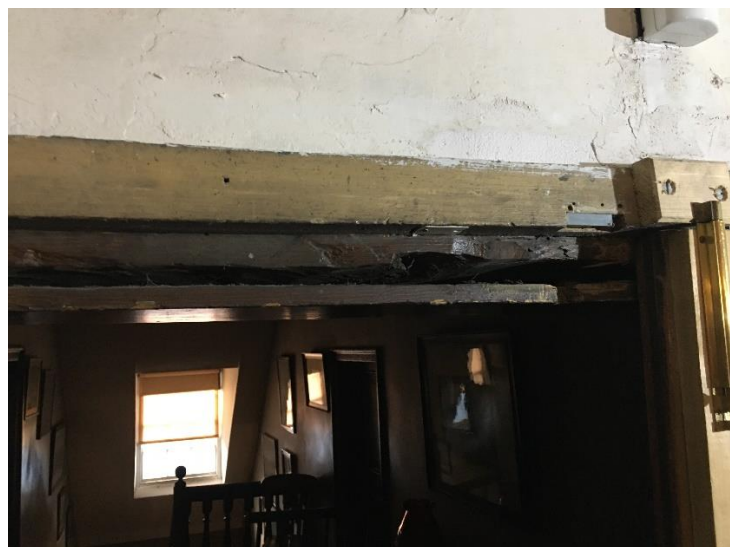
*Frame behind door with large gaps on the top and edges*

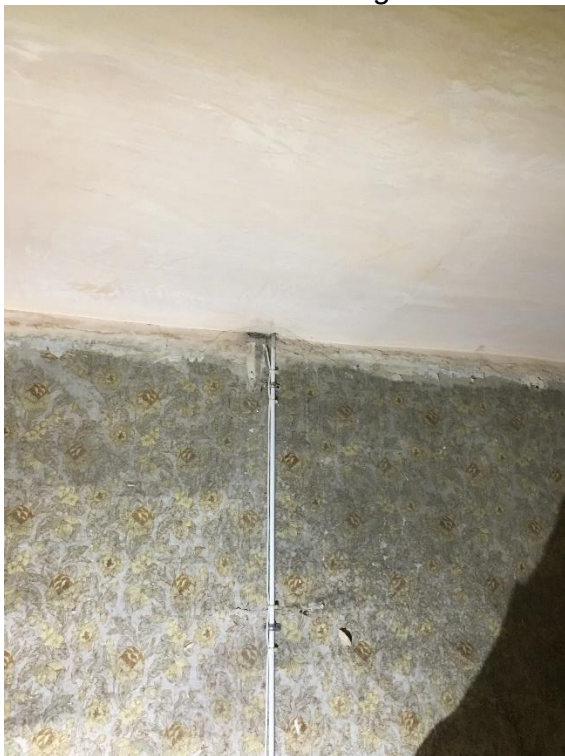
There are holes in the ceilings above stair V to the attic and in room T07 which should be filled either with lime plaster or an intumescent mastic.

*Holes in ceiling*

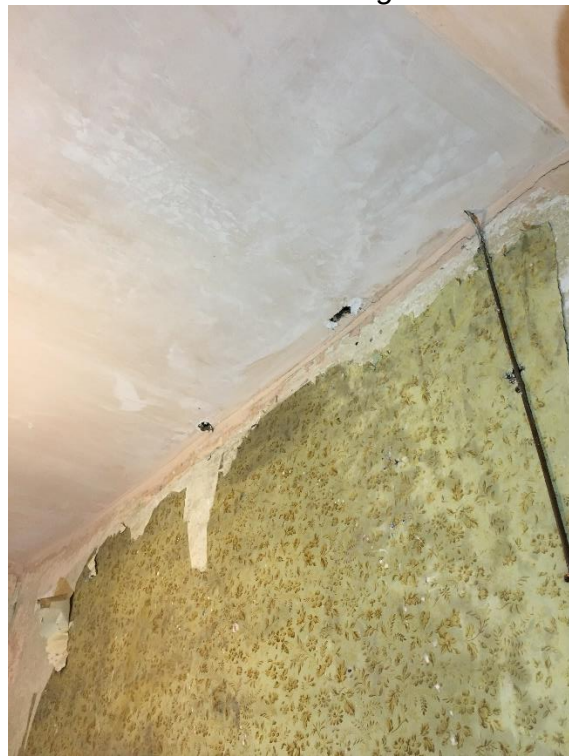
*Holes in ceiling*

Stair V is not underdrawn within the understairs cupboard in room T07 so the cupboard should be emptied, and the opening covered with 9mm Masterboard. Alternatively, the stairs could be underdrawn with plasterboard and skim.

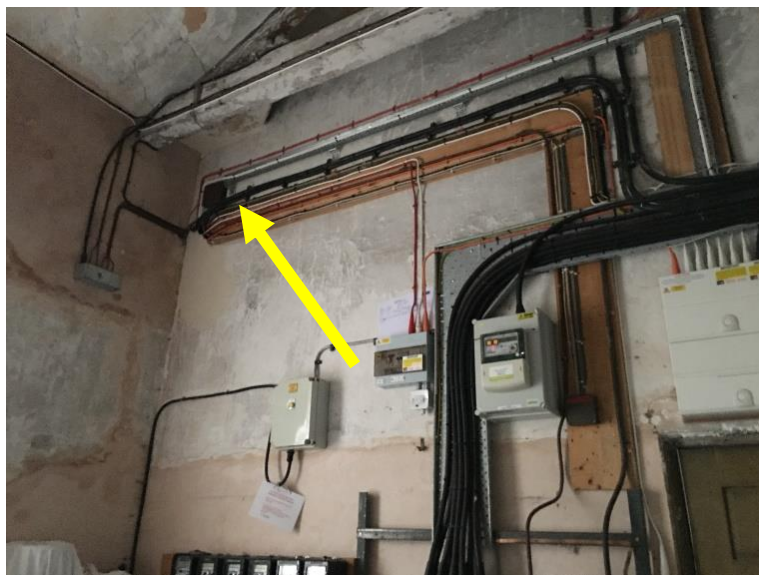
- a) The hole created for the passage of cables near the top of the East wall should be effectively fire-stopped with an Ablative Rockwool batt, sealed around the edges with intumescent mastic.

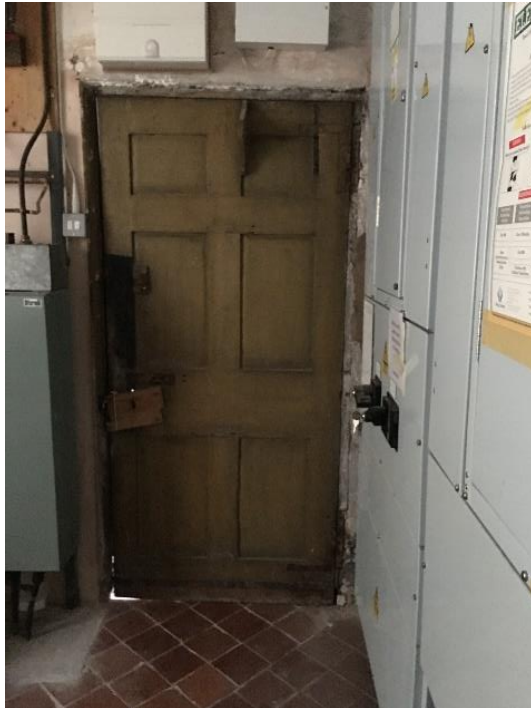
- b) The door is too thin and fragile to afford even 30 minutes fire resistance. I therefore recommended an FD60s door and frame is inserted on the inside of the existing door opening. The existing door could then be made outward opening to conceal the new door.

*Existing door*

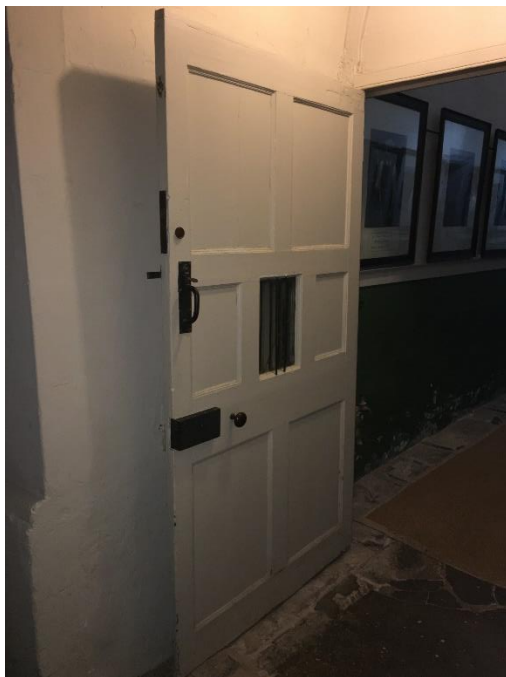
*Original external door G22 with glazing*

| G22 | Corridor/corridor | Unique | Originally an external door. 7 panel with cracked centre panel of glass. Large gap at base. Top | 40 | 20 | | Circulation spaces | | | | | |

| | | | fitted with existing fillet of wood. Warped and does not fit frame. Recommend:-<br>a) supply a new FD30s door and frame to South of this location held open on magnet or Freedor. See item 4 in opening paragraphs. | | | | | | | | |

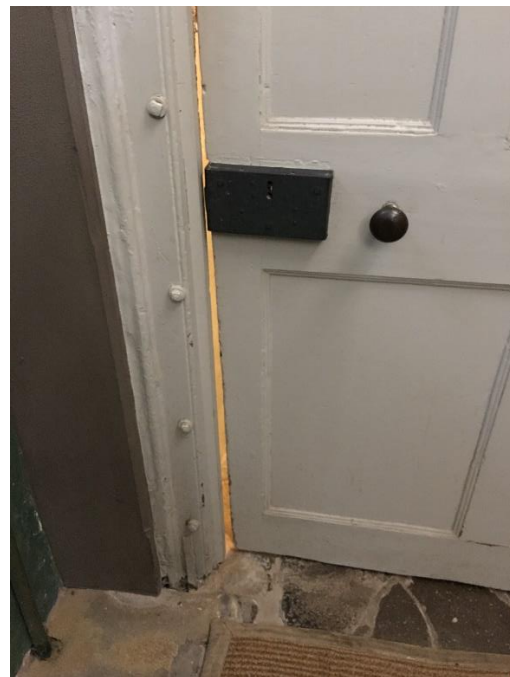
*Closed door G22 showing warping*

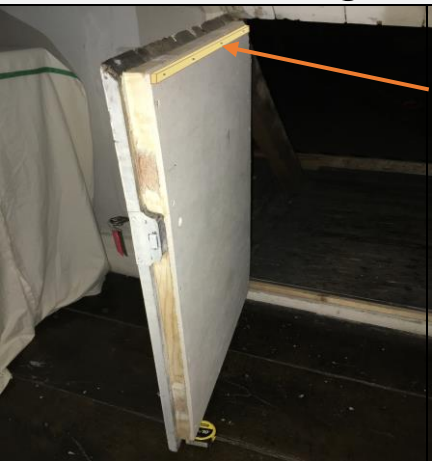
| T1 | Store T03 / North roof void | Unique | Vertical planks with fire-line board on rear. Vertical door with sloping hatch above Intumescent strips and cold smoke seals to edges. The sloping hatch is causing damage to fire-line board of the vertical door. It is recommended that a hardwood lipping is applied to the top face of the fire-line board to protect it from further damage. The missing board can be filled with a cementitious filler. | | | | | Baton to protect fire-line board | | | |
