**Building Survey**  
**12/01/22**

**Dymock Arms**  
**Penley, Wrexham**  
**LL13 0LS**

## **BUILDING CONDITION REPORT**

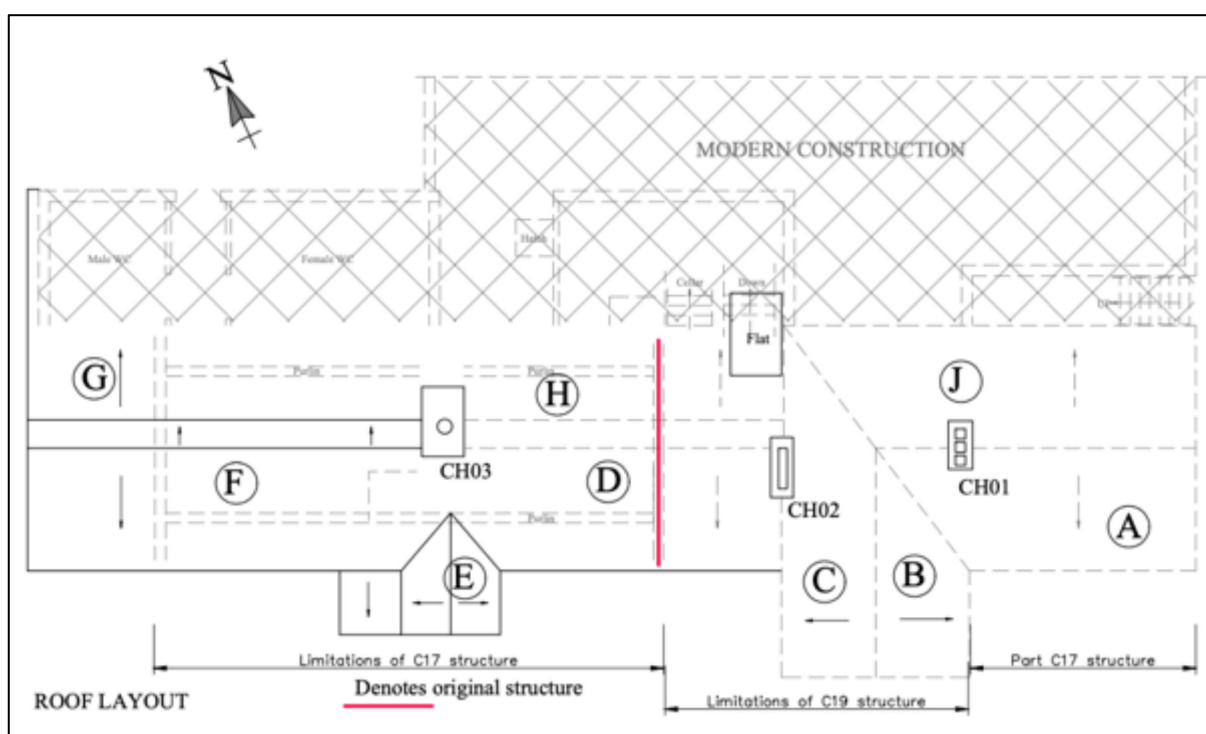
**3.01.01 Roof Areas** – Main roof coverings comprised natural slated pitched surfaces set on traditional timber sub structures. Refer to drawing below for indicative layout. Roof layouts and surfaces have evolved with the alteration and modification of the property during its lifetime.

**Condition** – Roofs A,B,C,D,J were not present. Remaining roofs E,F,G,H contained many slipped slates. Underfelt was noted to some roof surfaces. Extensive water ingress was noted to open areas of the remaining roofs, and may be advisable to install covers to protect the integrity of the structure. Significant fire damage to purlins within roofs F,G,H will render their structural reuse not possible, but may be adequate for the support of temporary sheeting.

**Action** – Install temporary waterproof sheeting above roofs E,F,G,H (Rating D2)

Full re-roofing and reconstruction of structure will be required subject to decisions on works to structures below. (Rating D3 - budget)

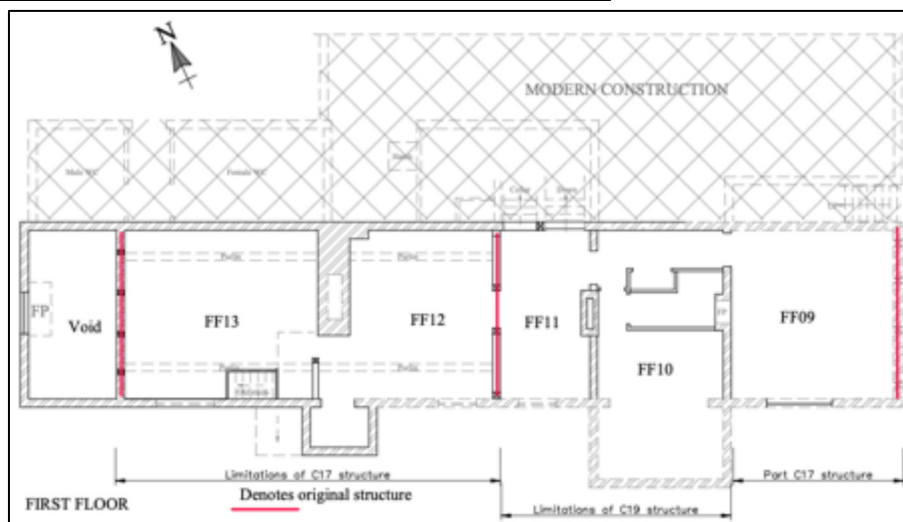
**Condition** – No significant cracking was noted to indicate foundation movement.  
**Action** – None.
- 3.01.08 Main Walls** – Comprising a mixture of timber frame with brick infill, and solid masonry constructions. Refer to reference plans below.

**Condition** – Many wall units were in disrepair, especially at first floor level. Timber framing collapse was noted to GF01. Ground floor walls were mostly adequate.

**Action** – Allowance for rebuilding upper sections (Rating D3)

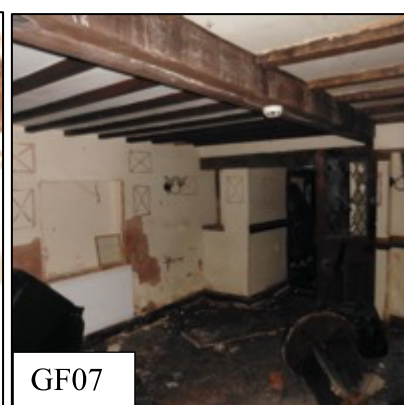
**Condition** – Exposed building areas GF01, GF02, GF03, GF04 contained very little or no ceiling structure. The ceiling was present in GF05, GF06, GF07 and GF08 but extensive damage to plasterwork was noted due to the water ingress.

**Action** – Allowance for replacement of ceilings (Rating D3)

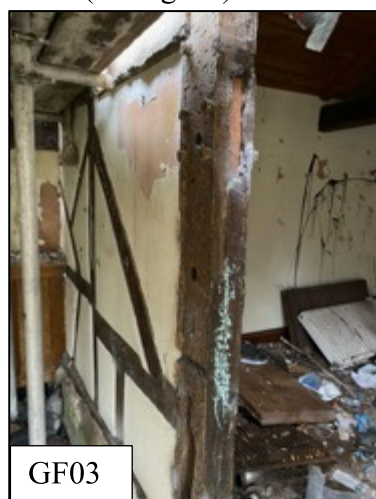
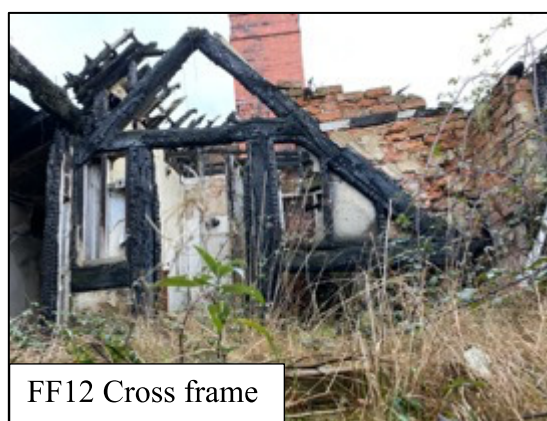
**Condition** – First floor units had been heavily damaged by fire, water or collapse. Ground floor constructions to the west were present, and in many areas repairable. The structural cross frame between GF04 and GF05 was heavily damaged by water ingress. The upper section of this frame between FF11 and FF12 was heavily fire damaged and beyond repair.

**Action** – Allowance for construction of new partitions (Rating D3)

Allowance for the replacement of the upper section of cross frame FF11-FF12 (Rating D3)

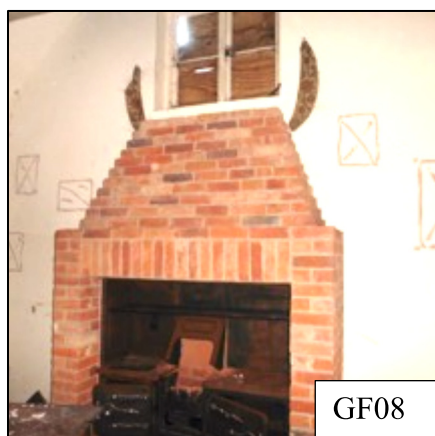
**Condition** – The cast iron grate to GF08 was still present. The flue detail for this fire could not be ascertained.

**Action** – Assess and certify for reuse (Rating D3)
