**Tree Condition Report  
Arboricultural Impact Assessment  
Arboricultural Method Statement  
Tree Protection Plan**

**Land at Wynnstay Technology Park, Ruabon LL14 6EN**

**Cartefi GO Ltd., 5 King Street, Wrexham LL11 1HF**

**11.11.2019**

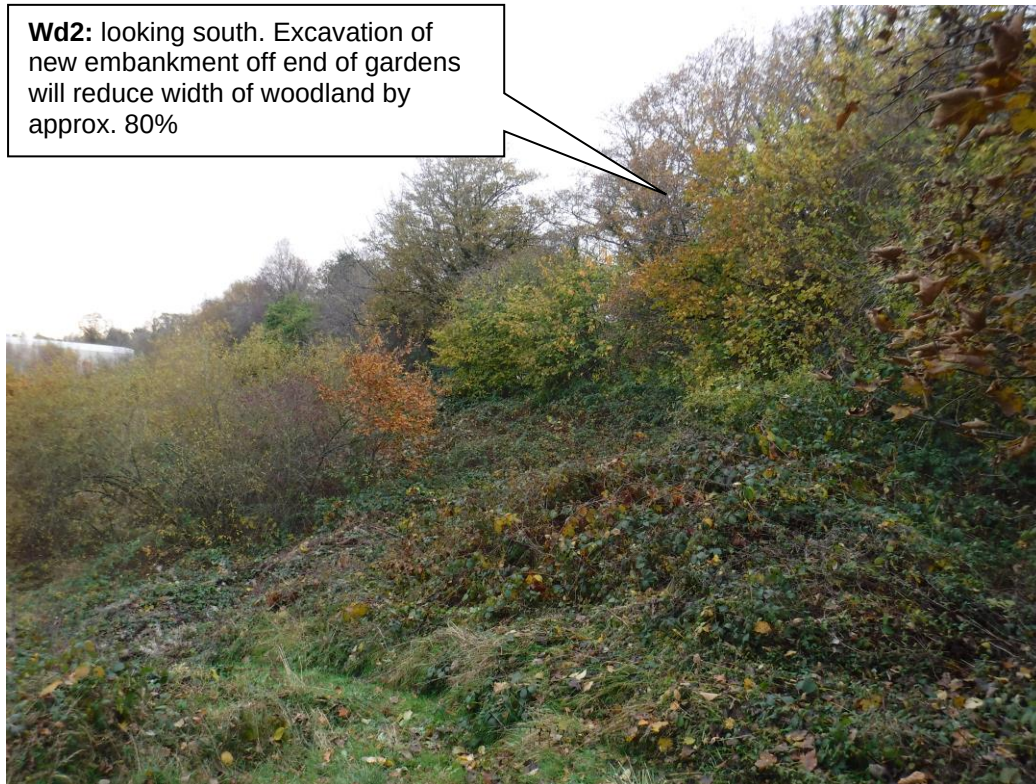
**Wd2:** looking south. Excavation of new embankment off end of gardens will reduce width of woodland by approx. 80%

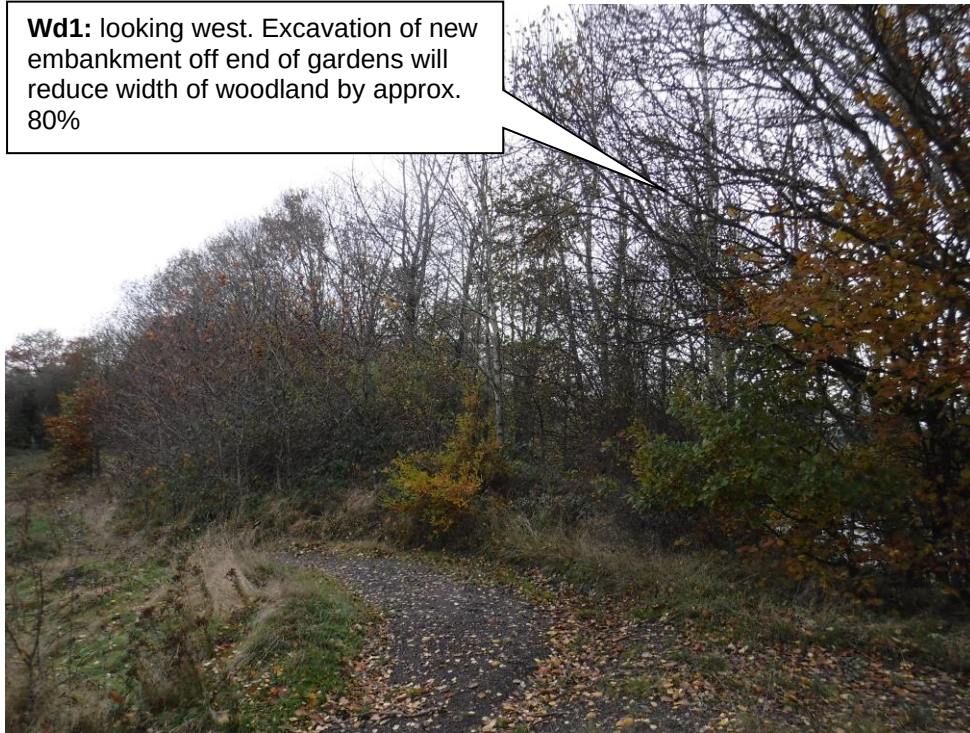
**Wd1:** looking west. Excavation of new embankment off end of gardens will reduce width of woodland by approx. 80%

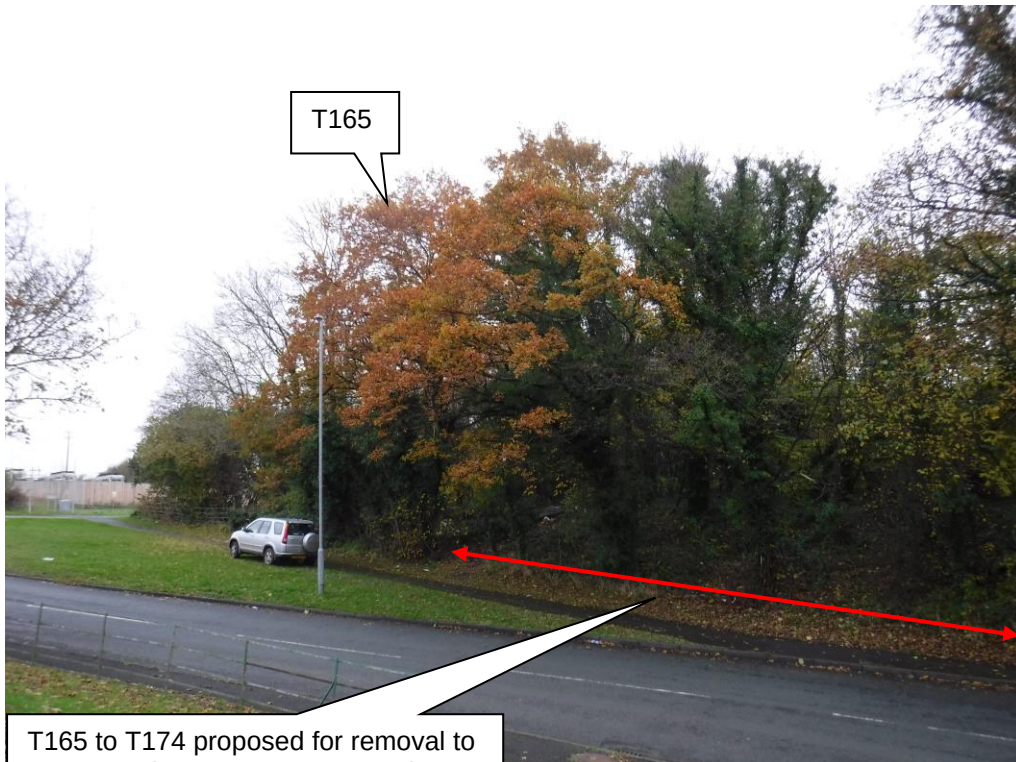
T165

| <p><b>Tree Condition:</b><br/> <b>Root:</b> No evidence of soil movement.<br/> <b>Stem:</b> no evidence of bark necrosis.<br/> <b>Crown:</b> Asymmetric development to south. No recent breakouts or significant dieback.<br/> <b>Tree Quality Assessment:</b> Ref.BS5837 (2012) 4.5.1 <b>Category A2</b> Trees, groups or woodlands of particular visual importance as Arboricultural and/or landscape features' <b>large tree visible from adjacent housing and highway. Life expectancy of at least 40 years.</b><br/> <b>Water Demand NHBC 4.2-B: High</b><br/> <b>Root Protection Area RPA:</b> for tree of 67cm diameter at 1.5m <math>(0.67 \times 12) = 8\text{m}</math>. <b>Radius</b><br/> Total RPA required at current stage of growth = 201m<sup>2</sup><br/> <b>Arboricultural Impact Assessment AIA:</b> <ul style="list-style-type: none"> <li>Excavation of a 45° embankment batter from the north end of the garden boundary of plot 1 will be required within the RPA</li> <li>No new trench excavation is permitted within the RPA</li> <li>RPA. 'BS 7.7.2.1: The design should not require excavation into the soil, including the lowering of levels and/or scraping, other than the removal, using hand tools, of any turf layer or other surface vegetation'.</li> </ul> <b>Method Statement: Construction of new dwellings</b> <ul style="list-style-type: none"> <li>The tree is proposed for removal by the Developer</li> </ul> </p> | |

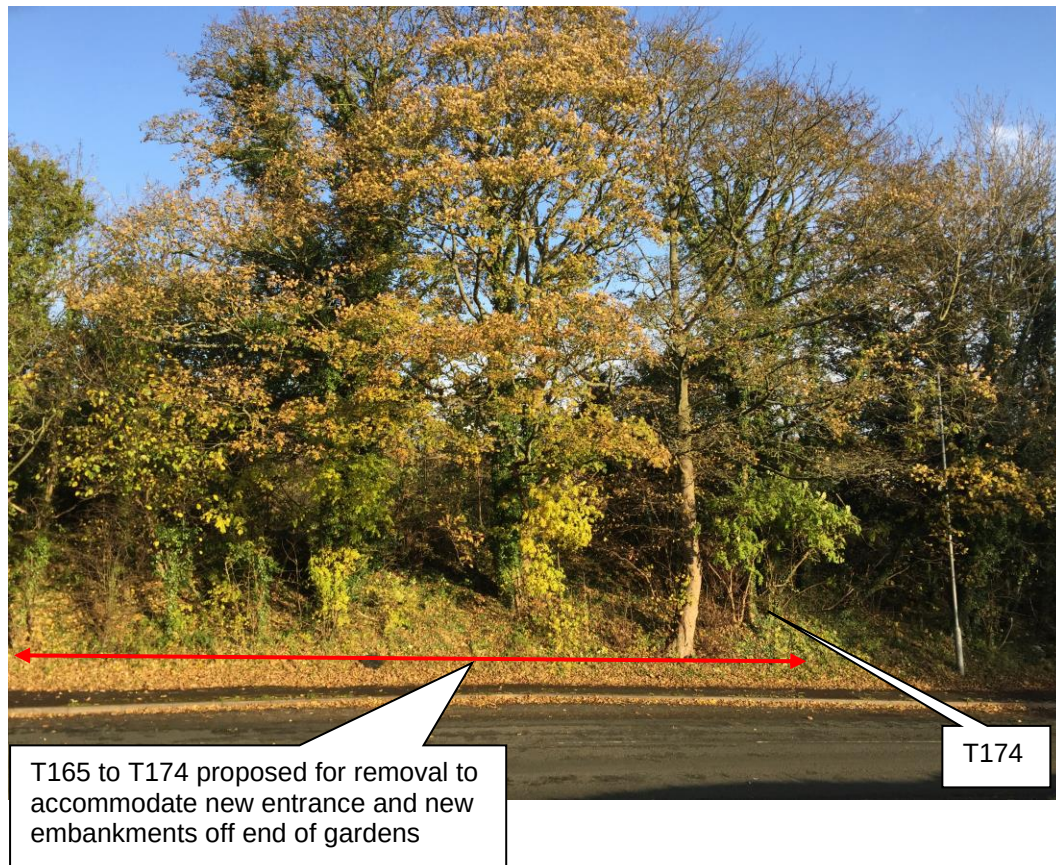
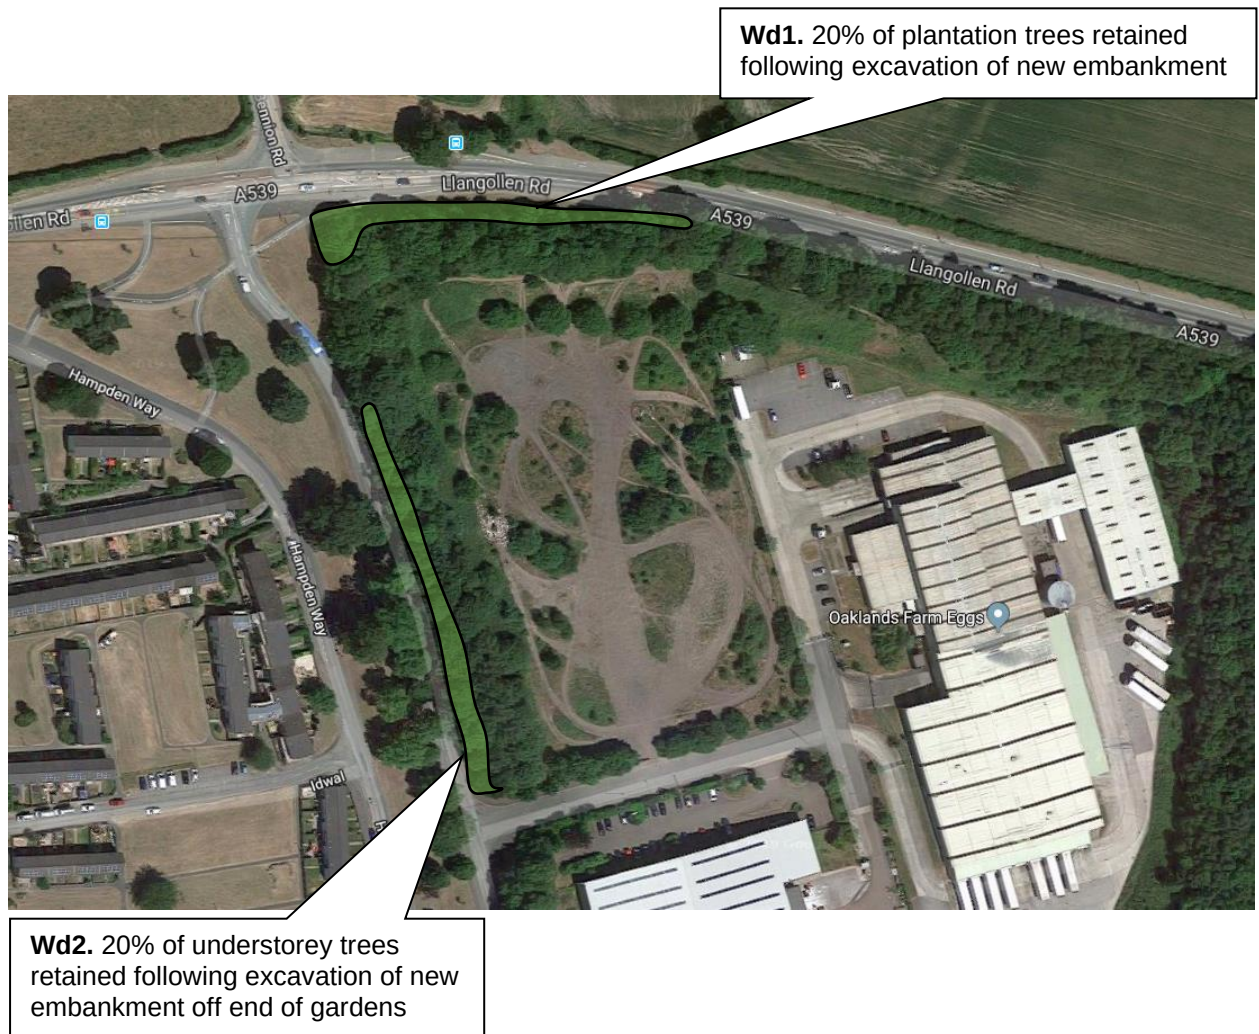
T165 to T174 proposed for removal to accommodate new entrance and new embankments to Plots 1 and 2
