## **Conservation report for 35-39 bridge street;**

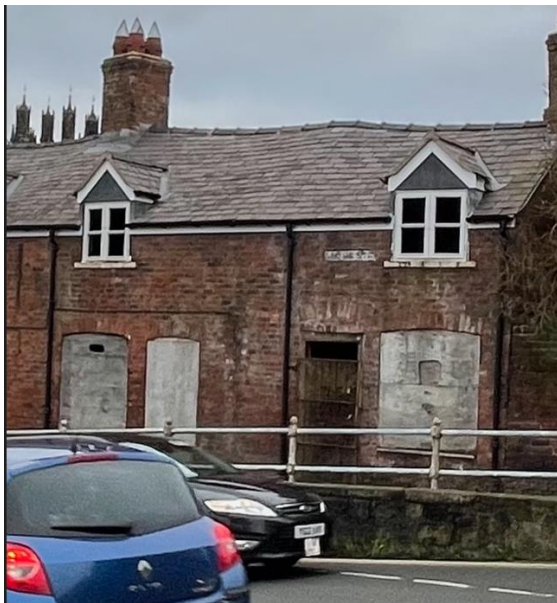
The same slates which were used, have been put back on the new frame to the roof. Any damaged tiles have been replaced with welsh slate, as per heritage recommendation. See below OLD photograph of roof before the repair.

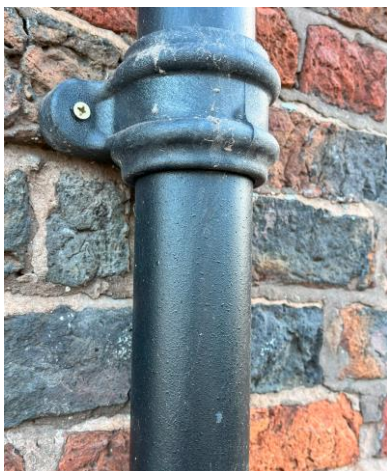
Plastic gutters originally and replaced with same material and coloured guttering.

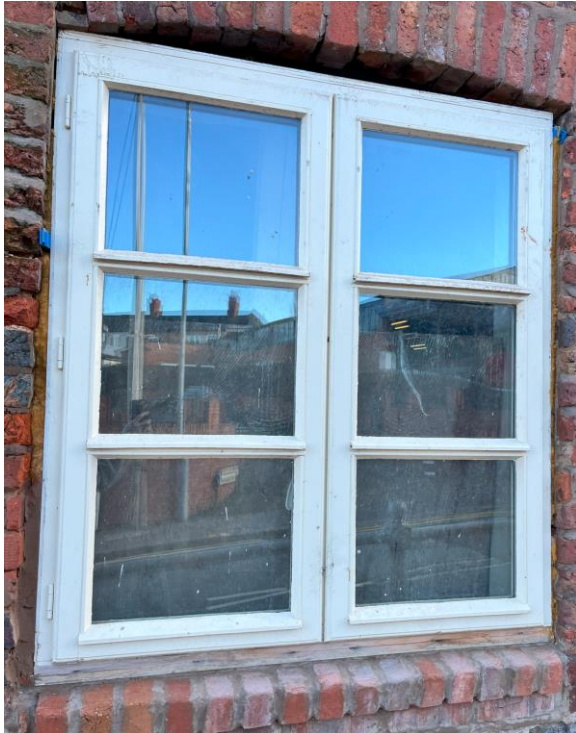
Wooden white framed windows, replaced with double glazed wooden white windows. The glazing type is the result of the noise report undertaken.

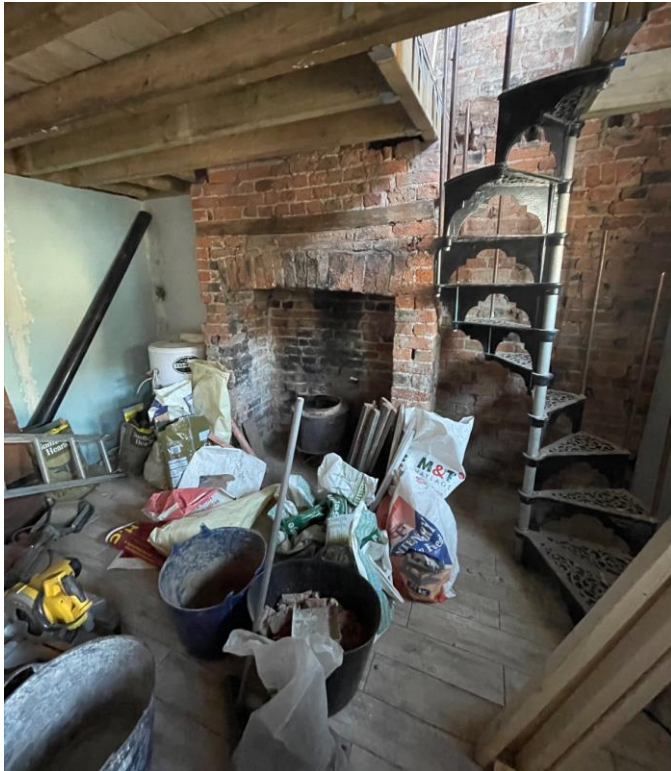
Original cast iron spiral staircases being installed. Original were cast iron but no banister, we are installing one with banister as unsafe.

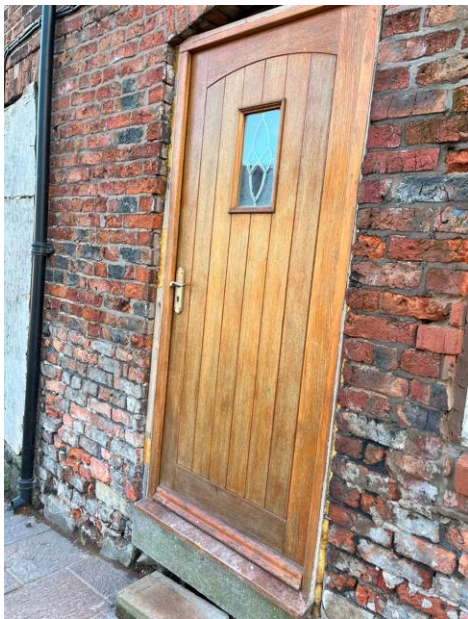
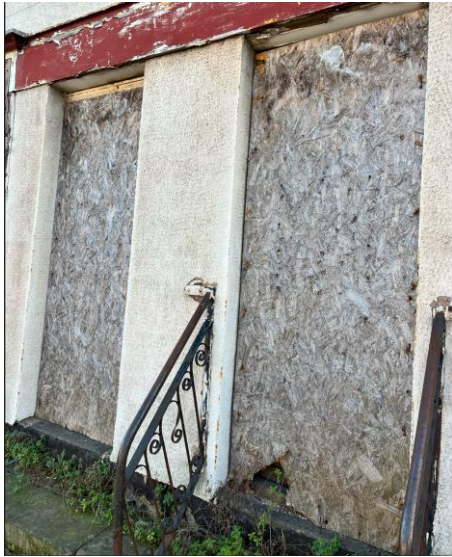
No doors inside when bought. Installing oak doors to use natural materials.

One door remaining on the entry/frontage when bought. It was oak wooden, we are matching to same material.
