Our Ref: 7962CMG240226L

Date: 26<sup>th</sup> February 2024

**Re: Proposed Development on land at Cwrt Pentwmpath, Llay**

**Preliminary Conceptual Site Model**

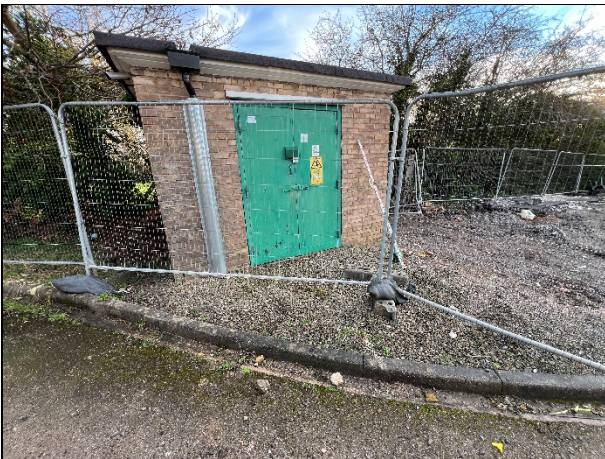
*Photograph 1: South west side and access point to electricity sub-station. Photograph taken by Coopers on 2<sup>nd</sup> February 2024*

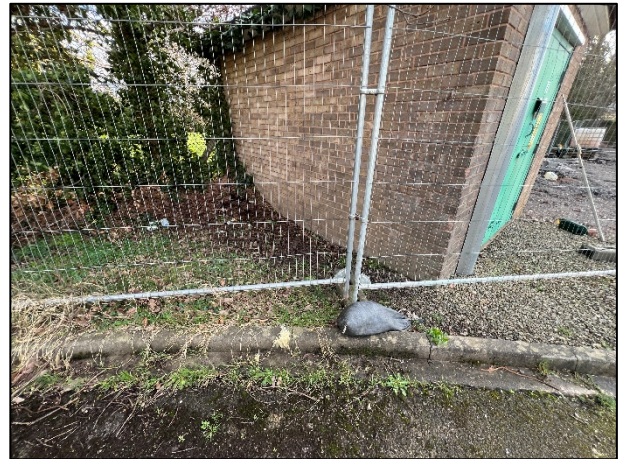
*Photograph 2: North west side of electricity sub-station. Photograph taken by Coopers on 2<sup>nd</sup> February 2024*

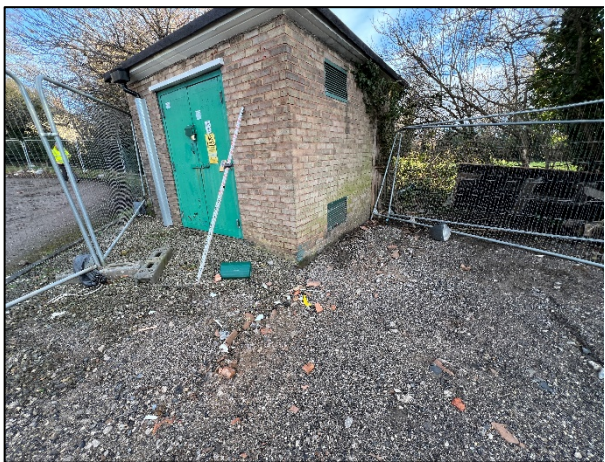
*Photograph 3: South east and south west side with access point to electricity sub-station. Photograph taken by Coopers on 2<sup>nd</sup> February 2024*

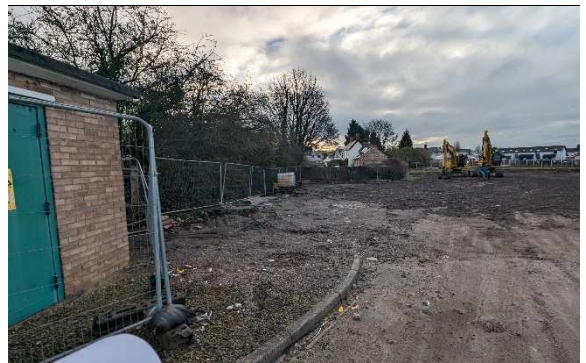
*Photograph 4: View to south east of electricity sub-station, with garage and tarmac stripped. Photograph received by Coopers from Castlemead Group Limited on 31<sup>st</sup> January 2024*

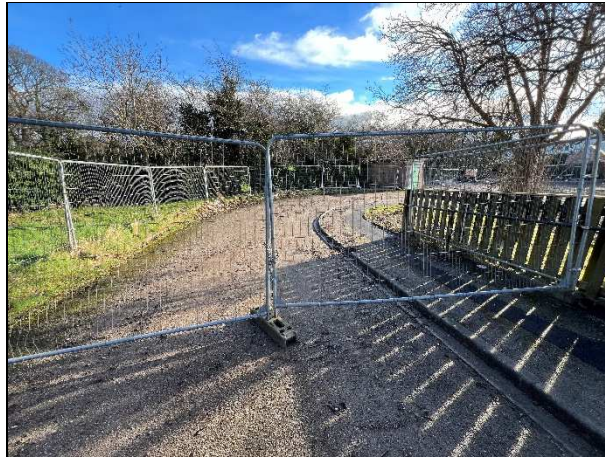
*Photograph 5: View eastwards along site access road towards electricity sub-station. Photograph taken by Coopers on 2<sup>nd</sup> February 2024.*

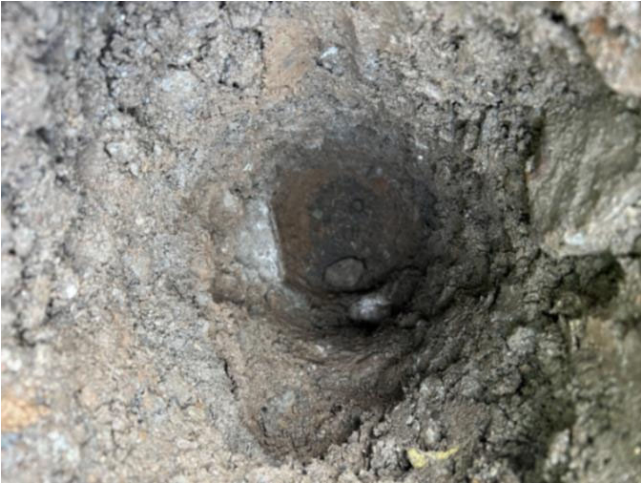
HDTP102

| Depth (m) | Sample / Tests | Water Depth (m) | Field Records | Level (mOD) | Depth (m) (Thickness) | Description | Legend | Water |
|---|---|---|---|---|---|---|---|---|
| 0.20 | JV | | | | (0.65) | MADEGROUND. Greyish brown, sandy, angular to sub-angular, fine to coarse GRAVEL of natural stone. Sand is fine to coarse. Rare inclusions of brick fragments and clay pipe. *Assumed as medium dense. | | |
| 0.50 | JV | | | | (0.65) | Brown, slightly silty, very clayey, fine to medium SAND. *Assumed as loose to medium dense. | | |

Location CAT scanned prior to digging.  
 Sides stable during digging.  
 No groundwater encountered during digging.  
 \*Based upon trenchside stability characteristics.  
 HDTP locations shown on Coopers Drawing No. 7962/01.  
 Backfilled with arisings upon completion.

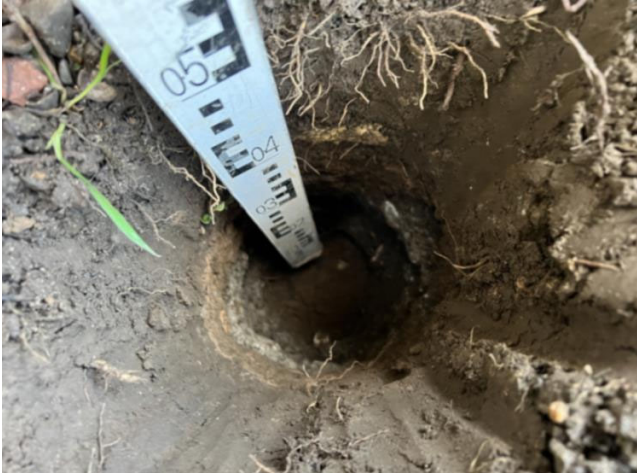
| 0.20 | JV | | | | (0.30) | MADEGROUND (similar to topsoil). Dark brown, sandy SILT. | | | |
| 0.50 | JV | | | | (0.25) | MADEGROUND. Greyish brown, sandy, angular to sub-angular, fine to coarse GRAVEL of natural stone. Sand is fine to coarse. *Assumed as medium dense. | | | |
| 0.60 | JV | | | | 0.55 | Brown, slightly silty, very clayey, fine to medium SAND. *Assumed as loose to medium dense. | | | |
| <div> <div> <b>Remarks</b><br/> Location CAT scanned prior to digging.<br/> Sides stable during digging.<br/> No groundwater encountered during digging.<br/> *Based upon trenchside stability characteristics.<br/> HDTP locations shown on Coopers Drawing No. 7962/01.<br/> Backfilled with arisings upon completion. </div> </div> | | | | | | | | | |
