**Pen Y Palmant, Minera**

## Pre-Planning Structural Inspection Report

RP 100870-001

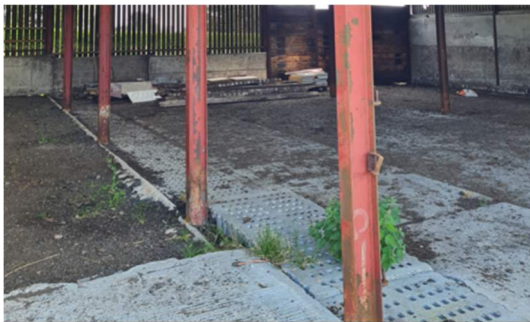
*Observation 1: Building 1*

- Signs of vegetation growing inside the structure through the ground floor slab
- Signs of deterioration to the paintwork

| Typical Defect/Observation | Comments and likely remedial action |
|---|---|
| Steel work showing signs of minor surface corrosion | <ul style="list-style-type: none"> <li>Clean steelwork where needed and apply a fresh coat of protective paint to the surface to ensure the surface is protected against corrosion</li> </ul> |

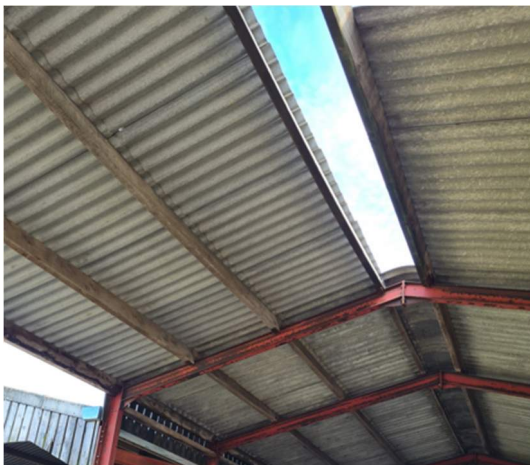
*Observation 2: Building 2*

- Sections of roof missing

| Typical Defect/Observation | Comments and likely remedial action |
|---|---|
| Missing and damaged sections of roof | <ul style="list-style-type: none"> <li>As part of the refurbishment works the damaged and missing roof panels should be replaced and any exposed structural timber members checked for signs of rotting and replaced locally if required</li> </ul> |

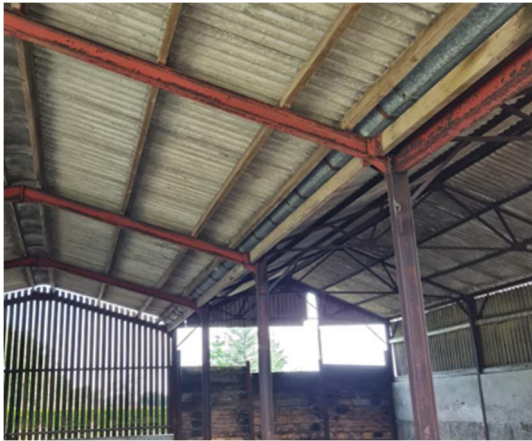
*Observation 3: Building 2*

- *Signs of deterioration to paint to steelwork*

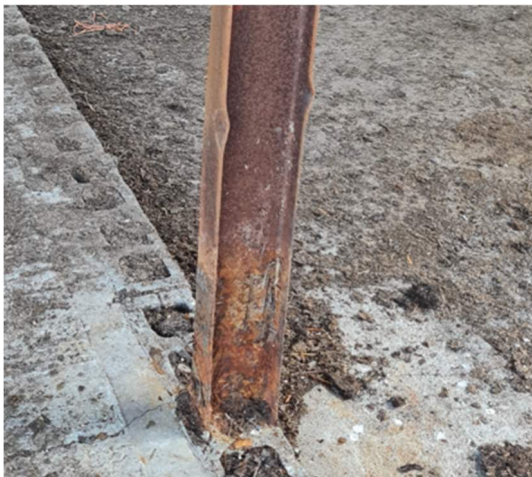
*Observation 4: Building 2*

- *Damage to column.*
- *Minor surface corrosion*

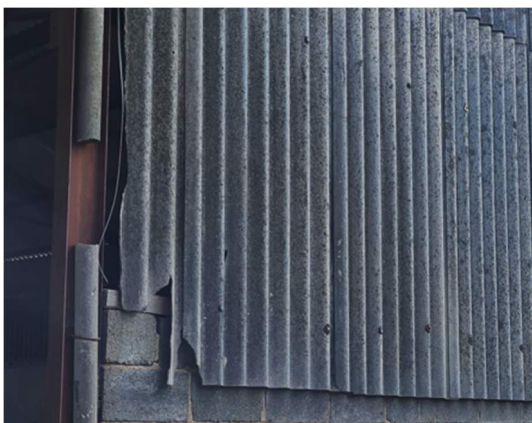
*Observation 5: Building 2*

- *Damaged sections of cladding*

| Typical Defect/Observation | Comments and likely remedial action |
|---|---|
| Damaged and missing cladding | <ul style="list-style-type: none"> <li>As part of the refurbishment works the damaged and missing cladding panels should be replaced and any exposed structural timber members checked for signs of rotting and replaced locally if required</li> </ul> |

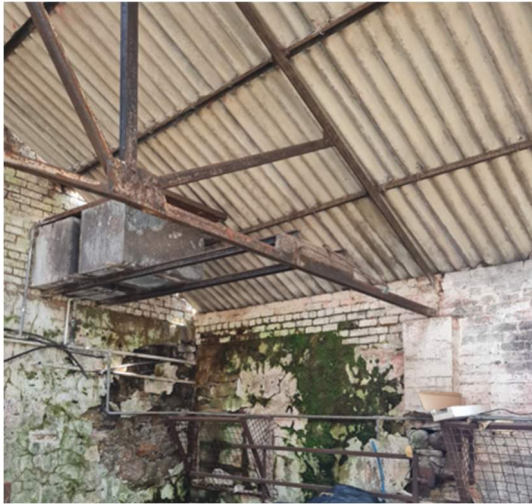
*Observation 6: Building 3*

- *Damp staining to masonry*
- *Missing/eroded mortar.*

| Typical Defect/Observation | Comments and likely remedial action |
|---|---|
| Cracked, damaged and eroded brickwork | <ul style="list-style-type: none"> <li>Brick work was observed to be damaged with missing or eroded bricks on building locations and cracked and eroded mortar joints.</li> <li>As part of the refurbishment works, localised repairs will be required to make good these areas of masonry.</li> <li>Damaged, cracked or eroded mortar joints will require re-pointing.</li> </ul> |
| Damp and mould to infill walls | <ul style="list-style-type: none"> <li>Due to exposure conditions damp and mould is evident. Walls to be cleaned to remove staining</li> </ul> |

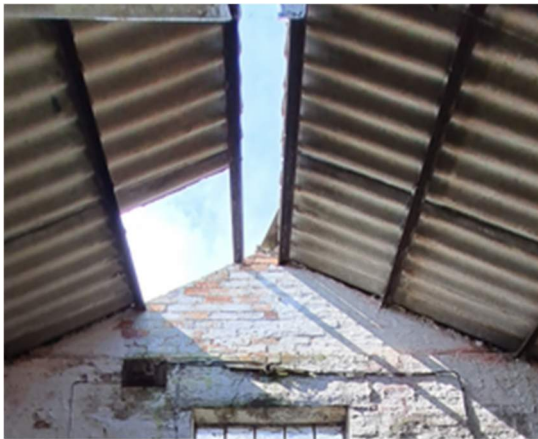
*Observation 7: Building 3*

- *Sections of roof missing*

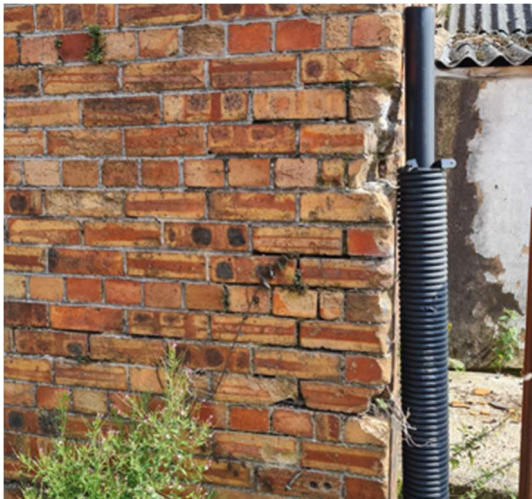
*Observation 8: Building 3*

- *Erosion to mortar joints.*
- *Missing sections of masonry.*
- *Signs of vegetation growth to lower courses of masonry.*

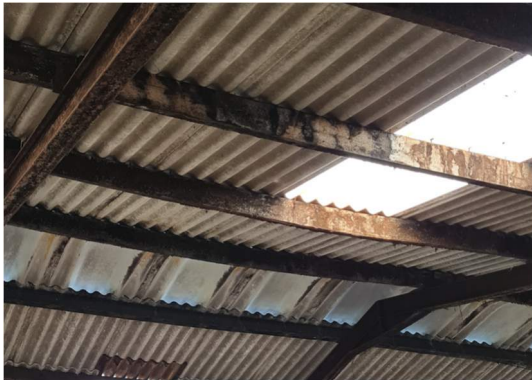
*Observation 10: Building 4*

- *Sagging timber purlins*

| Typical Defect/Observation | Comments and likely remedial action |
|---|---|
| Rotting and deflecting roof rafters | <ul style="list-style-type: none"> <li>Timber roof structure members show signs rotting, with some cases causing excessive deflection, these will need to be replaced.</li> </ul> |

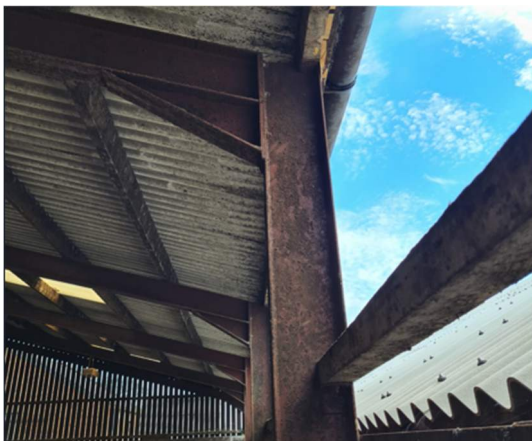
*Observation 11: Building 5*

- *Deteriorating paintwork*

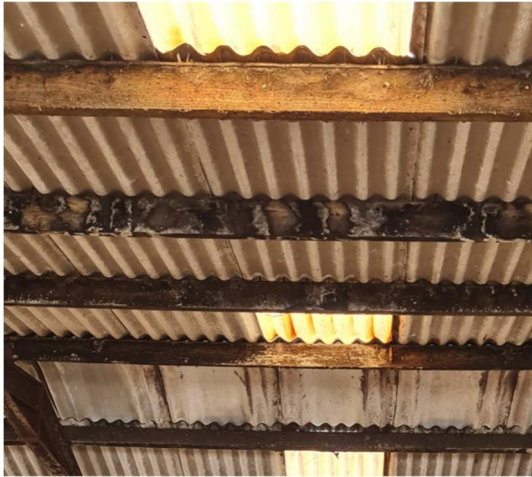
*Observation 12: Building 5*

- *Timber rafters showing clear signs of deterioration*

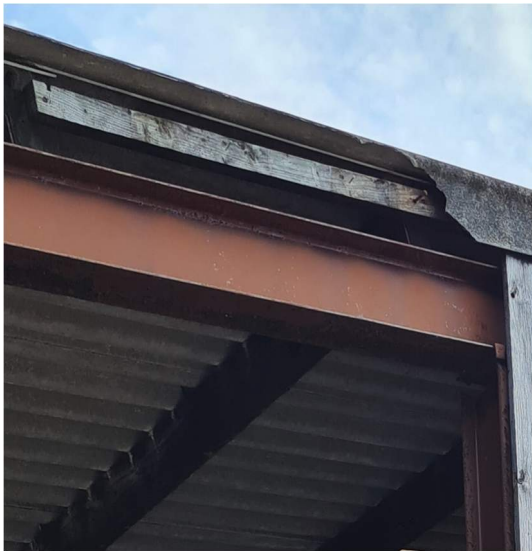
*Observation 13: Building 5*

- *Section of roof damaged exposing timber rafters*

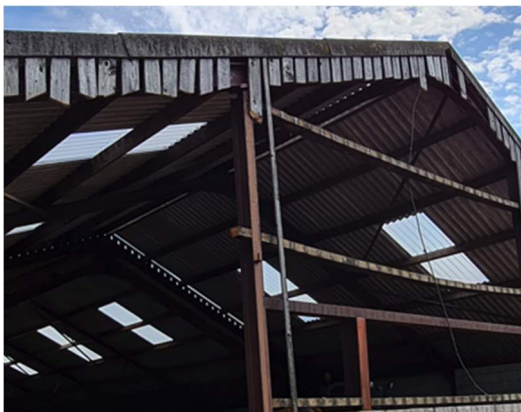
*Observation 14: Building 6*

- *Missing cladding*

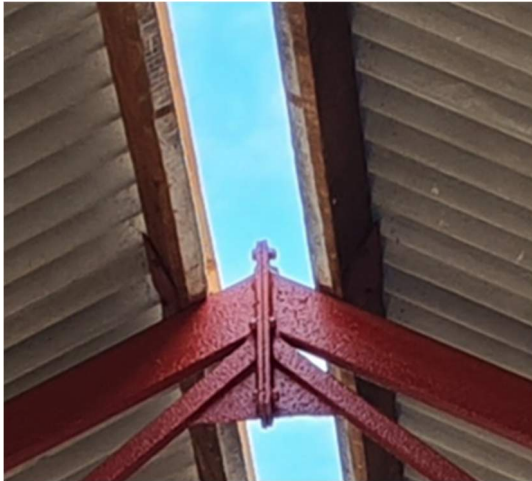
*Observation 15: Building 6*

- *Section of roof missing*

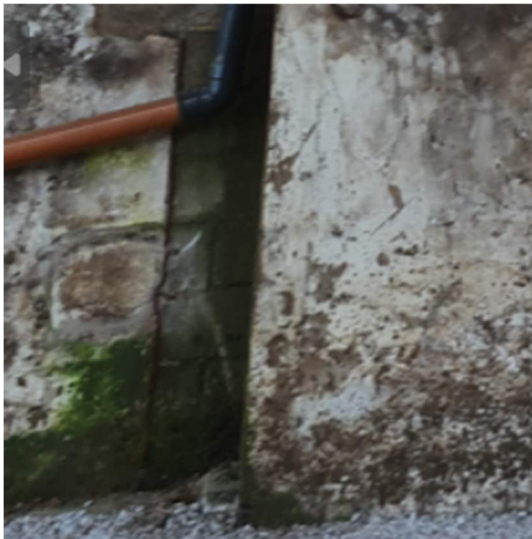
*Observation 16: Building 6*

- *Damp staining to masonry*
