# Structural Engineers Report For:

Plas Nantyr, Farm Office and Staff Facilities  
Nantyr. LL20 7DD

## STRUCTURAL SURVEY

**REF: N2815-01**

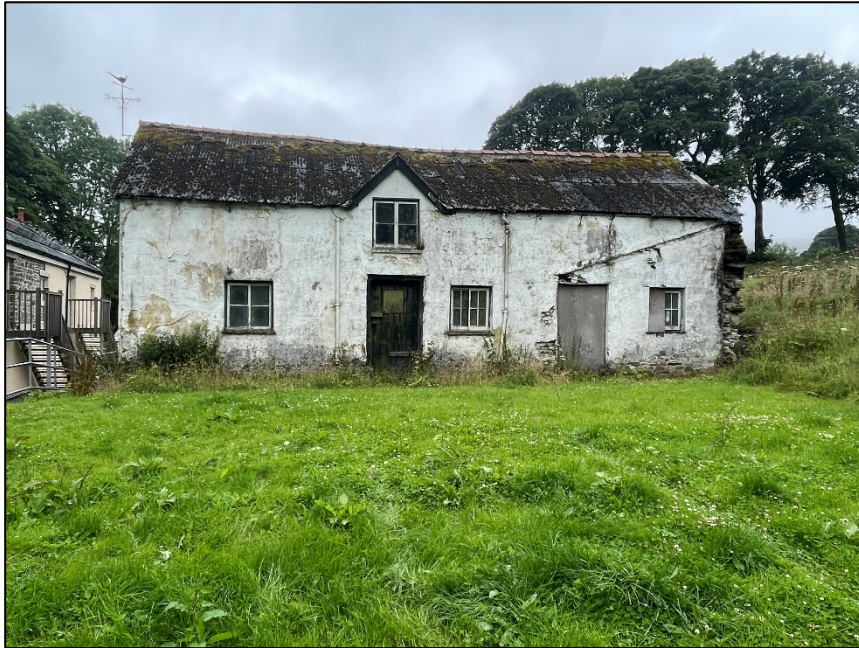
Photograph 1

This barn is a detached two storey building, located near Plas Nantyr Manor House. The building in question was once used as an office and staff facilities building (**photograph 1**).

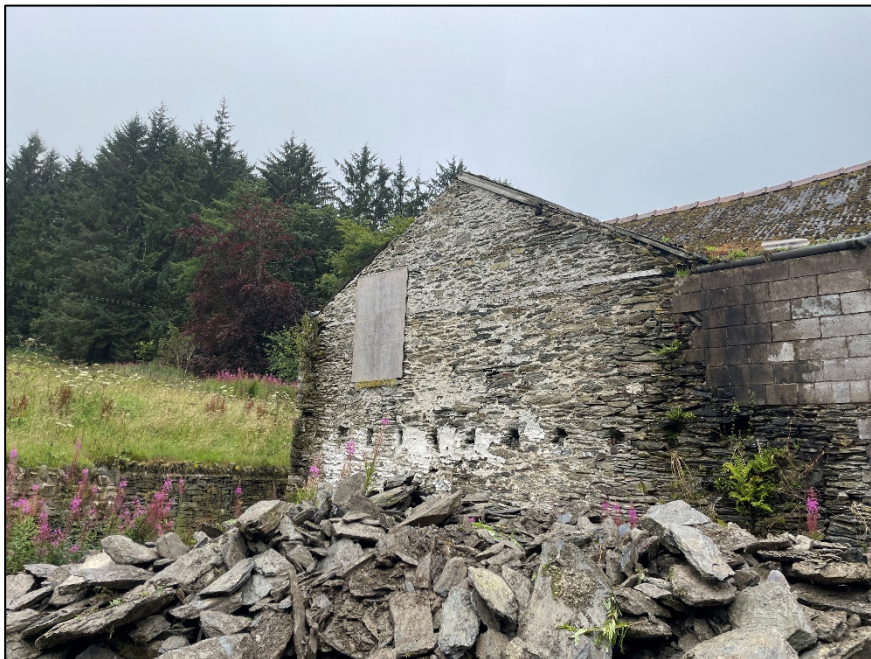
Photograph 2

The building consists of a duo pitched roof, with a small front gable above the front entrance door. There is also a gable at the rear of the property with an intersecting roof (**photograph 2**).

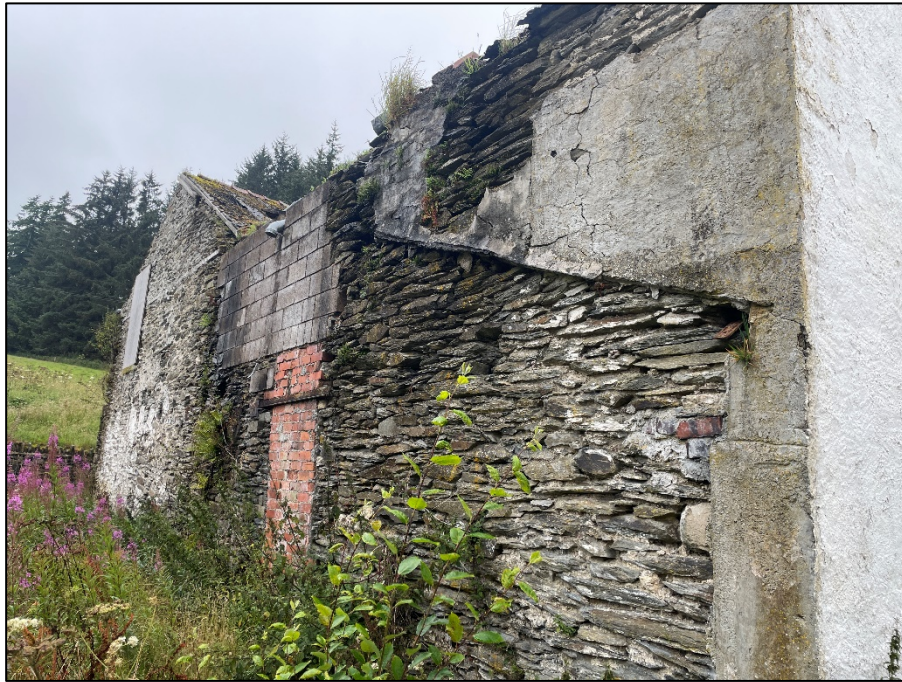
Photograph 3

There is also a sloping render line, along the rear face of the rear elevation (**photograph 3**), which suggest that some type of lean-to building was abutting the rear elevation at some point in the past. Similar sign could be found at the front elevation, which suggest that a lean-to building had presence here also.

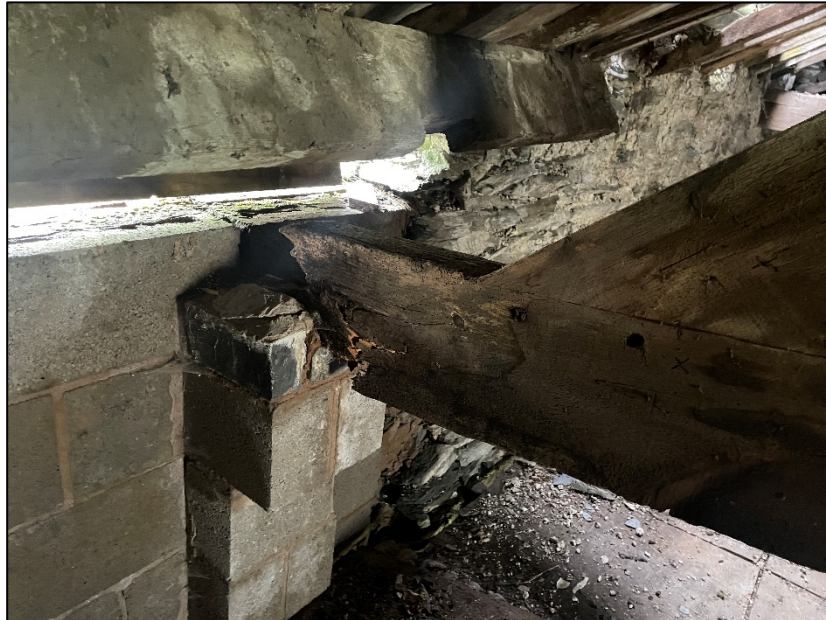
Photograph 4

Internally, the roof structure appeared to be in a poor structural condition. The central timber king post truss appeared to be significantly rotted at the bearing at rear elevation (**photograph 4**). Wet rotting at the bearing of the king post truss was apparent at location of historical rebuild of the rear elevation wall. This suggest that possibly, the roof at this location was once defective and leaking, allowing water into the rear elevation wall, and subsequently causing some movement and water ingress into the property. Hence localised rebuild.

Overall, we would comment that the roof structure has passed the end of its life and therefore requires rebuilding.

- It is recommended that the main roof structure is upgraded with modern construction, such as timber rafters and ridge beam to accommodate the increased loading from insulation and plasterboard. Subject to the architect/ council's requirements, the finishing of the roof can stay as corrugated sheeting or slates, fixed onto new treated battens, vapour-porous sarking membrane and insulation underneath to the architect's specification. It is not possible to reinstate the timber truss due to wet rotting. The new rafters should be fixed on to a timber wall plate, fixed down the external front and rear elevations of the property with stainless steel straps at 1.5m centers.

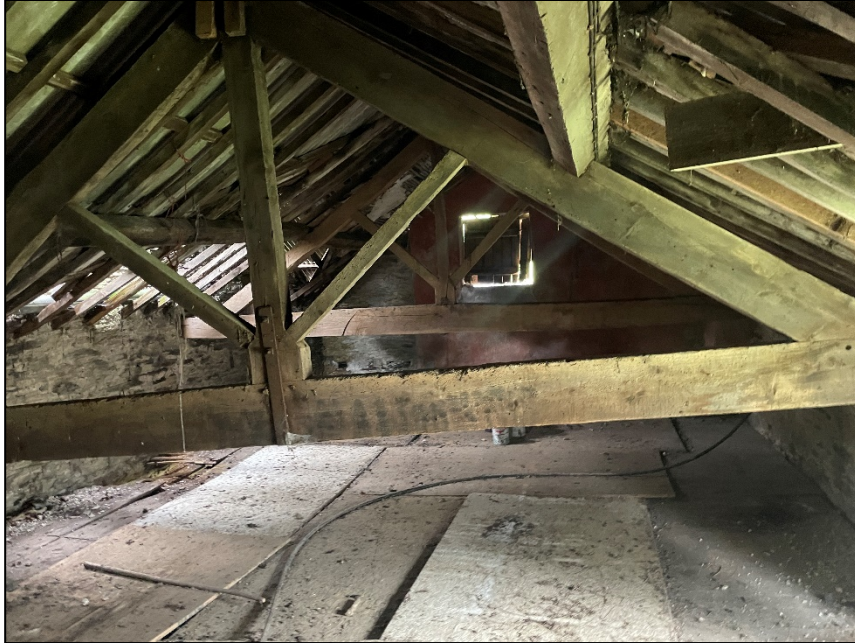
Photograph 5

The defective bearing of the king post truss had resulted in the truss to drop towards the rear elevation (**photograph 5**).

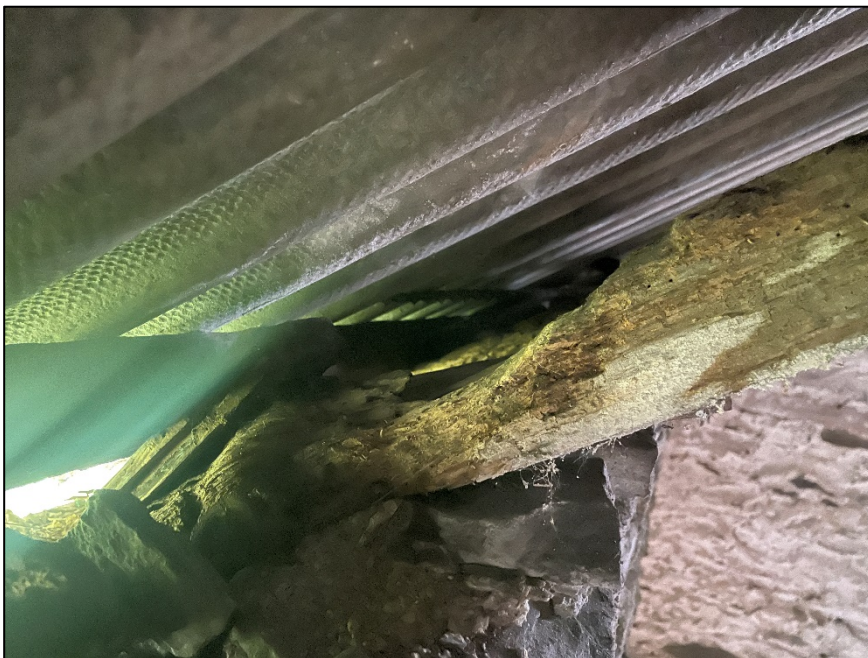
Photograph 6

Other bearing, towards the front elevation of a king post truss was also heavily rotted (**photograph 6**).

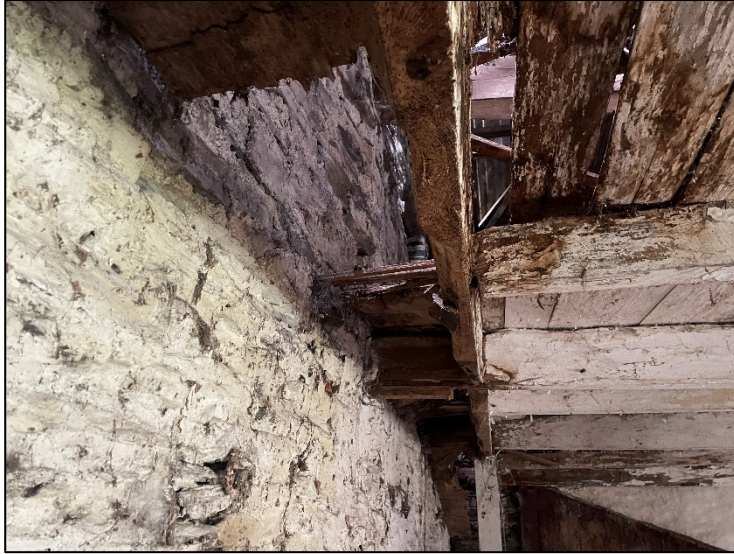
Photograph 7

The timber floors also appear to be of a poor structural condition. Many of the floor timber transfer beams appeared to be heavily rotted, and therefore require replacement (**photograph 7**).

- We recommend that the first floor is upgraded with modern timber joists. The joists should be bearing on to timber wall plate, resin anchor bolted into the internal face of the external walls. The timber wall plate should be 150x50mm C16 and bolted into the wall with M10 resin anchor bolts at 450mm centers. We would also recommend running the breathable membrane behind the timber wall plate to avoid potential rotting.

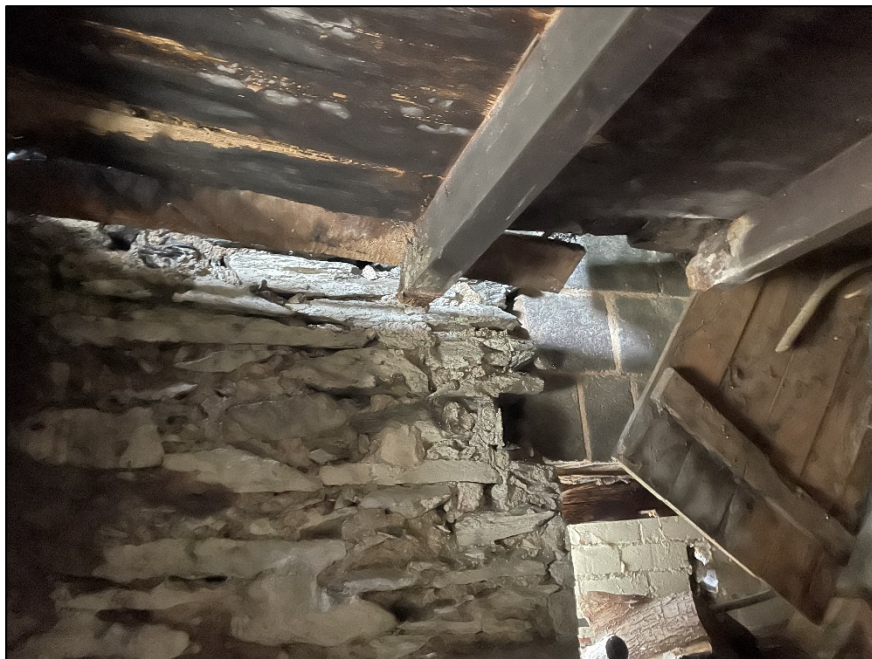
Photograph 8

The timber floor towards the rear elevation, below the location of rotted king post truss has partially collapsed. This has occurred likely due to persistence water ingress rotting the timber joists and transfer beams and subsequently causing them to collapse (**photograph 8**).

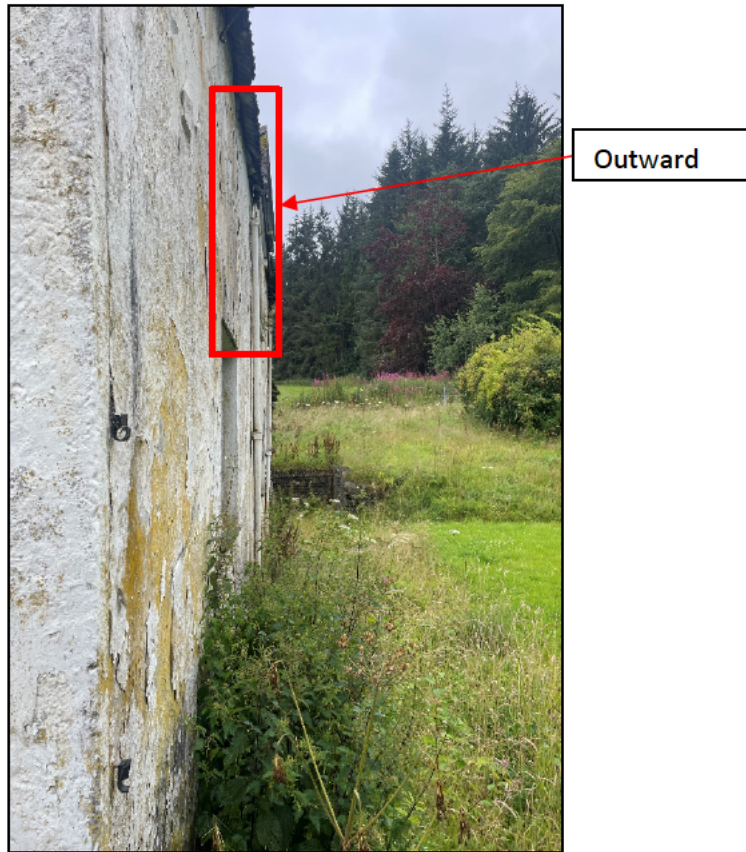
Photograph 9

At the front elevation, the wall panel above the front door appears to be bowing outward slightly (**photograph 9**). This typically is a result of outward force exerted by the roof structure, usually due to deflecting purlin members.

- The perimeter of the eaves should be capped using steel A252 mesh in 200mm deep layer of lean mix concrete, after all loose stonework is removed. This capping concrete tie will act as a tie for the whole external walls of the building to avoid any further outward leaning, whilst keeping water out from the wall construction.

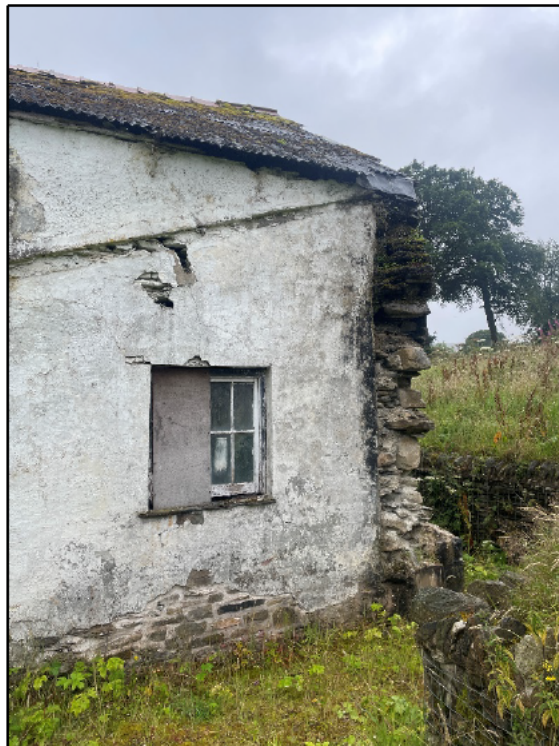
Photograph 10

As previously mentioned, there was once an extension extending out from the front-right hand side of the building. Since the demolition/ collapse of this extension, the corner of the remaining building has been left open, where originally the extension walls were toothed into the main wall. This corner has been left open, without capping as seen in **photograph 10**.

- We suggest that the front right hand corner of the building is tidied up, by re-toothed stonework from front elevation into the side elevation.
- We then recommend installing Helifix Helibars across the re-toothed front corner of the building. The location of the required stitching can be found within **Appendix B – SK01**. Product data sheet for the crack stitching installation can be found within **Appendix C**. The bars should be 6mm in diameter and should pass the end of the corner by a minimum length of 1000mm.
