# Preliminary Roost Assessment

& Nesting Bird Check

8-12 Priory Street

# Gritstone Ecology

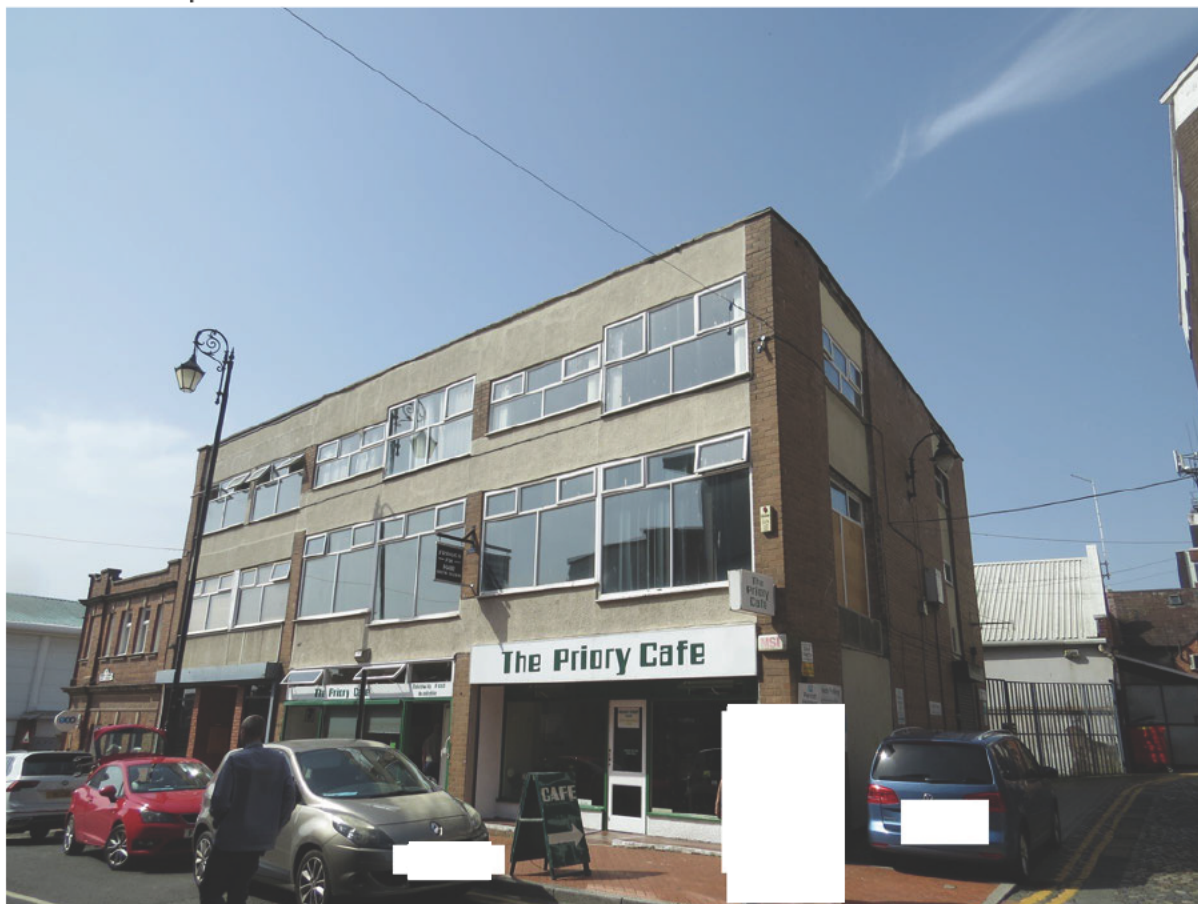
3.1a – The front of the building from Priory Street.

Nº8-12 priory Street, Wrexham, is a three storey building, with commercial premises on the ground floor, and unoccupied units above. It has a flat felt-covered roof, with brick palisade walls, covered with concrete capping stones. Timber fascia boards are fitted at the rear.

There are no chimneys, and no lead flashing is fitted. Walls are solid brick, with a painted cement render to the front. Lintels are concrete, sills are UPVC. Window and door frames are UPVC; all glass is intact.

The building is well maintained, and in good condition. The roof is in good condition with no gaps between materials. Capping stones on the palisade walls are fixed tightly with no gaps. Walls are in good condition, with no missing mortar or cracks.

There are no features externally which are likely be used by roosting bats, and no evidence of use by bats was present during the inspection.

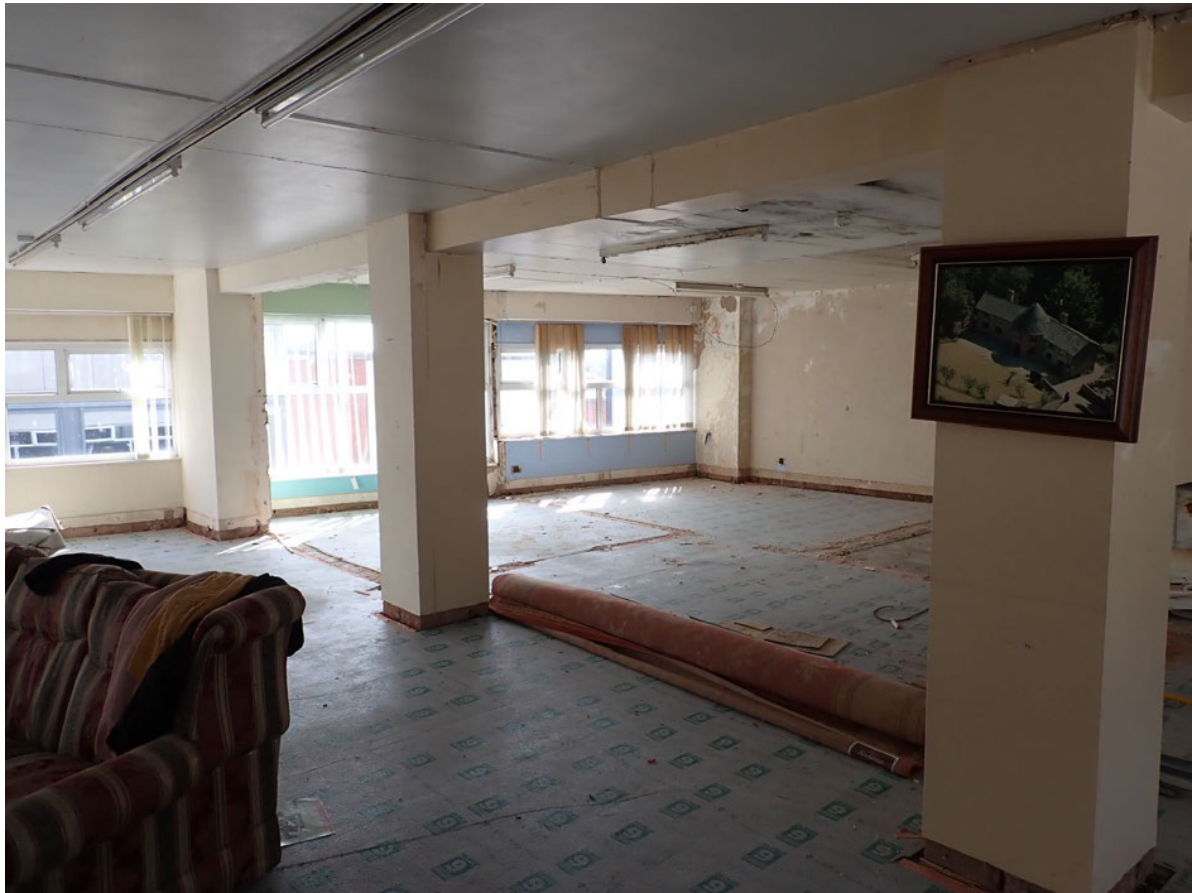
3.2a – The upper floor of the building.

The building has a flat roof with no enclosed roof voids. The upper floors of the building were in use until recently, and are filled with natural light through the windows. The ground floors are in operation as commercial premises.

The building is in good condition, and there are no gaps which could give access to roosting bats, or nesting birds.

The building has no cellar, and there are no other enclosed spaces which are suitable to be used by roosting bats.

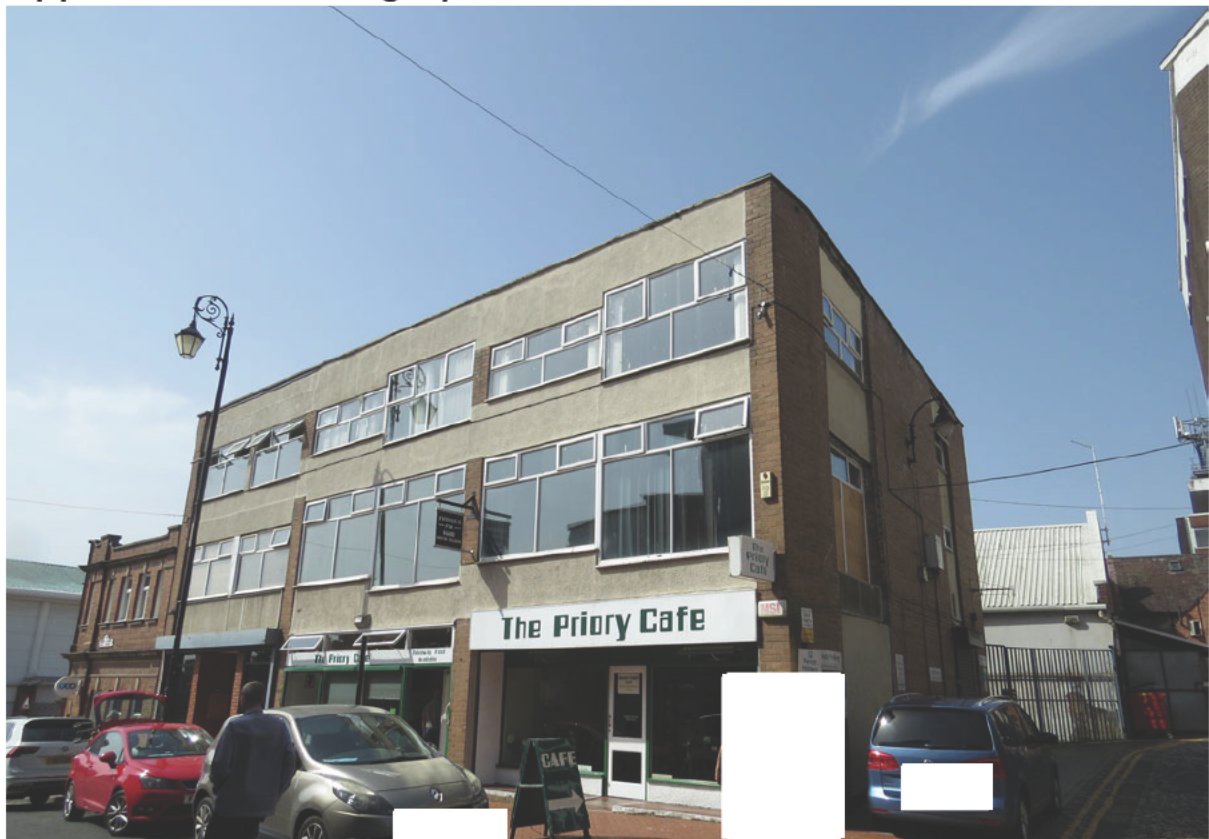
1 – The front of the building from Priory Street.

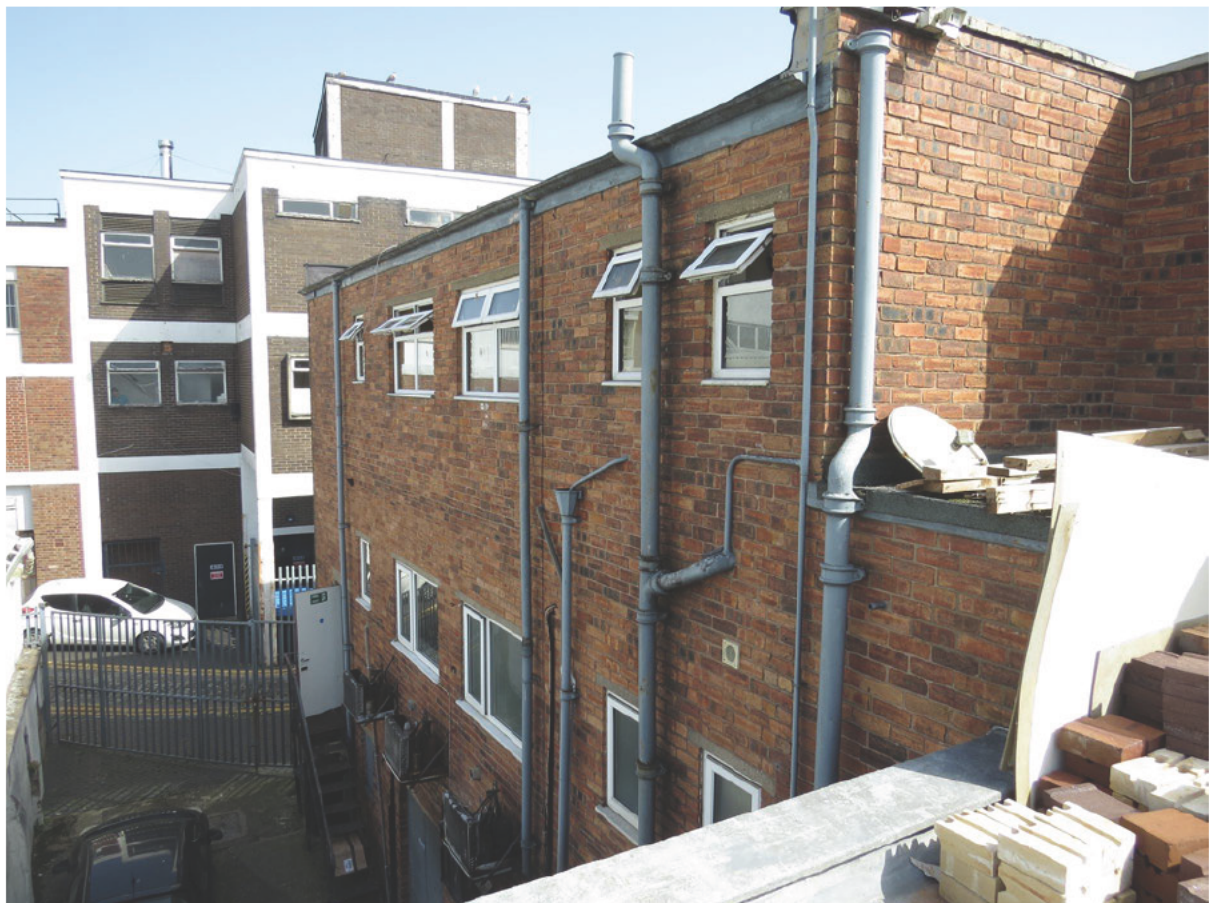
2 – The rear of the building and yard from the roof.

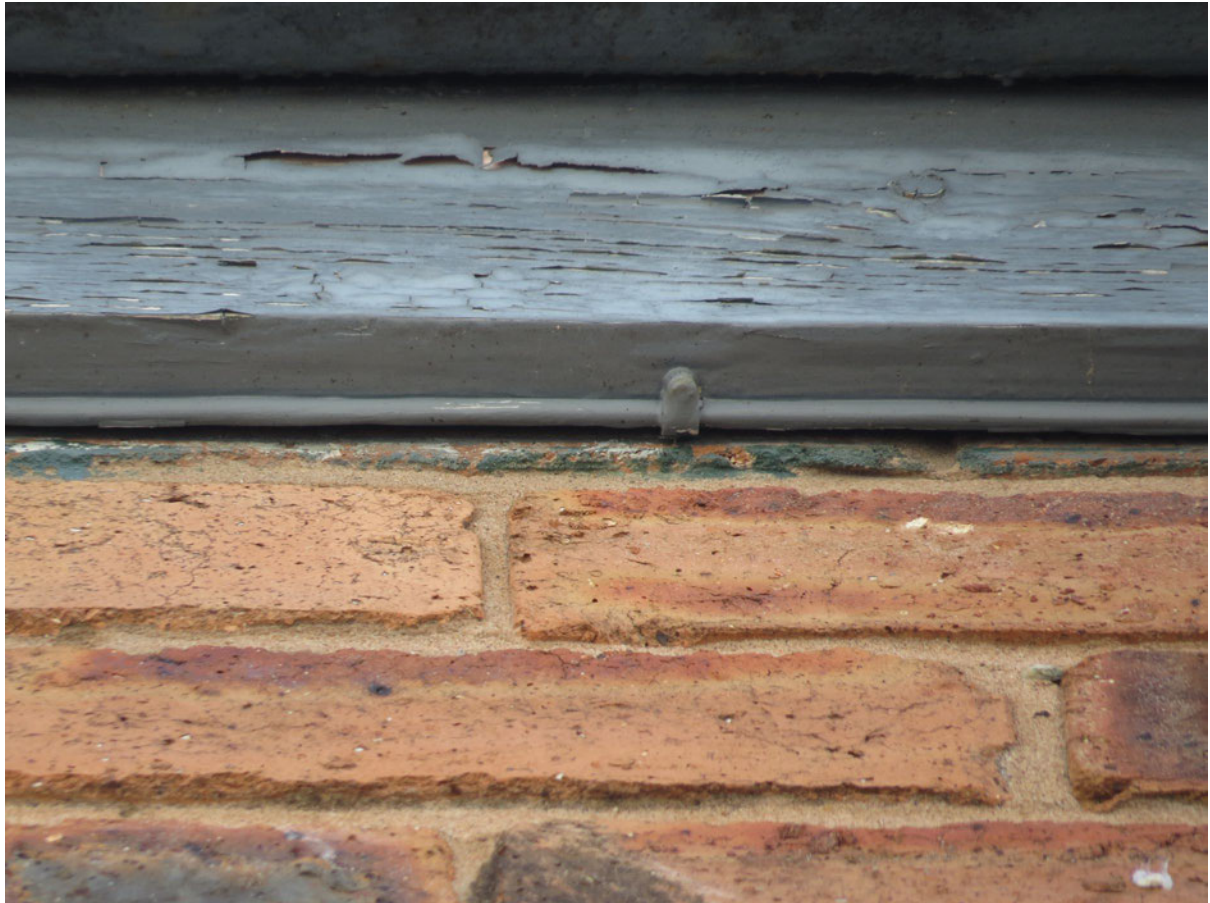
3 – Fascia boards at the rear are in good condition with no suitable gaps.

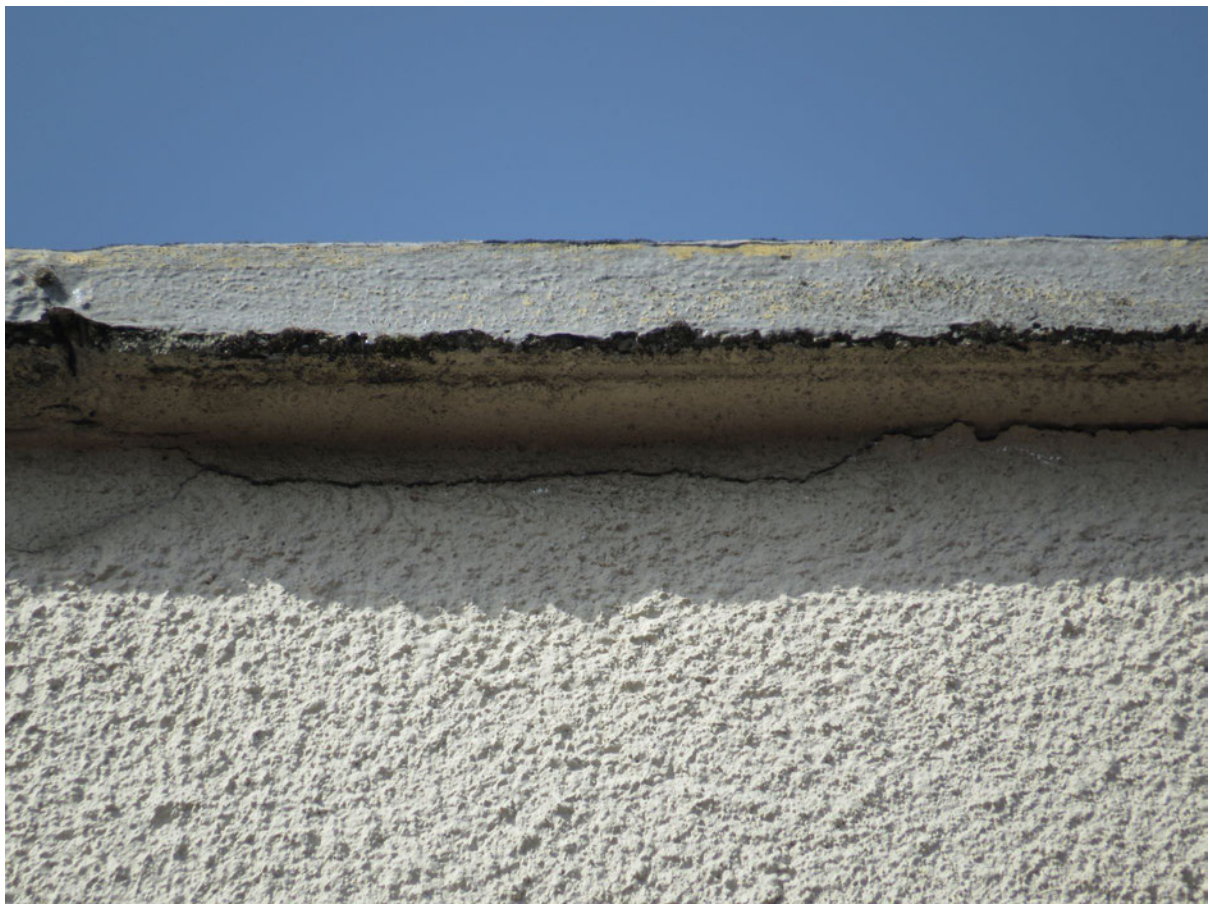
Roofing materials are in good condition, with no gaps between materials. Coping stones on the parapet walls are fixed in place with cement. There are no gaps between roofing materials which could be used by roosting bats.

4 – Parapet walls are sealed with coping stones with no gaps between materials.

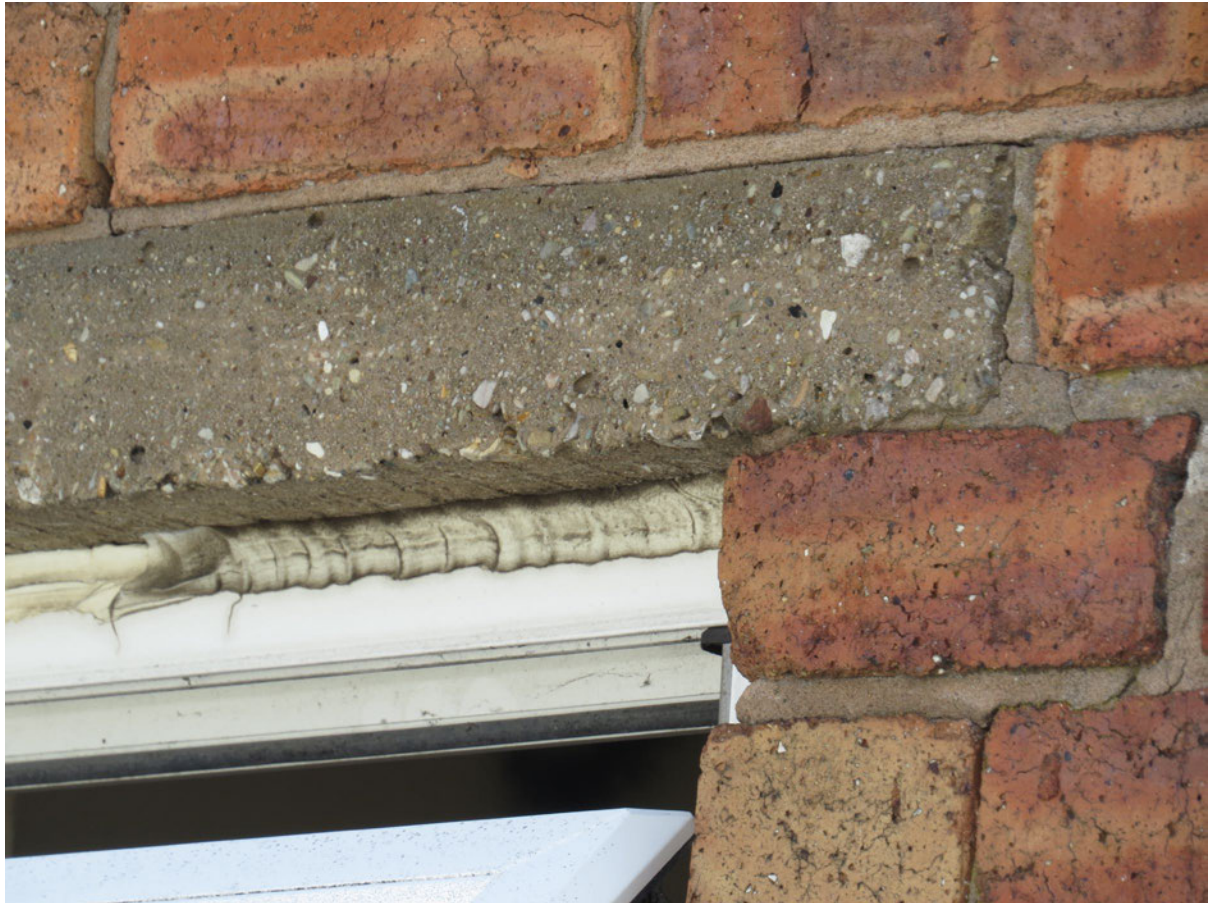
5 – Lintels are concrete, and are fixed into the walls with no suitable gaps.

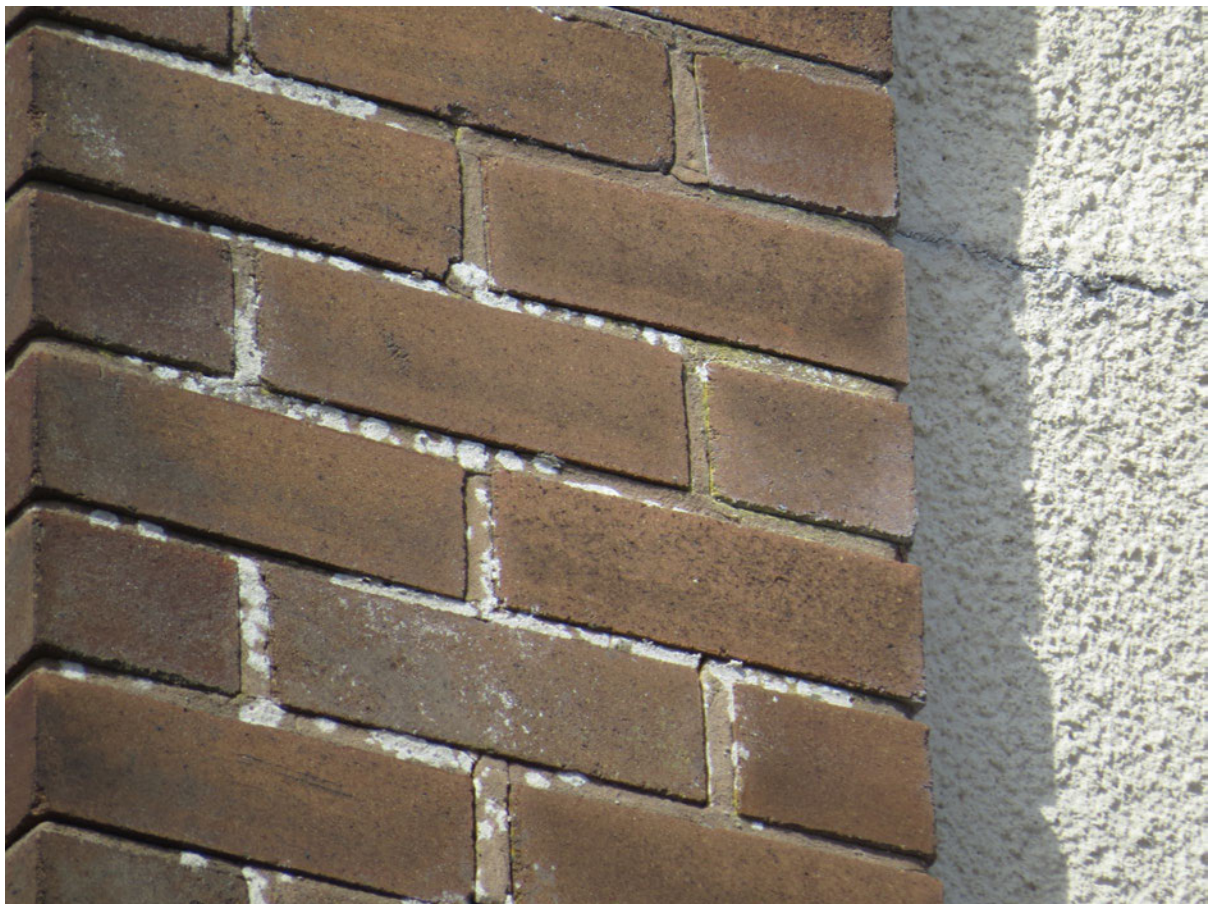
The walls are solid brick with no insulating cavity. Walls are in good condition, with no cracks, or missing mortar which could be used by crevice dwelling bats.

6 – Brickwork and render are in good condition with no suitable gaps.

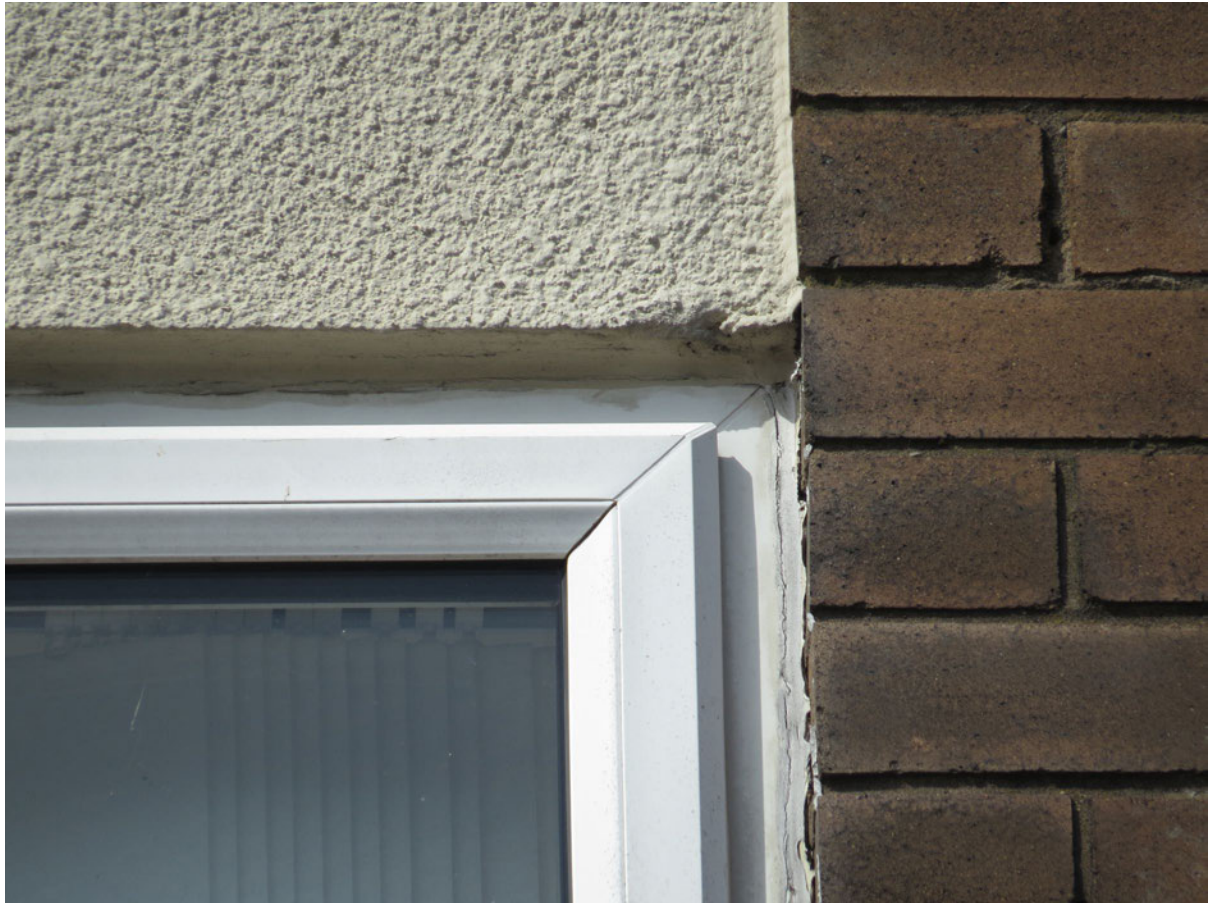
Window and door frames are fixed into the brickwork, gaps are filled with cement, or sealant, and offer no suitable roosting opportunities.

7 – Window and door frames are sealed tightly into brickwork with no suitable gaps.

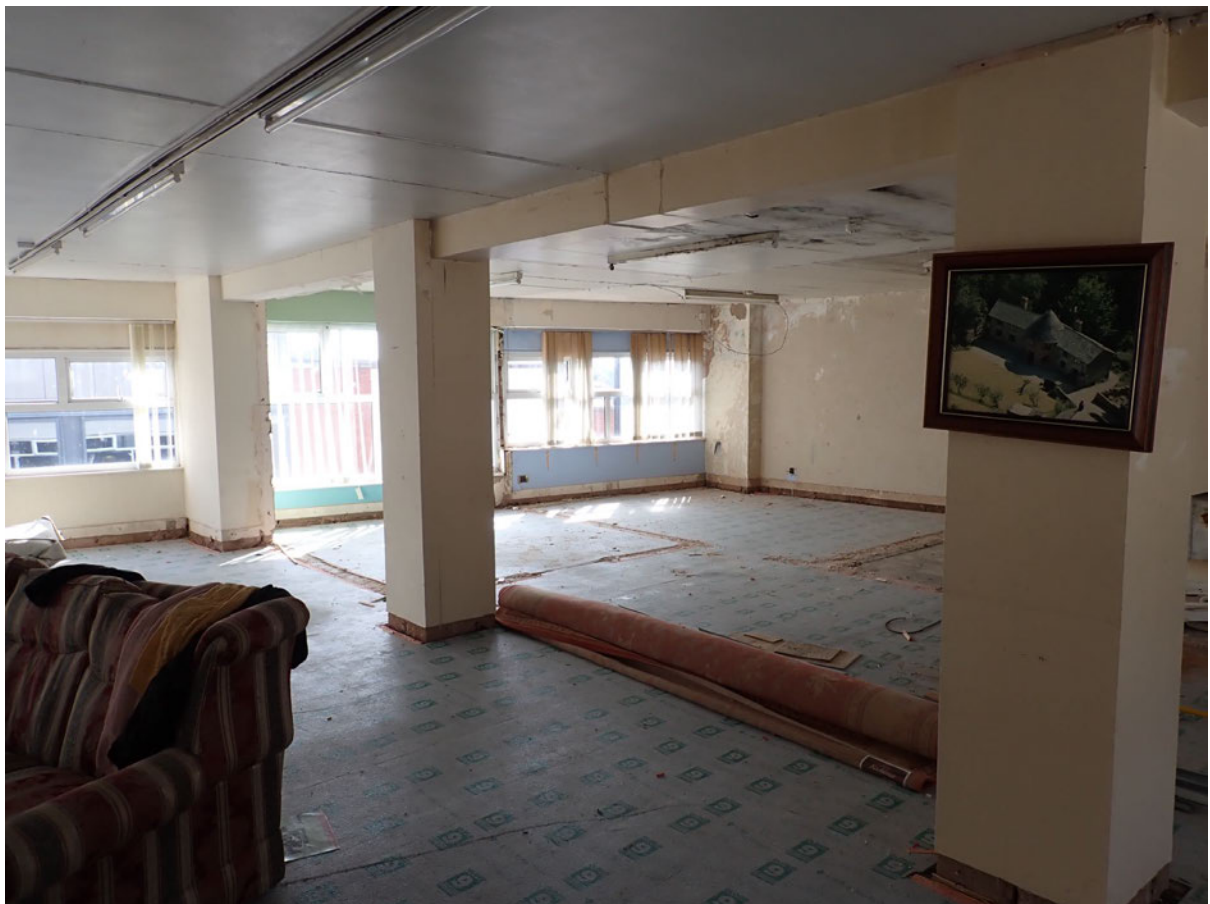
8 – There are no roof voids and the building is filled with natural light.

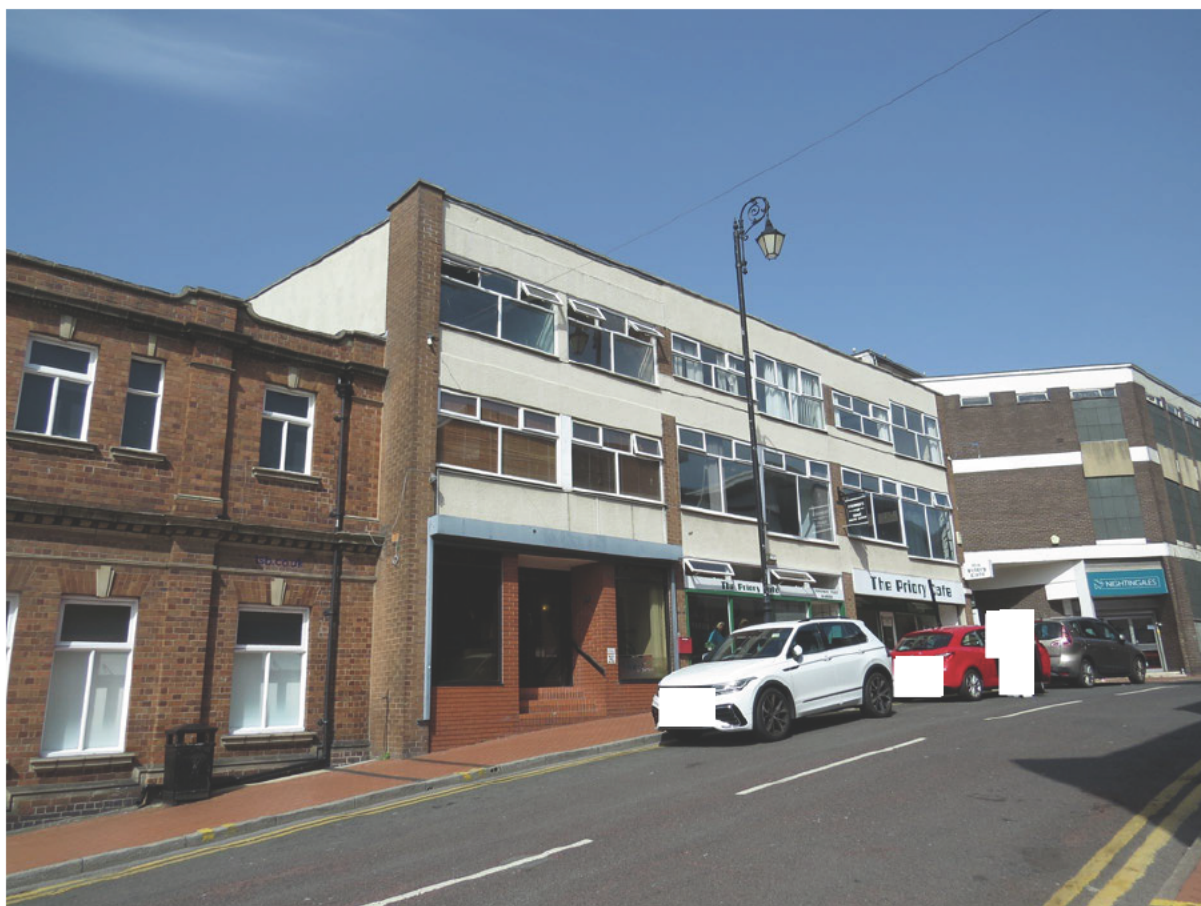
9 – The building is in a busy town centre location.

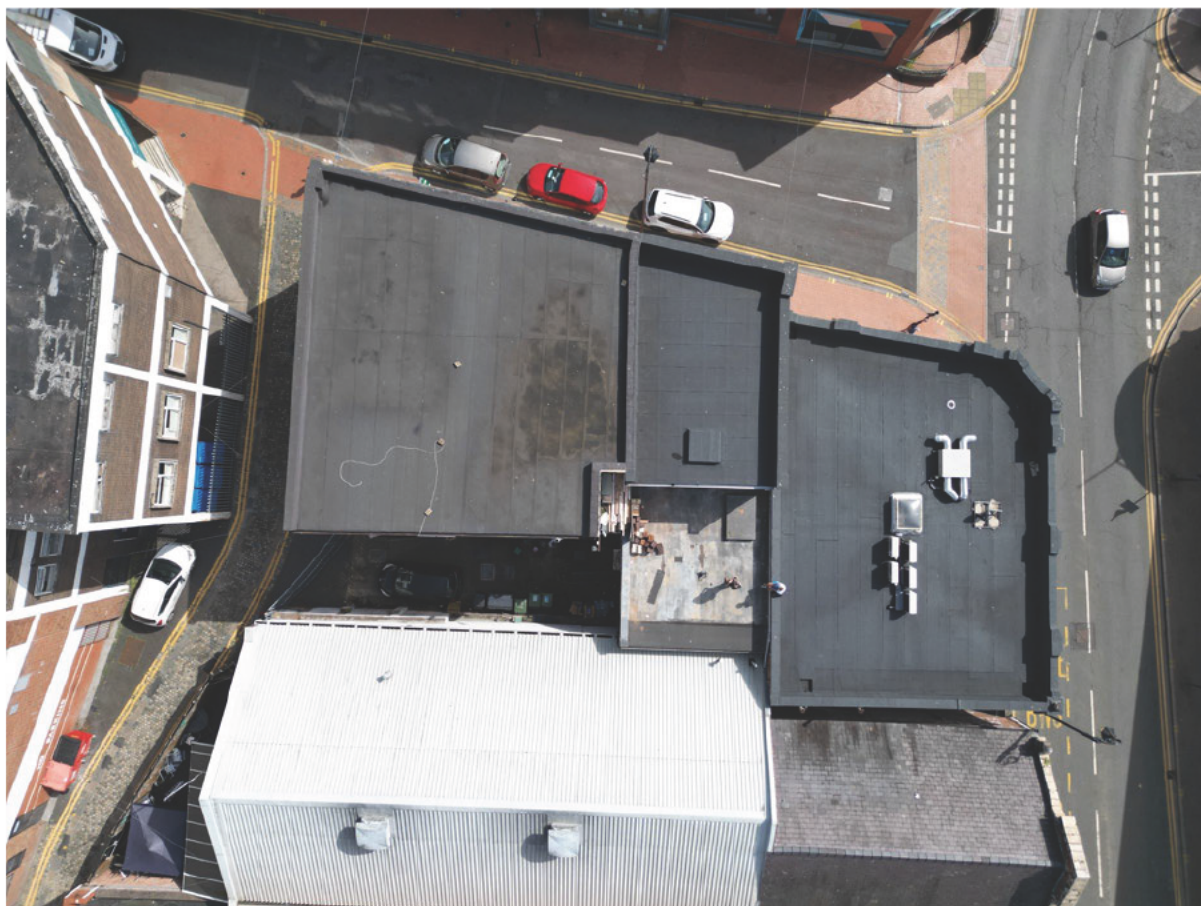
10 – The roof is in good condition with no gaps between materials.
