## Bat Survey Addendum – Tyn Y Coed

Date: 16<sup>th</sup> April 2024

Tyn Y Coed,  
Chester Road,  
Rossett,  
Wrexham

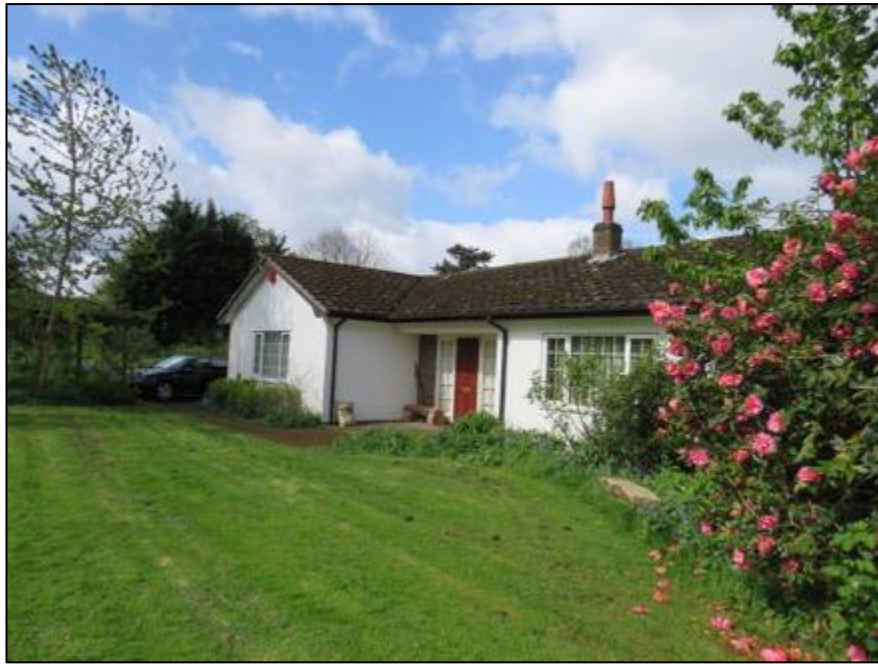
**Photograph 1:** A front view of the building.

The dwelling is in a similar condition externally as the previous visits, with the roof and fabric of the building very well sealed.

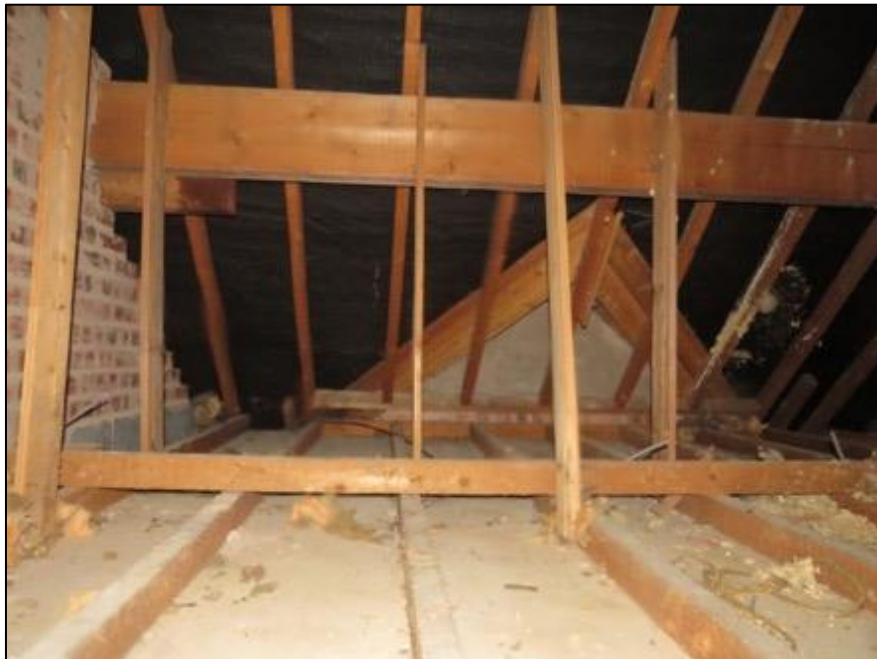
**Photograph 2:** An internal view of the main roof space.

The building configuration has been explained in the previous bat scoping report, and this remains the same. The condition of the building has remained the same since previous survey work. The roof space comprises wooden purlins and rafters supporting the external roof tiles. The floor is boarded. No signs of bats were noted.

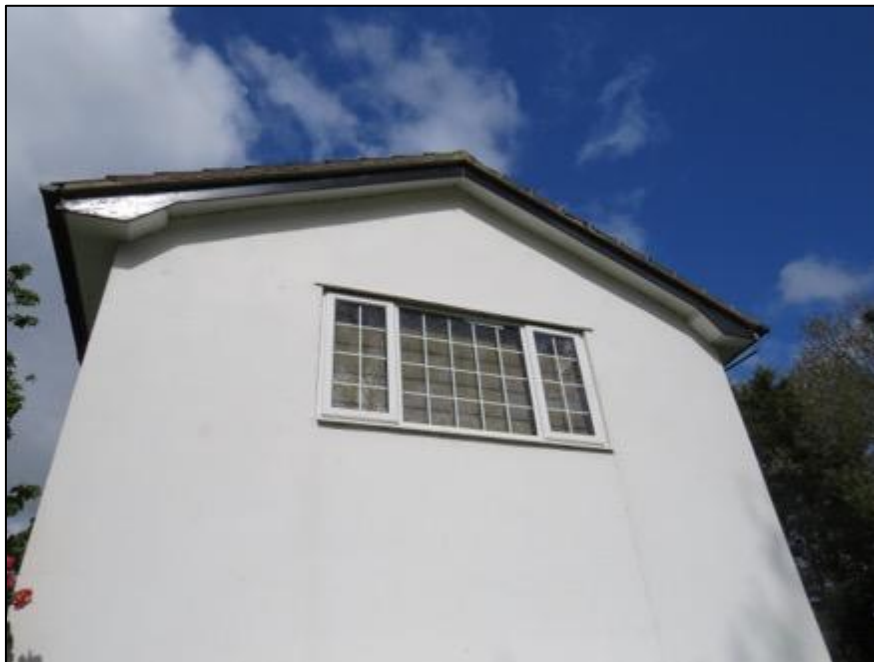
**Photograph 3:** An external view of the main house the facias are all well sealed.

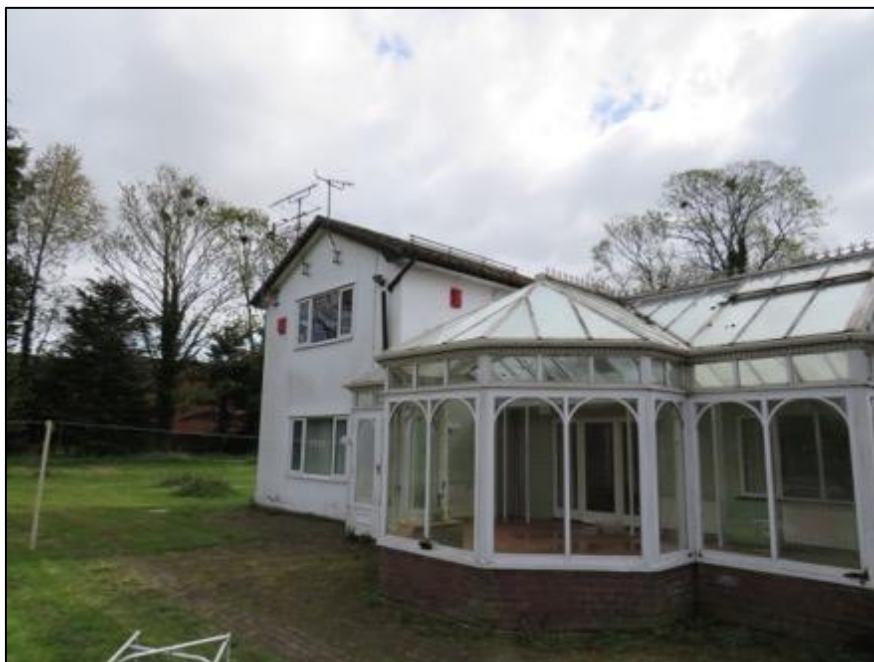
**Photograph 4:** The rear view of the dwelling showing the conservatory.

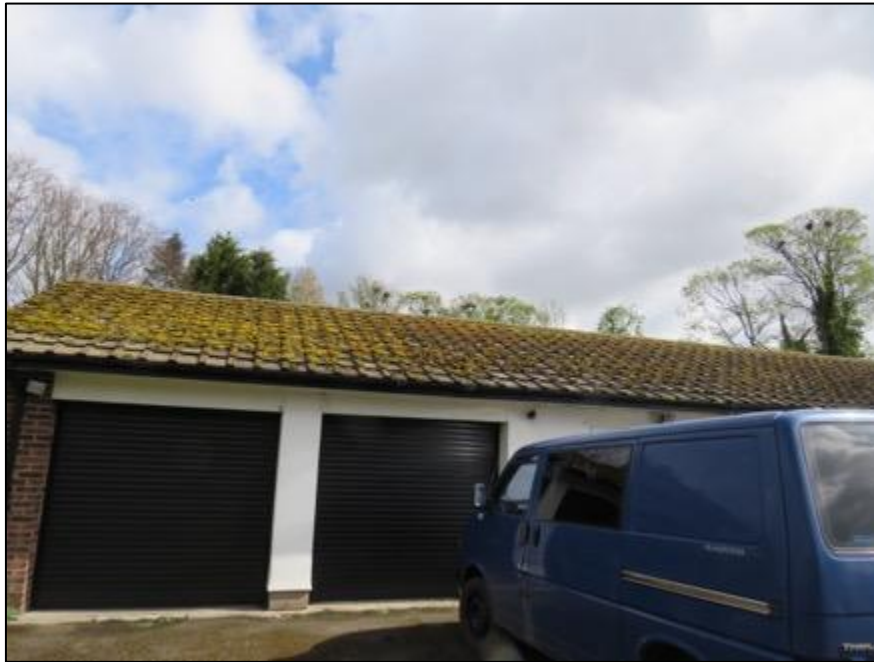
**Photograph 5:** The single storey building contains garages and a small dwelling, this structure is in excellent condition, with no potential bat access points noted.
