# Heritage Impact Statement

Cintra, 39 Salop Road, Overton. LL13 0EH

## Repair & Restore

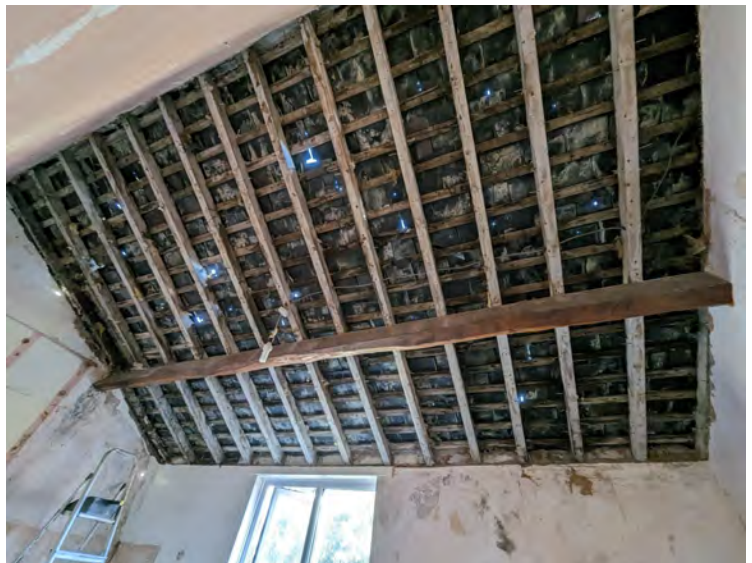
The vaulted ceiling in the back bedroom (photo to the right) and bathroom had visible holes through the plasterboard ceiling where water ran/dripped through every time it rained. The full extent of leaking areas was revealed when the ceiling was removed and revealed more holes than I could count.

All of the roof battens were visibly sodden and rotten along with one of the roof rafters to the far left of the room (shown in the image above) which was crumbling away.

- Scaffolding was erected
- Tiles were removed saving any that could be reused.
- Roof was stripped of rotten battens front & back
- The rotten rafter in the back bedroom was replaced with new air dried oak.
- The rotten oak wall plate in the bathroom was replaced with a new air dried oak wall plate.
- New tandalised roofing battens were fitted
- Breathable felt was fitted to the roof battens
- The roof was re-tiled using the slates that were saved and the rest were reclaimed welsh slate which matched the original slates

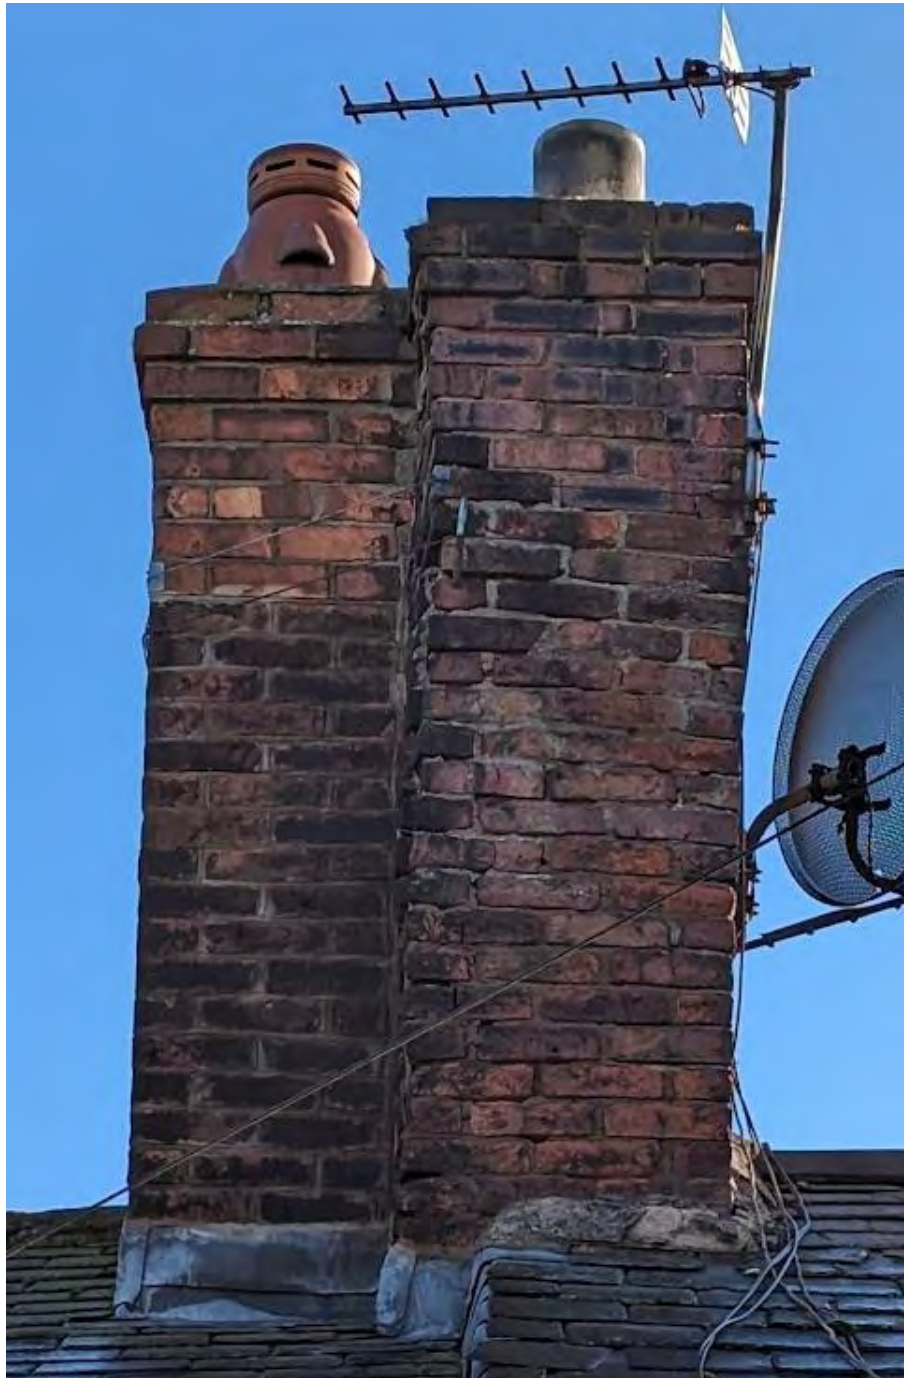
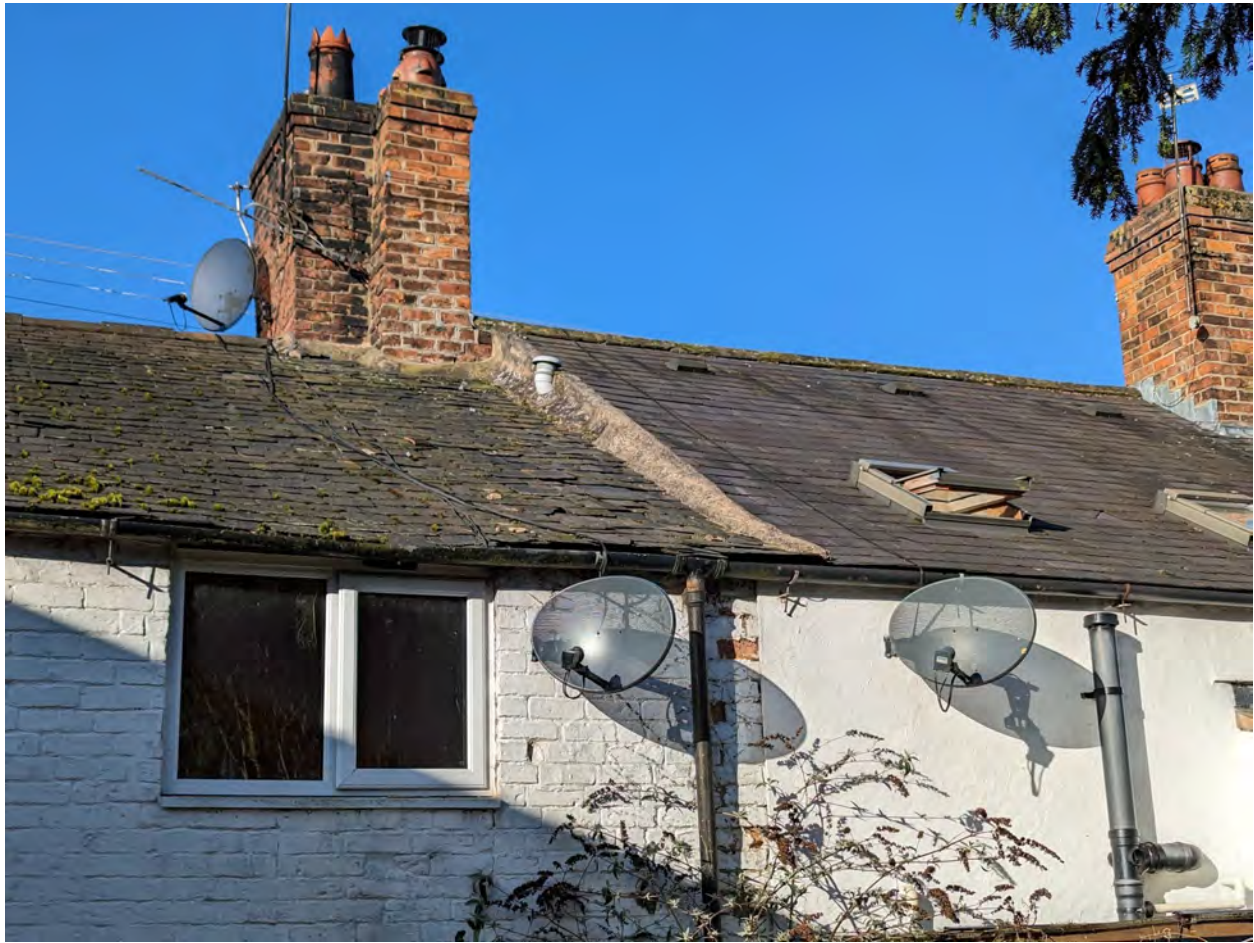
The chimney was starting to lean, had holes in between the bricks, mortar joints disintegrated, and many holes around the base allowing water to pour straight into the attic.

Thankfully none of the chimney bricks needed replacing, it was just all the mortar that needed raking out and repointing with lime mortar in keeping with original materials.. The old chimney pot was broken and not safe to be left up there so that was also replaced with a reclaimed pot.

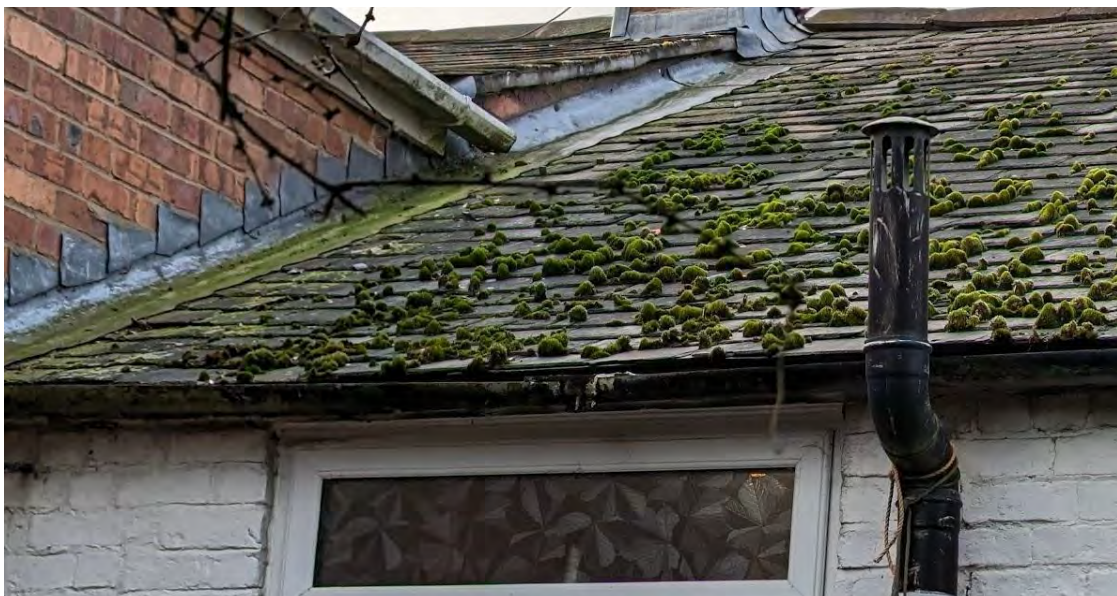
The gutters were cracked and broken and allowed water to pour down the face of the building in many areas.

The gutters were replaced like for like with black UPVC and they sit discreetly under the eaves and there's no visible change in the appearance from the previous ones, except these ones work efficiently.

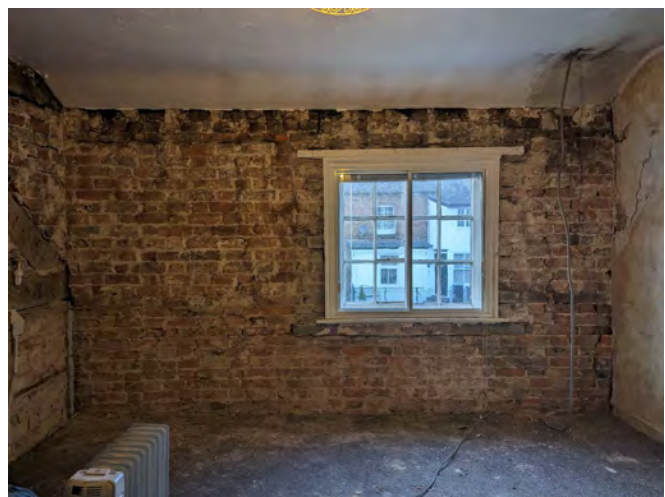
LEFT: The bricks and the wood in the top right corner of the wall and the wood that lead to it was all very damp, wood rot and wood worm.

RIGHT: The whole of this wall was damp, the worst area at the top as you can see how wet it is. The lime plaster had been skimmed over with gypsum

and further repairs, then woodchip, lining paper and then a type of thin polystyrene wall paper. All of which was probably done in an attempt to cover up the damp patches but only made things worse.

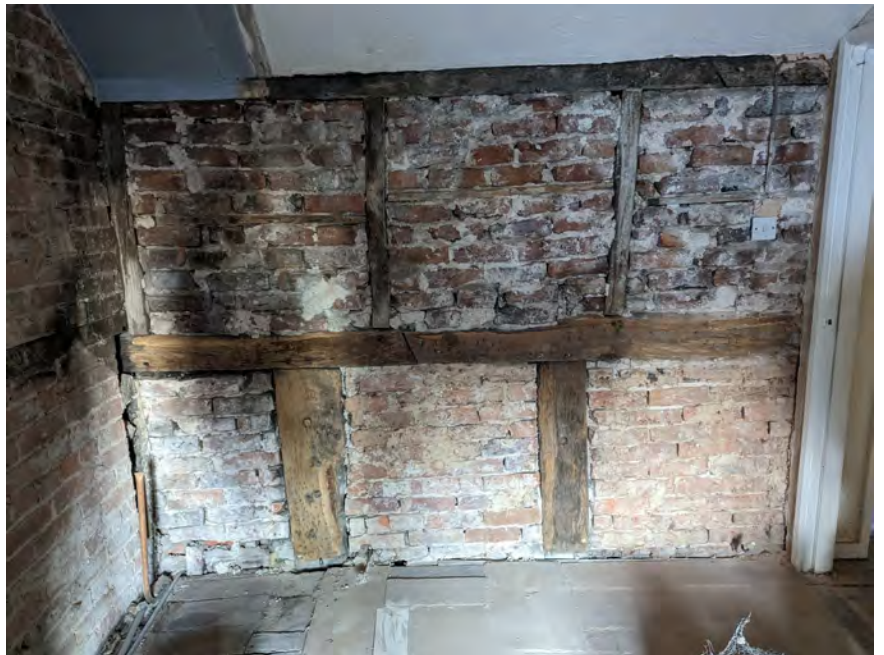
LEFT: The chimney breast was one of the worst areas on this wall, it was so wet that the lime plaster was just falling away from it.

RIGHT: This wall which is now an internal wall would have been the original back of the house. You can see the roof slopes down to meet it and from inside the attic you see where the original roof comes down to meet this wall. At first this was a mystery as to why it was so wet, it was general only the external walls upstairs that had the damp issues. As you can see in the photo, the top half of the wall was very damp, there were also areas of white and dark spores. It was because water had been leaking down from the roof/attic timbers and into this wall.

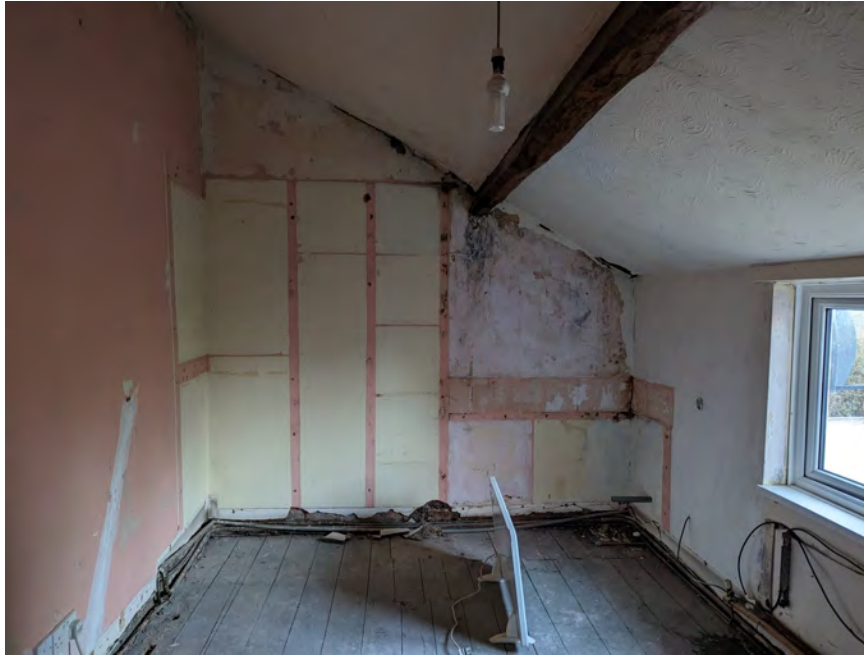
The dampness on these walls, caused by condensation, but predominantly coming from the badly leaking roof which I evidenced earlier in this document.

Despite all the damp, the plaster itself was all firmly adhered to the walls, there was no need for removal. The walls were cleaned down with bleach and left to dry out.

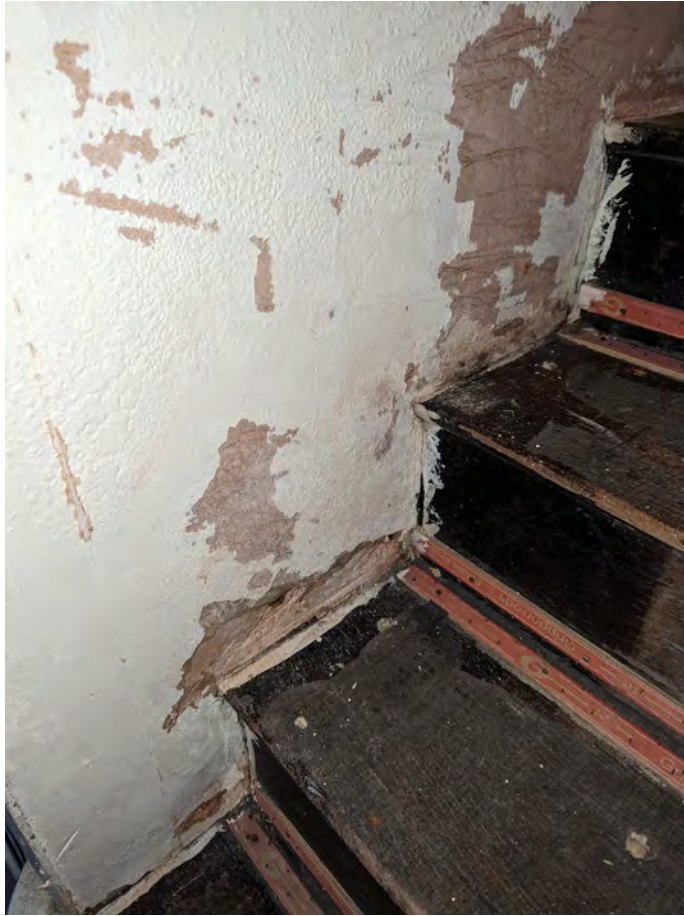
Apart from the utility room, this was one of the wettest areas of the whole house, the wall that was under the bathroom and that joined the utility room. The staircase treads were spongy when you walked on them, the wood was damp to the touch and the moisture meter readings off the scale. This is a central area of the house so for it to be the wettest was confusing to begin with until we discovered the cause of the damp in the bathroom which was mainly from the leaking pipes. This then explained why this wall was so wet because all of the water had been travelling through the wooden floor down this wall. It had woodchip on it but had detached itself completely and was falling off in strips and underneath that which you can see here was

bubbling paint/salts and extremely soggy plasterboard. This was all removed and we hope that this would allow the wall to dry out.

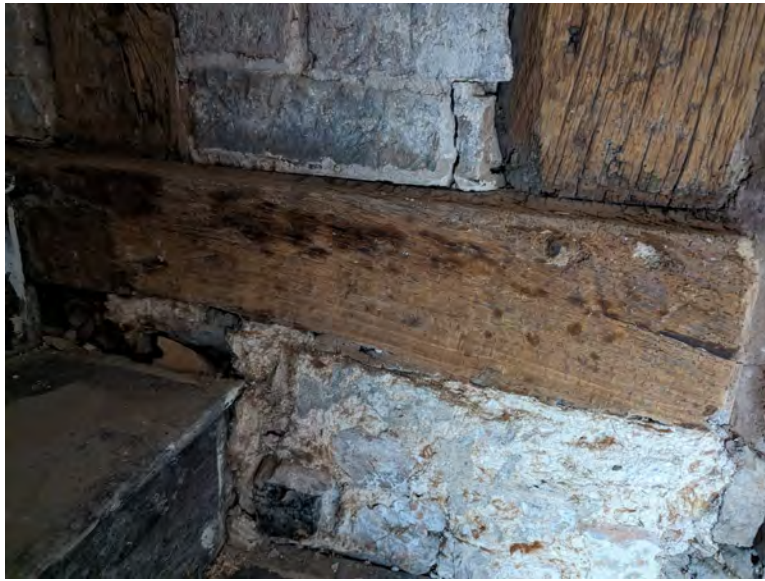
LEFT - This is the opposite side of the staircase, the wall was extremely wet and you can see the dampness in the wood. Which had no reason to be so wet, there was no leaky water pipes above it, the wall was drier the higher up you went so it had to be coming from below or from something that was attached to it.

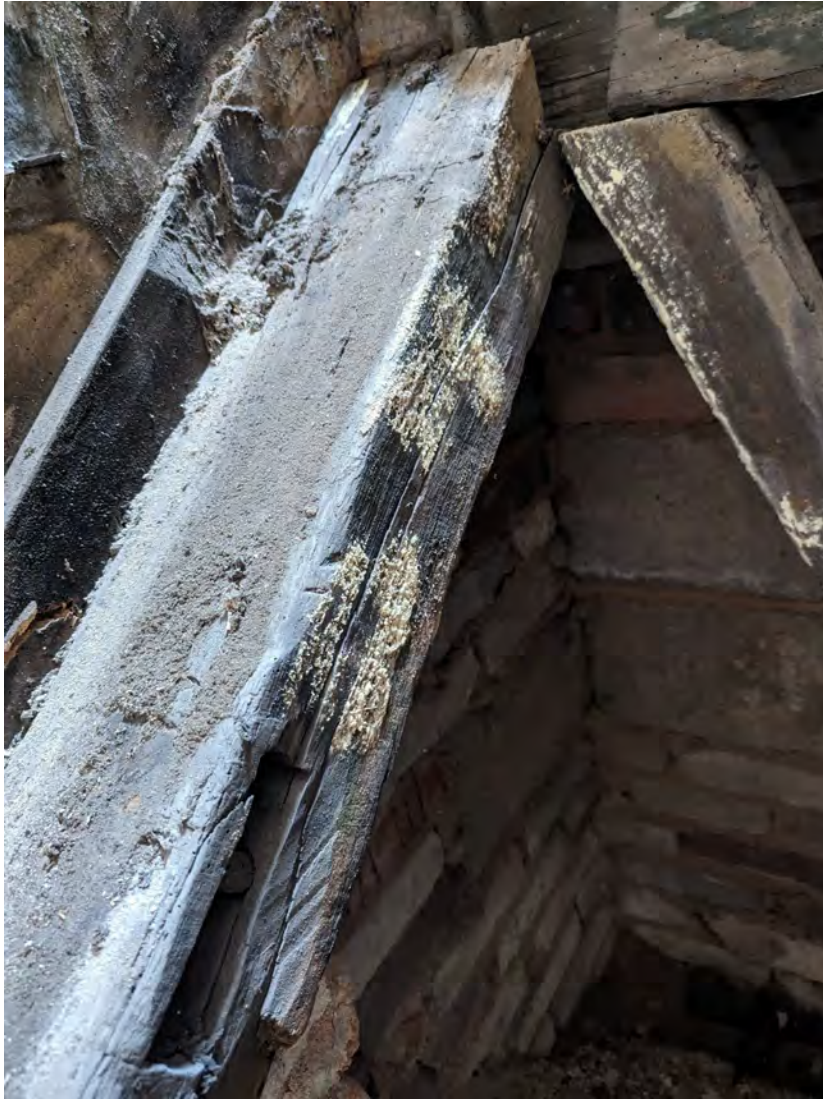
It was soaking wet under there, perhaps difficult to see the extent in these photos because the removal kicked up a lot of dust but it was so wet. The floor, the brickwork and all the wood you could break bits away in your hands and there was a lot of fungus.

My joiner fitted a temporary ladder/staircase so that work could continue and all the space to dry out, which within a week we already started to see progress, all the surrounding wood in the walls began to dry.

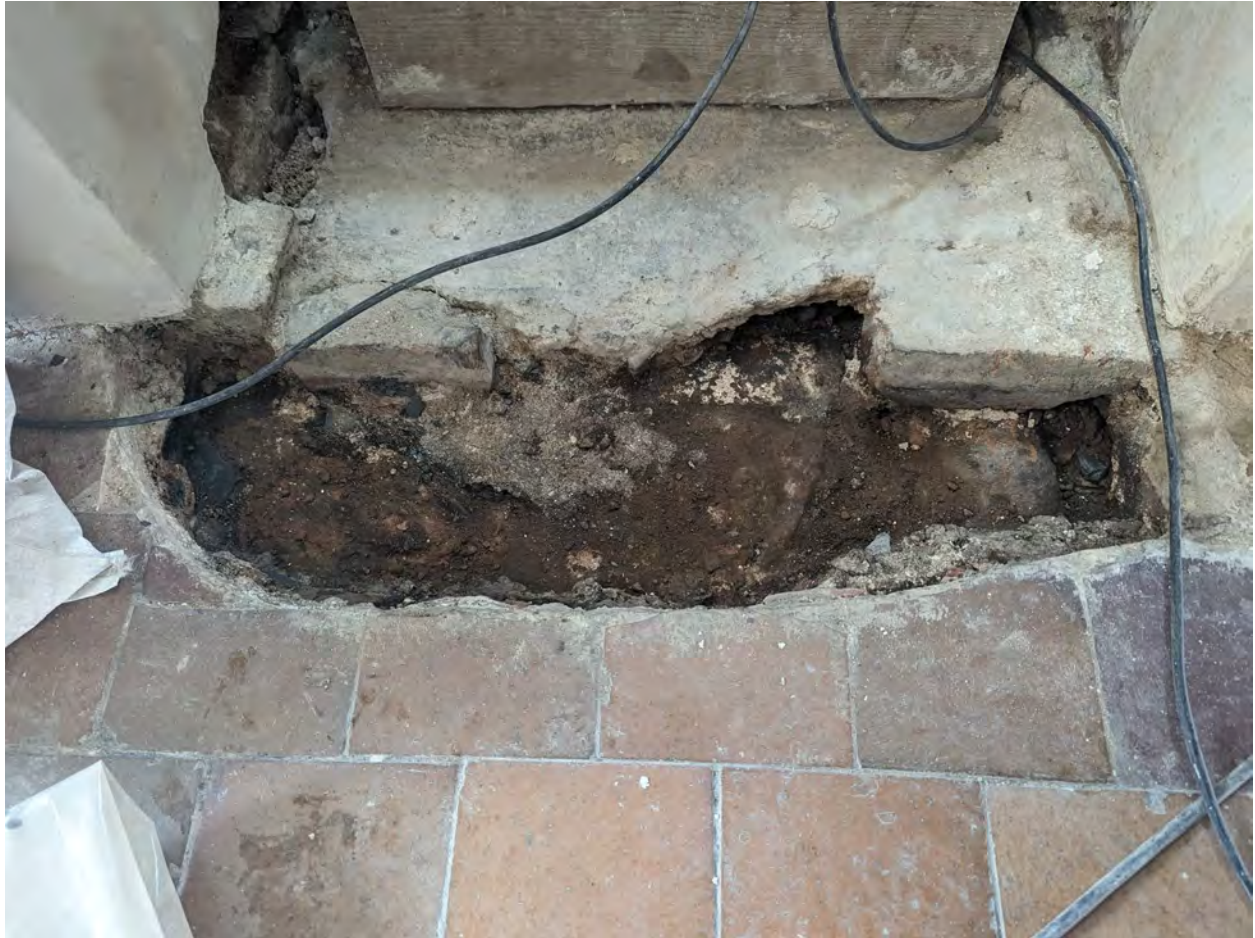
ABOVE - This is at the bottom of the stairs and is where the bottom step sat in, it was sat directly in contact with soil. The wood must have drawn up any moisture from below and it completely baffled me why it would have been done like this. This wouldn't have been the original staircase from the first part of the build in the early 1800's because this is located in the extended part of the house in the kitchen but is still very old and I have no idea how it lasted as long as it did with these foundations. Perhaps the moisture in the soil wasn't enough to cause too much of a problem until recent years when the bathroom plumbing has been leaking, the water has travelled down the walls, into and under the staircase and had nowhere to go except which resulted in widespread decay.

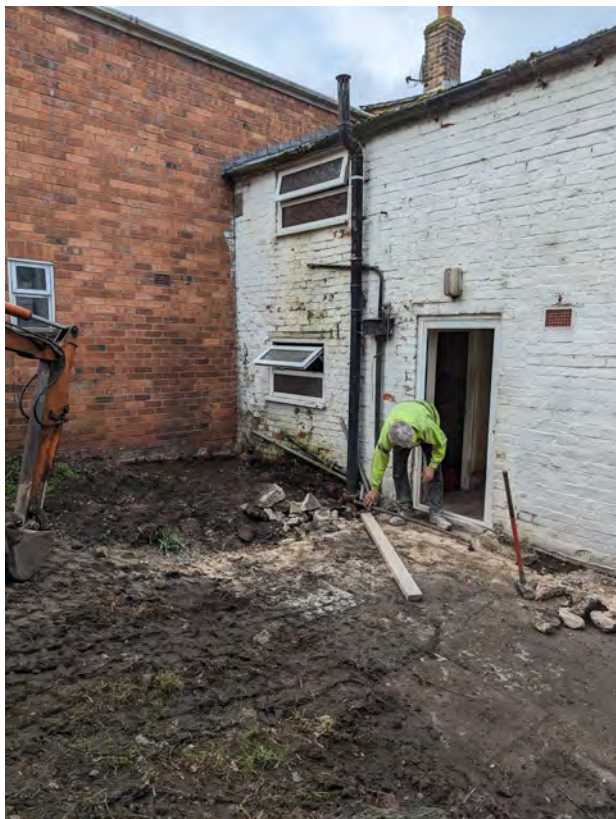
ABOVE - This was after the concrete was removed, it revealed that there was some strange brickwork, bricks were sticking out of the wall and they were in the exact same shape as the damp patch inside.

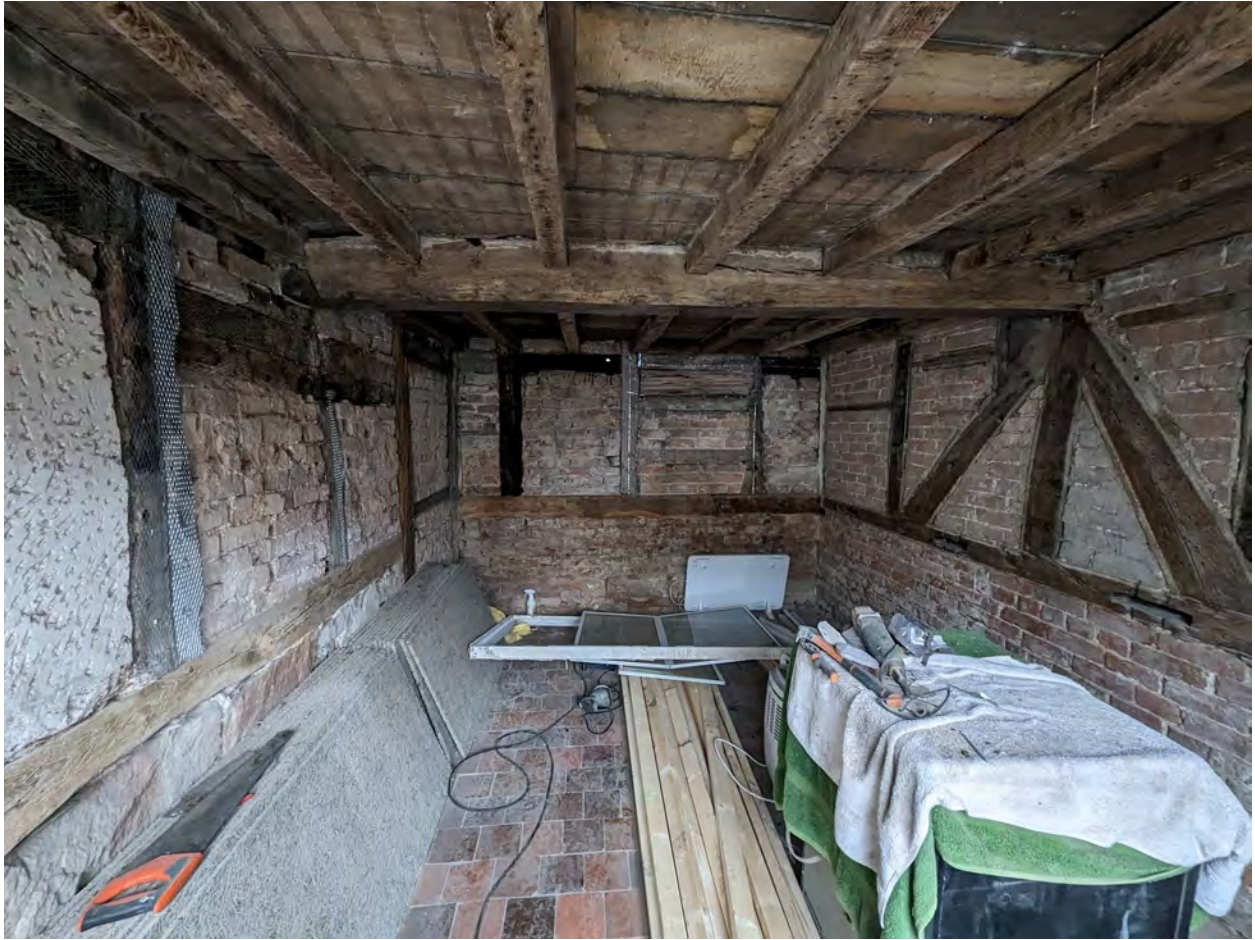
In the photo above of the office, if you look at the far wall, apart from the window wall, this was the wettest part of the room. You can see all the dark patches on the wood and brickwork. Again, a mystery to begin with because it was the centre of the house and nowhere near any outside walls or leaky pipes. But after the issue with the staircase was discovered we were able to follow the path of dampness along the connecting timbers as it travelled into the adjoining rooms. And once the staircase was removed and that area dried out, so did everywhere else.

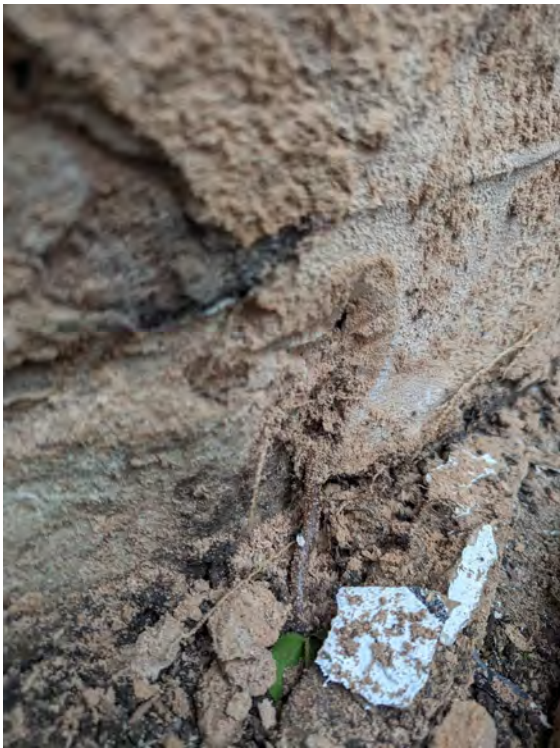
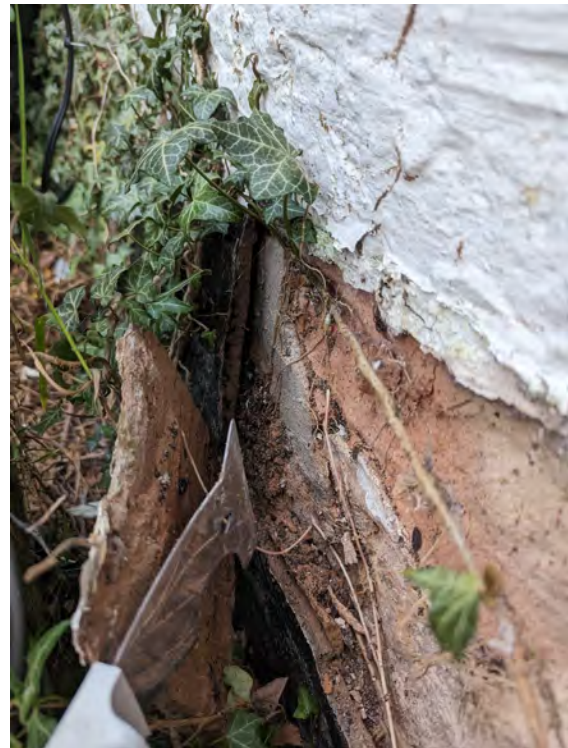
The window wall didn't dry out when all the damp plaster was removed, it wasn't until the ground level at the front of the house was lowered, the broken render that was trapping moisture behind it and allowing plant roots to penetrate through was removed and all the deteriorated mortar joints repaired, then the wall began to dry.

Once the wall inside was showing visible signs of drying out the render was replaced with a new lime render to protect the brickwork from the elements.

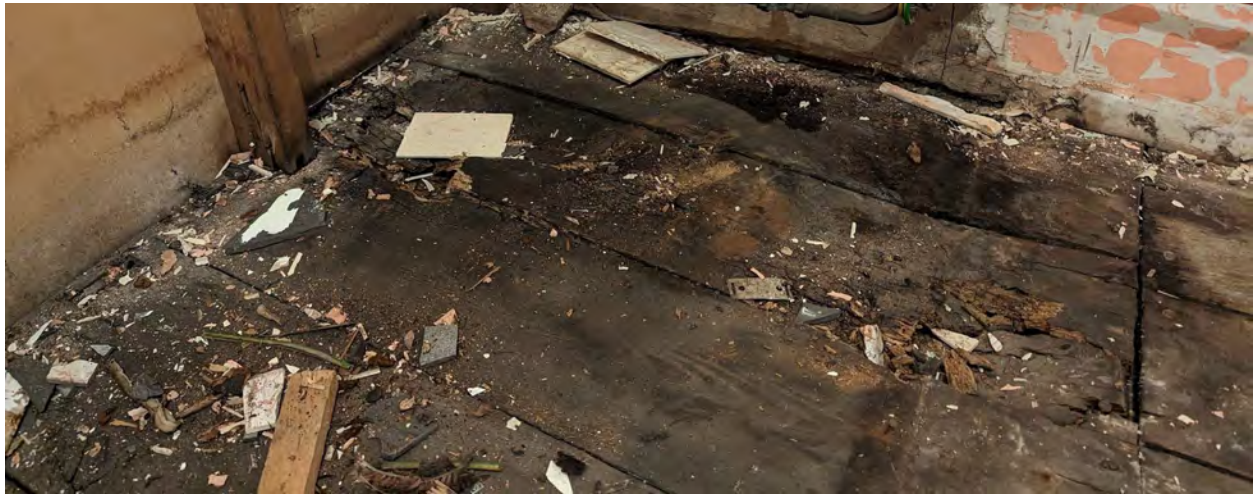
This was the worst part of the bathroom floor, under the bath where it had been leaking for a long time, the boards that were beyond restoration had to be cut away.

We purchased some floorboards that had been in a Victorian linseed oil mill from Tomlinson Reclamation Yard in Nantwich. They were heavily saturated in oil and it was a lengthy process to clean them up using a wire brush, scraper and sander but it was worth the effort because the wood underneath had been preserved beautifully because of all the oil.
