## WHEN EVERYTHING HAD DRIED OUT

## **INSULATING THE EXTERIOR WALLS PRIOR TO PLASTERING & REPLACING PLASTERBOARD WITH WOOD WOOL BOARDS IN THE LIVINGROOM / OFFICE / FRONT BEDROOMS / HALLWAY & STAIRCASE**

## INSULATING THE EXTERIOR WALLS & PREPARING THE WALLS READY FOR PLASTERING IN THE KITCHEN / UTILITY ROOM / BACK BEDROOM & BATHROOM

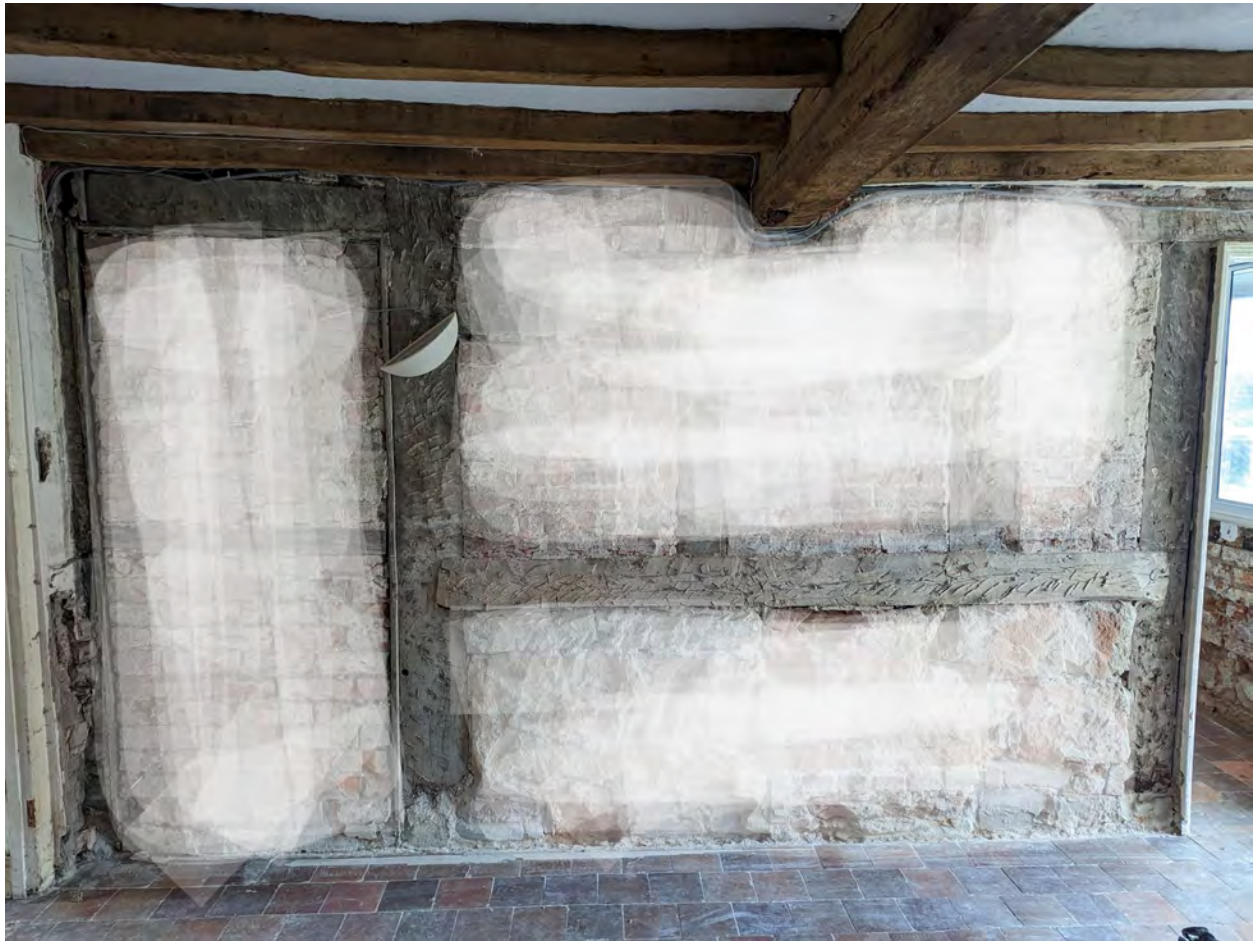
In each room we discussed what areas were to be plastered, some of the wood was going to be plastered over but I wanted to keep a lot of it exposed, I felt it would be such a shame to hide those fascinating details. Each piece of oak could tell it's own story and was full of gnarly character that I felt I would be doing it a disservice if it was to be covered up. I also knew that the areas where the lime plaster had been put on top of the wood were the worst areas for the plaster having absolutely no attachment to the wood, there had been air gaps between all of it through the house. Some of the walls were straight forward but for the complicated ones I took a photo of them and painted different ways (on my phone) that it could be plastered, it made it easier to visualise the final look.

Any of the oak that was plastered over, first had to have a steel mesh attached to it, so that the plaster has something to key to and to prevent the same detachment that had happened previously.

Hemp lime plaster was used for the whole project, horse hair was only added to the scratch coat then there was a second float coat and the final top coat.

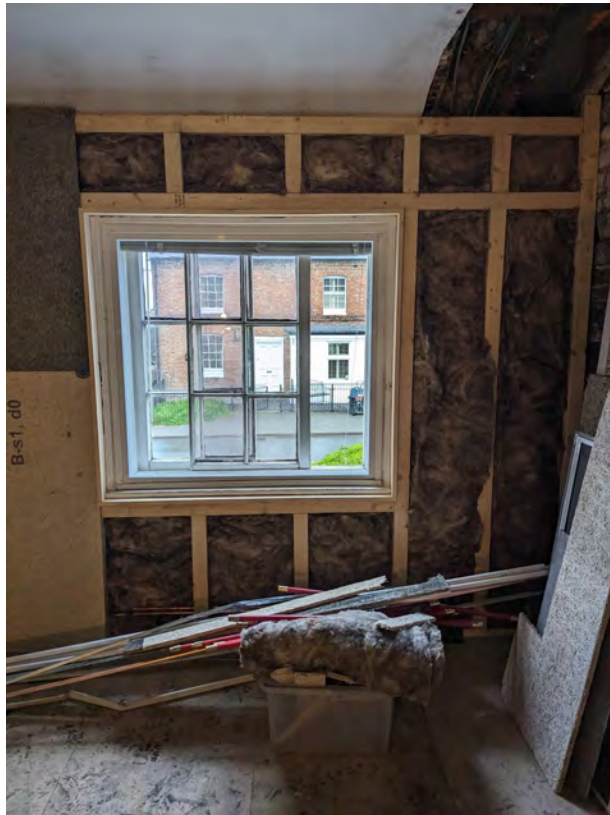
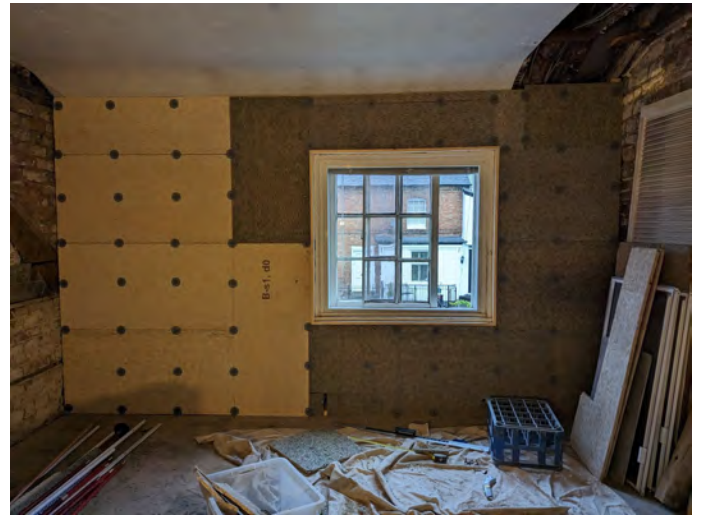
## FRONT MAIN BEDROOM

**ABOVE - It looks like different boards were used but they were all the wood wool celenit boards, each batch varied in colour**

The ceiling had damaged areas from a water tank that had once leaked and been repaired very badly. These areas were cut away and then it was over boarded ready to be skimmed, Rather than pull down the whole ceiling, over boarding was the least destructive and safest option. My plaster said there might be a very small chance of asbestos in the artex due to the age of it so we decided to avoid disturbing it as much as possible.

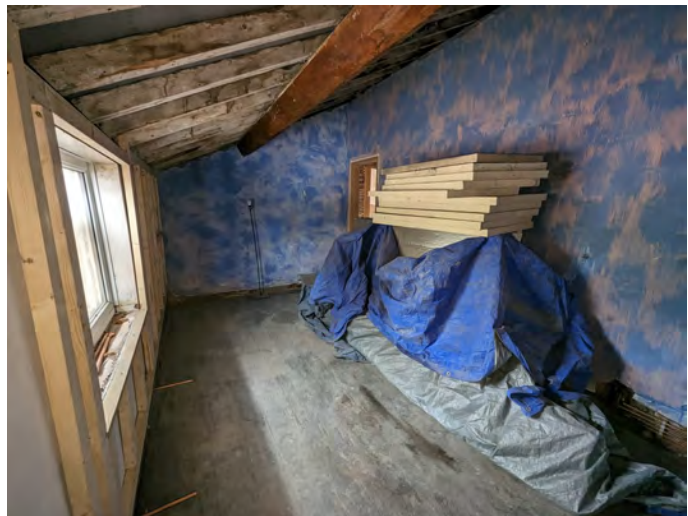
## BACK BEDROOM

The render in these rooms was solid, a few big cracks here and there but firmly attached to the walls, it hadn't been badly affected by the leaking roof and the mould spores had been removed and hadn't returned once there was heat and ventilation. So we had no intention of disturbing the render and used a product recommended by our plasterer to allow a fresh coat of gypsum skim to be applied over the top.

- Blue grit, a bonding solution, was painted on the walls to give the skim a good surface to adhere to.

A stud framework was built on the exterior wall of the back bedroom, with wool insulation and plasterboard on top. The ceiling was insulated with Celotex insulation boards and plasterboard.

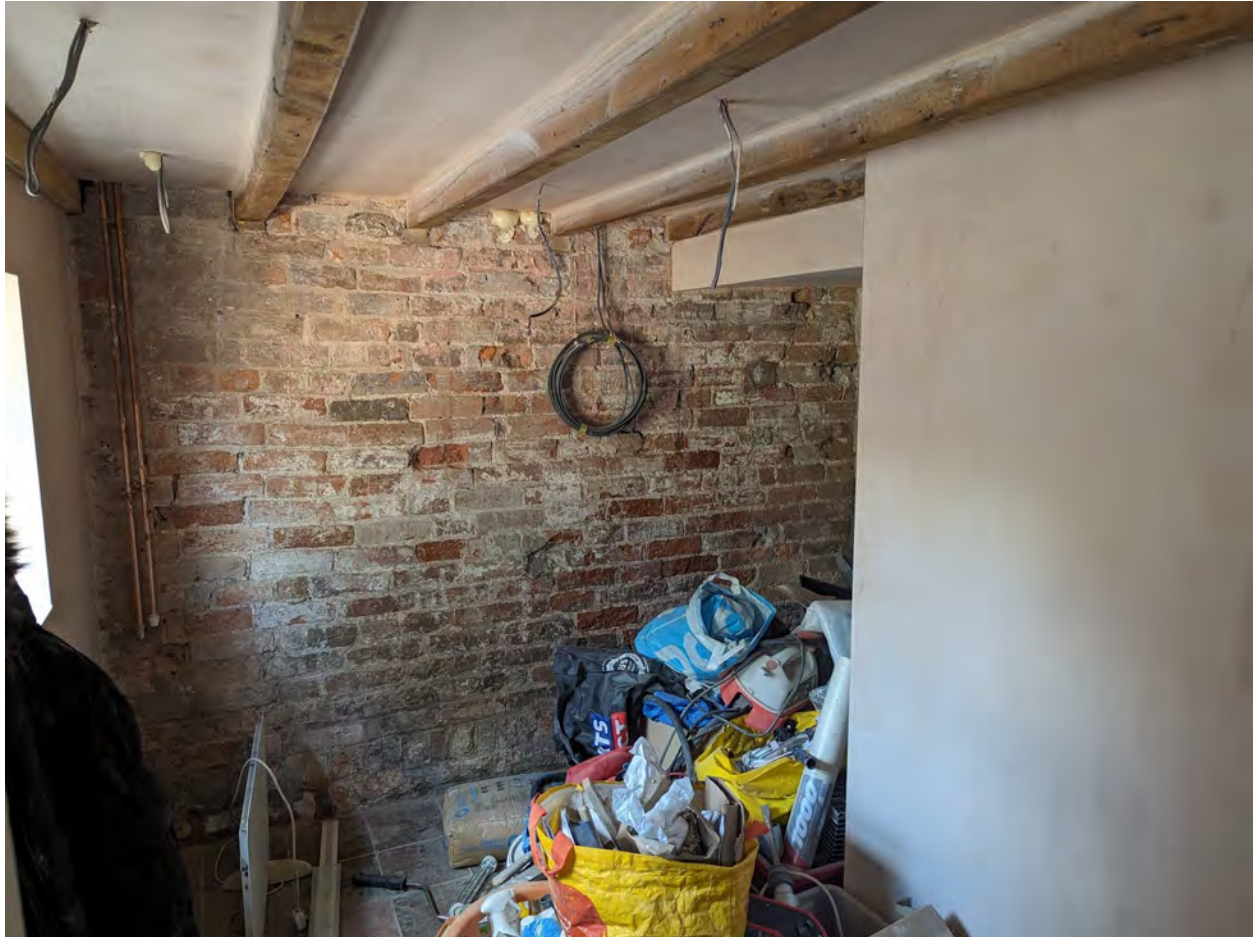
## Utility

RIGHT - This is inside where the cupboard used to be which is now an open space for ventilation purposes, and also as a feature to show the brickwork of the back wall of the original building.

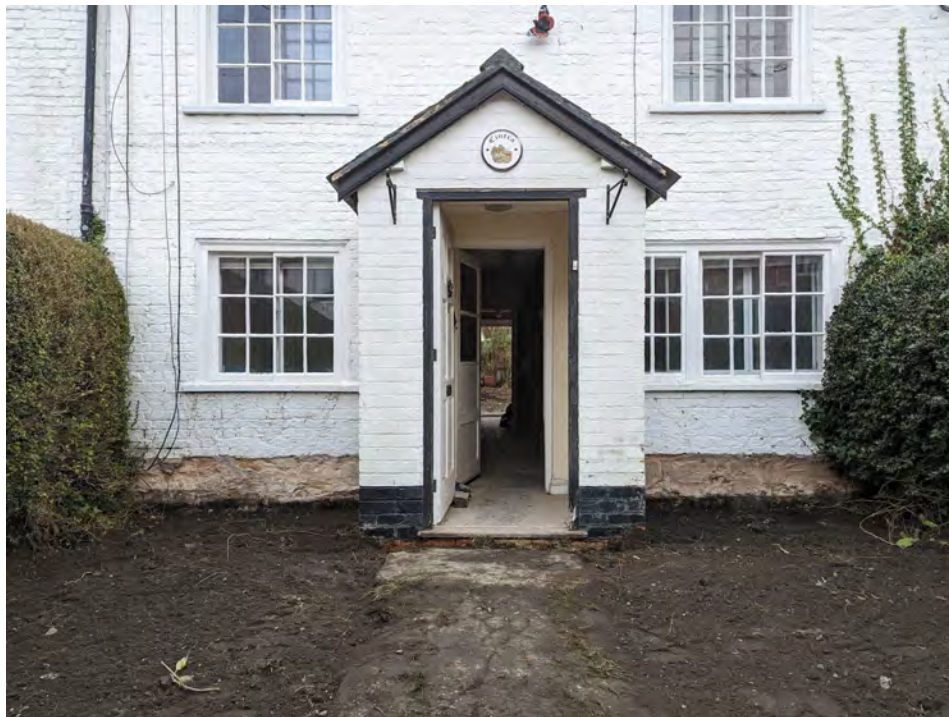
RIGHT - This is before it was lowered at the front, it's hard to see in the photo but the lawn was 2 big bulges either side of the porch which sloped down to a concreted area underneath each window. This concrete was slightly higher than the floor inside.

The concrete was removed and the ground dug away and levelled out at a height of 150mm lower than the floor inside.

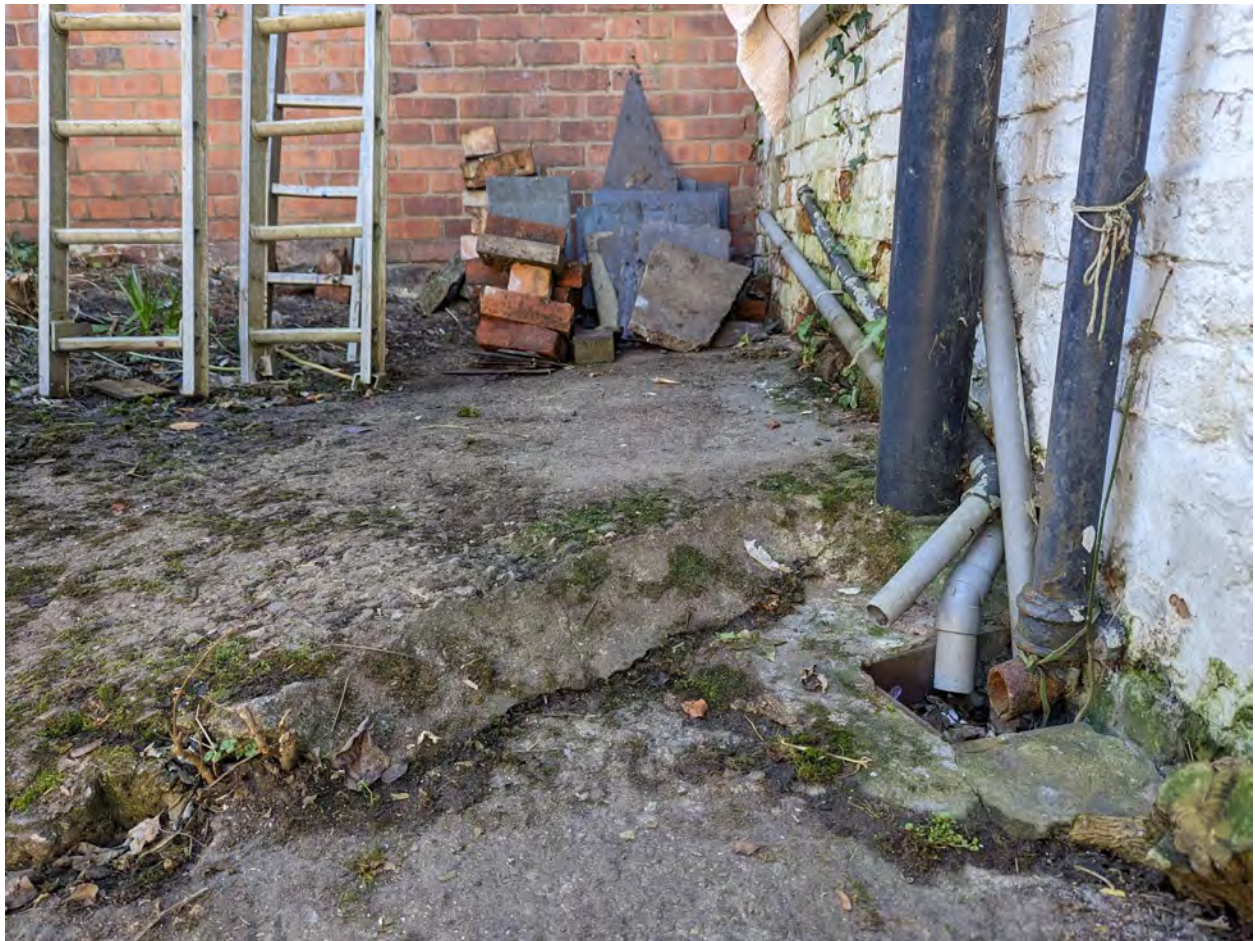
At the back, this was the original mass of concrete that was causing all all the problems -

Once it was removed and all the protruding bricks cut back the inside was able to start drying out.

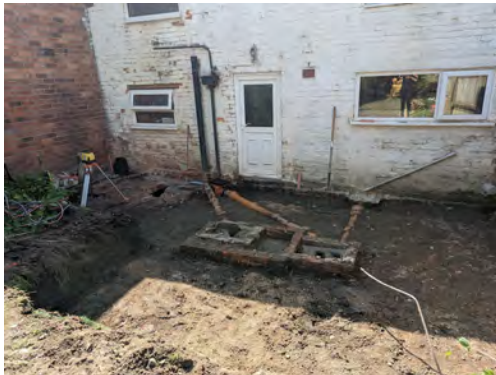
The groundworker had done some temporary repairs on the leaking drain early on in the project just to tide us over until he was able to come back and replace the full drainage system and manholes.

The rest of the concrete was removed from the back of the house and the earth dug away to reach the pipes. The garden itself was about a metre higher than the ground floor and it sloped down to the house and when it rained the water would just fill up the concrete area with nowhere to go except sit against the house. So the main objective with lowering the ground level at the back was so that there could be a drainage channel next to the house

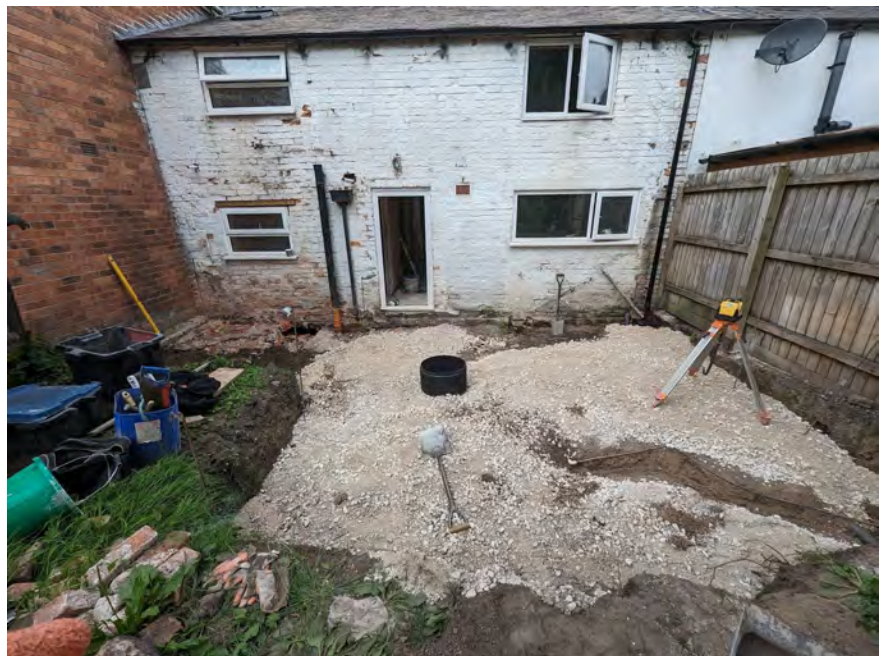
And I wasn't there the day that he was removing the old pipes and fitting the new ones so all i have is the photo from when I got there after work, by this point it had all been done and covered over -

Combining the 2 rectangular manholes into one square one made such a difference once the patio was laid because we were able to use a recessed manhole cover and disguise it completely.

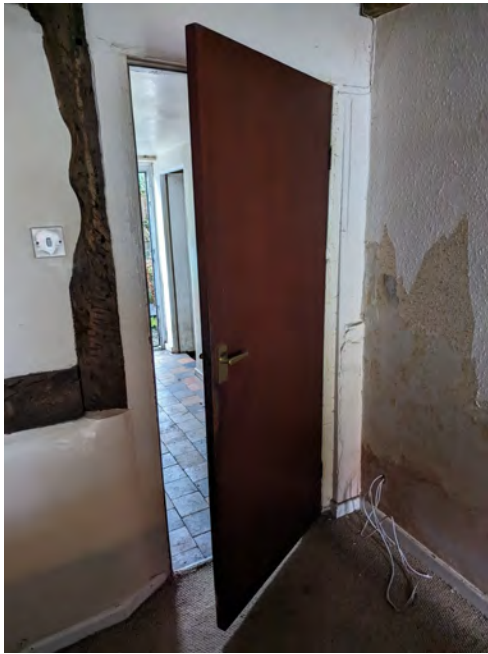
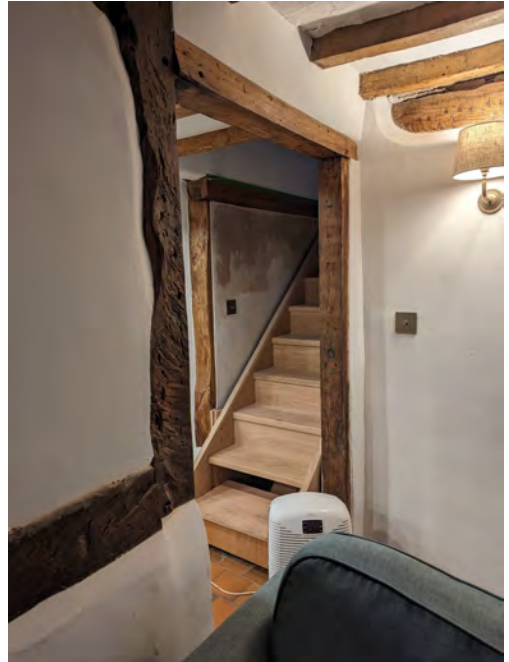
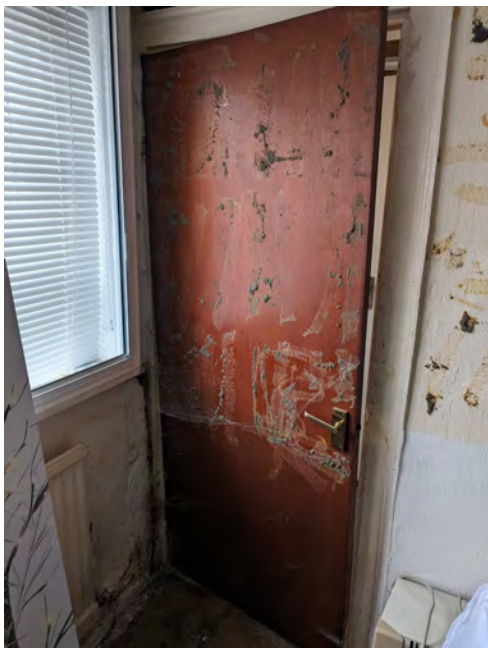
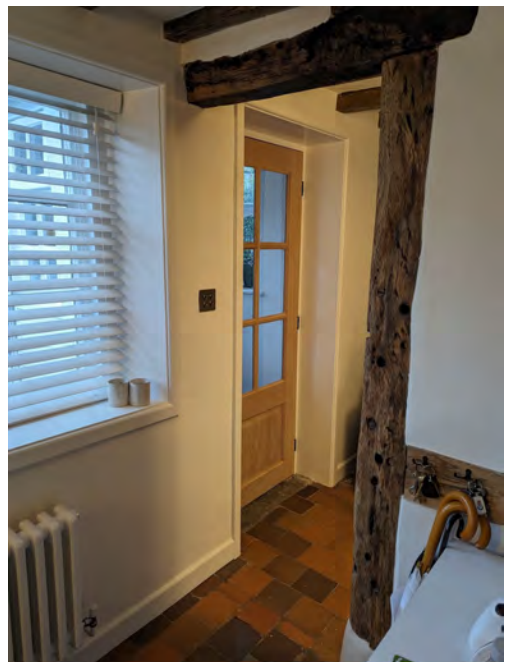
## Doors

The door into the office and the door from the living room into the kitchen were removed, they were fitted in the late 1970's by the previous owner, not in-keeping with the age of the property and in bad condition. When they were removed we discovered the oak framework and decided that it made more sense to have more of an open plan layout, the same as Kew Cottage next door, making the oak framed doorways a feature.

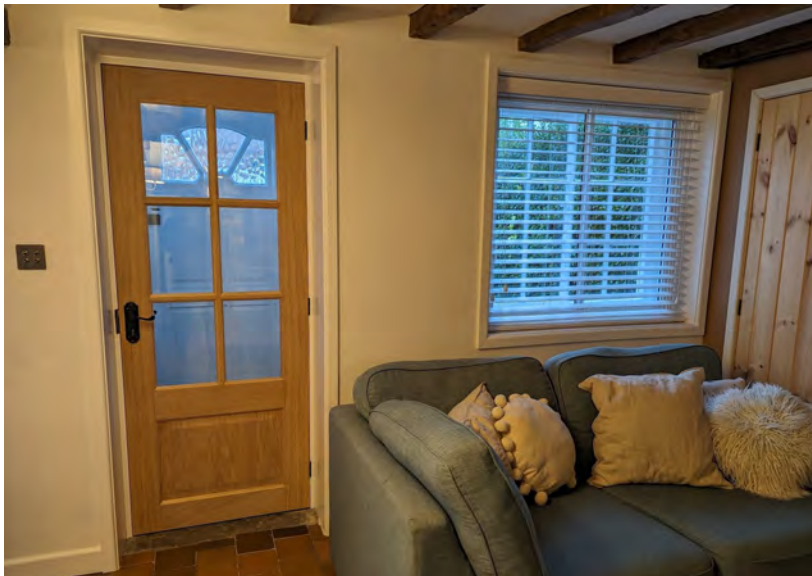
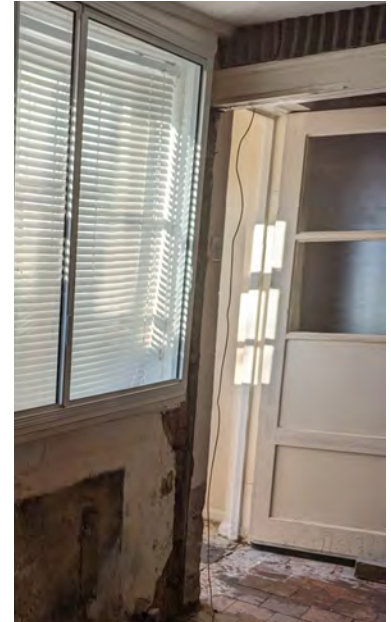
## Porch door

RIGHT - This was a glass paned door, also not fitting with the age and character of the building, meant to have 3 panes of glass but one had been replaced with a piece of wood and painted white at some point. It was outdated and damaged so we replaced it with an oak door and frame with 6 panes of glass to match the front windows IMAGE BELOW.

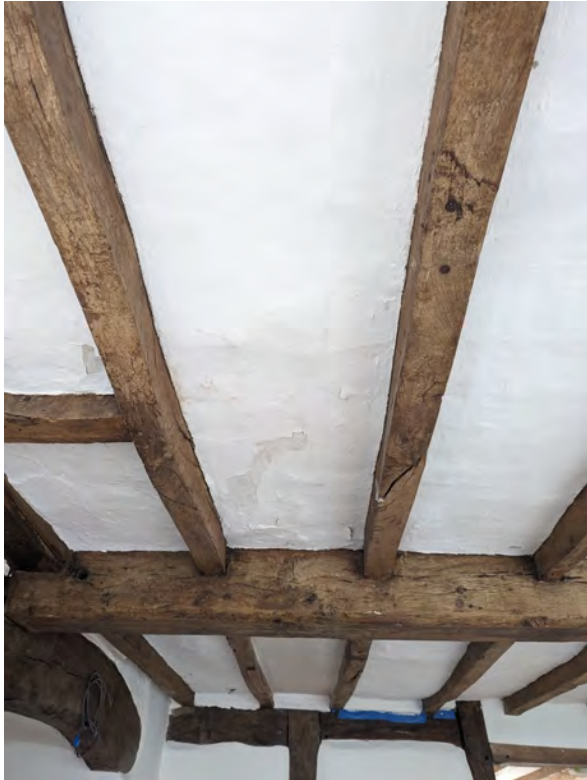
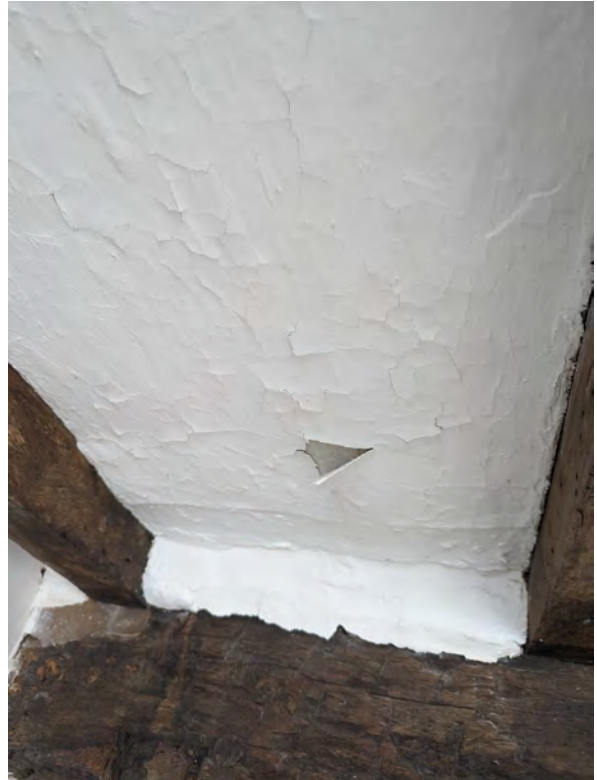
## Living Room ceiling

This is the original lime plastered ceiling, not in the best condition, the paint was all flaking off and there was many areas of lime that just crumbles if you pressed it but it hadn't been affected by any leaks or mould and as long as nobody touches it will probably last for years to come.

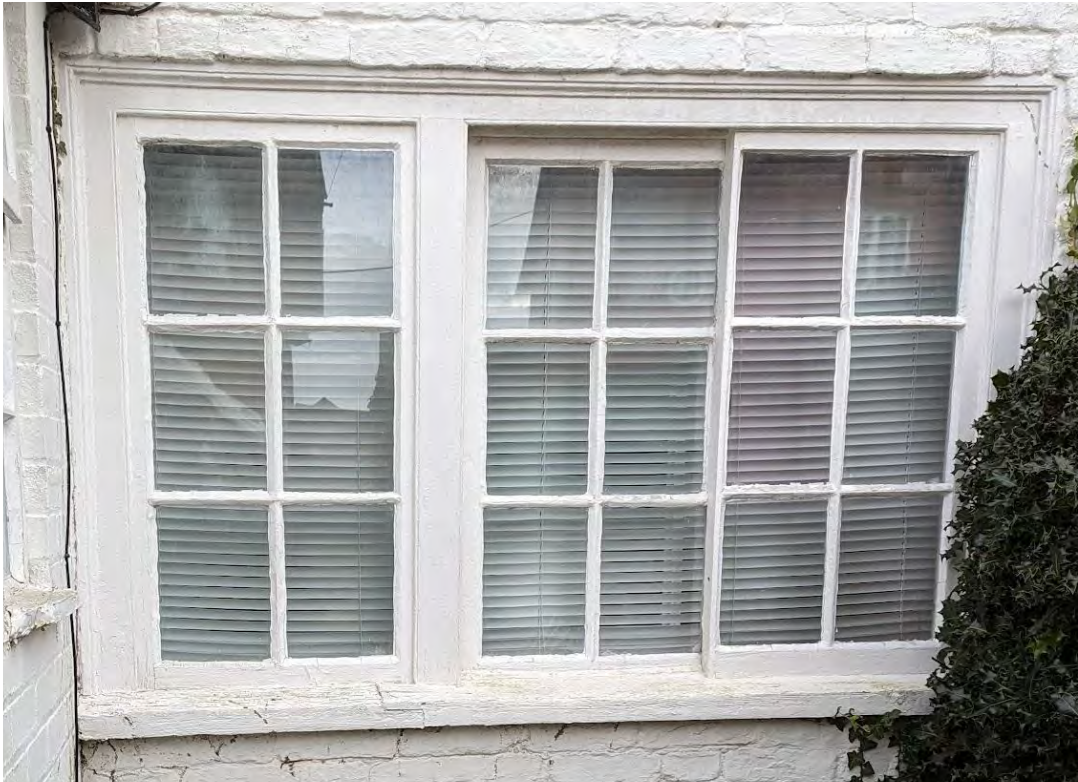
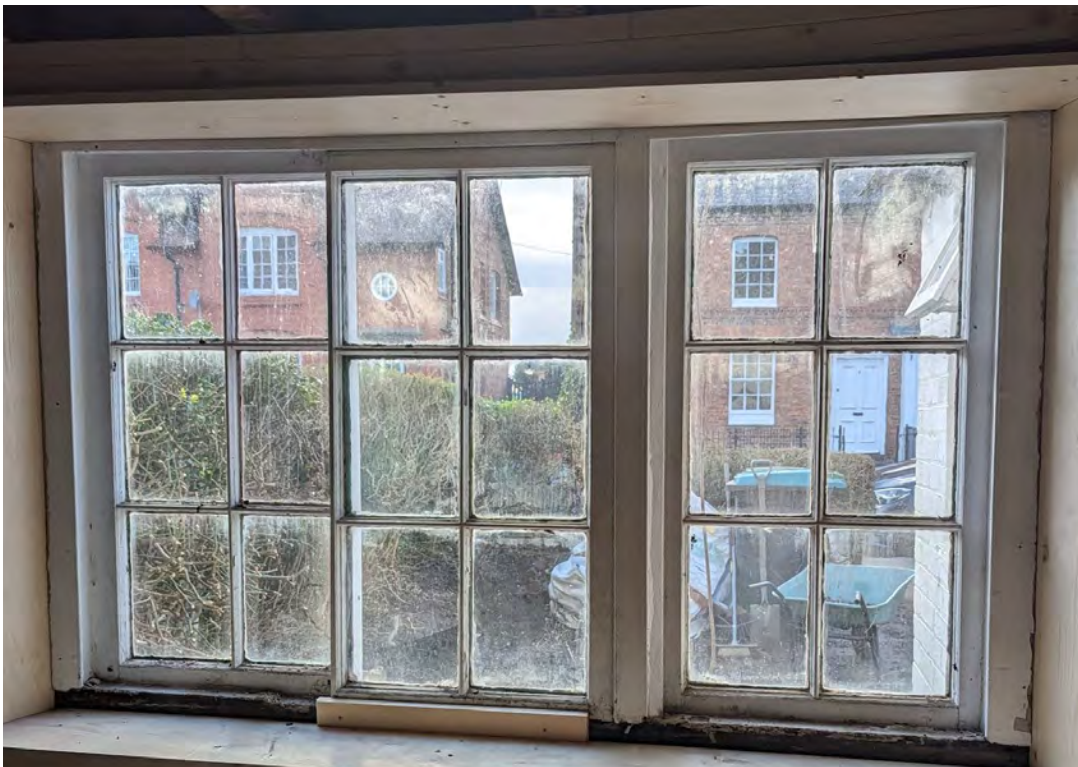
Front windows

These are the original single glazed sash windows, quite unsafe, major heat loss source and unable to be opened because the frames are so fragile. They were sanded down and wood filler applied where needed and then painted, they are also sealed shut now so to stop the water penetrating inside.

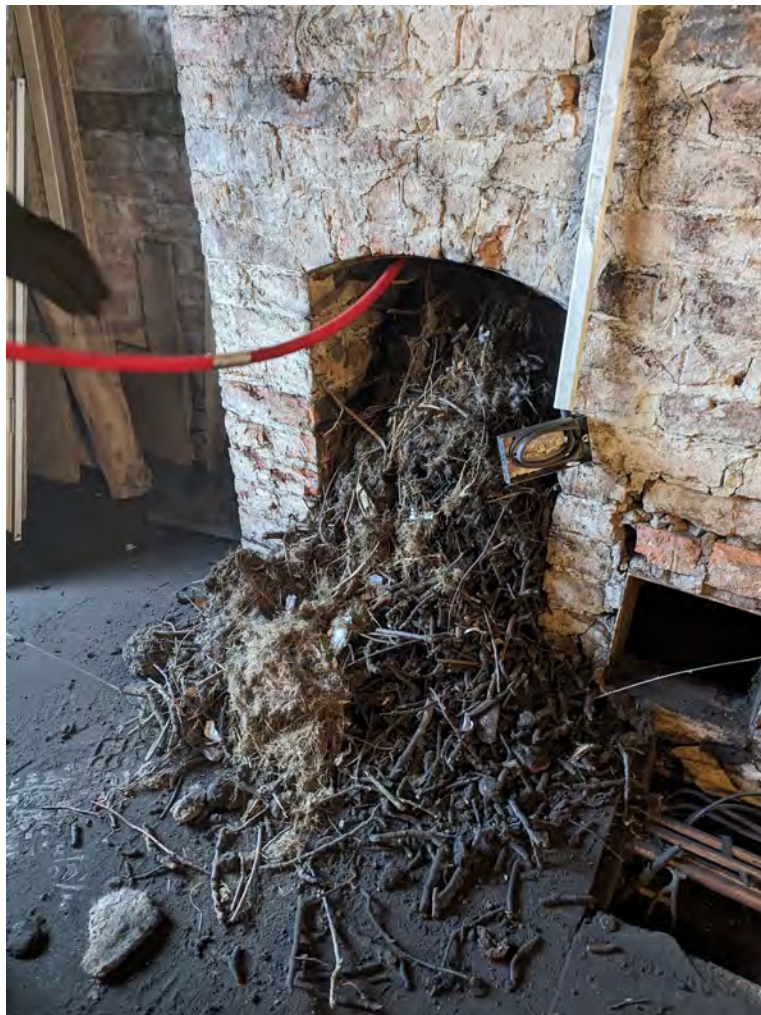
**Uncovering the little fireplace** in the Front Main Bedroom wasn't intended, I had originally planned to plaster over it. But we had a major issue when trying to clear out the chimney, it was an impossible task from the fireplace in the living room because it was blocked from the ground floor to the top of the chimney! We had to make a hole in it from inside the attic as well as chisel out the blocked up fireplace in the front main bedroom to try and dislodge the blockage.. The previous owner had stopped using the coal fire over 20 years ago so there was all those years of nests and debris to remove! It took 3 of us 4 hours to complete and most definitely the horriblem job in the whole project.
