# CCTV DRAINAGE REPORT

**CLIENT:** CASTLEMEAD GROUP

**SITE ADDRESS:** KINGSLEY CIRCLE,  
EATON DRIVE, WREXHAM, LL13 9BP

| Project Name | Project Number | Project Date |
|---|---|---|
| Q301_CASTLEMEAD_KINGSLEY_CIRCLE_EATON_DRIVE_WREXHAM | | 29/02/2024 |

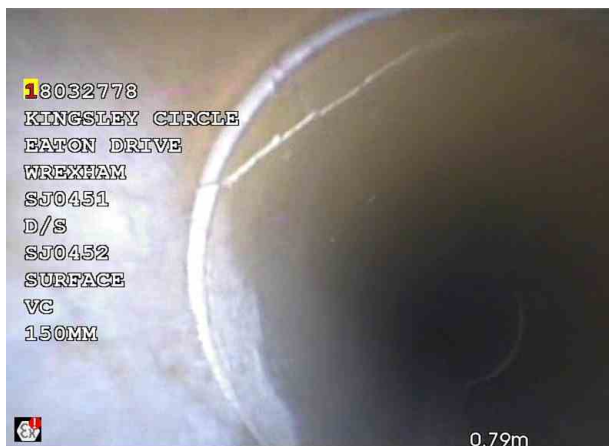
| Scale: | 1:111 | Position [m] | Code | Observation | MPEG | Photo | Grade |
|---|---|---|---|---|---|---|---|
| | 0.48 | FCJ | Fracture, circumferential at joint from 10 o'clock to 2 o'clock | 00:00:04 | 1_SJ0451_SJ0542.jpg | 3 / 2 | |

1\_SJ0451\_SJ0542.jpg, 00:00:04, 0.48 m  
Fracture, circumferential at joint from 10 o'clock to 2 o'clock

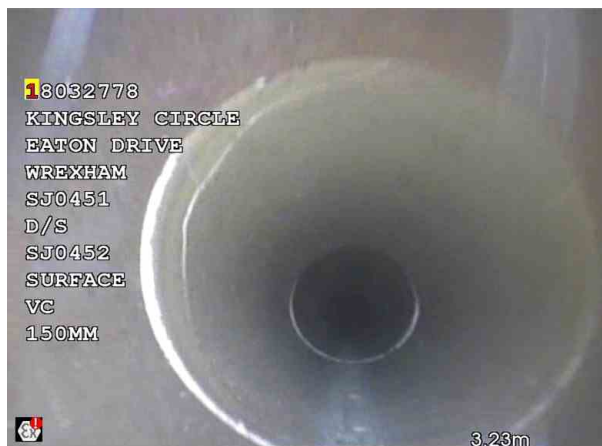
| Scale: | 1:111 | Position [m] | Code | Observation | MPEG | Photo | Grade |
|---|---|---|---|---|---|---|---|
| | 3.23 | FCJ | Fracture, circumferential at joint from 8 o'clock to 1 o'clock | 00:00:10 | SJ0451X_5130bcdbe9bb-4227 | 3 / 2 | |

SJ0451X\_5130bcdb-e9bb-4227-9cec-b6ff4069ea8d\_20240229\_135838\_219.jpg, 00:00:10, 3.23 m  
Fracture, circumferential at joint from 8 o'clock to 1 o'clock

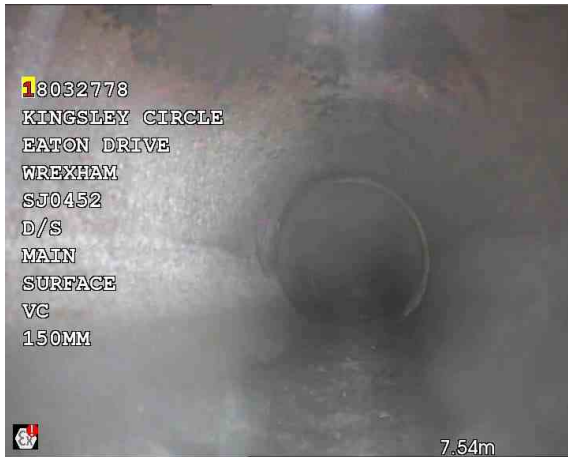
| Scale: | 1:192 | Position [m] | Code | Observation | MPEG | Photo | Grade |
|---|---|---|---|---|---|---|---|
| | | 7.44 | S01 | DES | Settled deposits, fine, 5% cross-sectional area loss, start | 00:00:25 | SJ0542X_87ebbb8c-8673-4f92- |

SJ0542X\_87ebbb8c-8673-4f92-aaf4-1be037cf3409\_20240301\_091208\_562.jpg, 00:00:25, 7.44 m  
Settled deposits, fine, 5% cross-sectional area loss, start

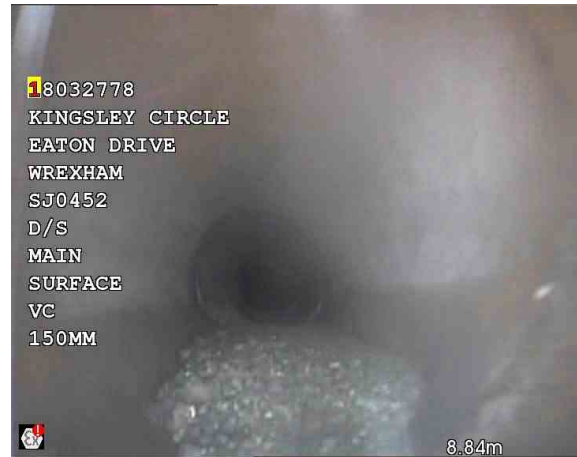
| Section | PLR | Grade | Description |
|---|---|---|---|
| 2 | SJ0542X | 4 | Settled deposits, coarse, 20% cross-sectional area loss |

| Scale: | 1:192 | Position [m] | Code | Observation | MPEG | Photo | Grade |
|---|---|---|---|---|---|---|---|
| | | 8.84 | | DER | Settled deposits, coarse, 20% cross-sectional area loss | 00:00:40 | SJ0542X_c10e0930-6a47-449b |

SJ0542X\_c10e0930-6a47-449b-b98d-a363c4a99fd1\_20240301\_091229\_308.jpg, 00:00:40, 8.84 m  
Settled deposits, coarse, 20% cross-sectional area loss

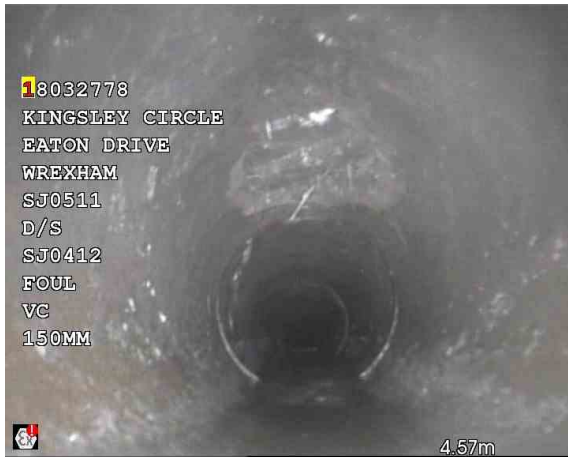
| Section | PLR | Grade | Description |
|---|---|---|---|
| 5 | SJ0511X | 4 | Hole in drain or sewer at 12 o'clock |

| Scale: 1:167 | Position [m] | Code | Observation | MPEG | Photo | Grade |
|---|---|---|---|---|---|---|
| | 4.57 | H | Hole in drain or sewer at 12 o'clock: POSSIBLE HOLE | 00:00:12 | SJ0511X_<br>bc672735-<br>70ef-4b88- | 4 |

SJ0511X\_bc672735-70ef-4b88-bc77-8b9e5d36a7b8\_20240301\_092819\_353.jpg, 00:00:12, 4.57 m  
Hole in drain or sewer at 12 o'clock, POSSIBLE HOLE

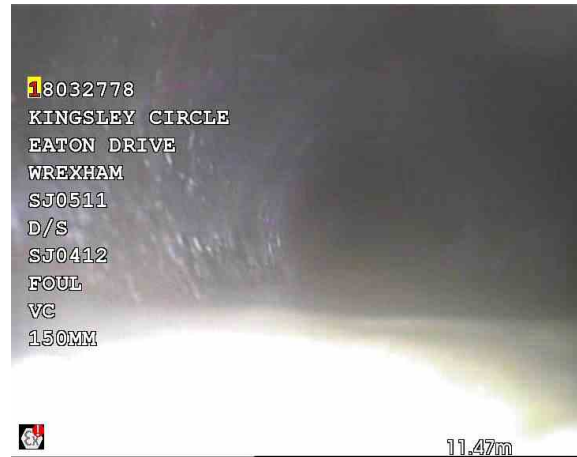
| Scale: 1:167 | Position [m] | Code | Observation | MPEG | Photo | Grade |
|---|---|---|---|---|---|---|
| | 11.47 | S01 DEF | Attached deposits, fouling from 5 o'clock to 7 o'clock, 10% cross-sectional area loss, start | 00:00:27 | SJ0511X_<br>e4d35471-<br>ab61-42d3 | |

SJ0511X\_e4d35471-ab61-42d3-a042-d57c73febdfe\_20240301\_092846\_152.jpg, 00:00:27, 11.47 m  
Attached deposits, fouling from 5 o'clock to 7 o'clock, 10% cross-sectional area loss, start

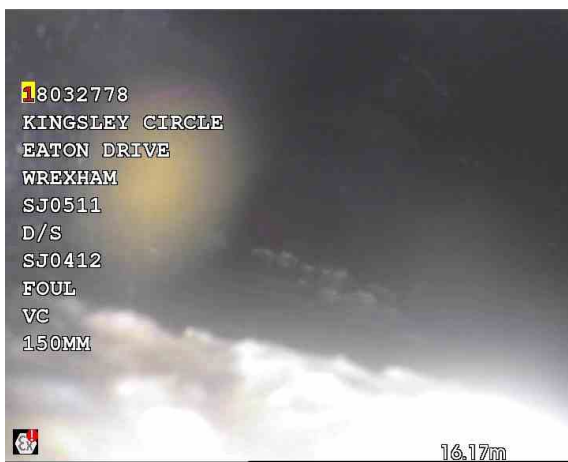
| Section | PLR | Grade | Description |
|---|---|---|---|
| 5 | SJ0511X | 4 | Attached deposits, fouling from 3 o'clock to 9 o'clock, 40% cross-sectional area loss |

SJ0511X\_bd269a60-b32a-49d2-9dfc-6840527b5bdc\_20240301\_092927\_168.jpg, 00:00:58, 16.17 m  
Attached deposits, fouling from 3 o'clock to 9 o'clock, 40% cross-sectional area loss

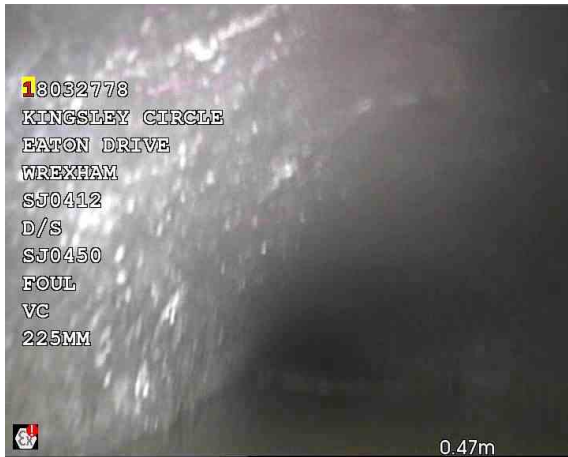
SJ0412X\_5a702869-e5e0-47f0-a0bd-e8515b278e30\_202403  
01\_093303\_922.jpg, 00:00:04, 0.47 m  
Settled deposits, coarse, 15% cross-sectional area loss, start,  
UNDER WATER

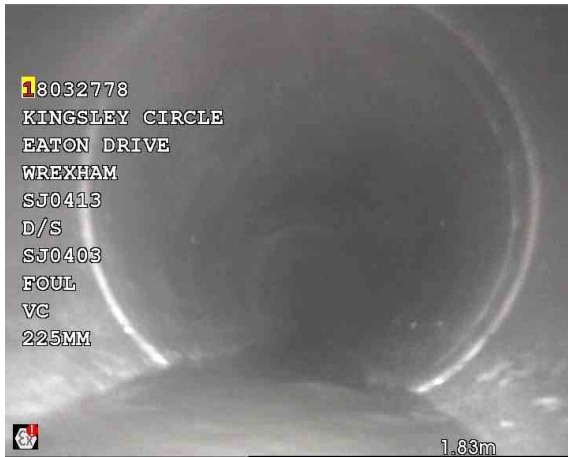
| Scale: | 1:165 | Position [m] | Code | Observation | MPEG | Photo | Grade |
|---|---|---|---|---|---|---|---|
| | 1.83 | CCJ | Crack, circumferential at joint from 1 o'clock to 6 o'clock | | 00:00:06 | SJ0413X_f 43602e6-3 80e-4d55- | 2 / 2 |

SJ0413X\_f43602e6-380e-4d55-a9dc-8ed3b42e20cb\_2024030  
1\_093447\_858.jpg, 00:00:06, 1.83 m  
Crack, circumferential at joint from 1 o'clock to 6 o'clock

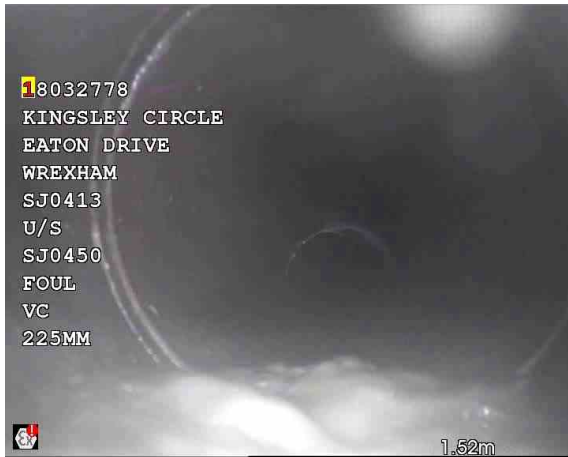
| Scale: | 1:204 | Position [m] | Code | Observation | MPEG | Photo | Grade |
|---|---|---|---|---|---|---|---|
| | 1.52 | CCJ | | Crack, circumferential at joint from 7 o'clock to 12 o'clock | 00:00:12 | SJ0450X_941a9b09-fe52-4156- | 2 / 2 |

SJ0450X\_941a9b09-fe52-4156-8da6-3a8a9d3f0437\_2024030  
1\_093716\_502.jpg, 00:00:12, 1.52 m  
Crack, circumferential at joint from 7 o'clock to 12 o'clock
