# Conversion of Outbuildings, Hillside, Erbistock

## Structural Appraisal Report

August 2023

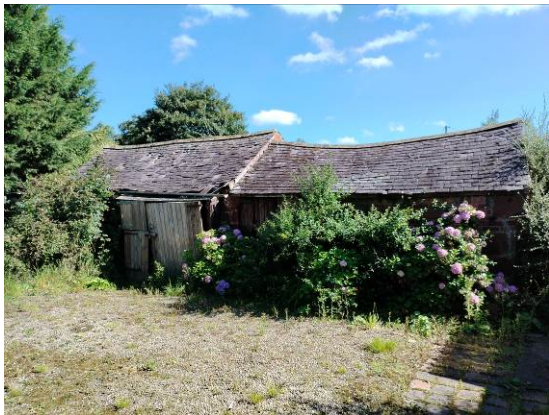
The elevation comprises brickwork to full height on the left-hand side and masonry with a brickwork addition to the right-hand side. Lintels to openings comprise timber units (see Photo 1). The roof over is finished with slate.

Cracking was noted at the junction with the right-hand side elevation. The cracking was noted as up to 4mm wide and extends through an area of previous repair (see Photo 2). The defect is indicative of a lack of bonding at the corner and roof spread. A corroded pattress plate would suggest that the defect has been an issue for some time. Degradation to timber lintels was apparent. Severe rot and section losses were apparent to the lintel over the large door opening which has resulted in significant sag. Sagging was apparent to the remaining lintels indicative of long-term weathering.

Photo 1 – Front Elevation.

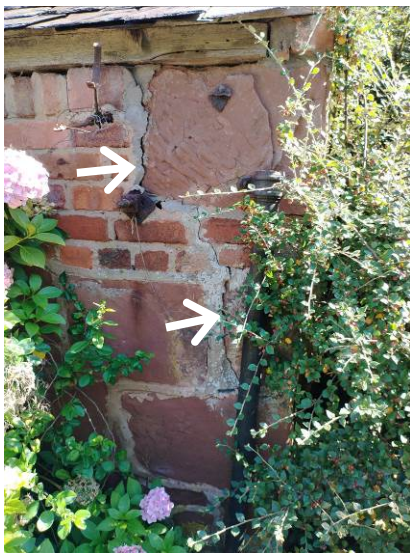
Photo 2 – Cracking at junction with side elevation.

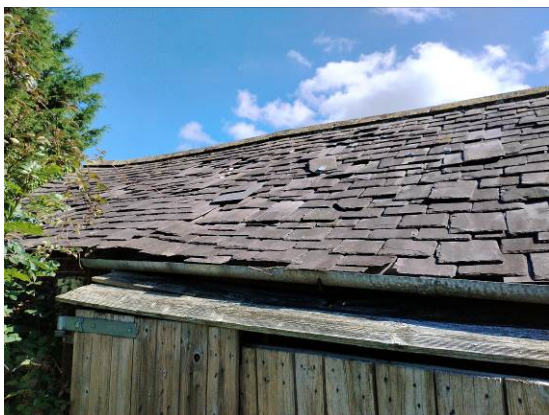
The roof over is in generally poor condition with significant areas of missing or broken slate finishes apparent (see Photo 3). The alignment of the ridge shows significant sagging between supports especially in the right-hand section of the roof. The guttering is generally missing with no downpipes apparent.

Photo 3 – Typical condition of roof finishes.

- Remove existing slated finishes to the roof and set aside for re-use. Demolish all existing rafters, purlins, trusses and brick walls supporting the roof. Provide new roof construction as required to suit new layout.

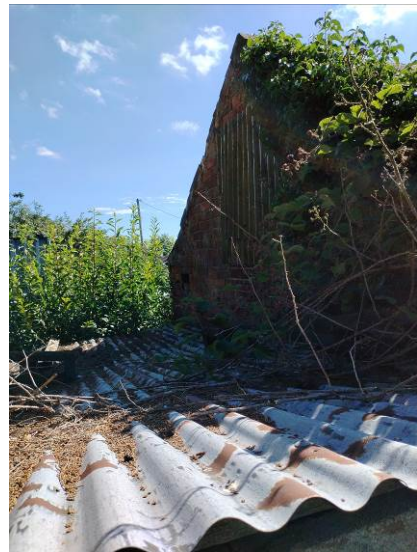
The elevation comprises brickwork to full height with a timber lintel to the opening. The roof over the adjacent pen is finished with corrugated steel cladding (see Photo 4). The window opening is blocked off with translucent sheeting.

Photo 4 – Left Hand Side Elevation.

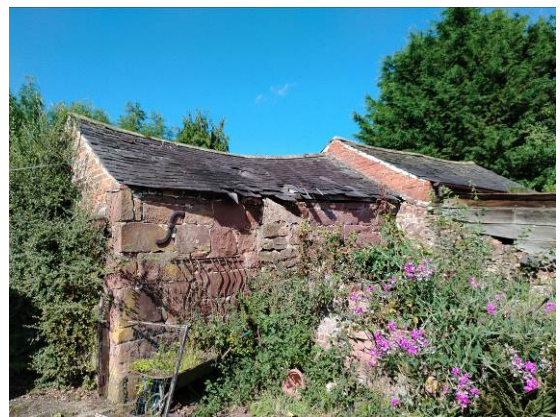
The elevation comprises brickwork to full height on the right-hand side and masonry with a brickwork addition to the left-hand side. Lintels to openings comprise timber units (see Photo 5). The roof over is finished with slate.

Photo 5 – Rear Elevation

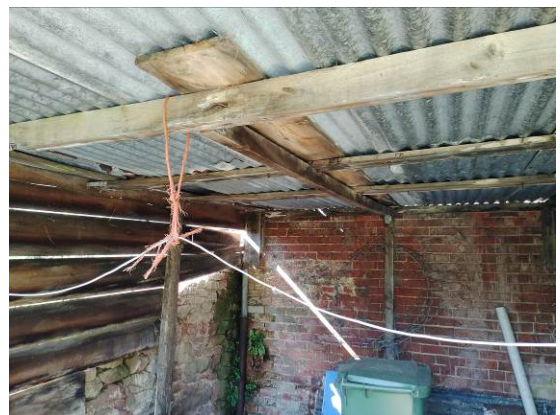
No significant cracking was apparent at the time of inspection. Staining is apparent to small areas of the elevation due to water cascading from the roof (see Photo 6). Minor erosion was apparent to the brick faces locally with more widespread minor erosion to the faces of sandstone units. Degradation to timber lintels was apparent, though no section losses were noted.

Photo 6 – Staining to elevation due to water cascading downface from roof.

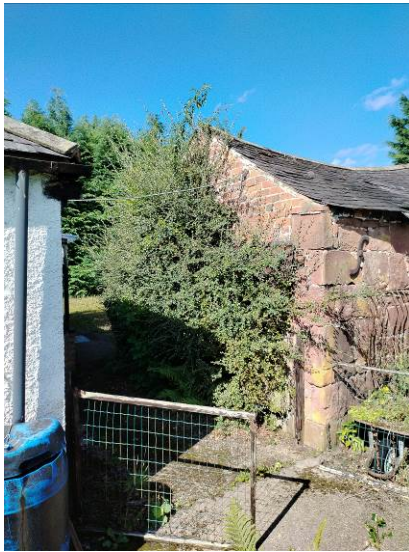
The elevation comprises sandstone masonry to eaves level with brickwork to the gable peak above (see Photo 7). Profiled steel cladding has been secured over the door opening at low level.

Photo 7 – Right hand Side Elevation.

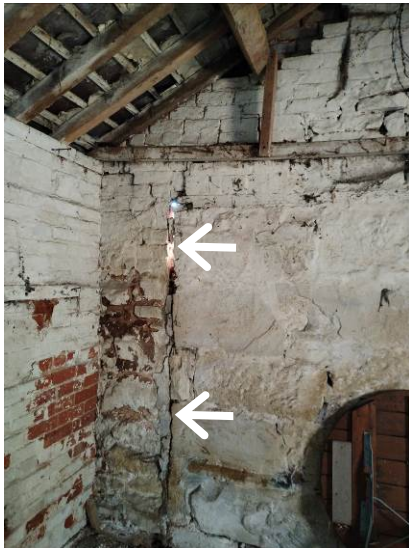
A gap up to 45mm wide was noted between the masonry and brickwork on the internal wall (see Photo 8). Where the pointing was present, the gap was noted as up to 6mm wide. This is probably due to slight differential settlement between the original masonry wall and the brickwork addition and appeared historic in nature. The front elevation wall shows a significant outwards bow at up to 4.0% (40mm in 1.0m) at the window opening. This defect has resulted from roof spread. The timber lintels to all of the openings have significant sag with associated cracking to brickwork above. The timber lintel over the large door opening has failed due to severe rot at one end and being significantly undersized (see Photo 9). The lintel has been propped in the past with limited success. Peeling/missing lime wash finishes at low level are indicative of rising damp.

Photo 8 – Gap between masonry and brickwork.

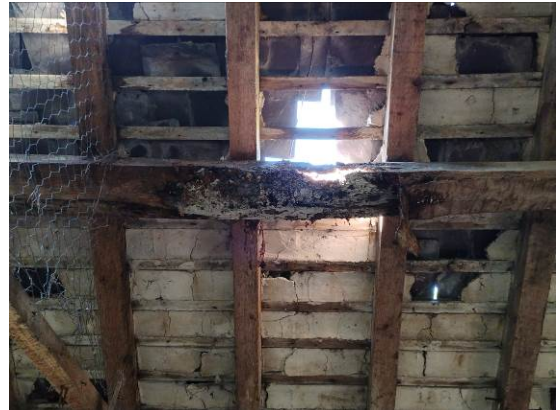
The roof over the room appeared to be in poor condition with numerous slipped or missing slates apparent. Staining is apparent to the rafters and purlins with several areas of advanced rot noted. Severe section losses are apparent to one of the purlins as a result of weather penetration over an extended period (see Photo 10). Similar section losses are also apparent to the intermediate truss (see Photo 11). All of the purlins show significant sagging down the planes of the roof.

Photo 10 – Staining and section losses to purlin.

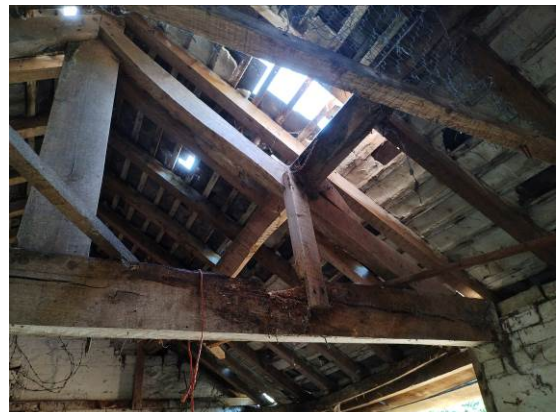
Photo 11 – Staining and section losses to truss.

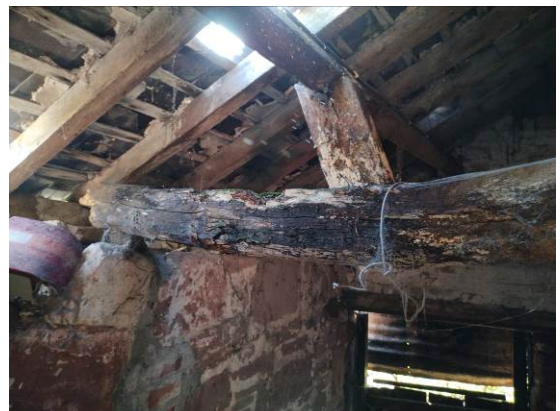
The roof over the room appeared to be in poor condition with numerous slipped or missing slates apparent. Staining is apparent to the rafters and purlins with several areas of advanced rot noted. Severe section losses are apparent to the intermediate beam as a

result of weather penetration over an extended period (see Photo 12). All of the purlins show significant sagging down the planes of the roof.

Photo 12 – Severe section losses to beam.

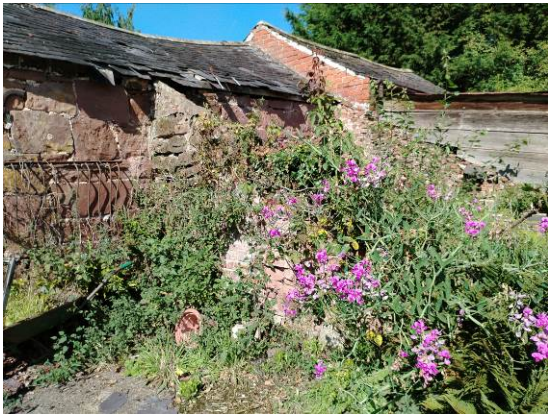
The Derelict Lean-to is located on the rear elevation. The area has tapered sandstone masonry and brickwork walls and no roof over (see Photo 13). The floor construction is unknown due to vegetation growth within.

The walls were noted as generally straight and plumb where visible. Eroded pointing is prevalent throughout with some loose units apparent along the top edges of the walls.

Photo 13 – Derelict lean-to.

- Demolish and rebuild walls to derelict lean-to on rear elevation. Walls to be constructed off new mass concrete strip foundations.
- Demolish timber framed store and blockwork pen outriggers.

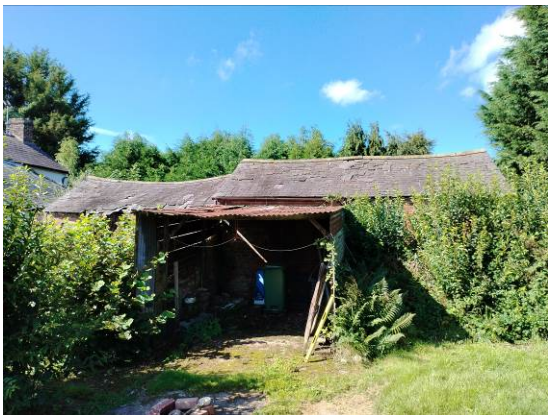
The Store is located on the rear elevation. The area comprises a lightweight timber framing with corrugated steel and timber cladding to the walls and roof (see Photo 14). The floor comprises a concrete slab.

The lightweight timber framing supporting the roof shows evidence of staining due to weather penetration and sagging between support indicative of undersized sections. Areas of significant section losses were apparent to the sheeting on the walls.

Photo 14 – Store.
