Tree Condition Report  
Arboricultural Impact Assessment

Church View, School Lane, Bronington, Whitchurch, SY13 3HN

Adam Turnell  
Architect & Landscape Architect

**Inspection Date:** 24.05.2021

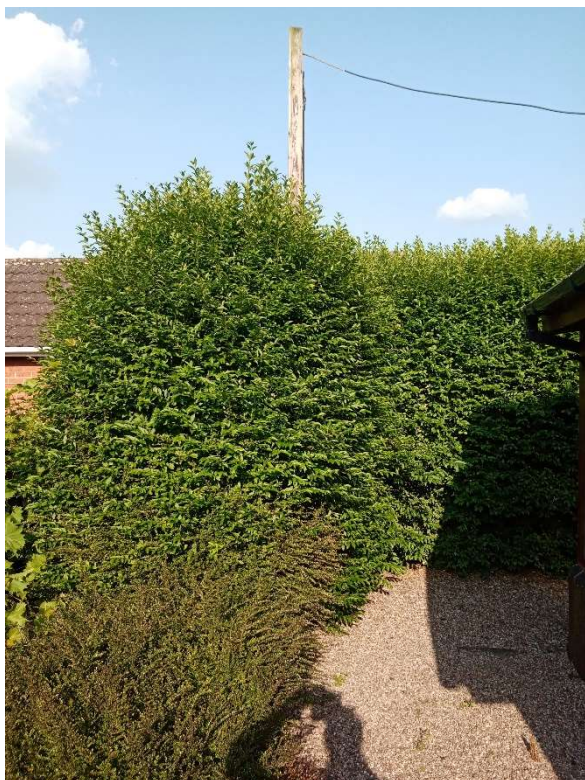
| Reference Number | Species | DBH (mm) | Height (m) | Age | Average Crown Spread (m) | Crown Clearance (m) | Comments | Estimated remaining contribution | Tree Quality category rating |
|---|---|---|---|---|---|---|---|---|---|
| G1 | Green Privet | - | 3.0 | Early Mature | See Plan | 0.0 | Group of green privet shrub planting. Low value group. | 10-20 | C3 |

Photo 1: G1 adjacent to the existing property

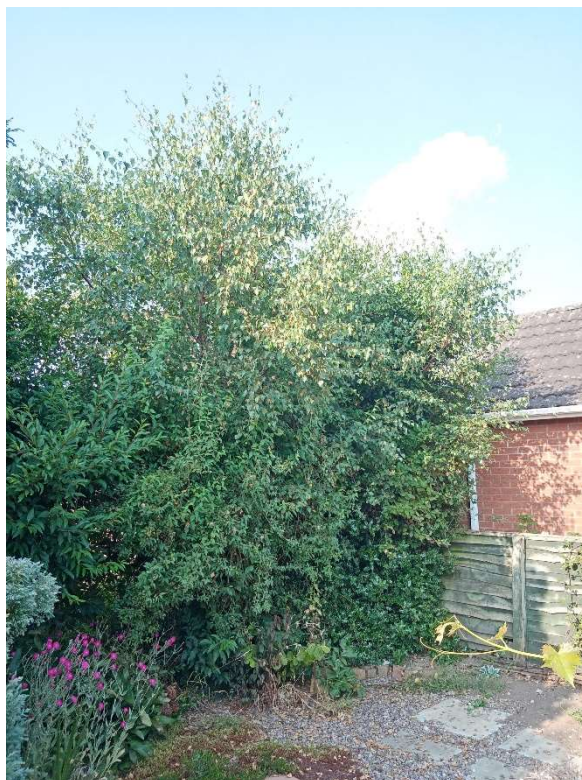
| Reference Number | Species | DBH (mm) | Height (m) | Age | Average Crown Spread (m) | Crown Clearance (m) | Comments | Estimated remaining contribution | Tree Quality category rating |
|---|---|---|---|---|---|---|---|---|---|
| T1 | Holly | 200 | 3.0 | Mature | 1.0 | 1.5 | Single stem at ground level with mutli-stems at 1.5m due to unsympathetic past pruning. Partially suppressed by tree above. | 10-20 | C2 |
| T2 | Silver Birch | 350 | 5.0 | Semi Mature | 3.5 | 2 | Single-stemmed with an upright stem and a balanced crown. No previous pruning. No major visible defects. | 20-40 | B1 |
| T3 | Laurel | - | 2 | Young | 1.5 | 0.0 | Multi stemmed at ground level. No previous pruning. No major visible defects. | 10-20 | C2 |

Photo 2: T1 – T3 in the north east corner of the site

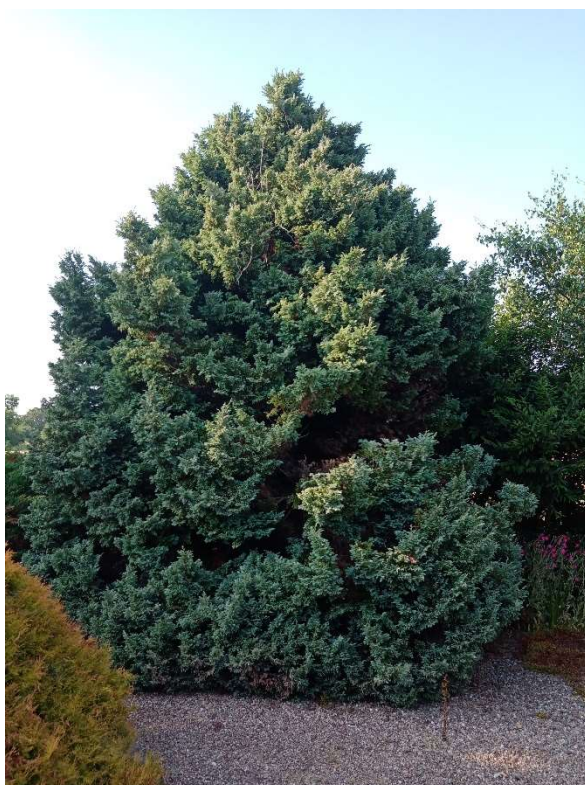
| Reference Number | Species | DBH (mm) | Height (m) | Age | Average Crown Spread (m) | Crown Clearance (m) | Comments | Estimated remaining contribution | Tree Quality category rating |
|---|---|---|---|---|---|---|---|---|---|
| T4 | Leylandii<br>'Haggerton Grey' | 400 | 5.5 | Mature | 2.0 | 0.0 | Single stemmed at ground level with no significant pruning. | 10-20 | C2 |
| T5 | Leylandii | 250 | 1.5 | Semi Mature | 1.5 | 0.0 | Single stemmed at ground level with no significant pruning. | 10-20 | C2 |

Photo 3: T4– T5 on the northern boundary of the site.

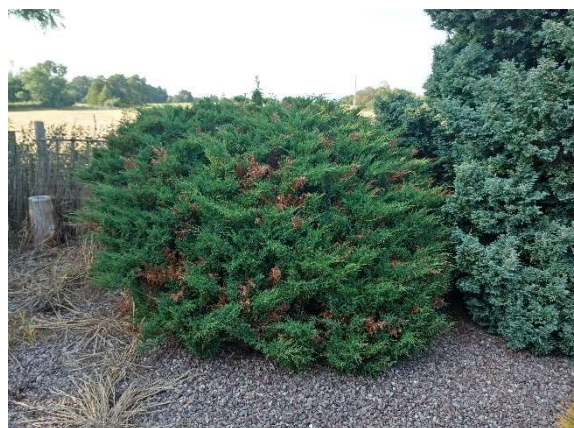
| Reference Number | Species | DBH (mm) | Height (m) | Age | Average Crown Spread (m) | Crown Clearance (m) | Comments | Estimated remaining contribution | Tree Quality category rating |
|---|---|---|---|---|---|---|---|---|---|
| T6 | Leylandii | 200 | 2.0 | Semi Mature | 1.5 | 0.0 | Single stemmed at ground level with no significant pruning. | 10-20 | C2 |

Photo 4: T6 on the northern boundary of the site.

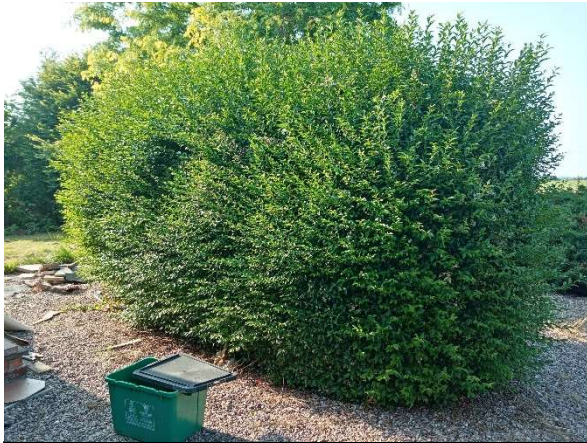
| Reference Number | Species | DBH (mm) | Height (m) | Age | Average Crown Spread (m) | Crown Clearance (m) | Comments | Estimated remaining contribution | Tree Quality category rating |
|---|---|---|---|---|---|---|---|---|---|
| G2 | Green Privet | - | 3.0 | Early Mature | See Plan | 0.0 | Group of green privet shrub planting. Low value group. | 10-20 | C3 |

Photo 5: G2 in the centre of the site behind the existing property

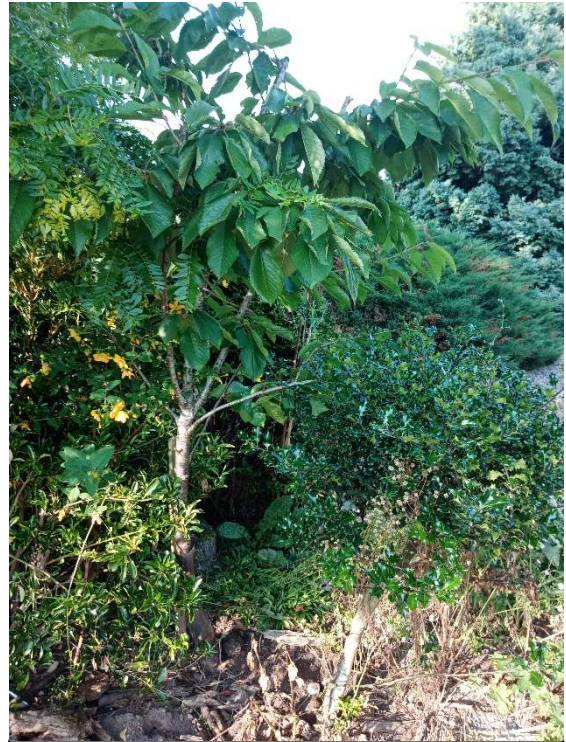
| Reference Number | Species | DBH (mm) | Height (m) | Age | Average Crown Spread (m) | Crown Clearance (m) | Comments | Estimated remaining contribution | Tree Quality category rating |
|---|---|---|---|---|---|---|---|---|---|
| T8 | Holly | 50 | 2.0 | Young | 0.5 | 1.0 | Single-stemmed with an upright stem and a balanced crown. No previous pruning. No major visible defects. | 20-40 | C3 |
| T9 | Cherry | 50 | 2.5 | Young | 1.0 | 1.5 | Single-stemmed with an upright stem and a balanced crown. No previous pruning. No major visible defects. | 20-40 | C3 |

Photo 6: T8 & T9 located centrally along the northern boundary of the site.

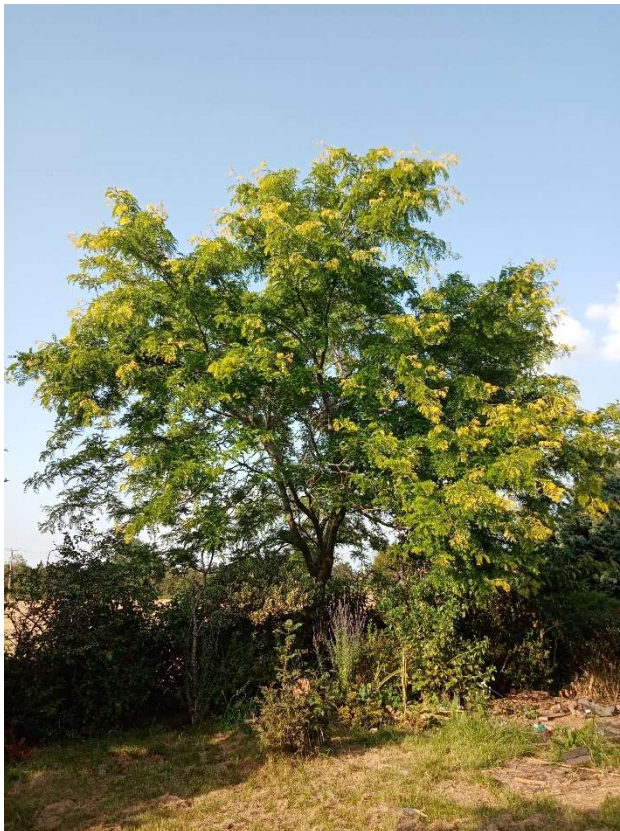
| T10 | Rowan | 220 | 7.5 | Semi<br>Mature | 5.0 | 2.5 | Single-stemmed with an upright stem and a balanced crown. No previous pruning. No major visible defects. | 20-40 | B1 |
| T11 | Holly | 50 | 1.5 | Young | 0.5 | 1 | Single-stemmed with an upright stem and a balanced crown. No previous pruning. No major visible defects. | 20-40 | C3 |
| T12 | Crab apple | 180<br>comb | 2.0 | Semi<br>Mature | 1.5 | 0.5 | Multi-stemmed at ground level; with a spreading, slightly unbalanced crown. No significant pruning. No major visible defects. | 10-20 | C2 |

Photo 7: T8 – T12 along the northern boundary of the site.

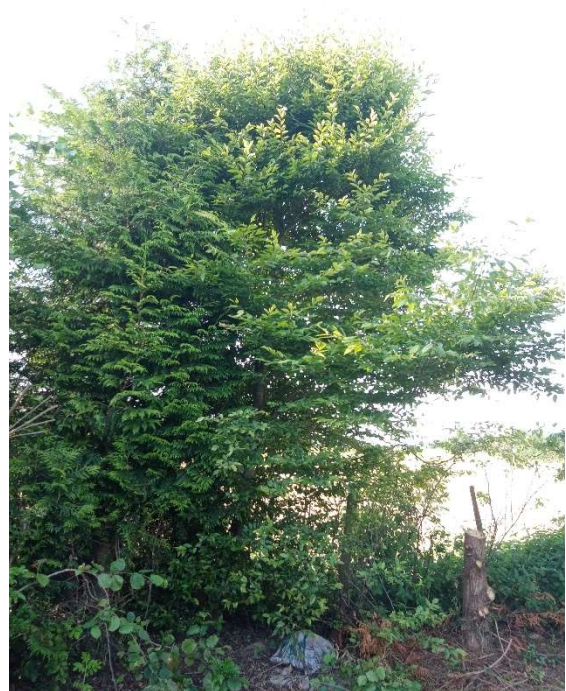
| T13 | Stump | n/a | n/a | n/a | n/a | n/a | Proposed that the stump is removed. | n/a | n/a |
| T14 | Stump | n/a | n/a | n/a | n/a | n/a | Proposed that the stump is removed. | n/a | n/a |
| T15 | Beech | 150 | 5.5 | Early<br>Mature | 3.0 | 1.5 | Single-stemmed with an upright stem and a balanced crown. No previous pruning. No major visible defects. | 20-40 | B1 |
| T16 | Leylandii 'gold' | 200<br>comb | 5.5 | Early<br>Mature | 1.5 | 1.0 | Twin stemmed at ground level. No significant pruning. Crossing branches in crown of tree. | 10-20 | C3 |

Photo 8: T13 – T16 located in the north western corner of the site.

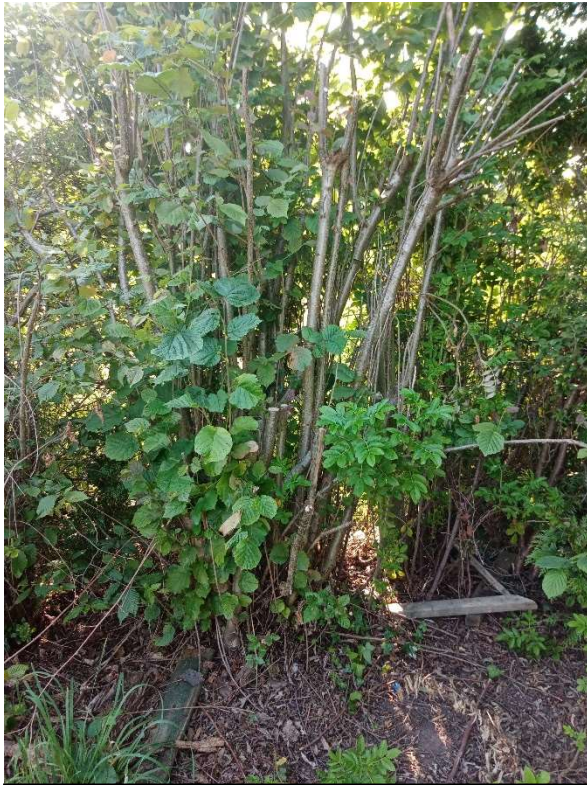
| T19 | Beech | 450<br>comb | 3.5 | Early<br>Mature | 2.0 | - | Multi stemmed at ground level. Significant historic pruning has resulted in heavily unbalanced growth. No high value specimens present. | <10 | U |

Photo 9: T19 located on the western boundary of the site.

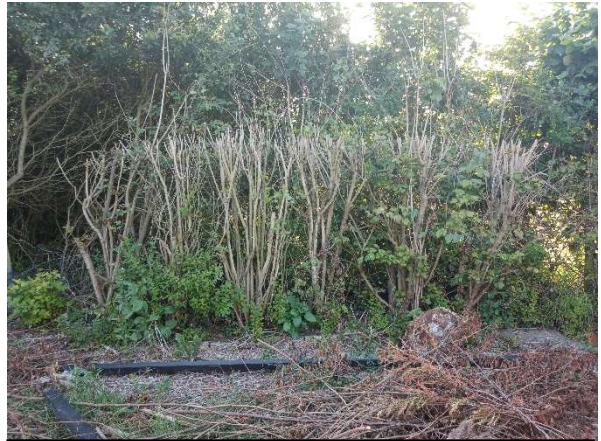
| G4 | Mixed Species | - | 3.0 | Early<br>Mature | See plan | 1.0 | Row of semi-mature screening trees of generally low quality and value as individuals which looked to form original hedge along boundary. Group includes beech and Sycamore. Significant historic pruning has resulted in heavily unbalanced growth. No high value specimens present. | <10 | U |

| G6 | Mixed Species | - | 4.5 | Early/Semi<br>Mature | See plan | 1.0 | Group of semi-mature screening trees of generally low quality and value as individuals. Group includes beech, Sycamore, Hawthorn, Holly and Silver Birch. No high value specimens present. Dense Ivy to stems throughout. | 10-20 | C2 |

Photo 10: G4 on the western boundary of the site with G6 behind on the neighbouring land.

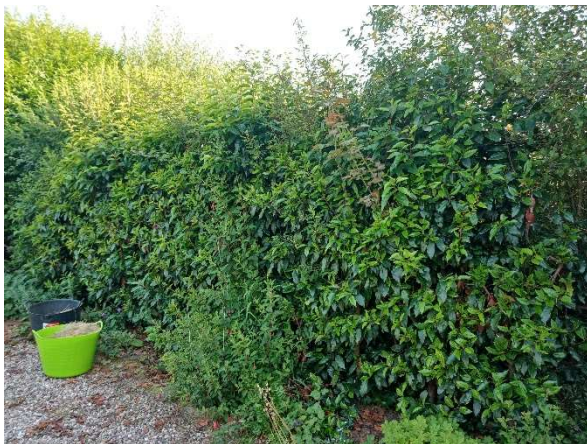
| G7 | Mixed Species | - | 4.0 | Early/Semi<br>Mature | See plan | 0.0 | Group of mixed garden tree and shrubs of low quality and value. Group includes privet, buddleia, holly, rose and laurel. | 10-20 | C3 |

Photo 11: G7 on the south west boundary of the site.

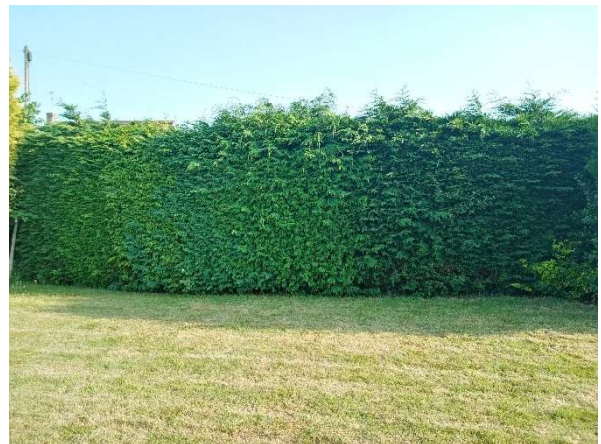
| H1 | Mixed Species | - | 3.0 | Early<br>Mature | - | 0.0 | A regular clipped garden hedge which included Laylandii and holly | 10-20 | C2 |

Photo 12: H1 on the south east boundary of the site.

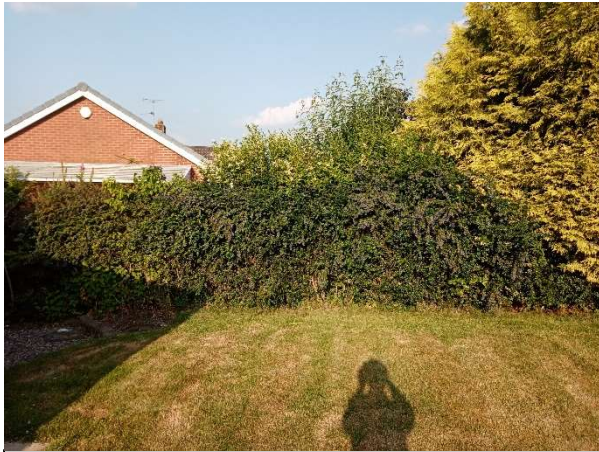
| T22<br>(on<br>neighbouring<br>property) | Laylandii 'gold' | 450<br>comb | 6.0 | Mature | 3.0 | 1.0 | Twin stemmed at ground level. No significant pruning. Crossing branches in crown of tree. | 10-20 | C2 |

Photo 13: T22 & G8 on the southern end of the eastern boundary of the site.

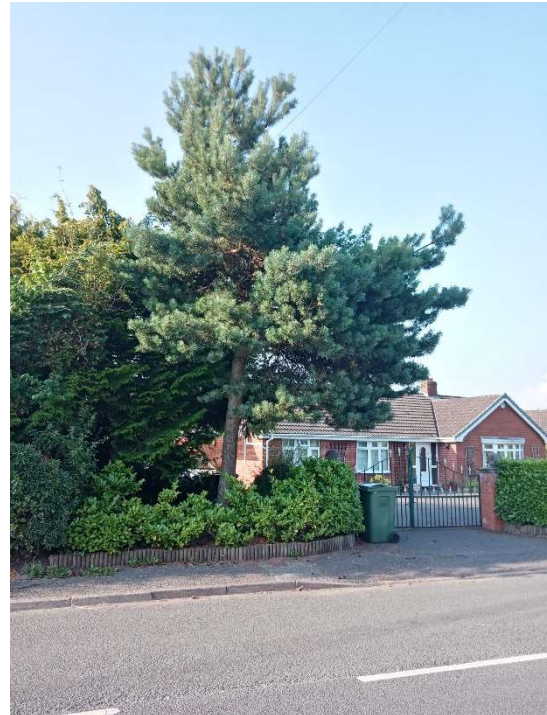
| T21<br>(on<br>neighbouring<br>property) | Laylandii 'gold' | 225 | 6.0 | Mature | 3.0 | 1.0 | Single stem at ground level. No significant pruning. | 10-20 | C2 |
| T23<br>(on<br>neighbouring<br>property) | Scot Pine | 300 | 7.0 | Early<br>Mature | 3.5 | 2.0 | Single-stemmed with a slight lean east and an unbalanced crown. No significant pruning. Deadwood in lower crown. Major crossing branches in union. Poor form. Situated below utility wires. | 20-40 | B1 |

Photo 14: T21-T23 on the neighbouring property adjacent to the south east corner of the site.

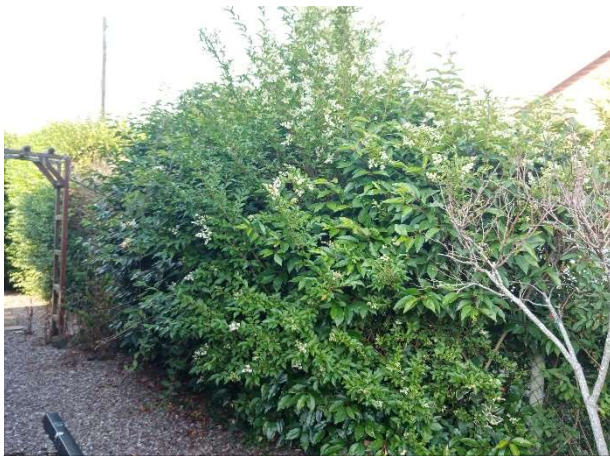
| G9 | Mixed Species | - | 2.0 | Early<br>Mature | See plan | 0.0 | Group of mixed garden tree and shrubs of low quality and value. Group includes privet, buddleia, holly, and laurel. | 10-20 | C2 |

Photo 15: G8 & G9 along the eastern boundary of the site.

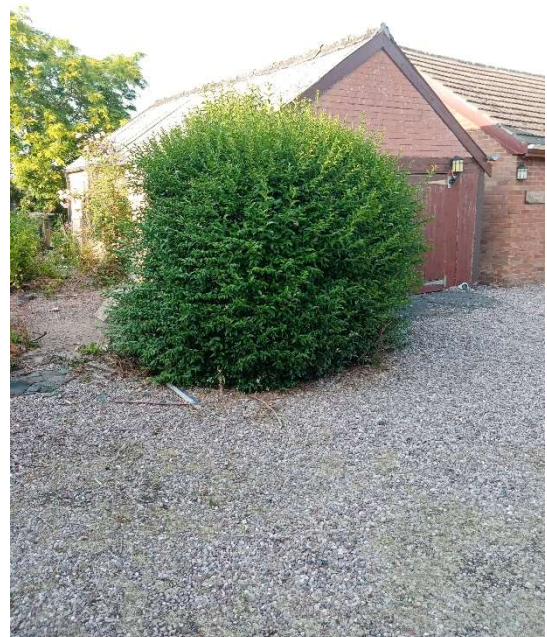
| G5 | Green Privet | - | 2.0 | Early<br>Mature | See Plan | 0.0 | Group of green privet shrub planting. Low value group. | 10-20 | C3 |

Photo 16: G5 adjacent to the existing garage and workshop building.
