## Demolition Survey

Unit 5/6/7/8/9 Bridgeway Centre  
Bridge Road  
Wrexham  
LL13 9QS

**TRAC Associates Limited**

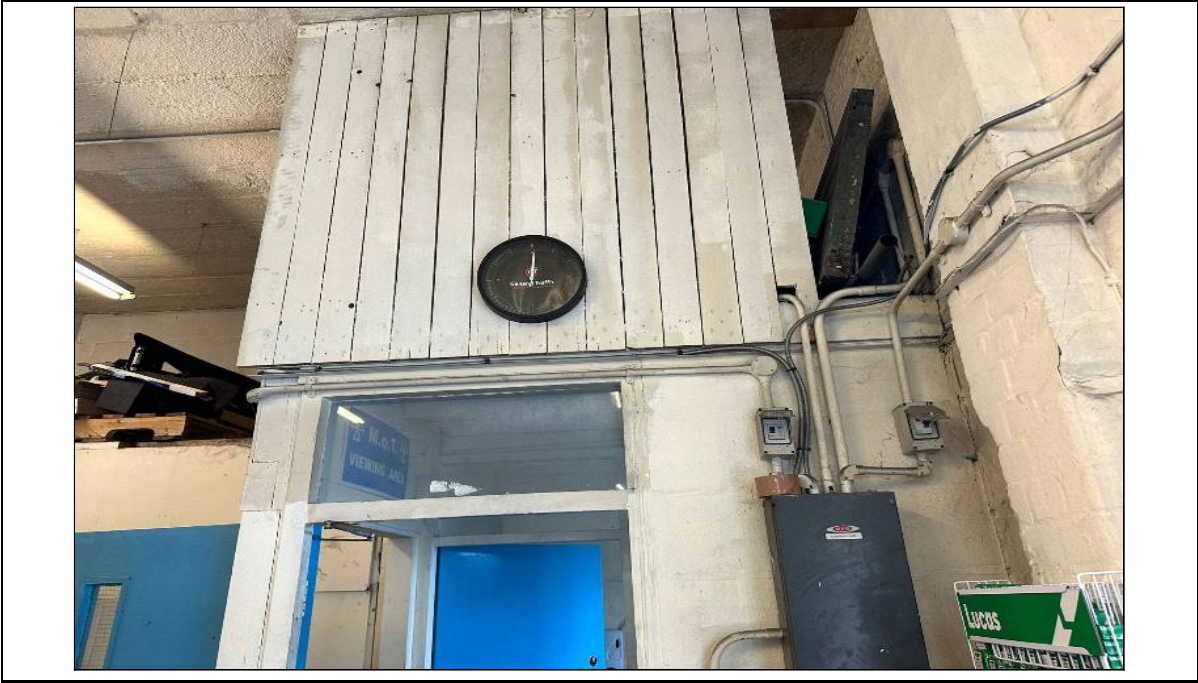
| Item Number / Sample No (S,SP,P,As) |
|---|
| 1 / Visual (P) |

| Item | Quantity |
|---|---|
| No access into live electrics in bill electrical units | 2no. |

| Material Risk Score | |
|---|---|
| Recommendation | Inspection Required |

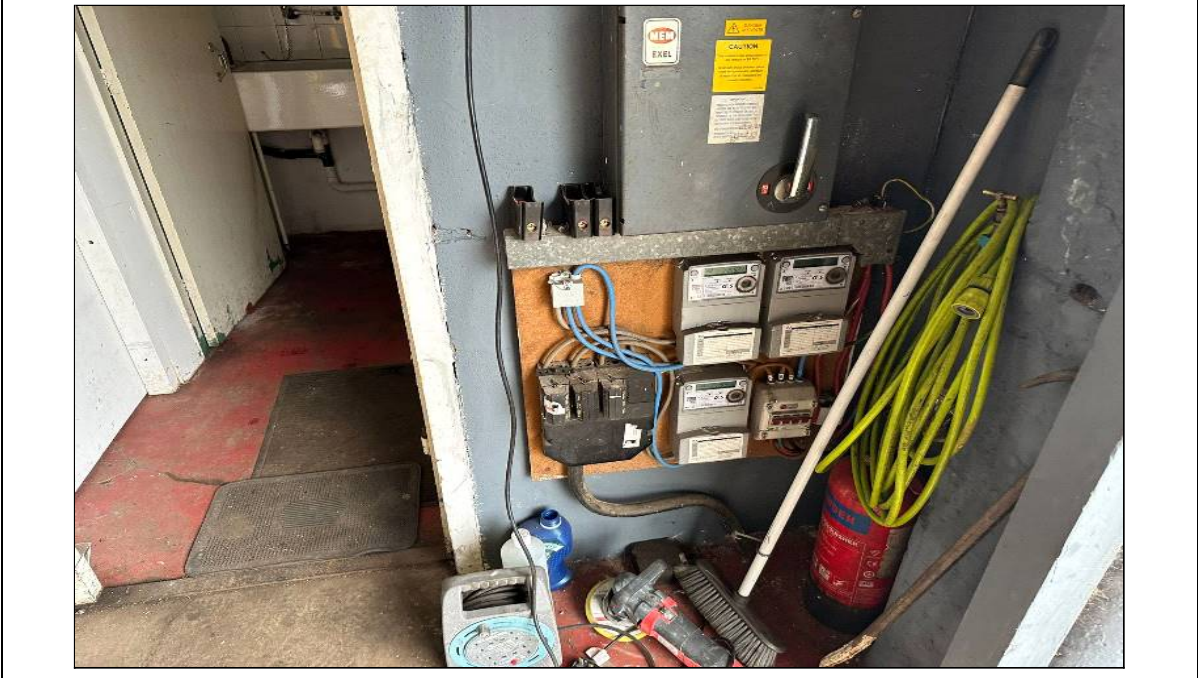
| Item Number / Sample No (S,SP,P,As) |
|---|
| 2 / Visual (P) |

| Item | Quantity |
|---|---|
| No access into live electrics bill electrical boxes | 2no. |

| Material Risk Score | |
|---|---|
| Recommendation | Inspection Required |

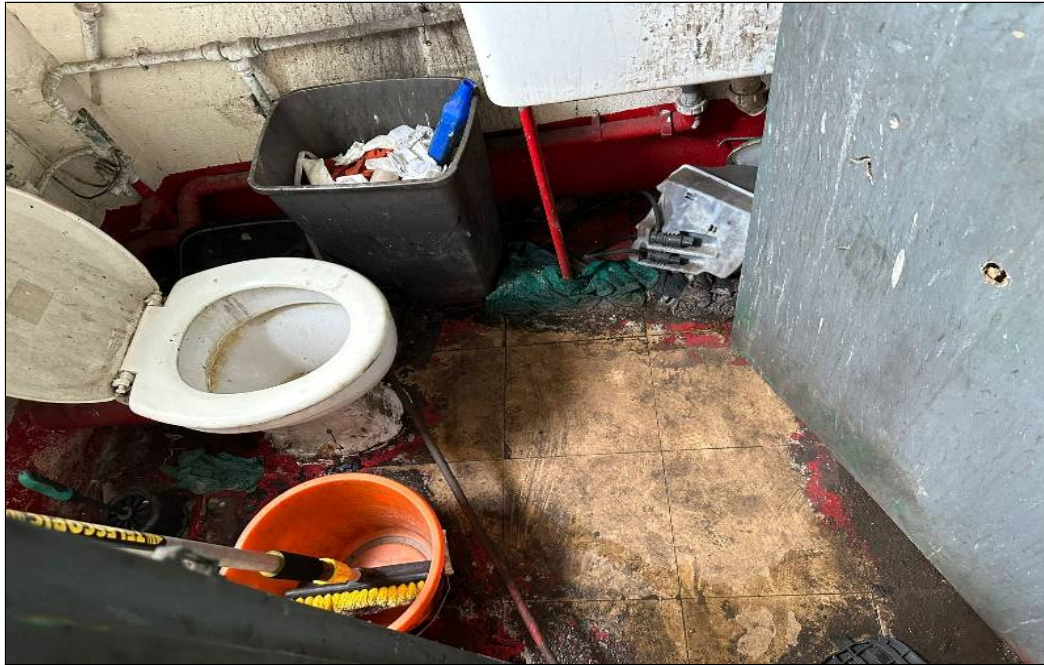
| Item Number / Sample No (S,SP,P,As) |
|---|
| 3 / Visual (P) |

| Item | Quantity |
|---|---|
| Floor tiles to floor of wc previously identified present in all unit wc areas | 30m <sup>2</sup> |

| Analysis | Product Type | Surface Treatment | Condition | Accessibility |
|---|---|---|---|---|
| Chrysotile (1) | Well-bound Material (1) | 0 | Low Damage (1) | Easily disturbed |
| 3 | | | | |

| Material Risk Score | |
|---|---|
| Comment | None licensed acm |

| Material Risk Score | |
|---|---|
| Recommendation | Remove in accordance with CAR 2012 |
