| <b>Project.</b><br>PROPOSED REPAIRS & ALTERATIONS TO THE COACH HOUSE, CEFN KYNASTON, HILL STREET, CEFN MAWR, LL14 3BA. | |
| <b>Title.</b> | PROPOSED FLOOR PLANS ELEVATIONS & SECTION. |
| <b>Drawing No.</b> | 10639.04.dsj |

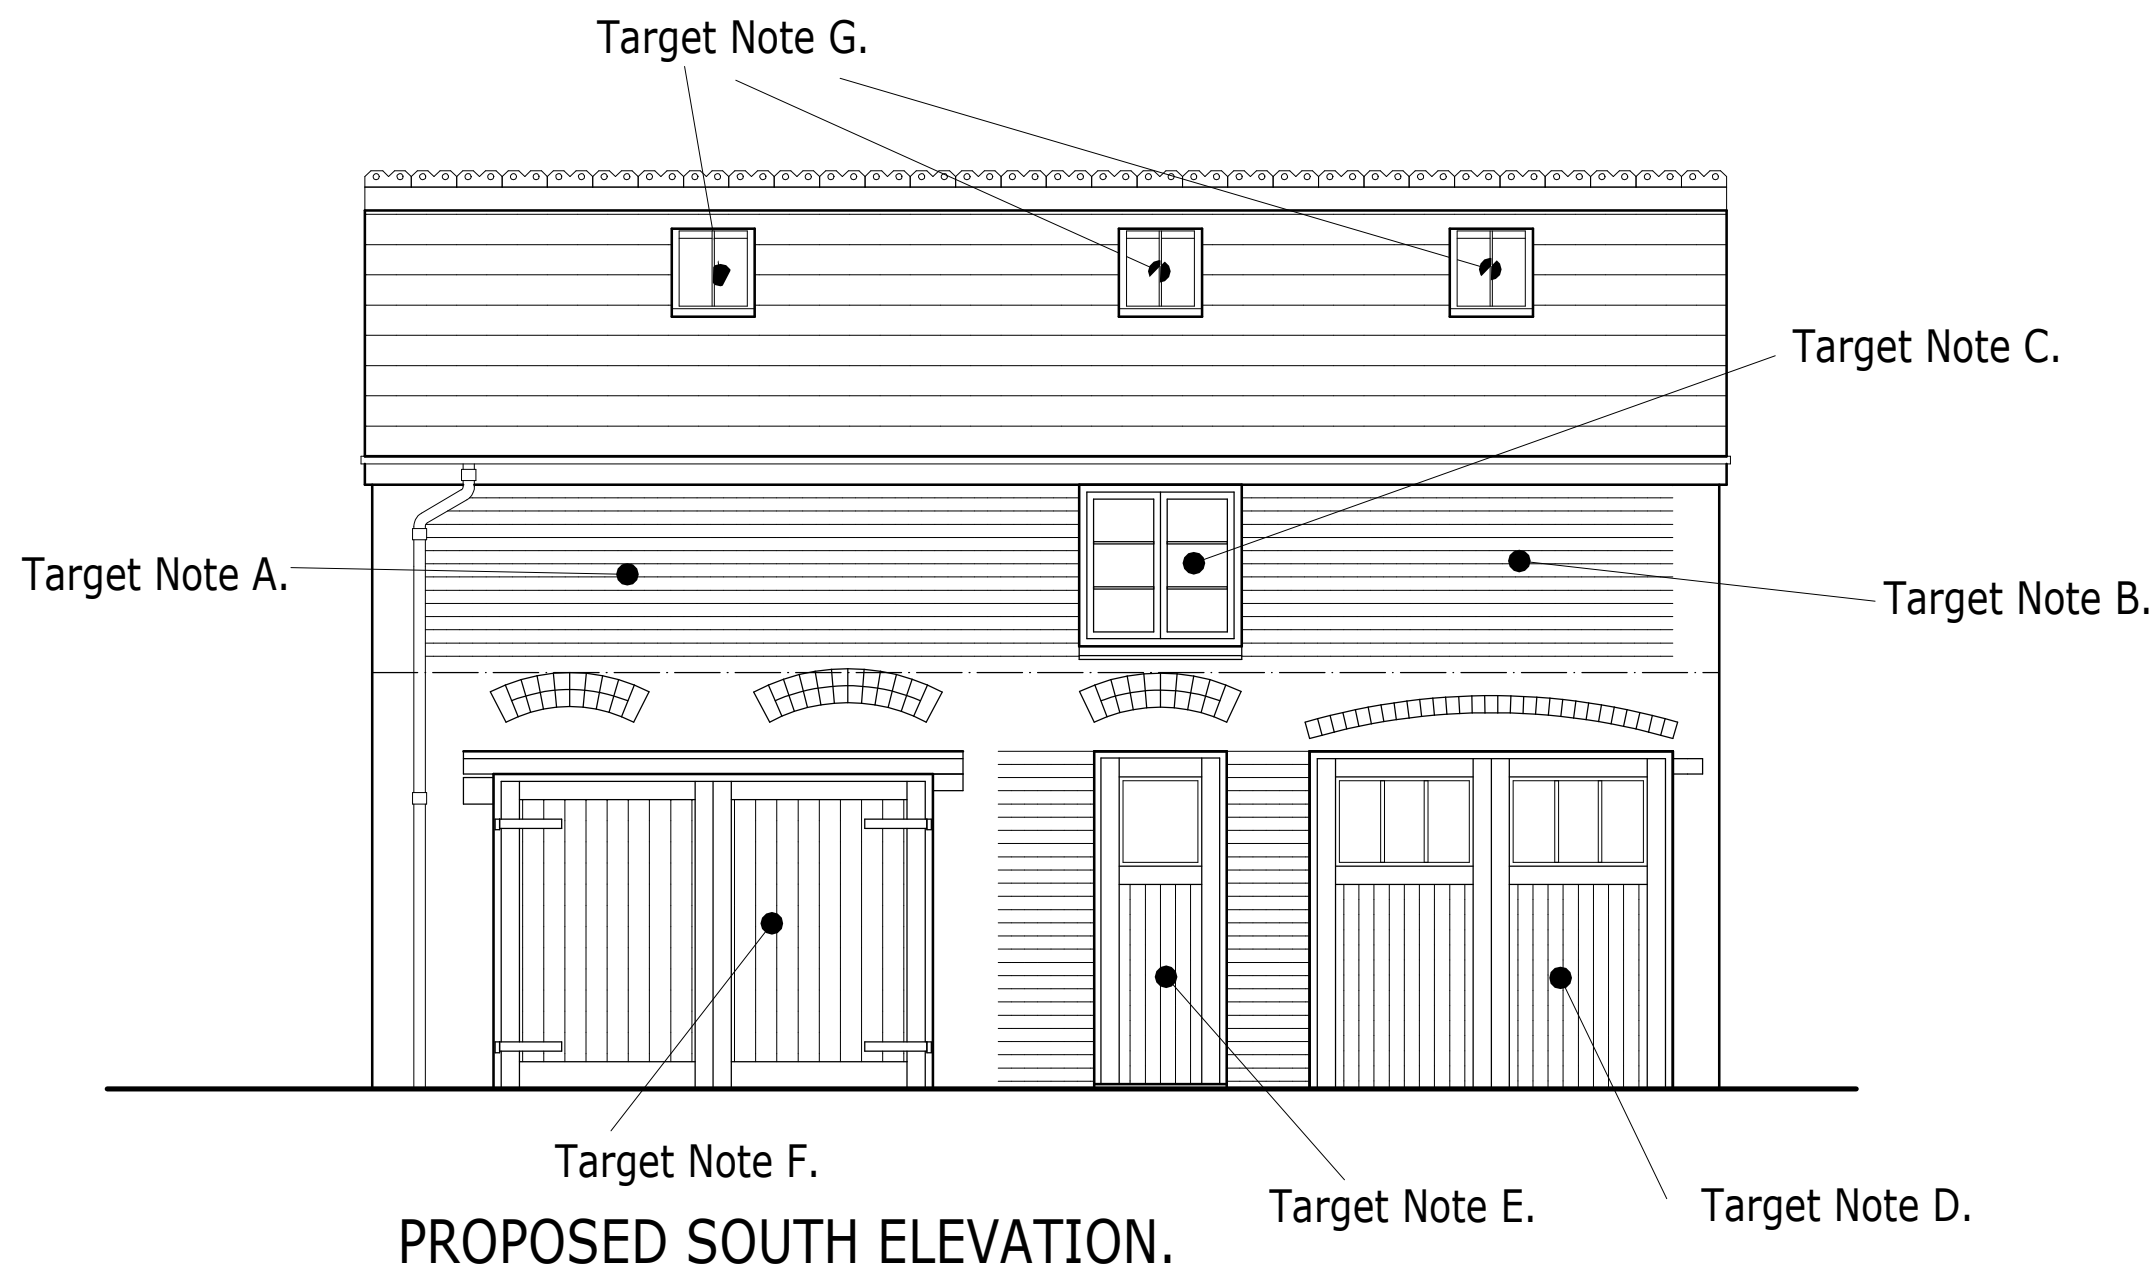
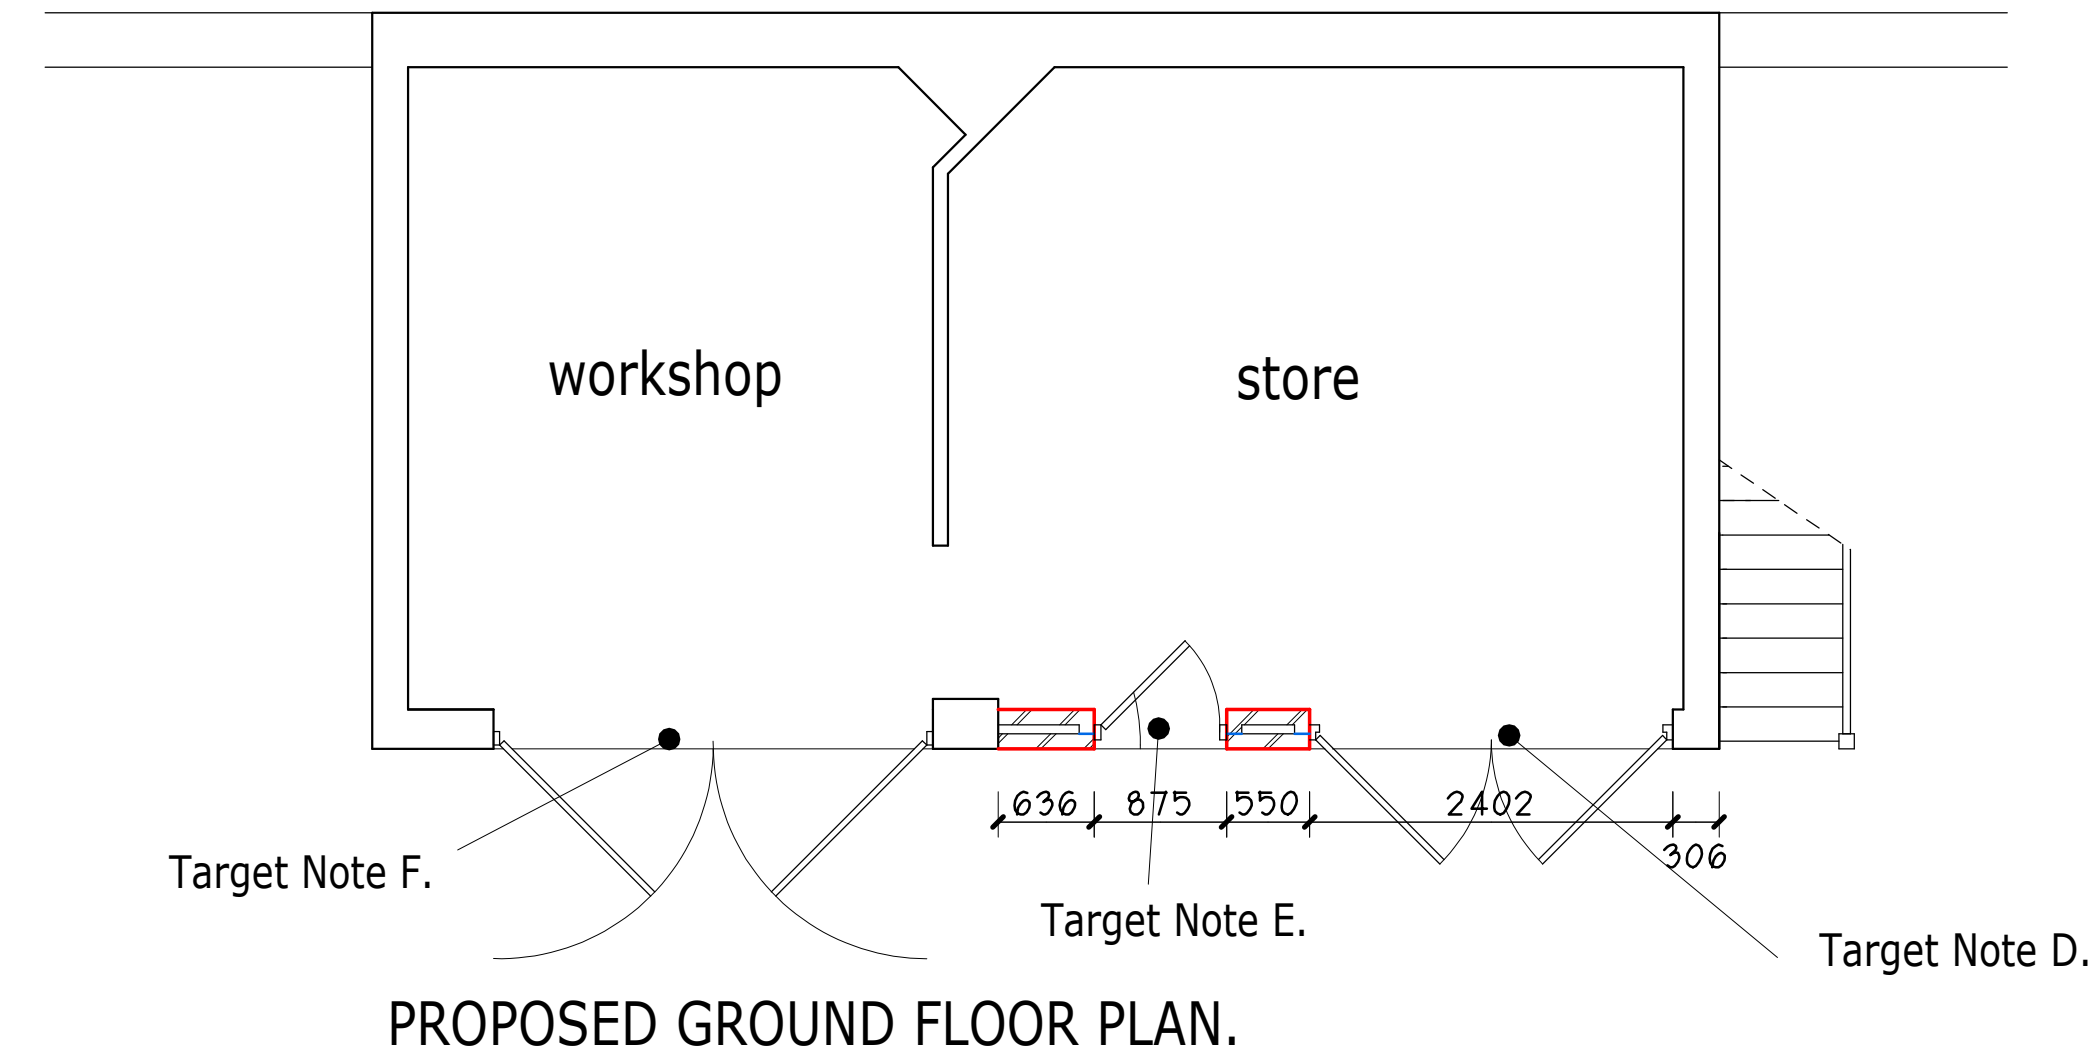
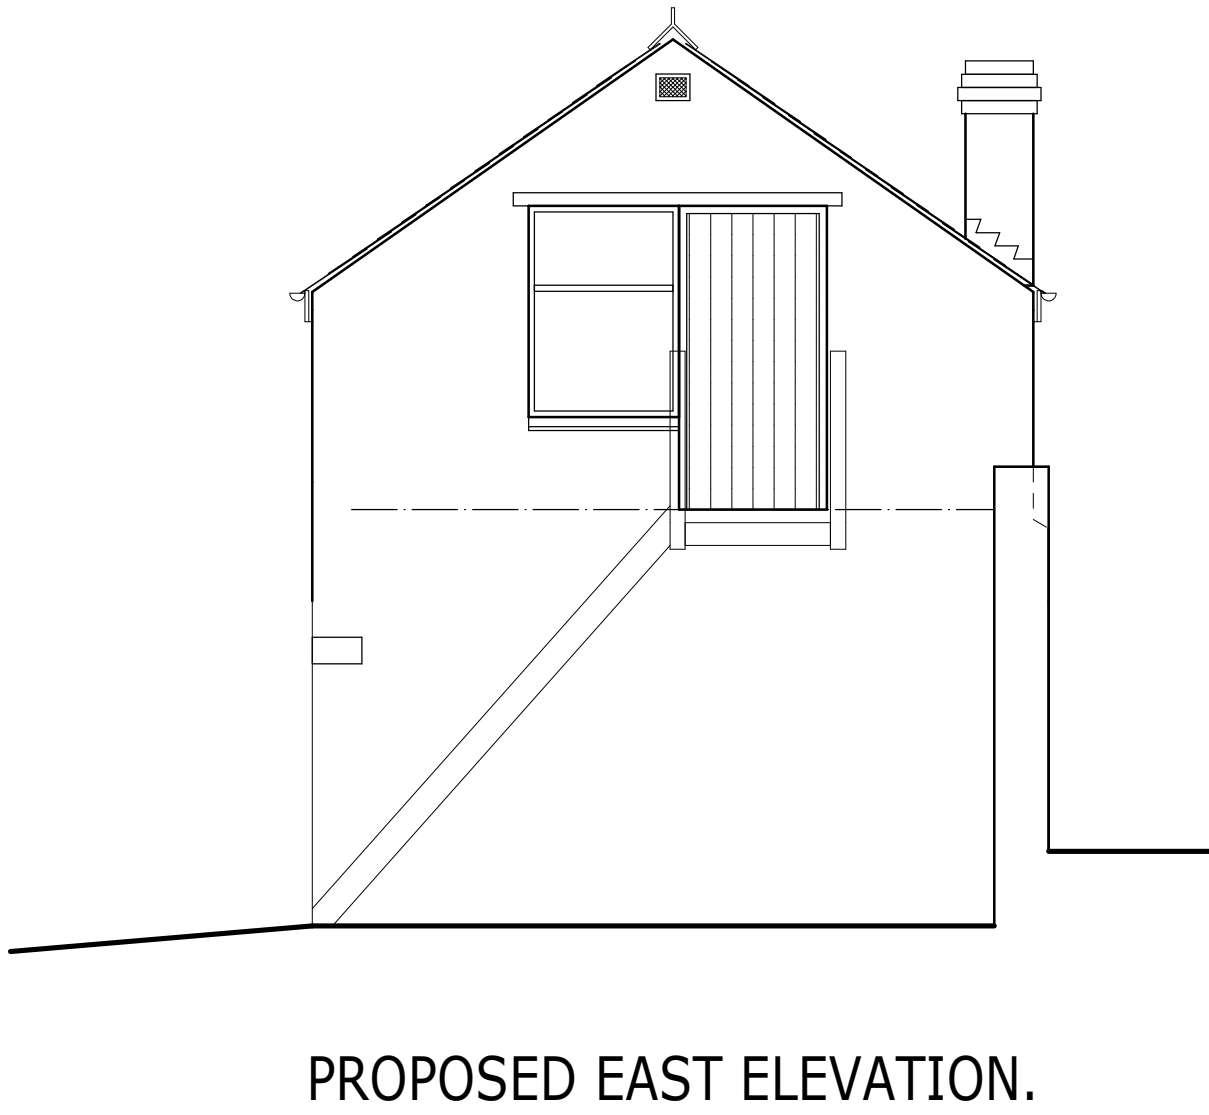
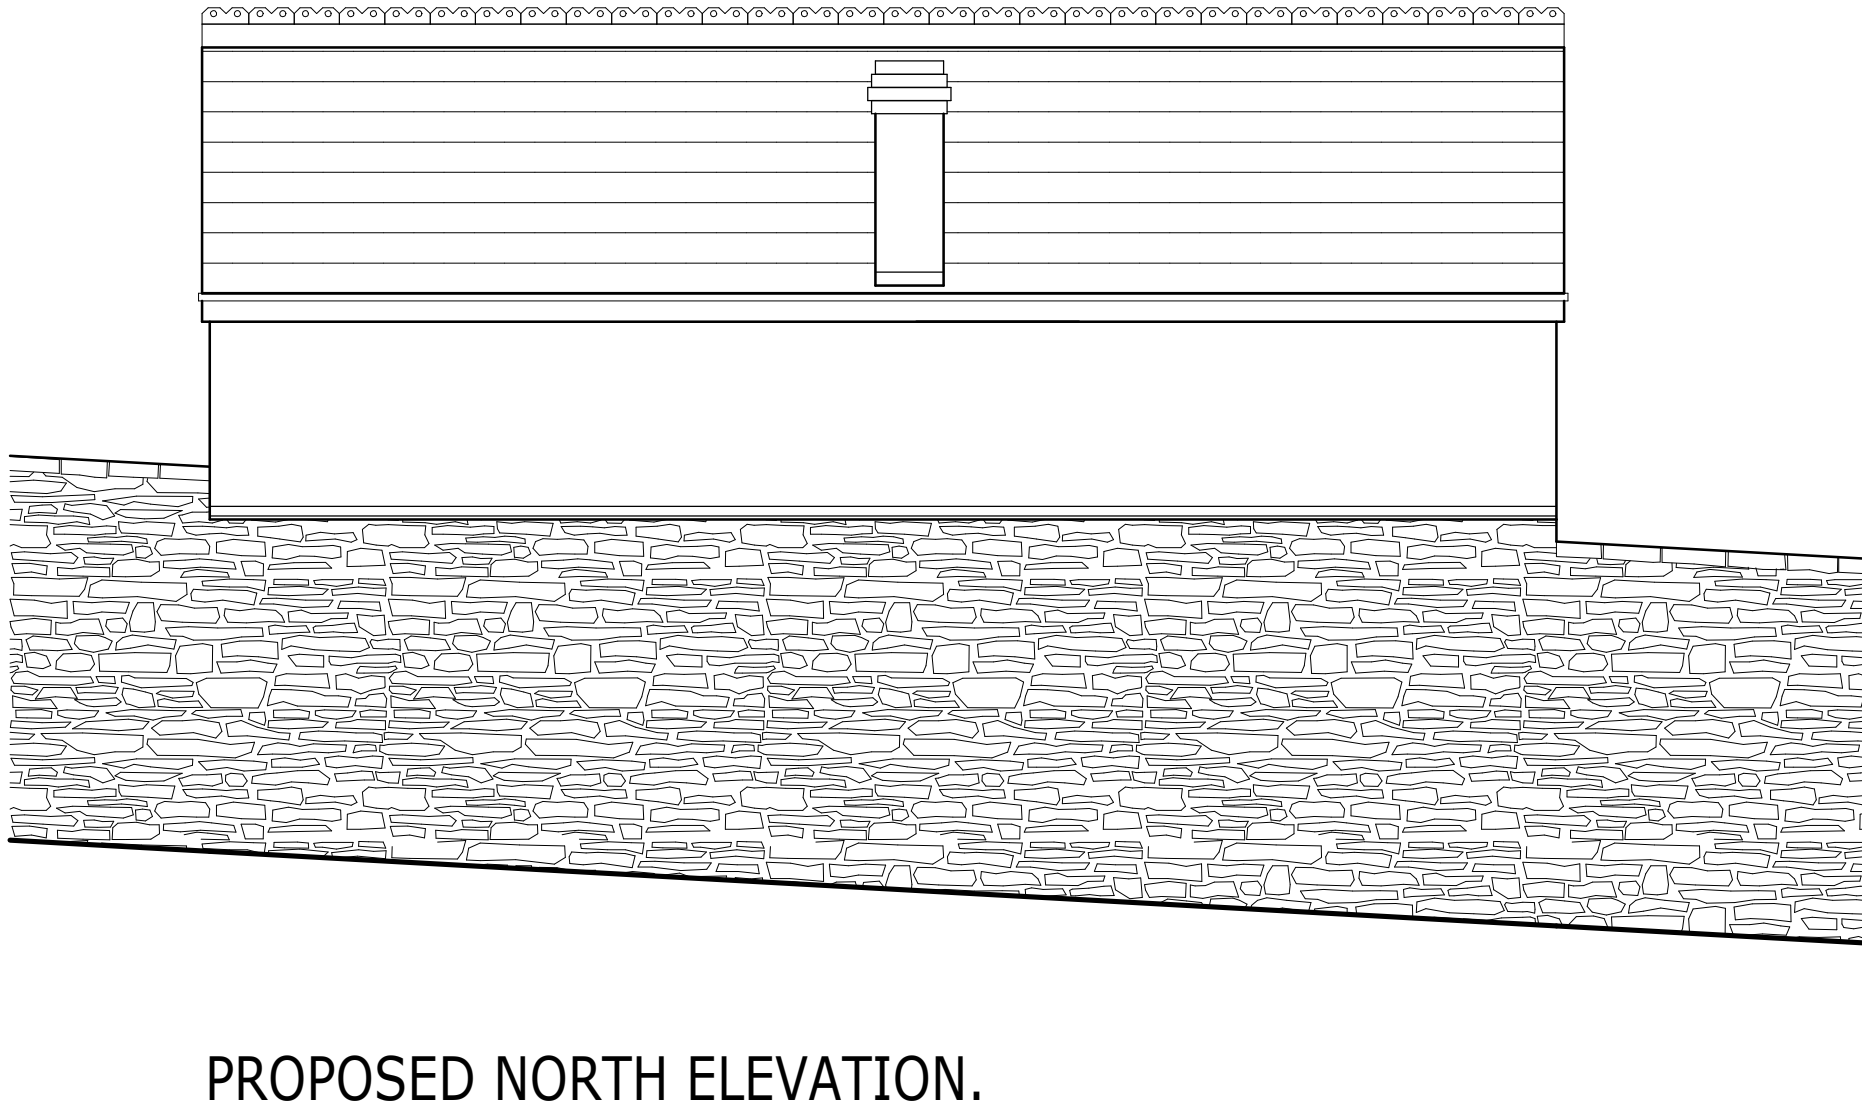
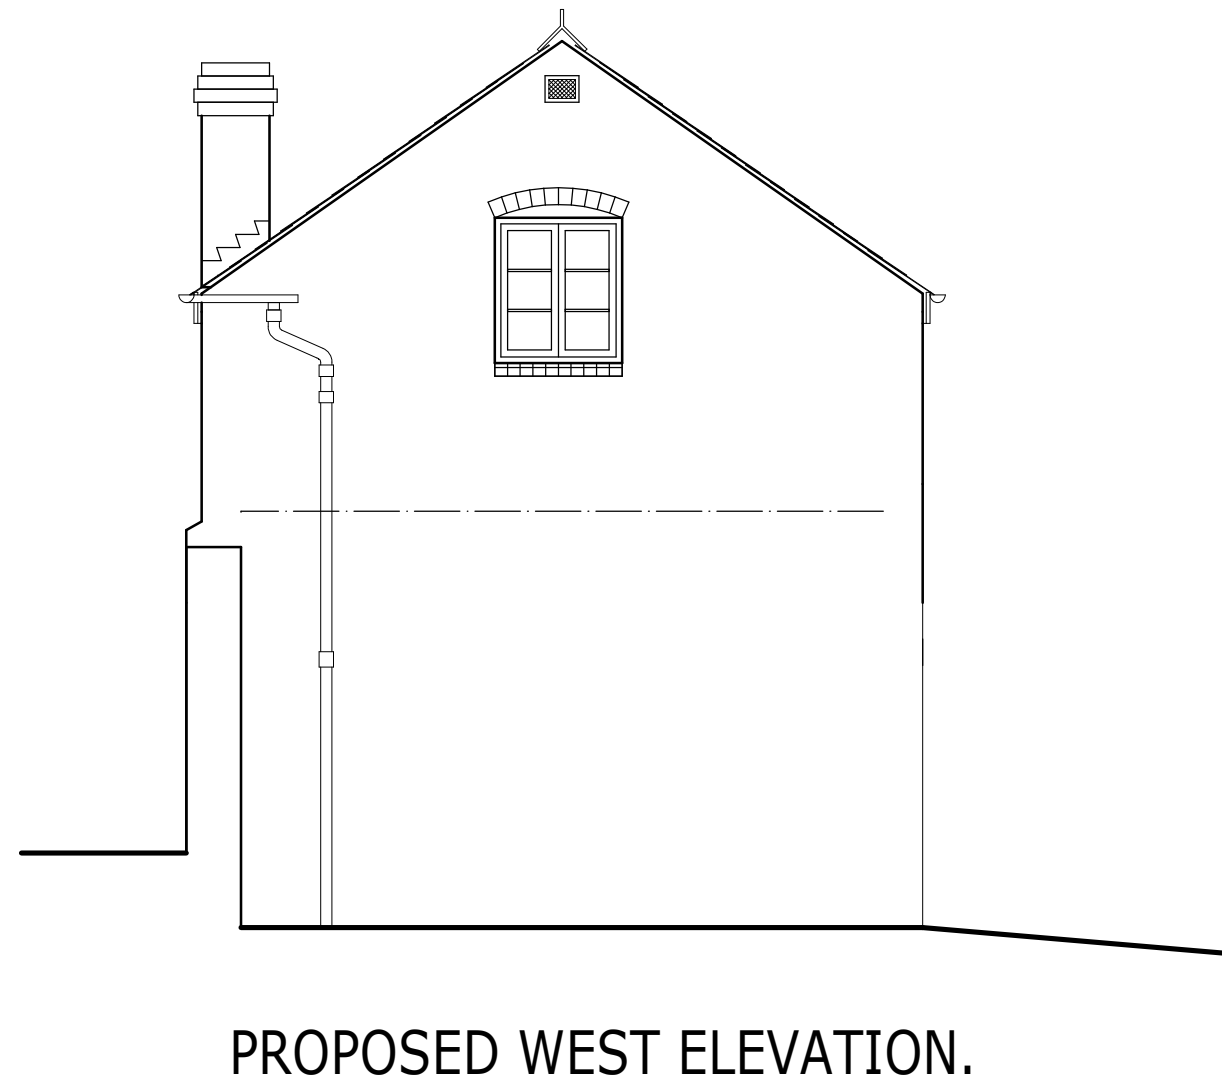
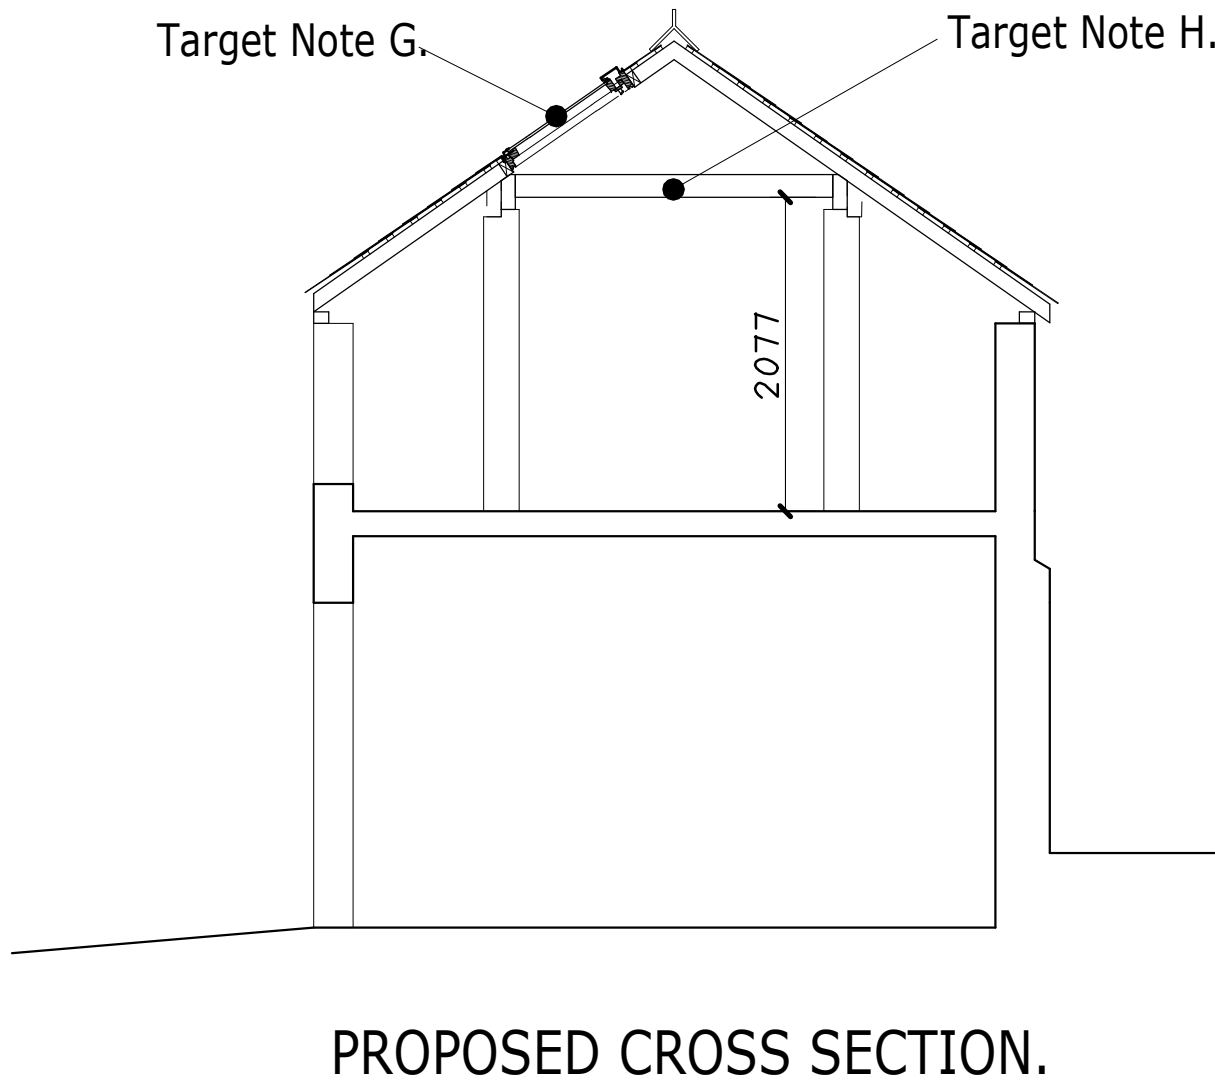
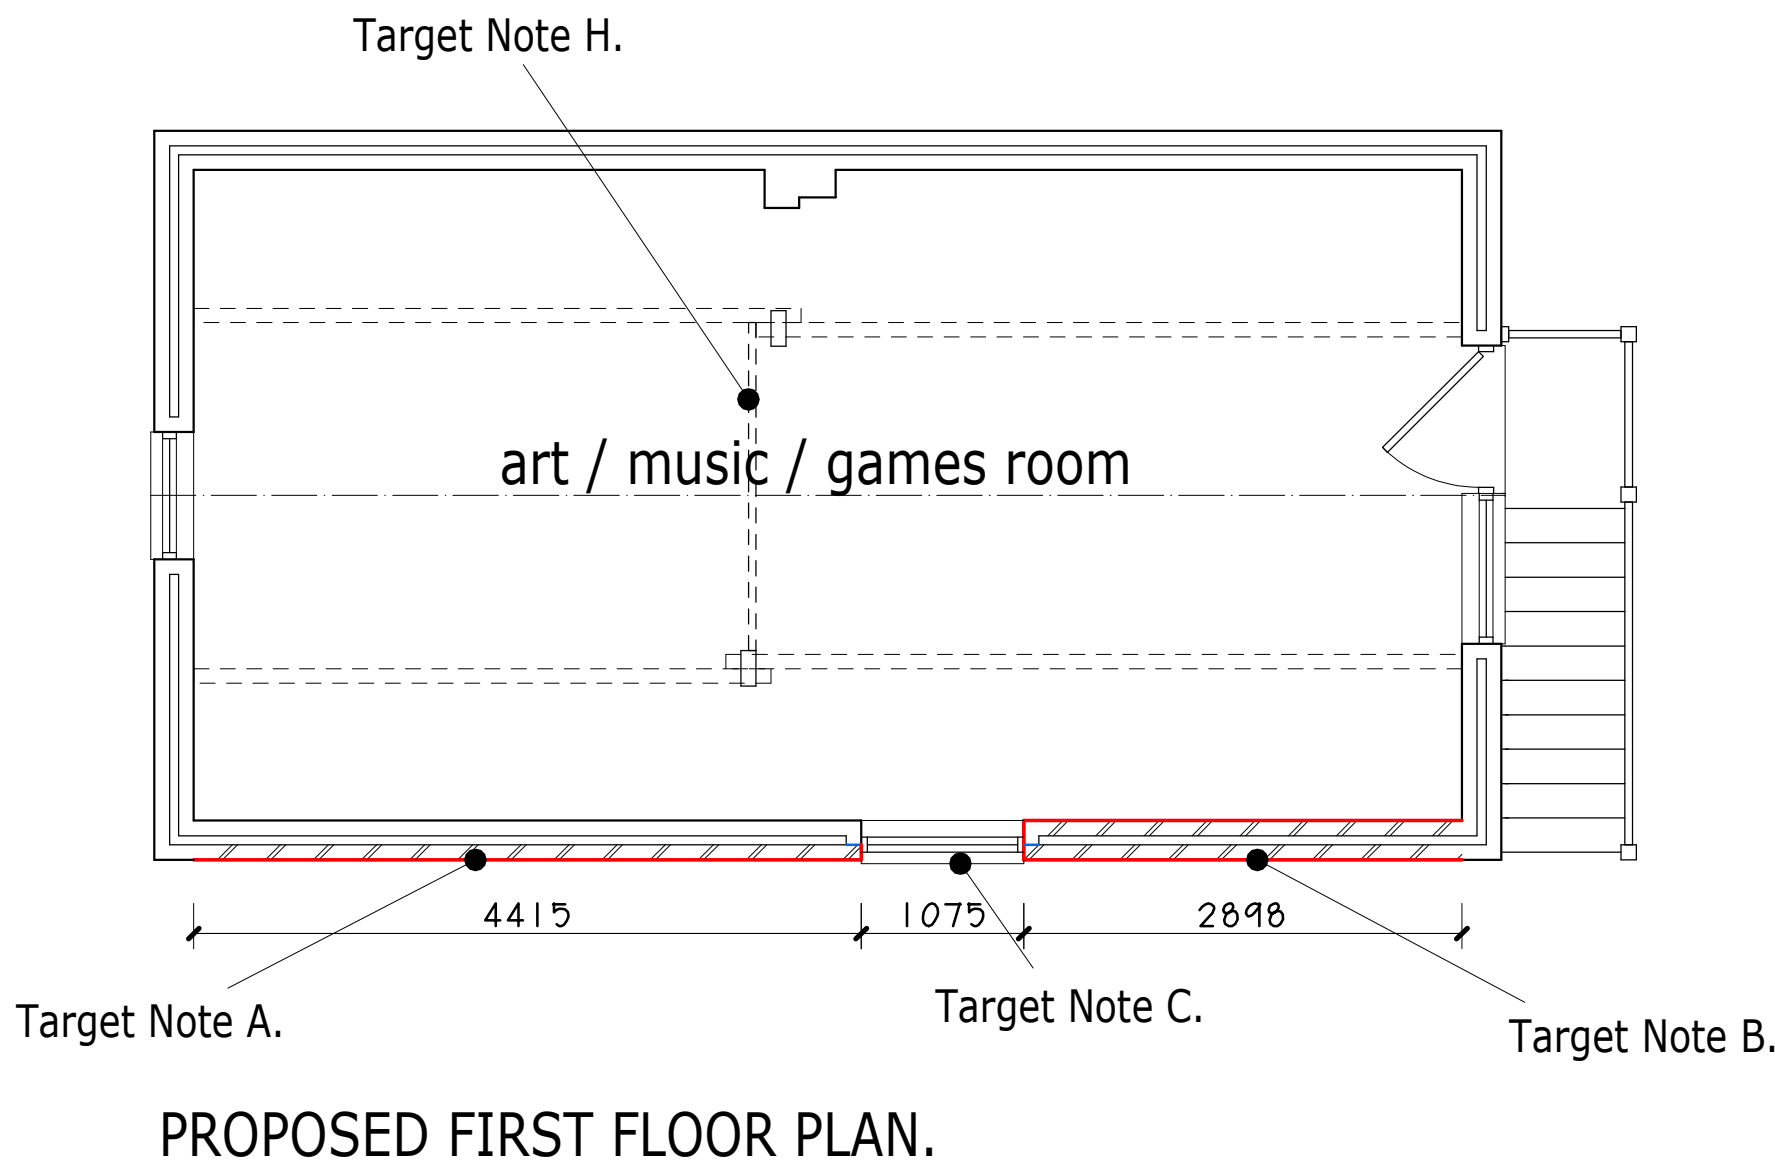
**TARGET NOTE A.**  
The existing external leaf of brickwork in this location has lost key with the internal leaf and therefore requires to be taken down brick by brick to first floor level and be re-built. Carefully take down brickwork and set aside bricks for re-use. Re-lay bricks in 3:1 sand:lime mortar mix and finish pointing flush. External leaf is to be tied to inner leaf with stainless steel Fishtail ties at 900mm horizontal and 450mm vertical staggered centres. Ties to be rawbolted to inner leaf mortar bed and perpend joints. Build brickwork up to existing 100mm x 75mm timber wallplate and tightly point between brickwork and wallplate. Provide and fix vertical DPC to side of window opening.

**TARGET NOTE B.**  
Both of the existing internal and external leaves of brickwork in this location have failed due to deflection of the supporting beams below. Carefully take down both leaves of brickwork and set aside bricks for re-use. Re-lay bricks in 3:1 sand:lime mortar mix and finish pointing flush. External leaf is to be tied to inner leaf with stainless steel wall ties built in at 900mm horizontal and 450mm vertical staggered centres. Build brickwork up to existing 100mm x 75mm timber wallplate and tightly point between brickwork and wallplate. Provide and fix vertical DPC to side of window opening.

**TARGET NOTE C.**  
Remove existing decaying timber access door and frame and dispose of. Following the rebuilding of the external wall / brickwork referred to at Target Notes A and B, provide and fix new glazed window as shown in a style to match the existing window to the western elevation. New window to comprise sealed double glazed units set in timber frames with casement opening lights as indicated. Glazing to comprise safety glass due to proximity to first floor level.

**TARGET NOTE D.**  
Existing later timber garage doors are to be removed and disposed of. Prop brickwork and first floor structure and remove defective / overstressed steel beams. Rationalise openings to correspond with original opening based upon the position of the brickwork arches and build new central pier as indicated using imperial size facing bricks to match existing built with 60mm thk clear cavity to match existing construction. Brickwork to be laid in lime mortar as specified at Target Note A. Provide and fix new boot type lintol over opening to support both internal leaf / first floor joists and outer leaf of brickwork. New Store Room double doors are to be purpose made in timber to the style indicated with high level glazed panels.

**TARGET NOTE E.**  
Provide and fix new boot type lintol over new Personnel Door opening to support both internal leaf / first floor joists and outer leaf of brickwork. New personnel door indicated is also to be purpose made, framed, ledged and braced timber door as shown with glazed light to upper panel.

**TARGET NOTE F.**  
Remove defective 3-part timber door and dispose of. Check steel beams over opening and report any perceived defects. New door is to comprise purpose made timber door in 2-parts are shown, side hung with traditional steel strap hinges as indicated. Door is to be framed, ledged and braced with solid timber panels all as shown.

**TARGET NOTE G.**  
Provide and fix 3No. Conservation Style Rooflights to the south facing roof slope to match the rooflights which are evident to the Main House and to improve natural light levels at first floor level. Rooflights are to be Type GGL, part No. CK04, 978mm deep x 550mm wide Conservation Style Rooflights by Velux and are to be fitted and flashed in accordance with the manufacturer's instructions.

**TARGET NOTE H.**  
As a purely precautionary measure, provide and fix 150mm x 50mm swd "Tie Beam" between both sets of existing timber purlins at the position of the purlin supporting posts. Tie beam to be fixed to each connected purlin with 100mm x 100mm x 100mm mild steel angles / cleats with 2No. M8 fixings to each connected timber member. Paint cleats gloss black on completion.
