## **McDonald's Restaurant, Land at Plas Coch Retail Park, Wrexham**

### **Road Safety Audit Stage 1**

**TMS reference no: 15932**  
**Date: 26<sup>th</sup> October 2020**

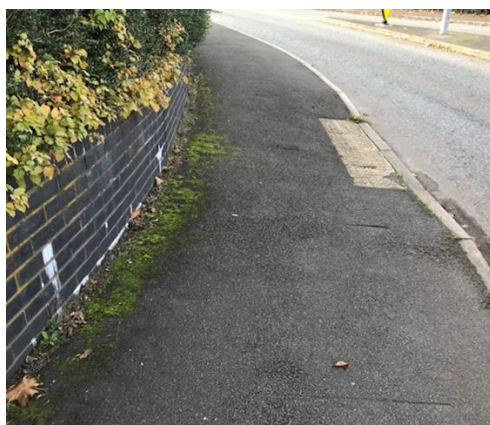
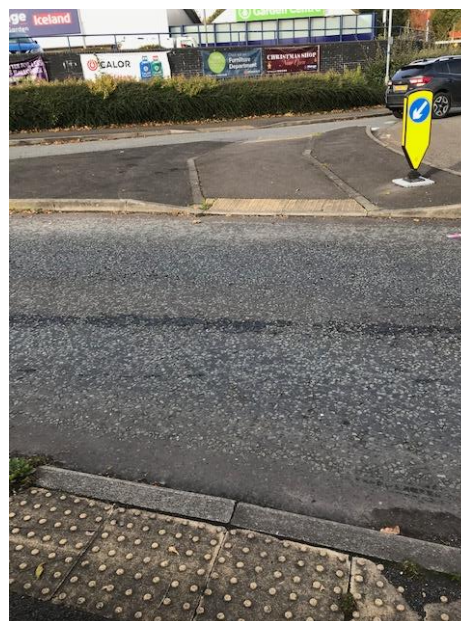
Location – Proposed splitter island alteration at the Retail roundabout access to development site access road

Summary: Risk of injury to visually impaired pedestrians and wheelchair users.

The existing splitter island has incorrect tactile paving, a high kerb upstand and steep footway ramp slopes. This could cause problems for both visually impaired road users and wheelchair users leading to collisions with passing vehicles and injuries.

The tactile paving should be a minimum of 800mm deep on the footways and the splitter island. The ramp slopes should preferably be 1 in 20 or a maximum of 1 in 12. The dropped kerbs should be flush with the carriageway or a maximum of 6mm high.

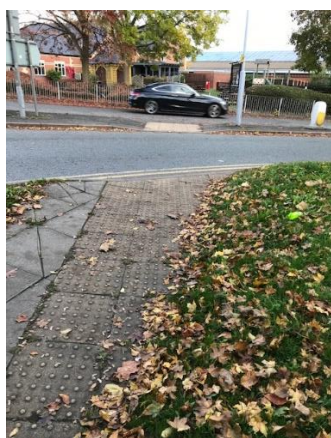
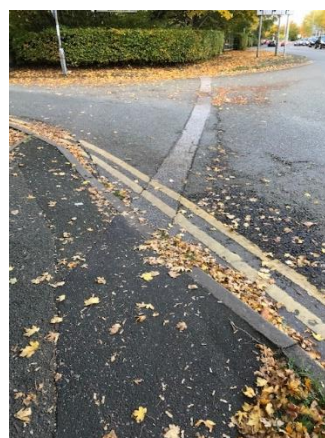
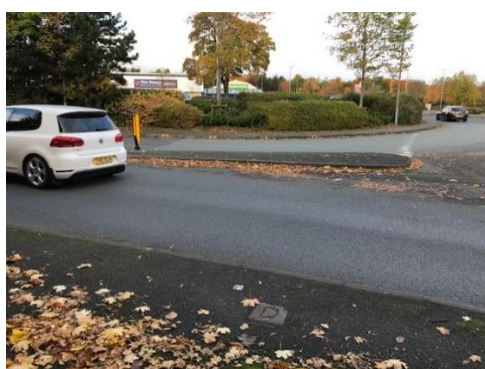
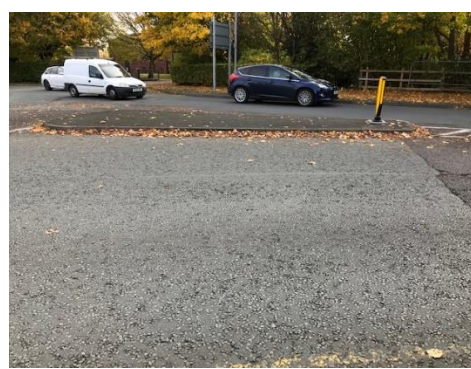
Location – Pedestrian crossing points

Summary: Risk of injury to pedestrians

The proposed restaurant will attract customers from the University / BBC Wales complex and properties north of the roundabout. The existing crossing facilities are poor with incorrect tactile paving across Plas Coch Road northern arm, no tactile paving across the entrance to the University / BBC Wales complex and incomplete / no dropped kerbs across the western and southern arms of the junction. This could result in pedestrians being hit by passing vehicles and injured.

A pedestrian crossing assessment should be carried out and appropriate crossing facilities provided.

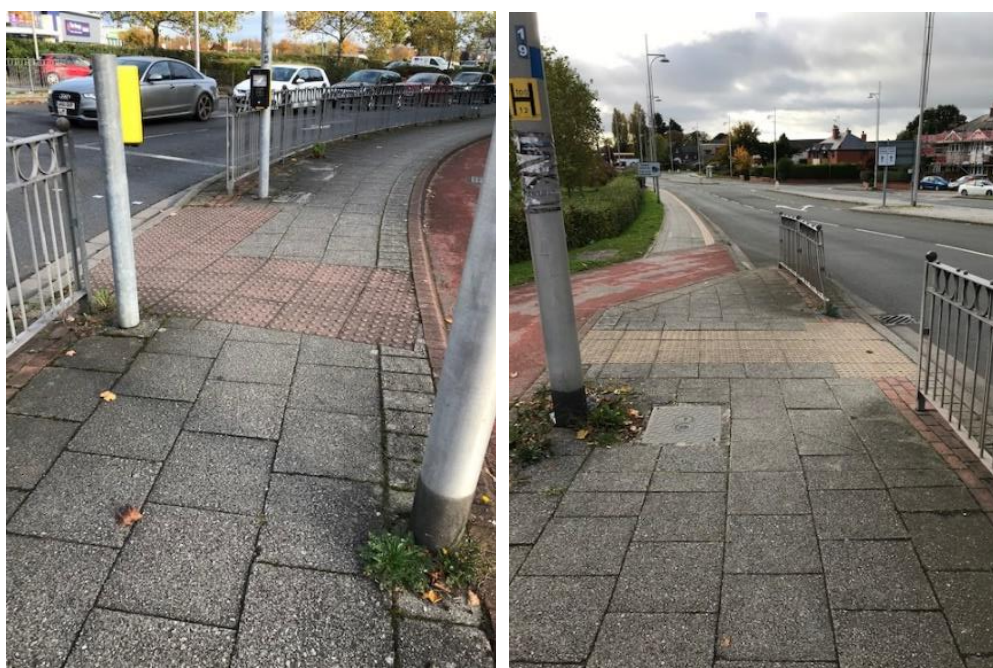
Location – Pedestrian crossing facilities

Summary: Risk of injury to pedestrians

The proposed restaurant will attract customers across Plas Coch Road and Mold Road.

The pedestrian facilities are incomplete, providing controlled crossings of 2 of the 3 signalised entry arms (Mold Road east and Plas Coch Road north) and none of the exit arms. This absence of facilities could lead to injuries to pedestrians from collisions with passing vehicles.

The tactile paving for the crossing of Plas Coch Road is incorrect with the stem on the wrong side of the crossing. Similarly, for the crossing of Mold Road east (exit from roundabout) the layout is also incorrect, using an old T shaped layout which was reserved for Zebra crossings but is no longer used. This could result in visually impaired pedestrians being hit by passing vehicles and injured.

The correct tactile paving layouts should be provided.

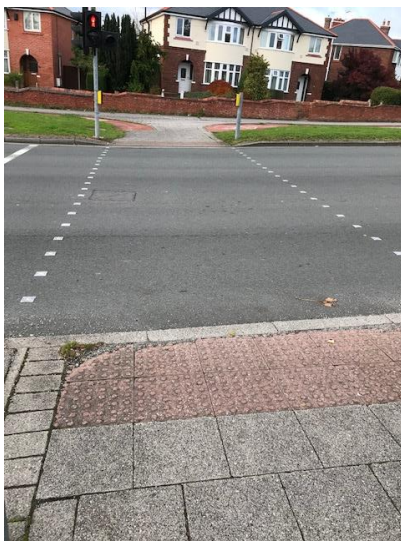
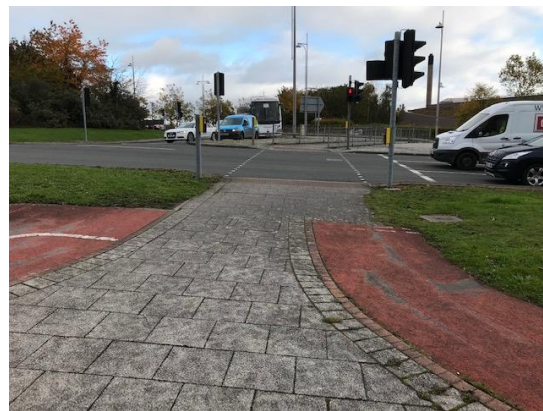
Location – Pedestrian crossing facilities

Summary: Risk of injury to pedestrians

The tactile paving layout for the Mold Road east entry arm does not have a stem which is should as it is a controlled crossing. Where the cycle tracks meet the crossing there is no signing for a change from segregated use to shared use with pedestrians and vice versa. This could result in visually impaired pedestrians being hit by passing vehicles and collisions between cyclists and pedestrians resulting in injuries.

The correct tactile paving layouts should be provided. Signs should be provided for the change in cycle track status.

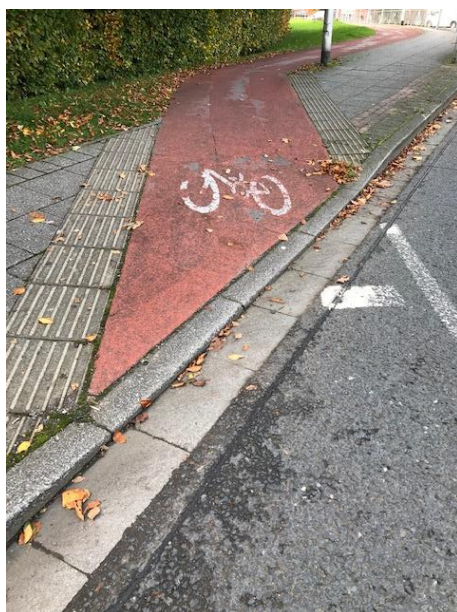
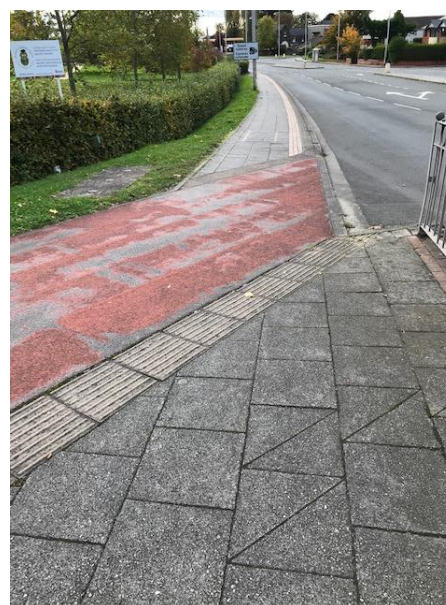
Location Cycle facility north east corner of roundabout

Summary: Risk of injury to cyclists and pedestrians

There is an off-carriageway cycle facility leading from Plas Coch Road across Mold Road east, linking to a cycle facility on the south-east side of Mold Road.

The facility leaving Plas Coch Road has a high kerb upstand which could lead to cyclists falling off their cycles. The corduroy tactile paving provided here and elsewhere it crosses footways is incorrect and could lead to cyclists colliding with visually impaired pedestrians.

Where the facility re-joins Mold Road it does not provide adequate guidance for cyclists to safely re-join the carriageway which could result in a collision with a motor vehicle.

The kerb upstand should be flush with the carriageway. The correct tactile paving layouts should be provided. White line guidance should be provided for cyclist re-entering the carriageway on Mold Road.
