# **BRYMBO HERITAGE PROJECT**

## **STRUCTURAL CONDITION ASSESSMENT**

**August 2023**  
**Suitability S2**  
**Revision P02**

**By:**  
Bingham Rawlings Partnership Ltd.

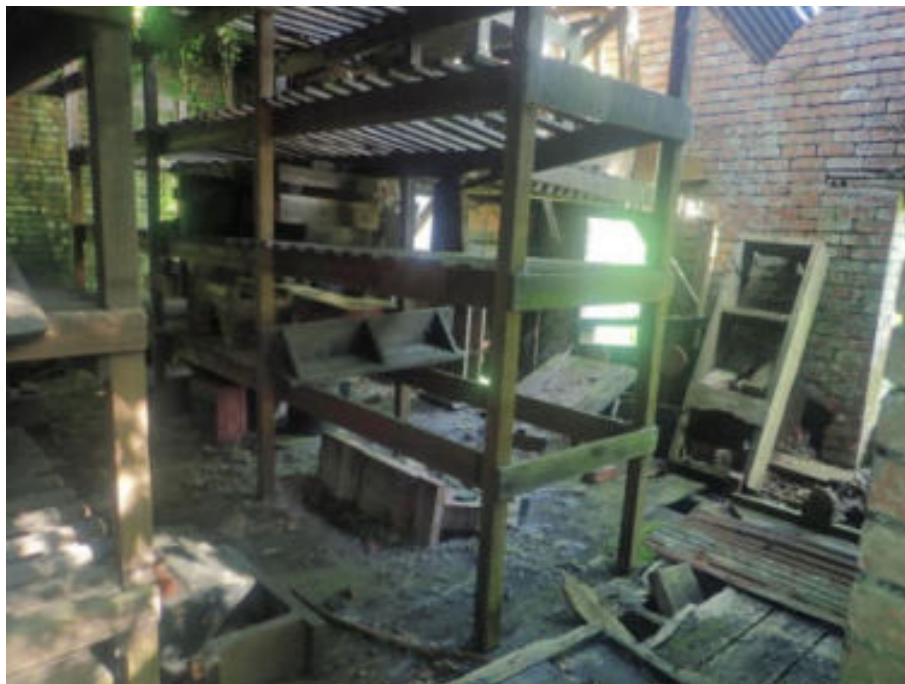
- 3.2.1 BA1 – Timber floor covering (boards) have perished. Not suitable for access due to basemen beneath.

*Figure 1. Typical perished timber floor covering*

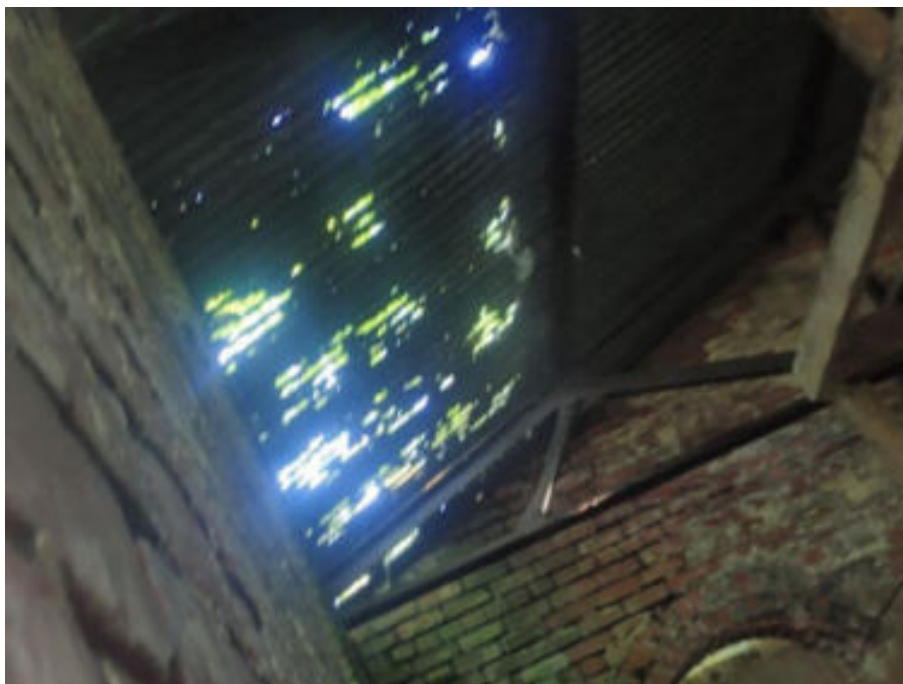
- 3.2.3 BA3 – Corrugated profile steel roof has corroded throughout with significant loss of area allowing penetrative water to enter the structure.

*Figure 3. Typical corrosion to corrugated profile steel roof*

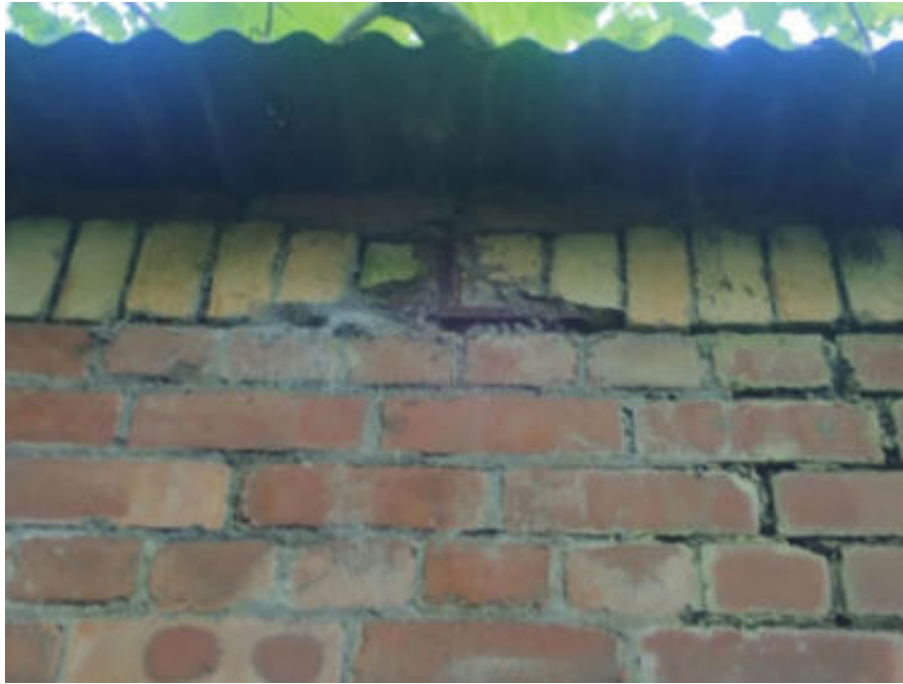
- 3.2.5 BA5 – The steel truss ends at their supports in the external walls penetrate to the external face and are exhibiting significant section loss through expansive corrosion. Deteriorated timber lintels to front façade windows through exposure and wet rot. Refer to defect BA5 in Defect Sketch in **Appendix D – Defect Sketches**.

*Figure 5. Typical corroded steel truss end*

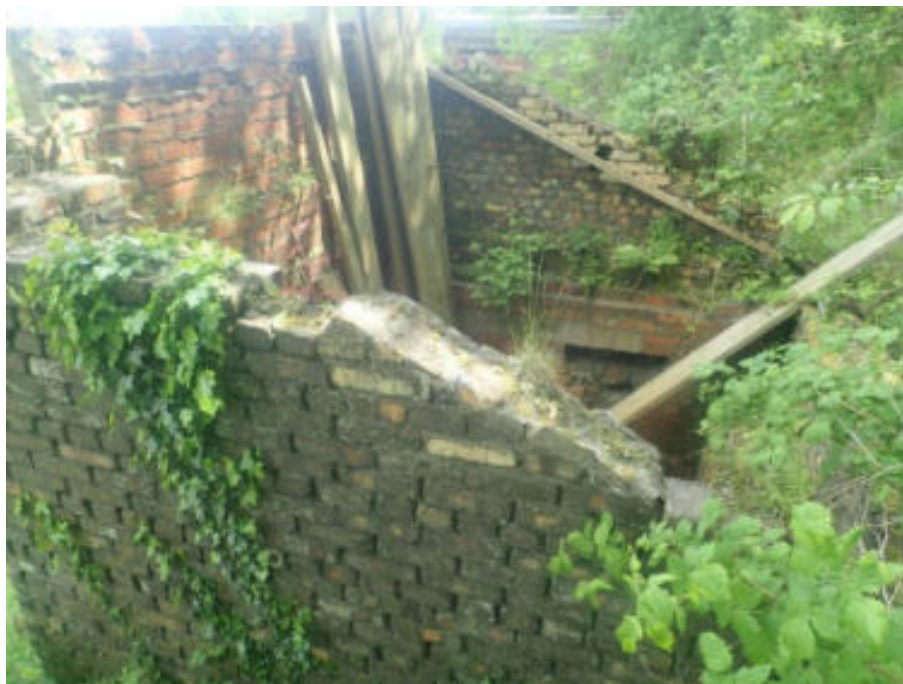
- 4.2.1 BB1 – Roof structure has historically failed and been removed.

*Figure 17. Removed roof*

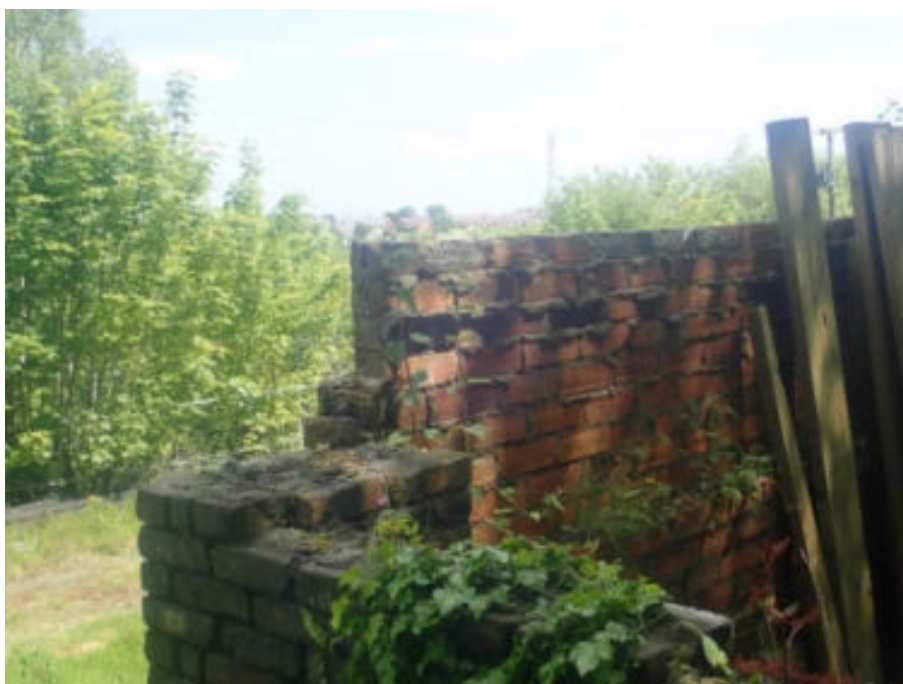
- 4.2.5 BB5 – Front panel half brick thick masonry has become loose and dislodged as a result of lack of restraint.

*Figure 21. Loose and dislodged panel*

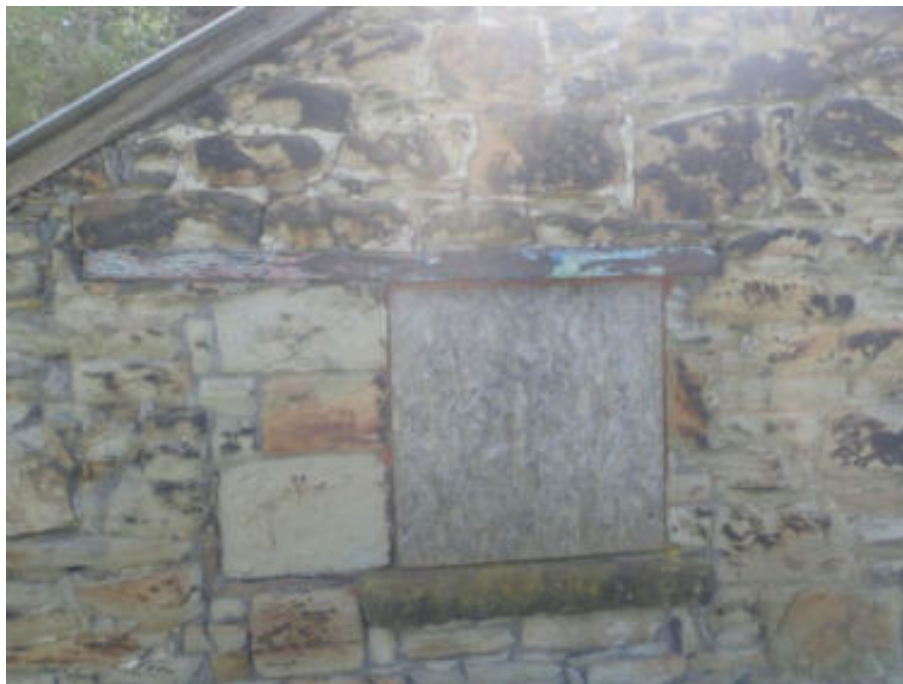
- 5.2.1 BC1 – Timber lintel to front elevation of pay office deteriorated due to exposure. Refer to defect BC1 in Defect Sketch in **Appendix D – Defect Sketches**.

*Figure 22. Deteriorated timber lintel*

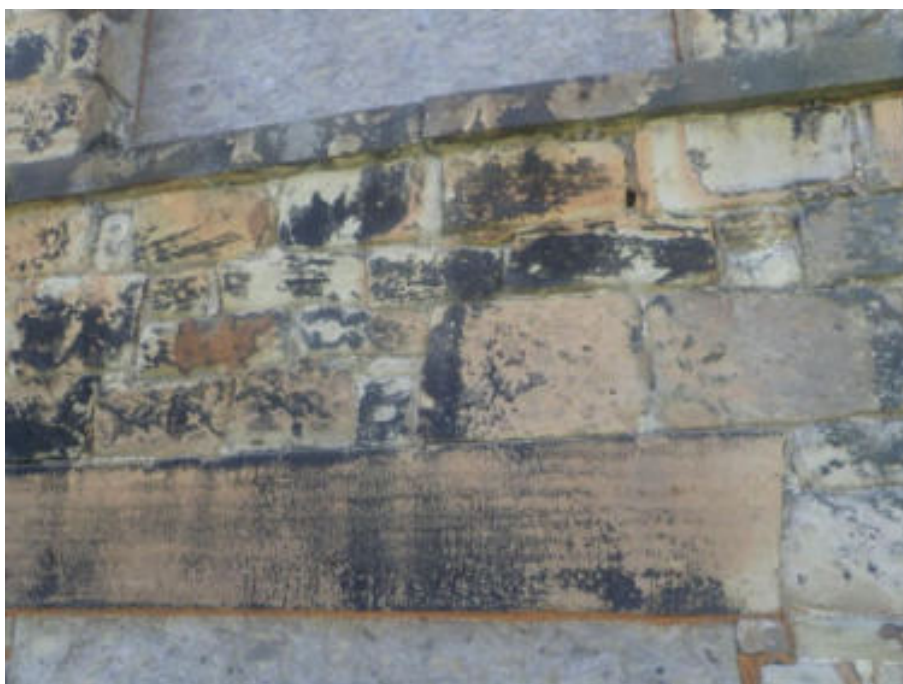
- 5.2.6 BC6 – Failed external wall panel due to dislodged natural stone lintel to window at ground floor of front elevation. Refer to defect BC6 in Defect Sketch in **Appendix D – Defect Sketches.**

**Figure 27.** *Failed wall panel*

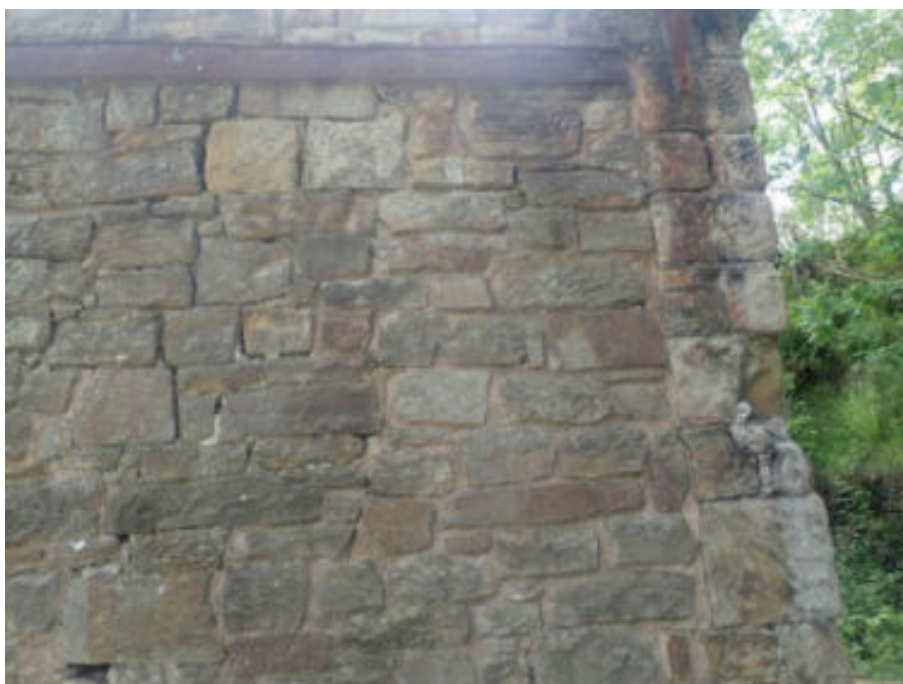
- 5.2.10 BC10 – Vertical fracture measuring 2.5mm in width at interaction of infill masonry panel and return rear elevation. Refer to defect BC10 in Defect Sketch in **Appendix D – Defect Sketches**.

*Figure 31. Vertical fracture*

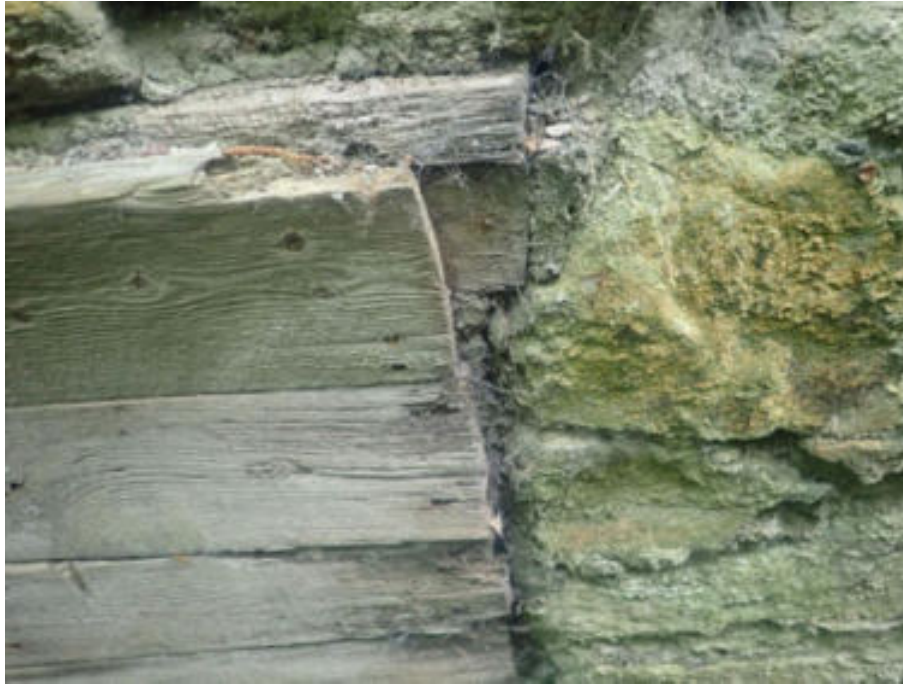
5.2.15 BC15 – Inadequate bearing to existing lintel over rear elevation ground floor opening. Refer to defect BC15 in Defect Sketch in **Appendix D – Defect Sketches**.

*Figure 36. Inadequate lintel bearing*

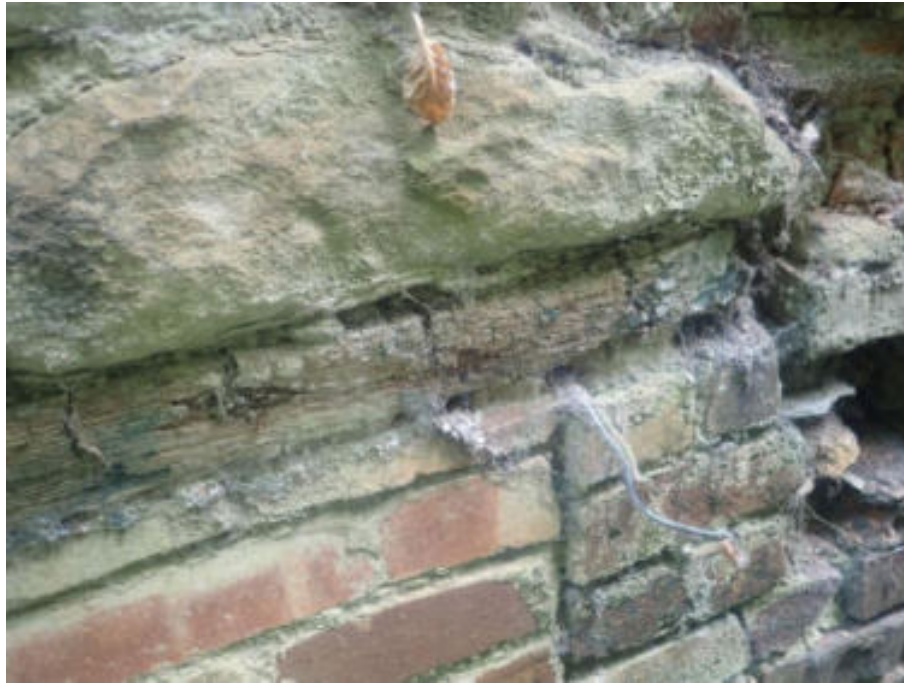
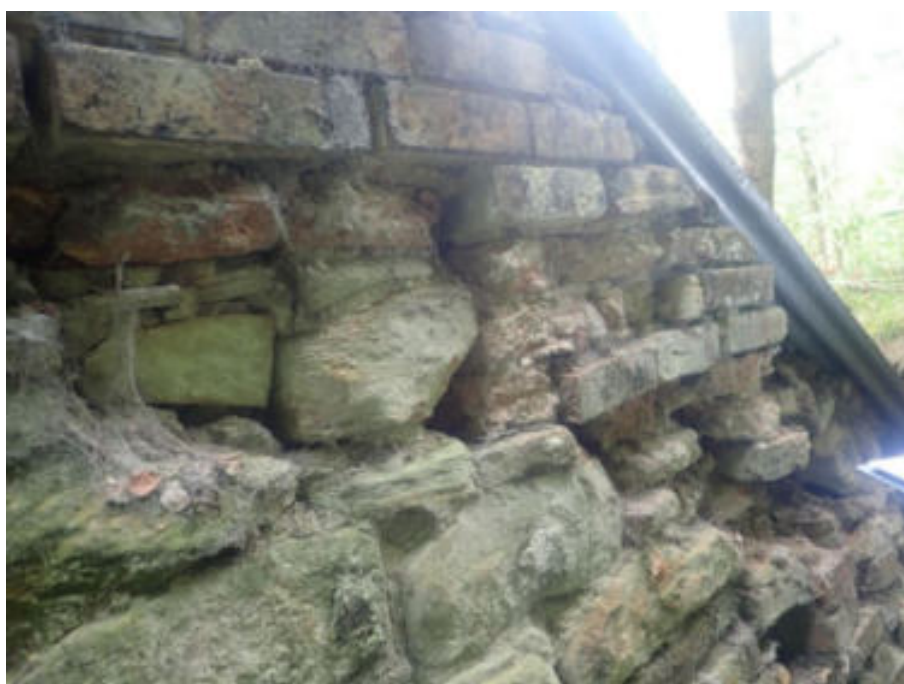
5.2.17 BC17 – Rear wall panel of pay office structure contains a failed timber lintel which has resulted in significant distortion of the external wall panel. The panel has been repaired historically using brickwork, however is considered to have failed. Refer to defect BC17 in Defect Sketch in **Appendix D – Defect Sketches**.

*Figure 37. Failed timber lintel*

*Figure 38. Failed wall panel*

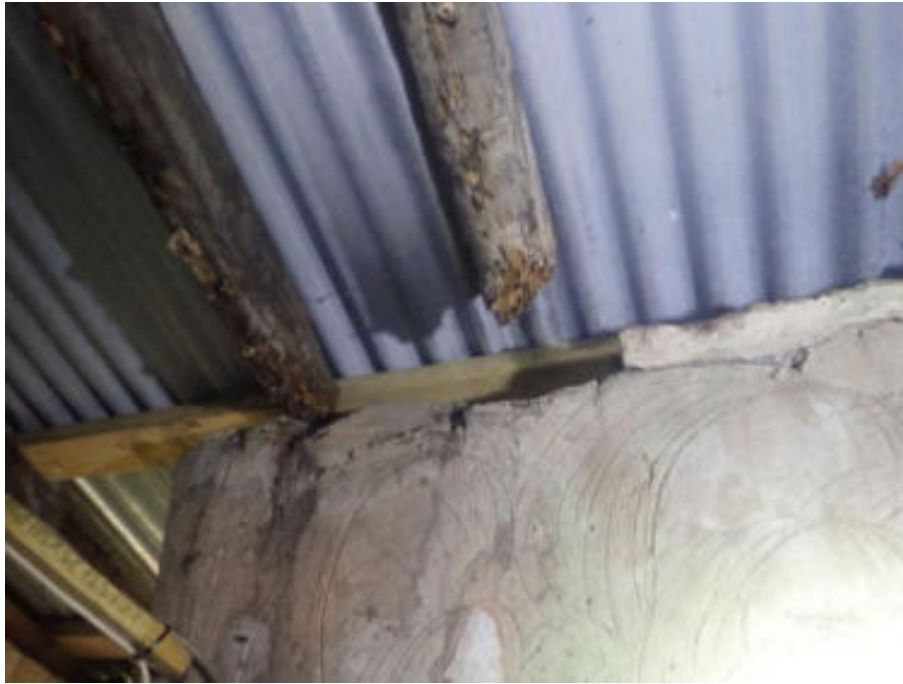
5.2.19 BC19 – The roof of the pay office structure has failed and has been historically strengthened. However, there is substantial loss of main structural elements, including rafters. Canted timber purlin has rotated significantly due to lateral thrust and there is no formal fixity between the roof and the gable of the main building.

*Figure 40. Typical loss of fixity*

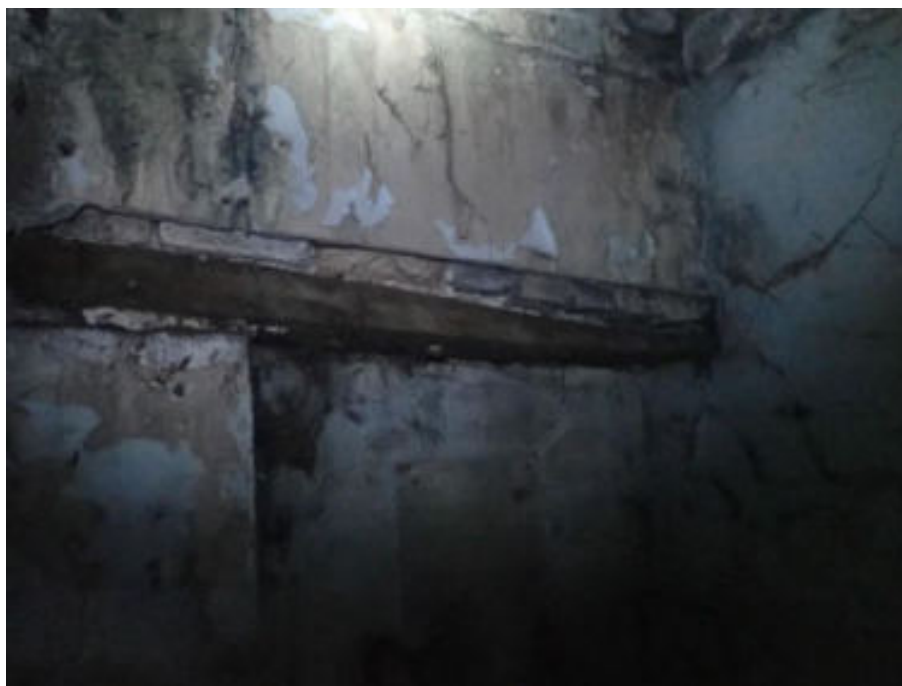
5.2.20 BC20 – Internal timber lintels between the pay office and the main building and forming the external opening to the rear elevation are inadequate and have entered a mode of failure.

*Figure 41. Inadequate timber lintel*

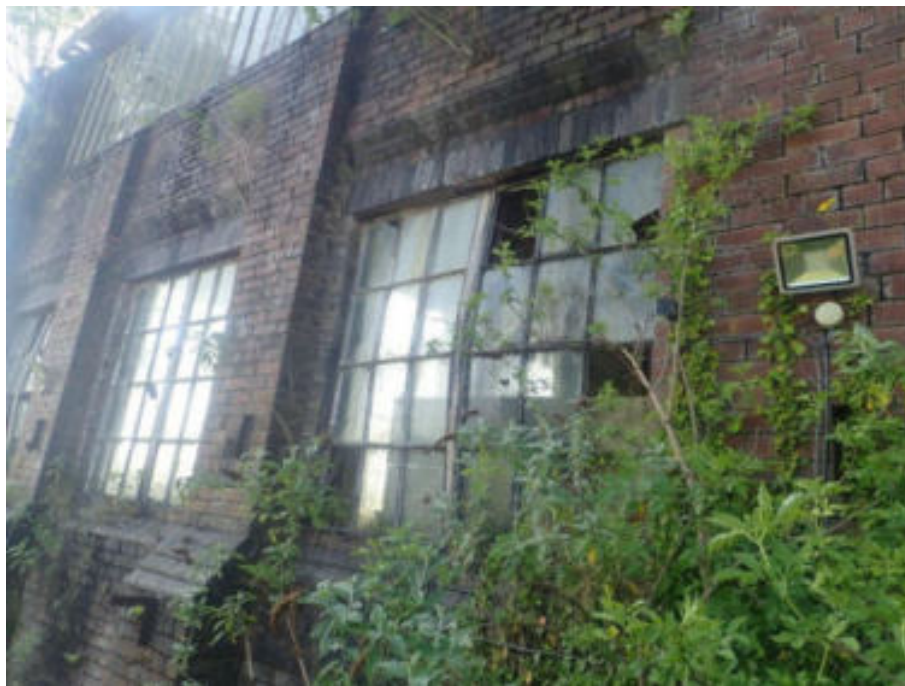
- 6.2.1 BD1 – Corroded steel lintels to external windows have caused central mullions to buckle.

*Figure 42. Corroded lintel and buckled mullion*

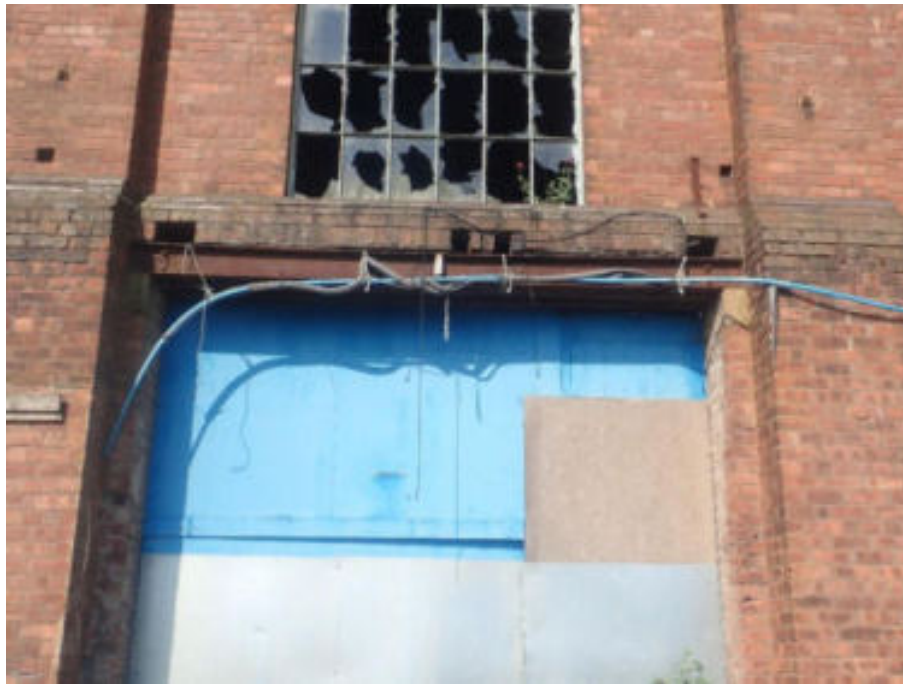
### 6.2.2 BD2 – Deflected and corroded steel lintel above door opening.

*Figure 43. Deflected and corroded lintel*

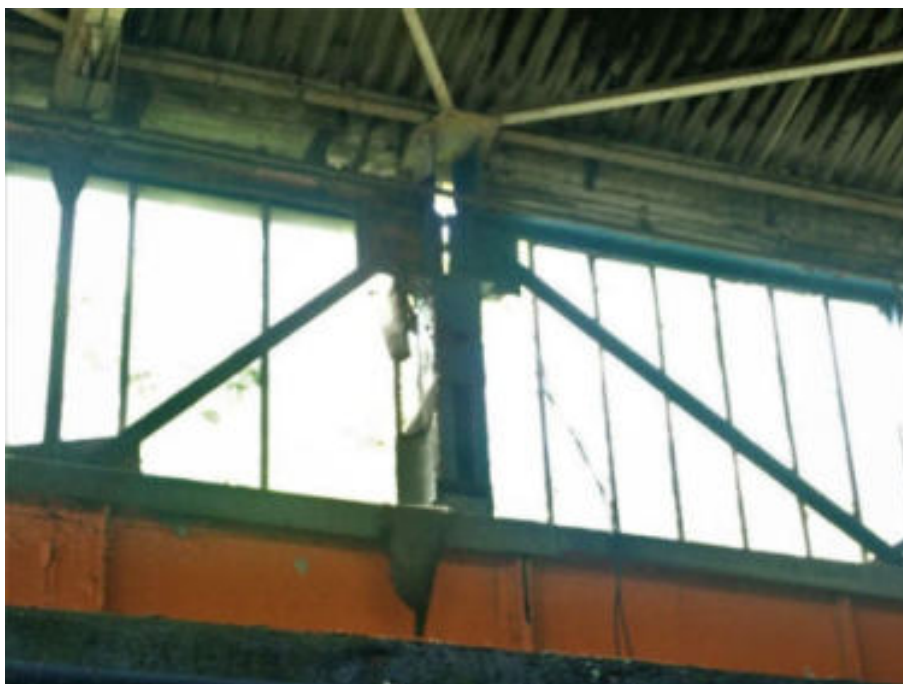
### 6.2.3 BD3 – Significant corrosion noted to connection nodes at top and bottom of lattice girder and the steel plates forming the openings.

*Figure 44. Typical corrosion to connections and steel plate*

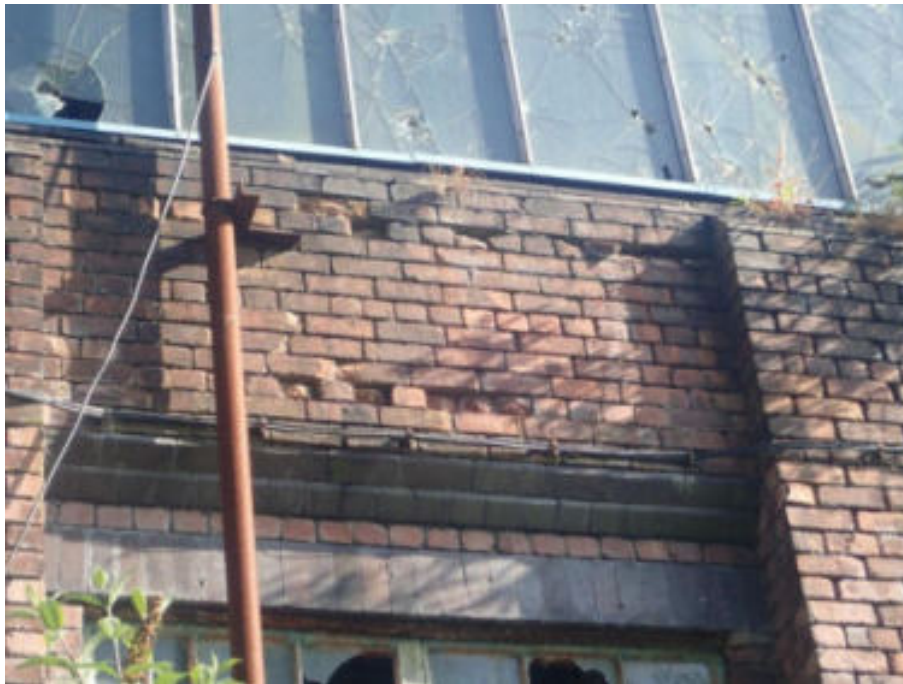
**6.2.4 BD4 – Missing and loose brick Approx 10% of total area.**

*Figure 45. Typical missing and loose masonry*

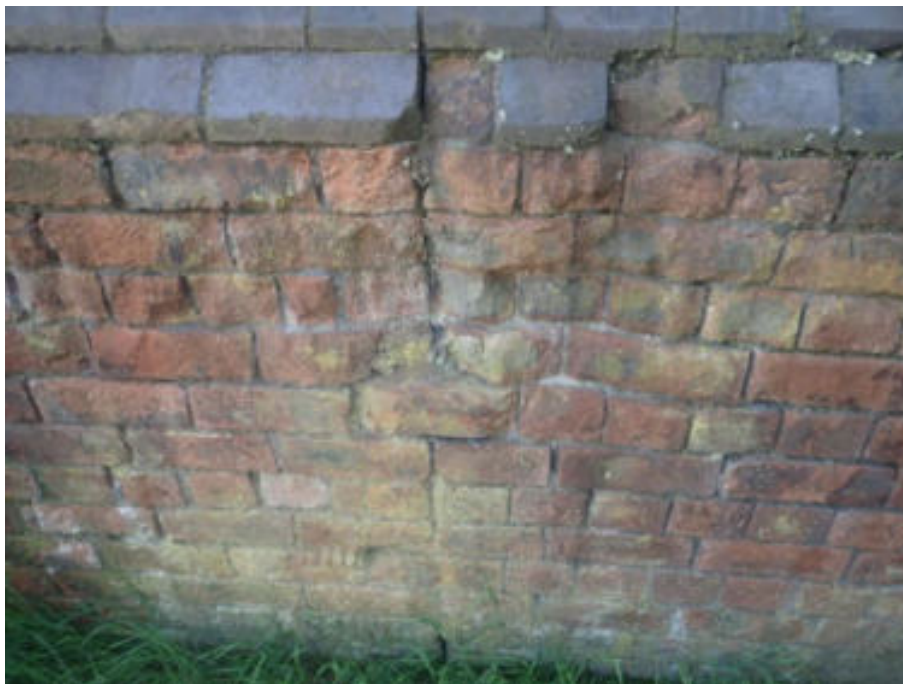
**6.2.5 BD5 – Deterioration of brickwork. Approx 10% of total area.**

*Figure 46. Typical deteriorated brickwork*

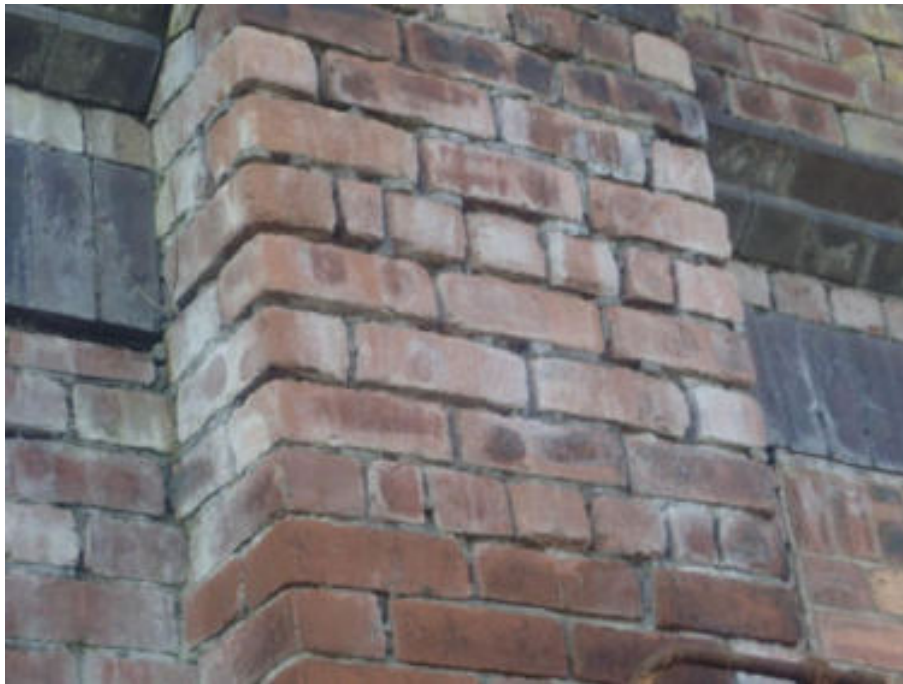
#### 6.2.8 BD8 – Significant desiccation of mortar pointing.

*Figure 49. Typical desiccated mortar*

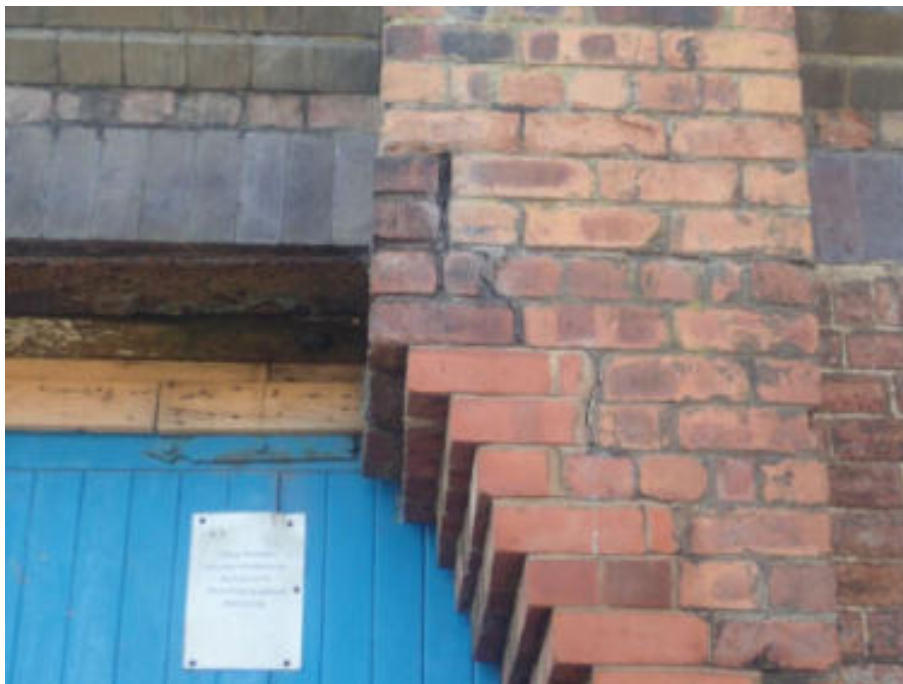
#### 6.2.9 BD9 – Brick corbel has failed.

*Figure 50. Failed corbel*

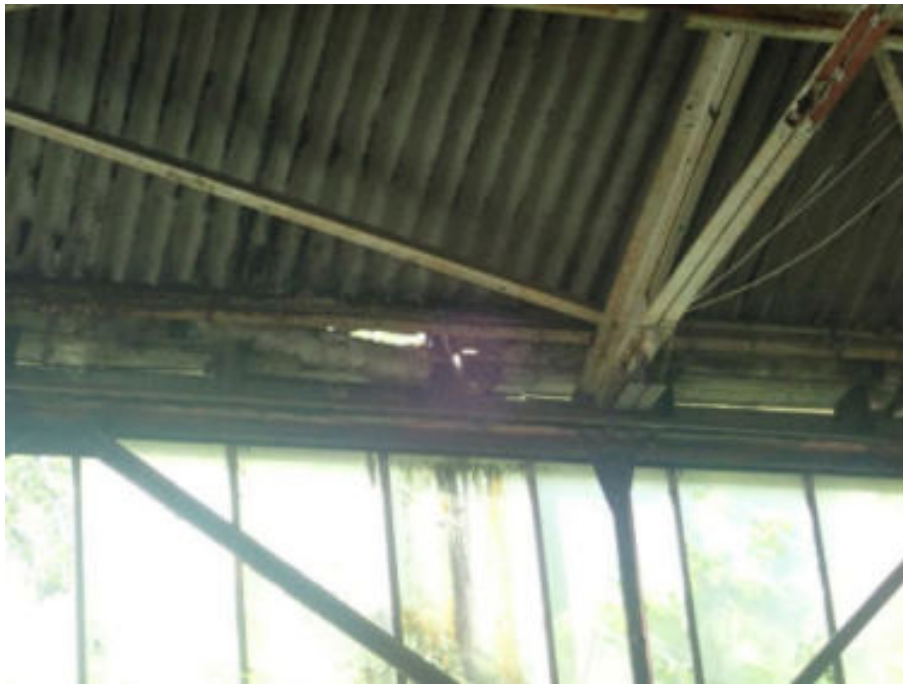
**6.2.10 BD10 – Significant corrosion noted on steel purlin at eaves.**

*Figure 51. Corrosion to purlin*

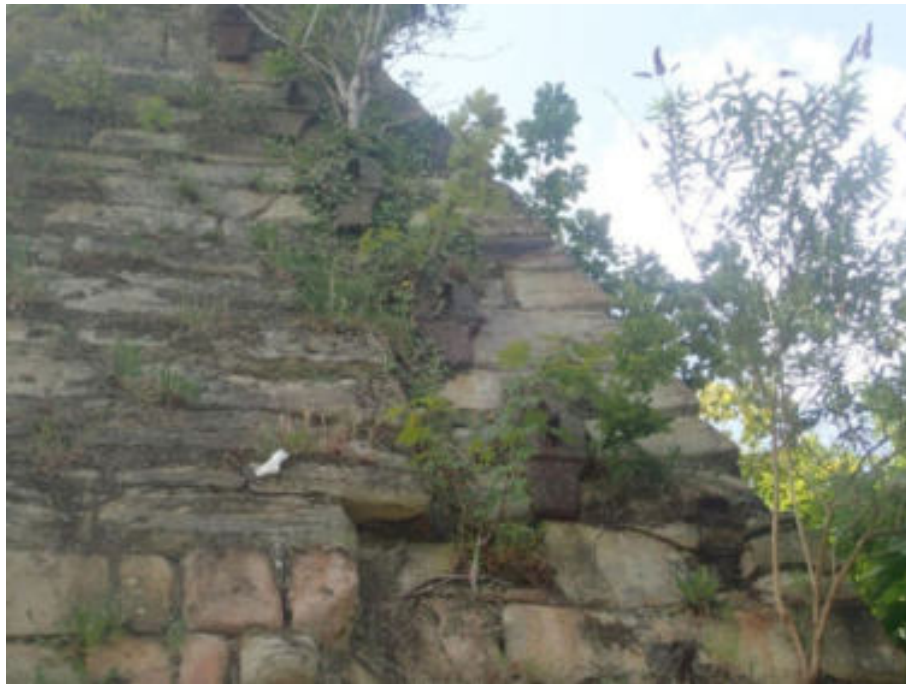
### 8.2.2 BF2 – Vegetation growth around the exterior.

*Figure 72. Typical vegetation growth*

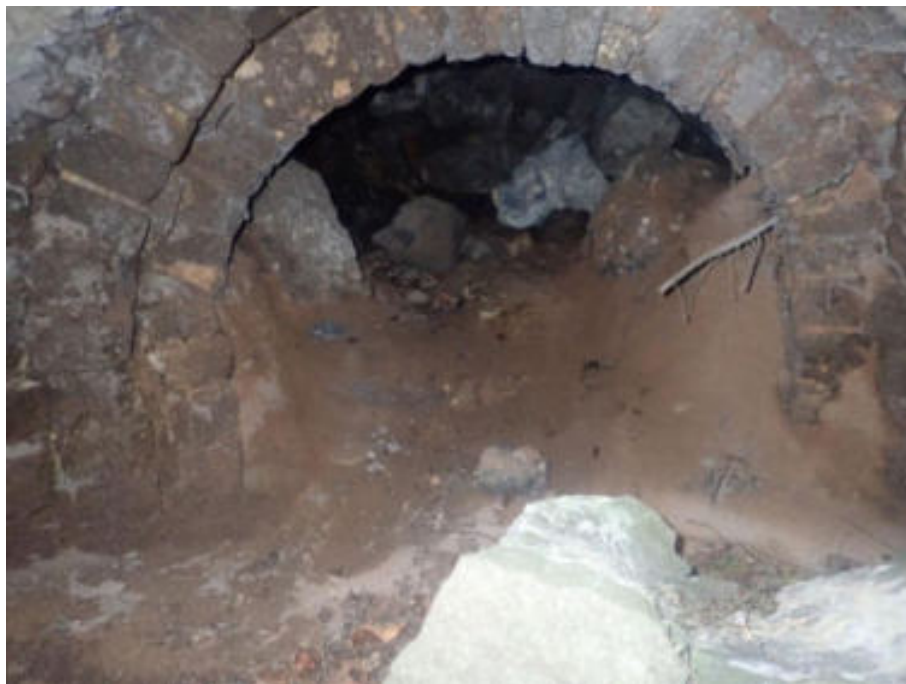
### 8.2.3 BF3 – Loose debris internally.

*Figure 73. Loose debris*

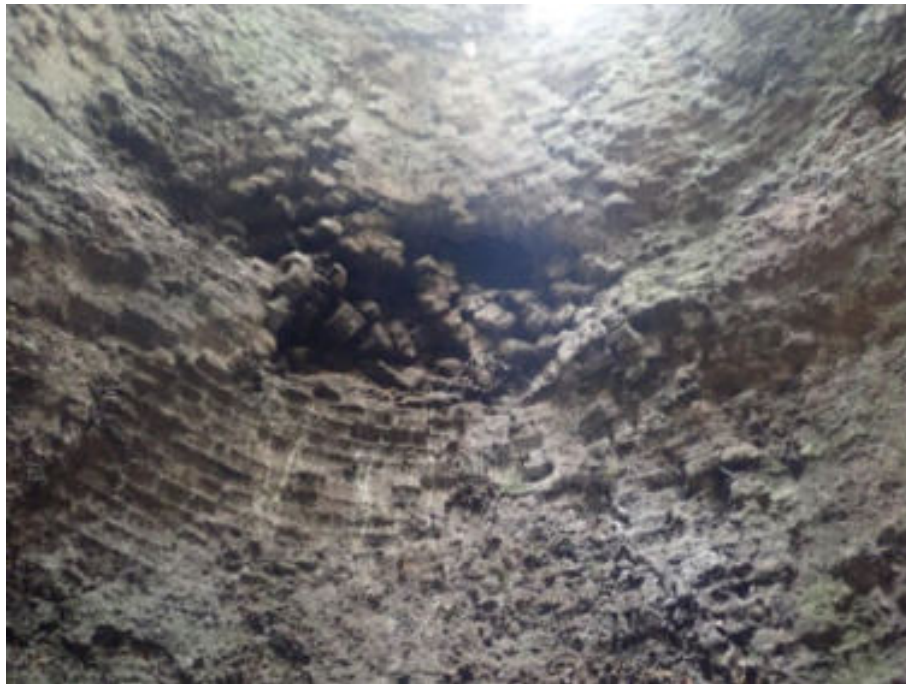
#### 8.2.4 BF4 – Beehive halfway up in hole.

*Figure 74. Beehive in hole*

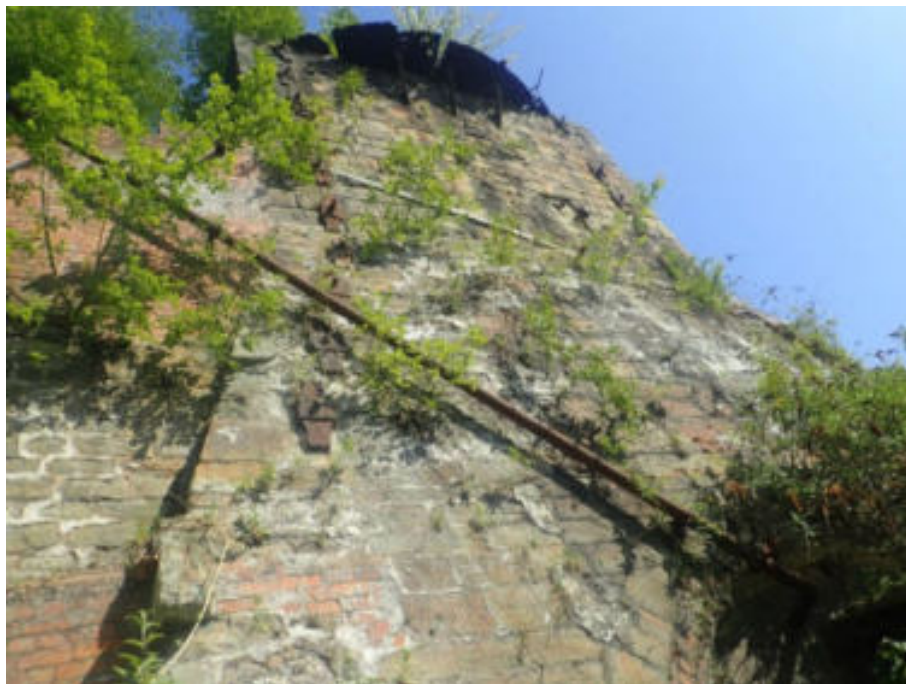
#### 8.2.5 RW17A – Missing mortar 5-10% of total area.

*Figure 75. Typical mortar loss*

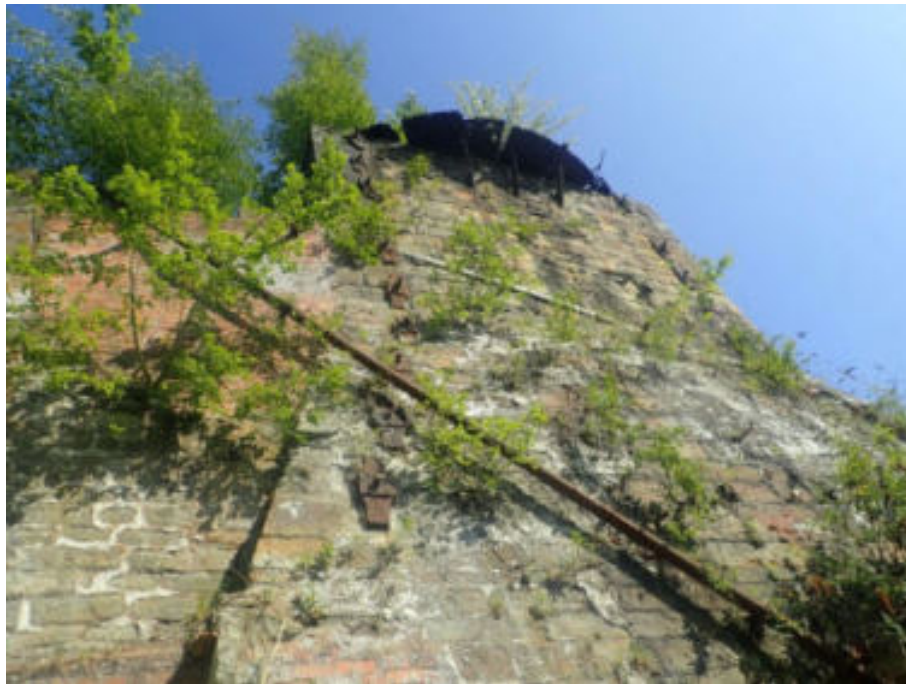
#### 8.2.6 RW17D – Vegetation growth.

*Figure 76. Vegetation growth*

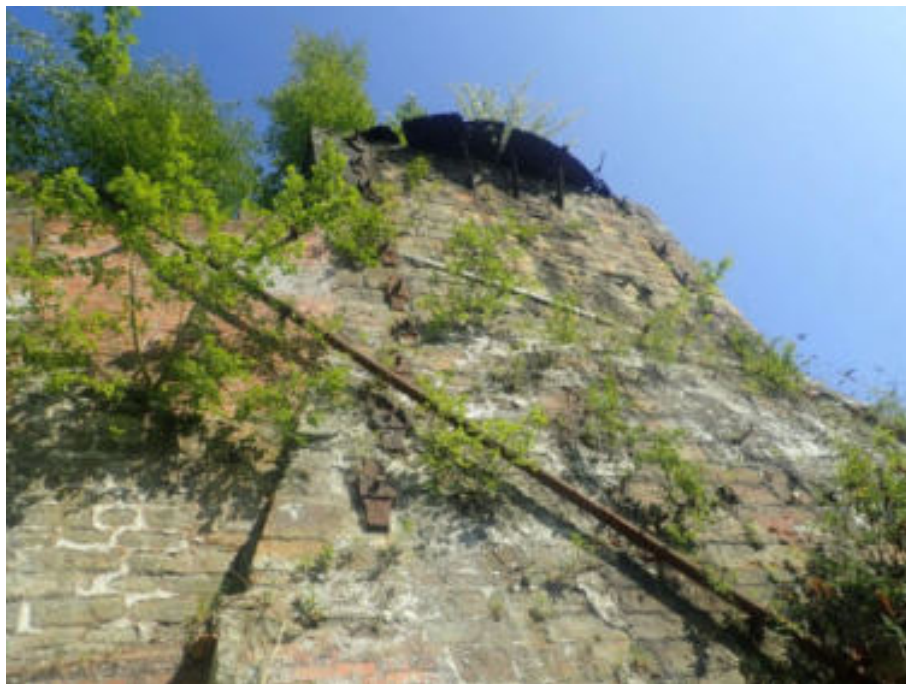
#### 8.2.7 RW17E – The majority of the steel ties were noted to having missing cast iron clips which restrain the face plate to the tension rod making them redundant.

*Figure 77. General view of ties*

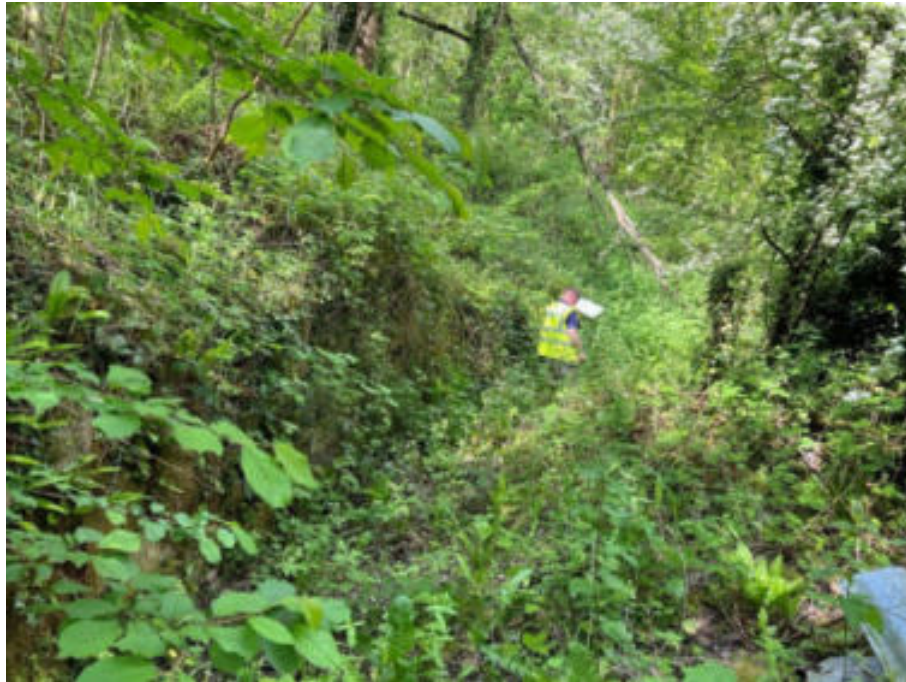
#### 14.2.2 RWC2 – Sapling and mature tree growth in retained areas above retaining wall.

*Figure 86. Tree and sapling growth*

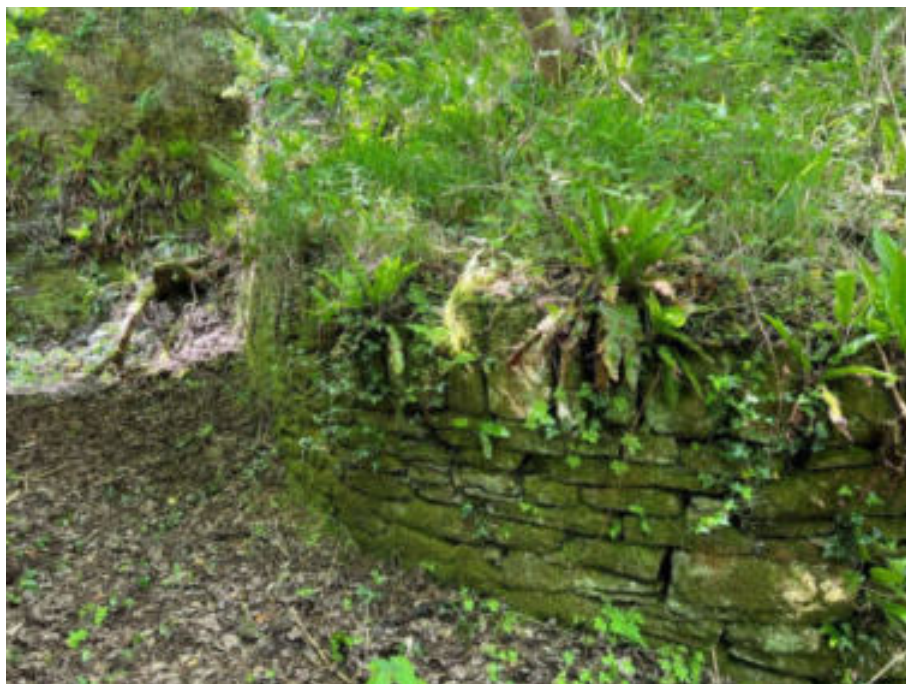
#### 14.2.3 RWC3 – Deterioration and desiccation of the mortar pointing.

*Figure 87. Deteriorated mortar*

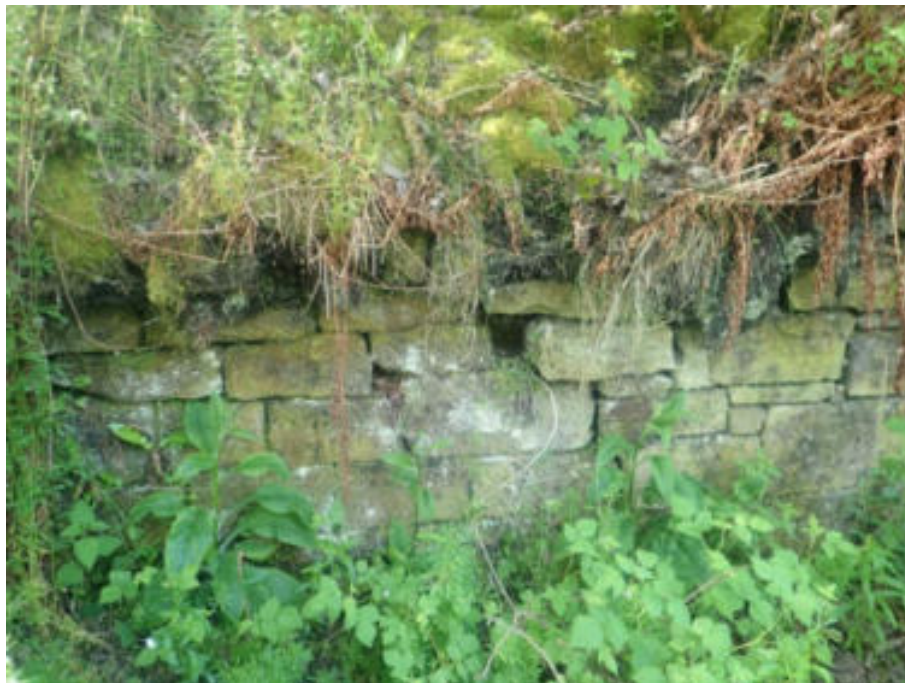
15.2.1 RW1A – Displaced and loose masonry.

*Figure 88. Typical displaced and loose masonry*

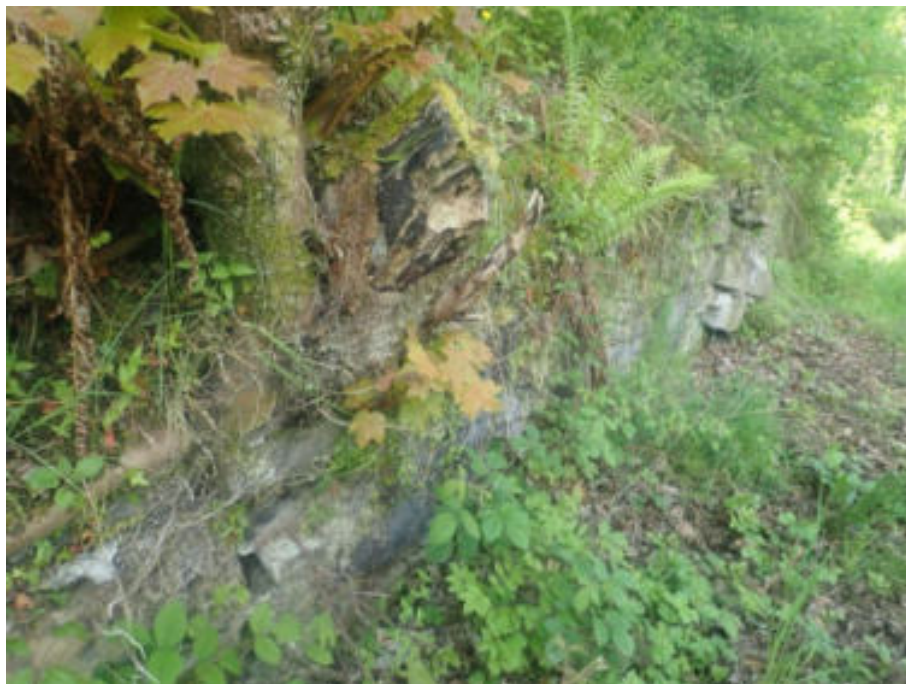
#### 15.2.5 RW1E – Remains of tree.

*Figure 92. Remains of tree*

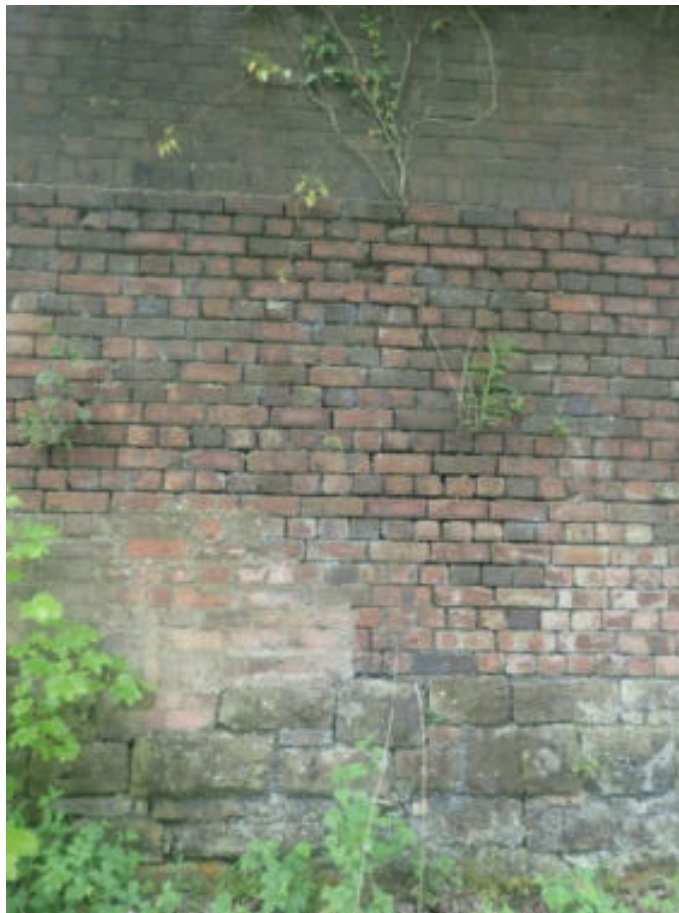
16.2.1 RW2A – Loose and missing masonry.

*Figure 94. Typical loose and missing masonry*

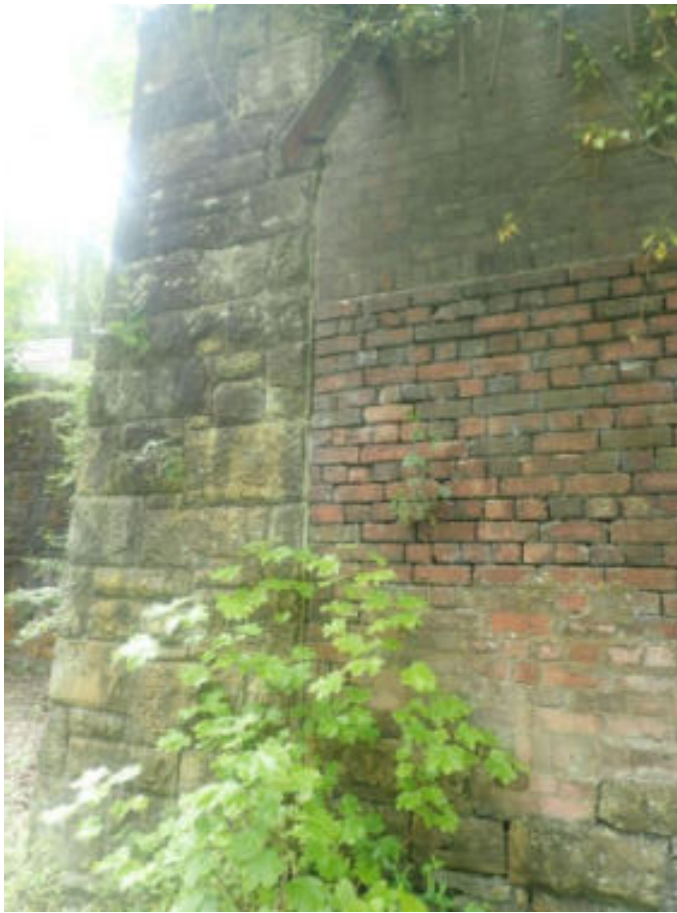
### 16.2.2 RW2B – Mortar loss.

*Figure 95. Typical mortar loss*

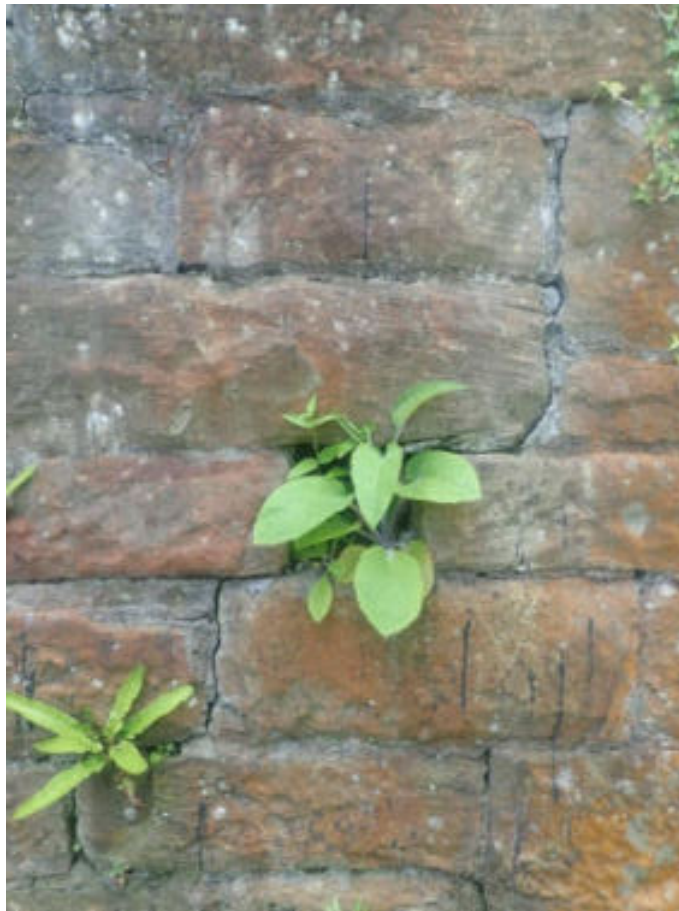
**16.2.4 RW2D – Diagonal fracture 5-10mm in width.**

***Figure 97. Diagonal fracture***

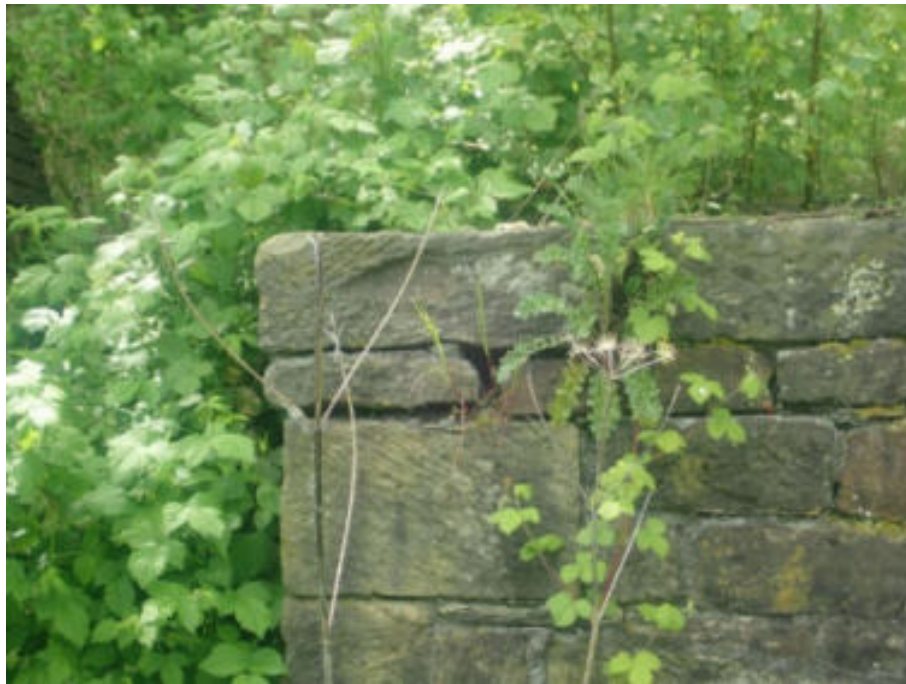
### 18.2.2 RW4B – Loose coping at corner of wall.

*Figure 106. Loose coping*
