# **BRYMBO HERITAGE PROJECT**

## **STRUCTURAL CONDITION ASSESSMENT**

**August 2023**  
**Suitability S2**  
**Revision P02**

**By:**  
Bingham Rawlings Partnership Ltd.

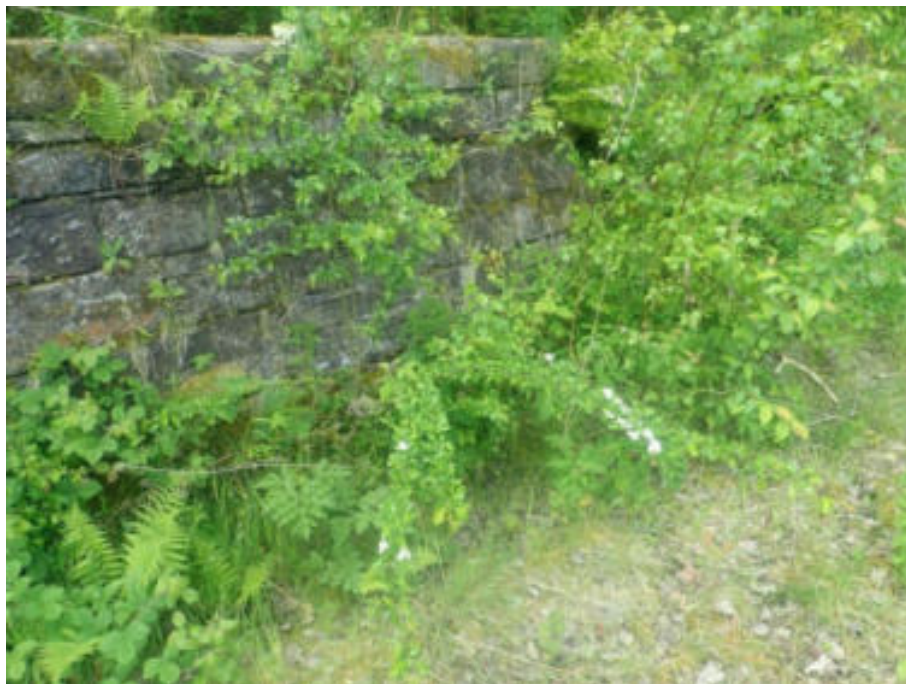
### 18.2.3 RW4C – Vegetation growth.

*Figure 107. Typical vegetation growth*

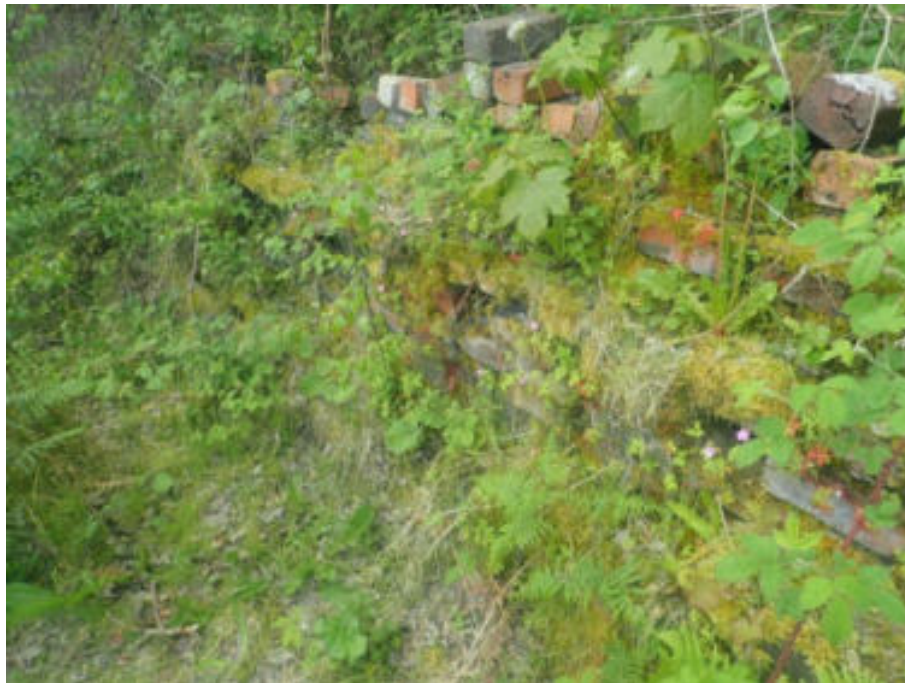
19.2.1 RW5A – Failed brick retaining wall.

*Figure 108. Failed wall*

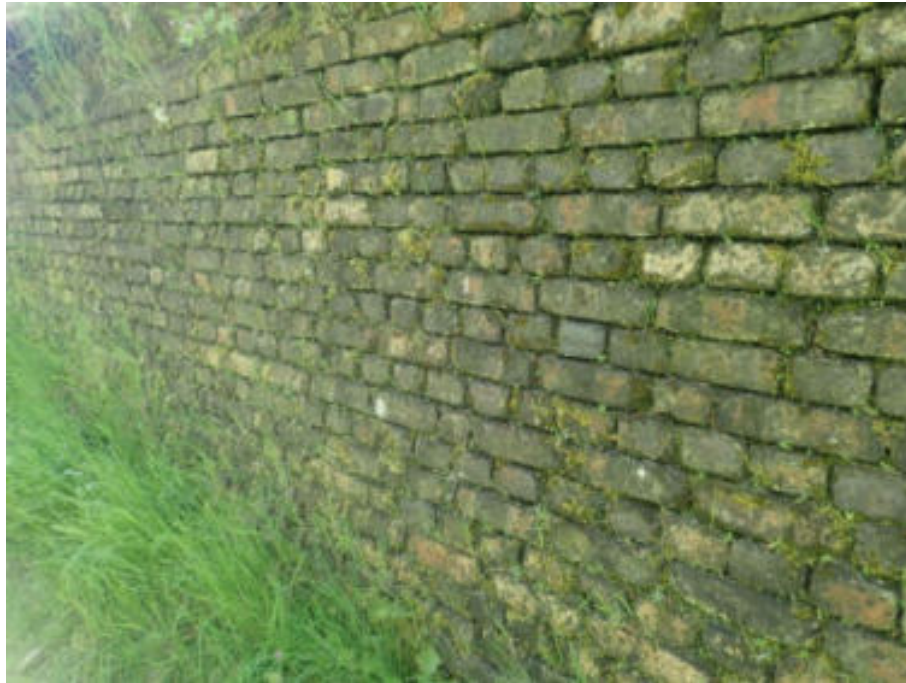
**22.2.2 RW8B – Vegetation growth.** Mature tree at approx. Ch.15m at risk of causing further movement or localised collapse to wall.

*Figure 120. Typical vegetation growth*

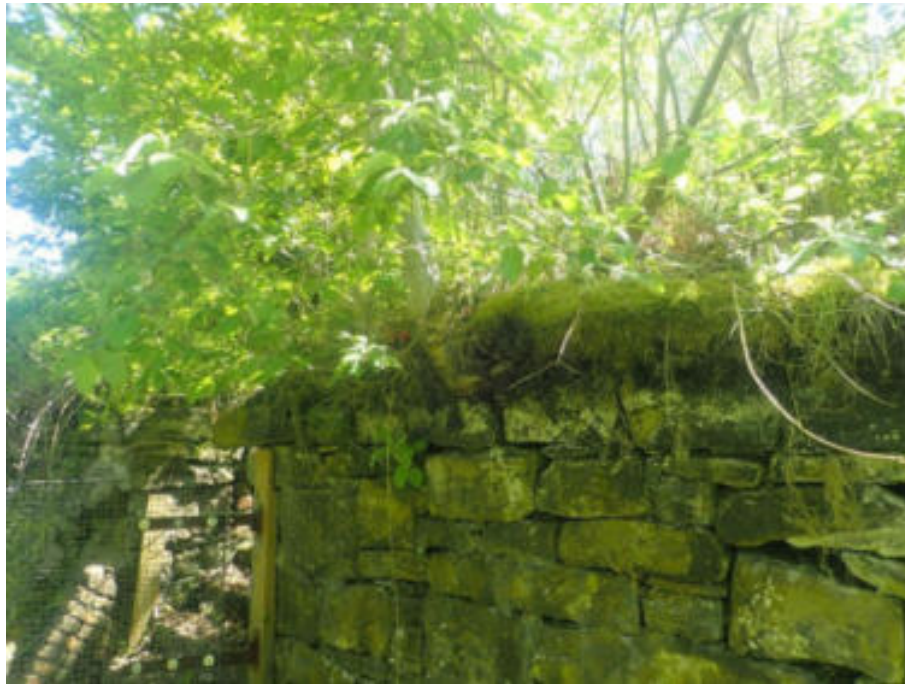
23.2.1 RW9A – Mature Tree noted on top of wall.

*Figure 122. Mature tree*

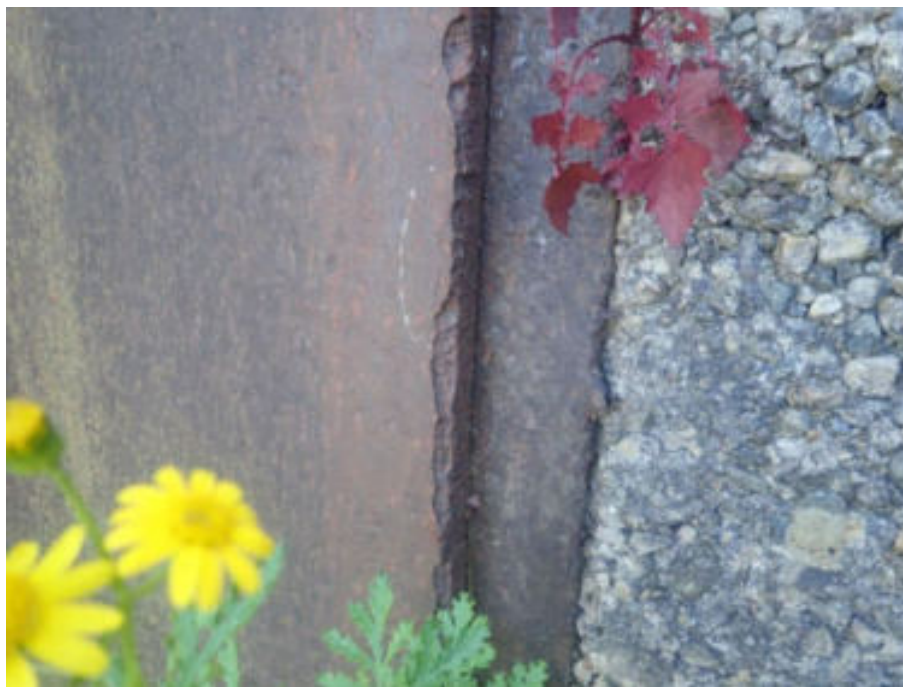
26.2.1 RW12A – Isolated areas of minor pitting were noted to the steel.

*Figure 128. Typical minor pitting to steel*

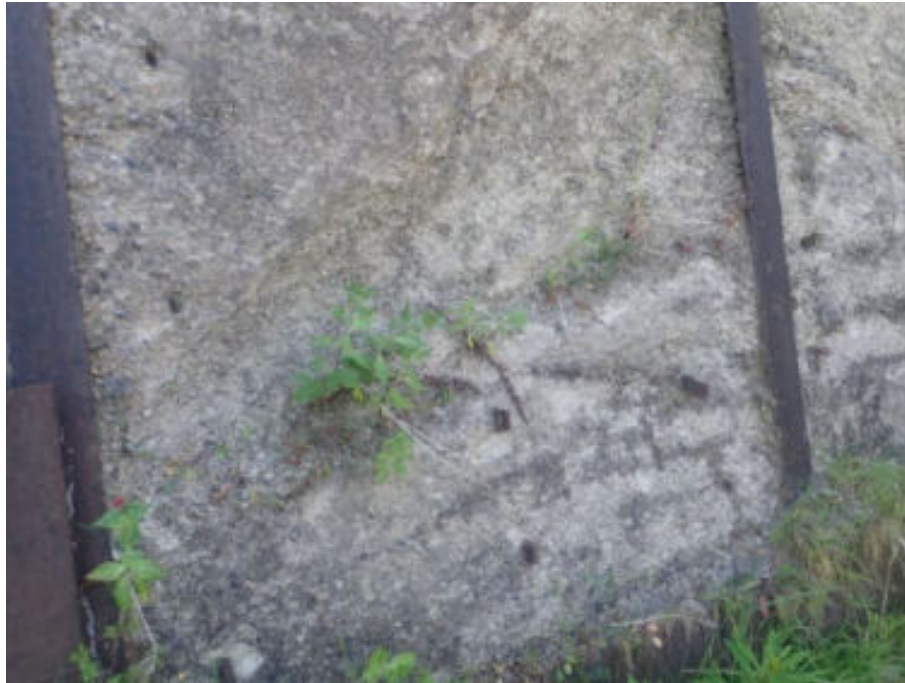
26.2.2 RW12B – Deterioration in the form of scaling was noted to the concrete with up to 100mm depth loss.

*Figure 129. Typical concrete scaling*

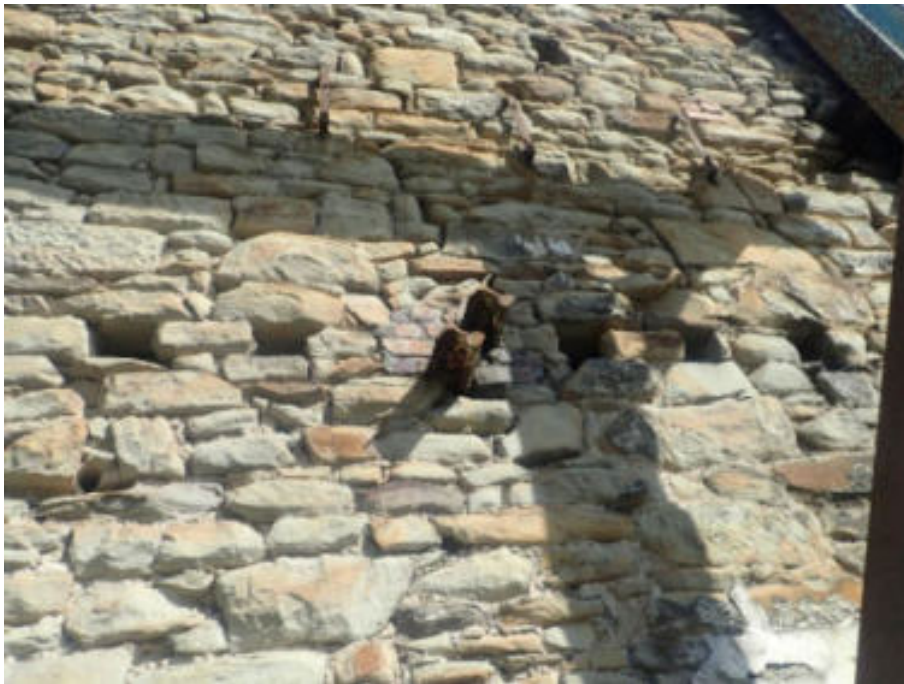
### 29.2.2 RW15B – Corrosion noted on steel structure members.

*Figure 140. Typical corrosion to steel*

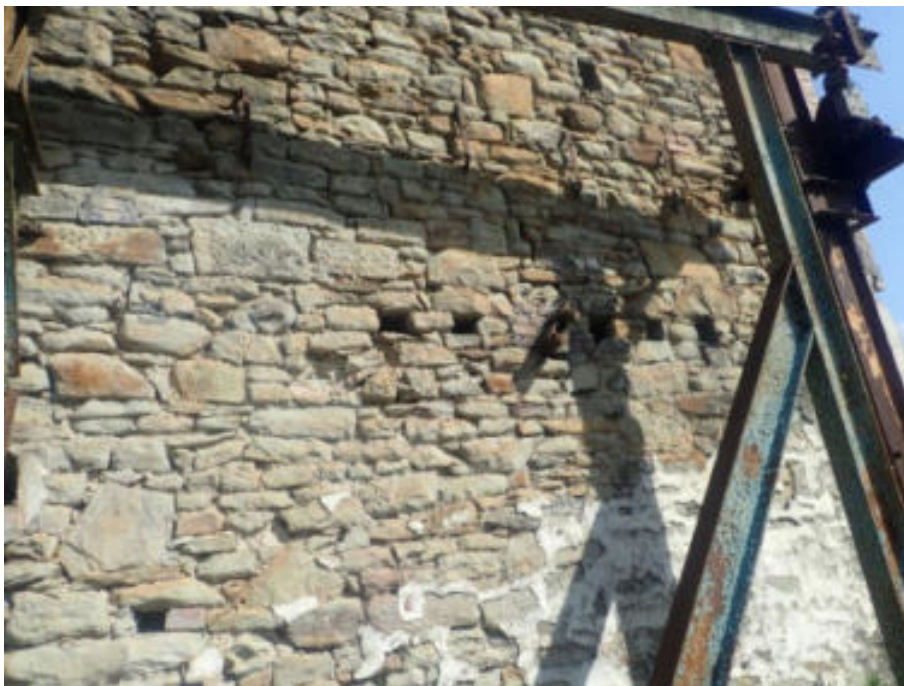
### 29.2.3 RW15C – Missing and loose masonry.

*Figure 141. Missing and loose masonry*

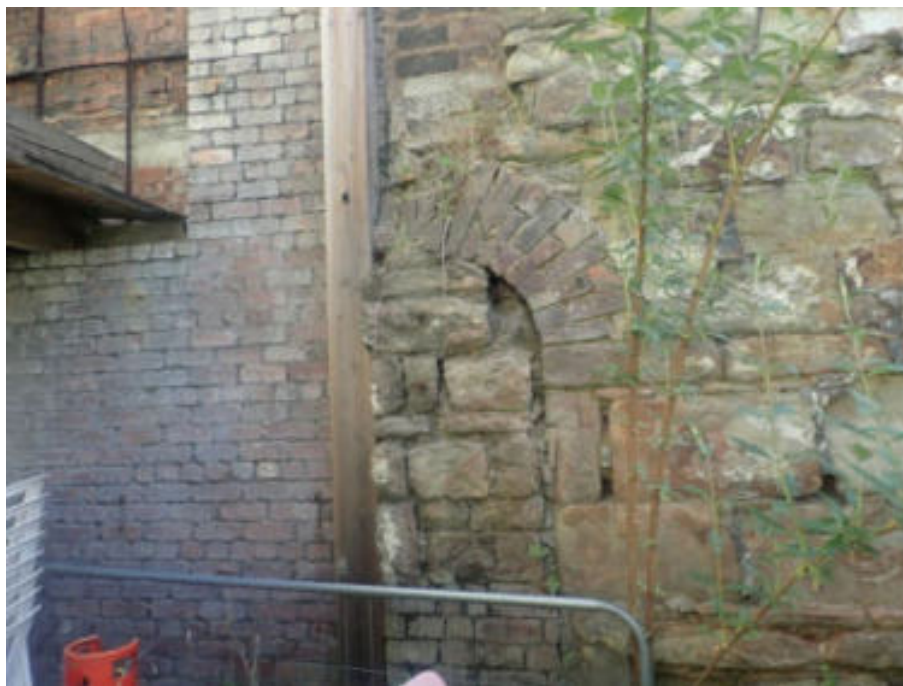
30.2.1 RW16A – Missing mortar 5-10% of total area.

*Figure 144. Typical mortar loss*

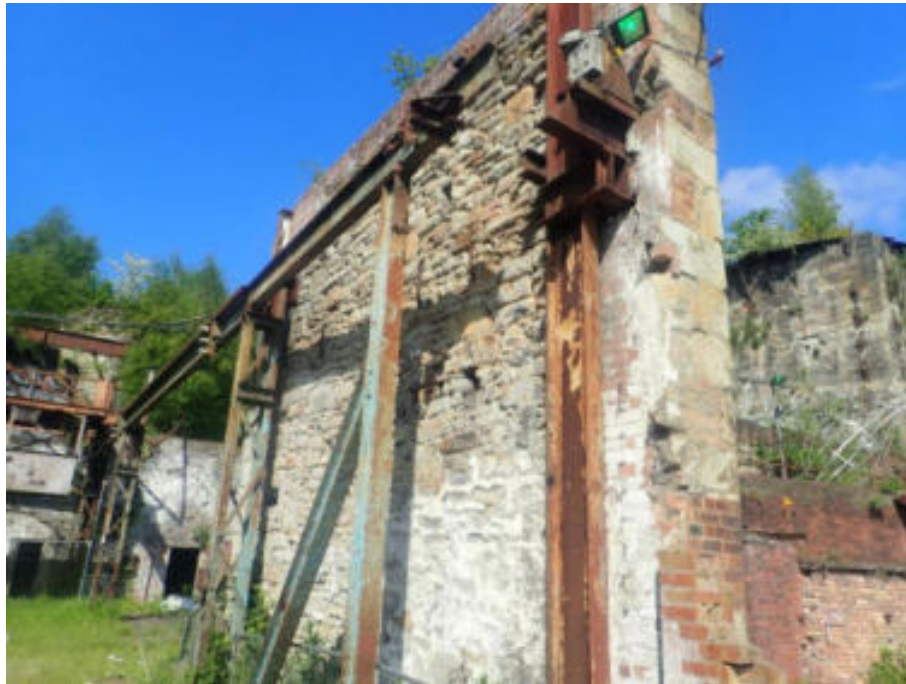
*Figure 147. Spalling to brickwork*

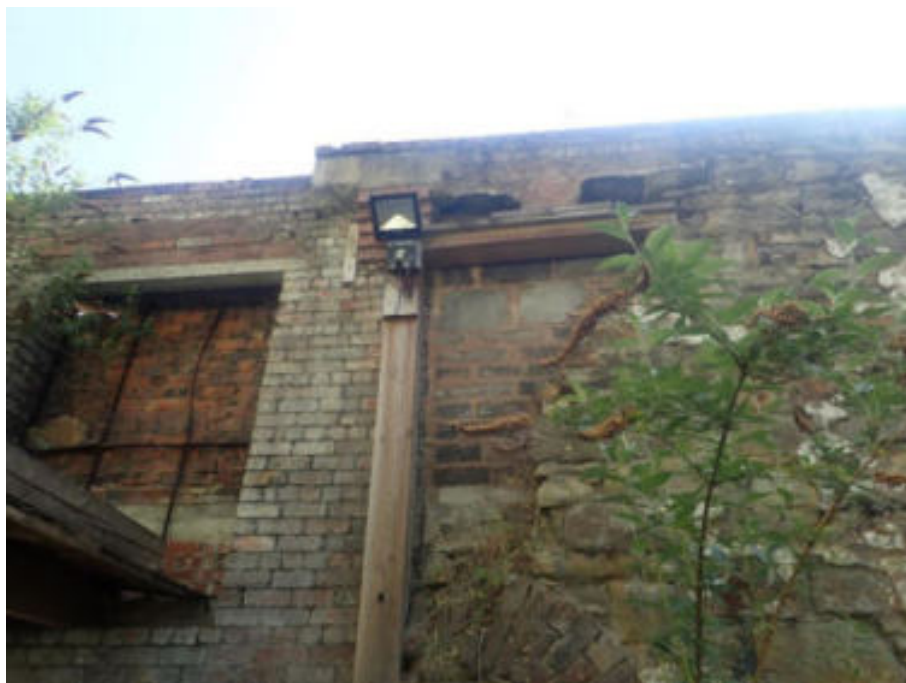
#### 30.2.4 RW16F – Temporary timber propping.

*Figure 148. Temporary timber propping*

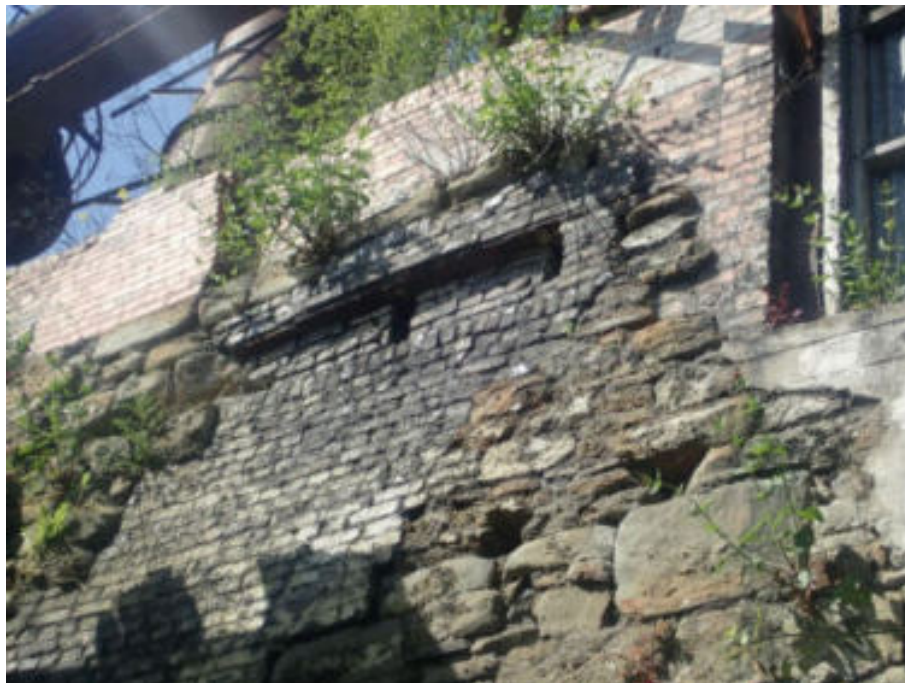
33.2.1 RW20A – Missing mortar 5-10% of total area.

*Figure 159. Typical mortar loss*

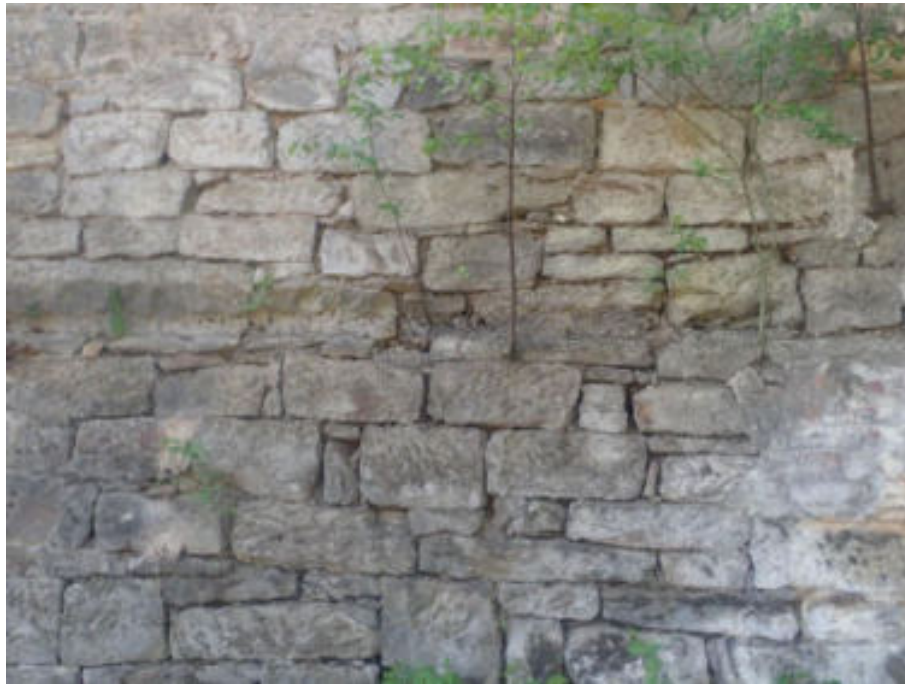
34.2.1 RW21A – Missing mortar 5-10%.

*Figure 162. Typical mortar loss*

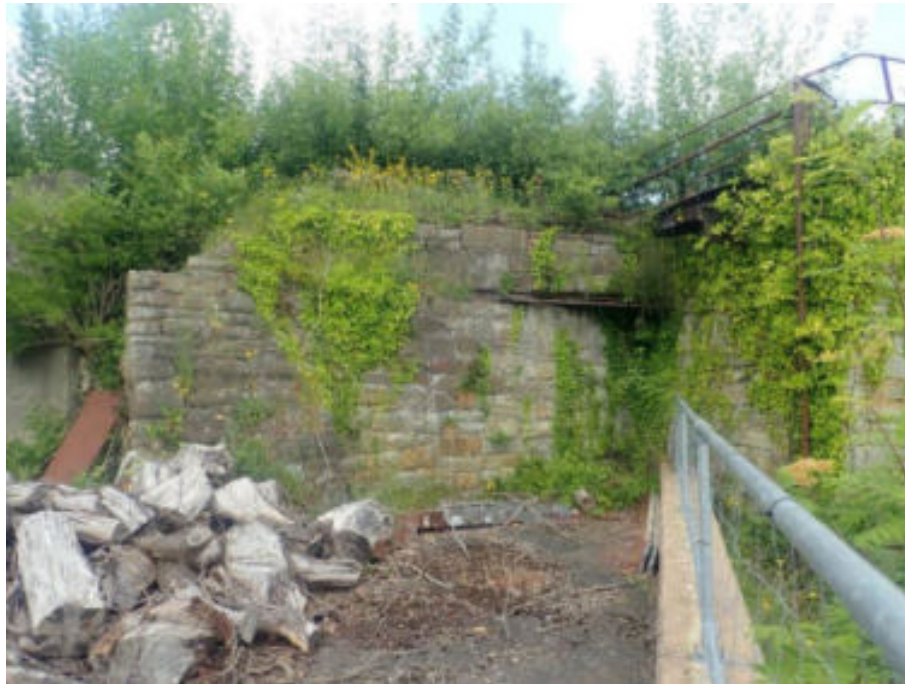
36.2.1 RW23A – Exposed and corroded steel beams.

*Figure 168. Corroded steel beam*

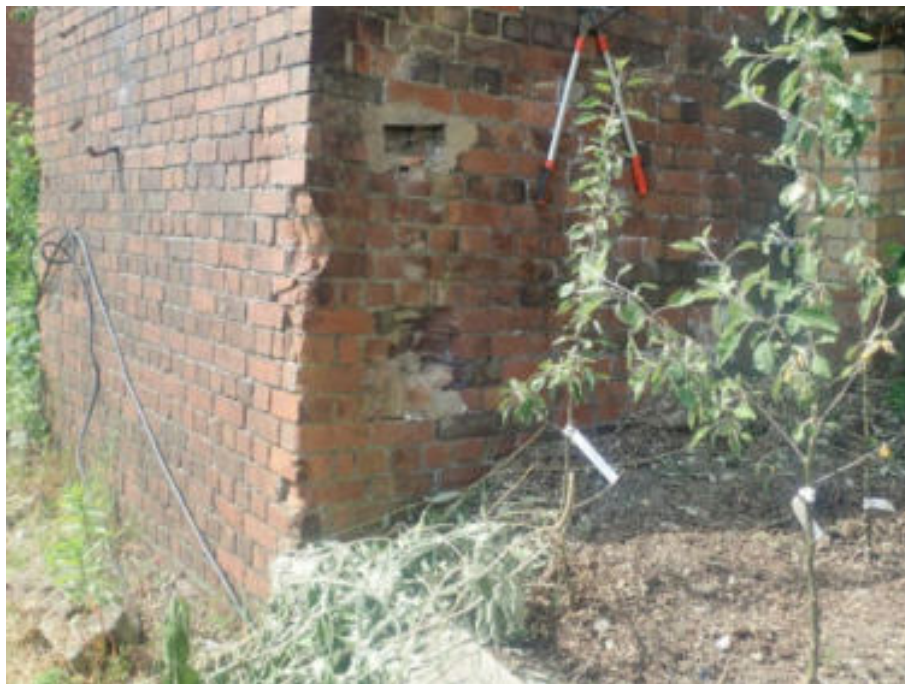
37.2.1 RW24A – Spalled brickwork < 5% of total area

*Figure 173. Typical spalled brickwork*

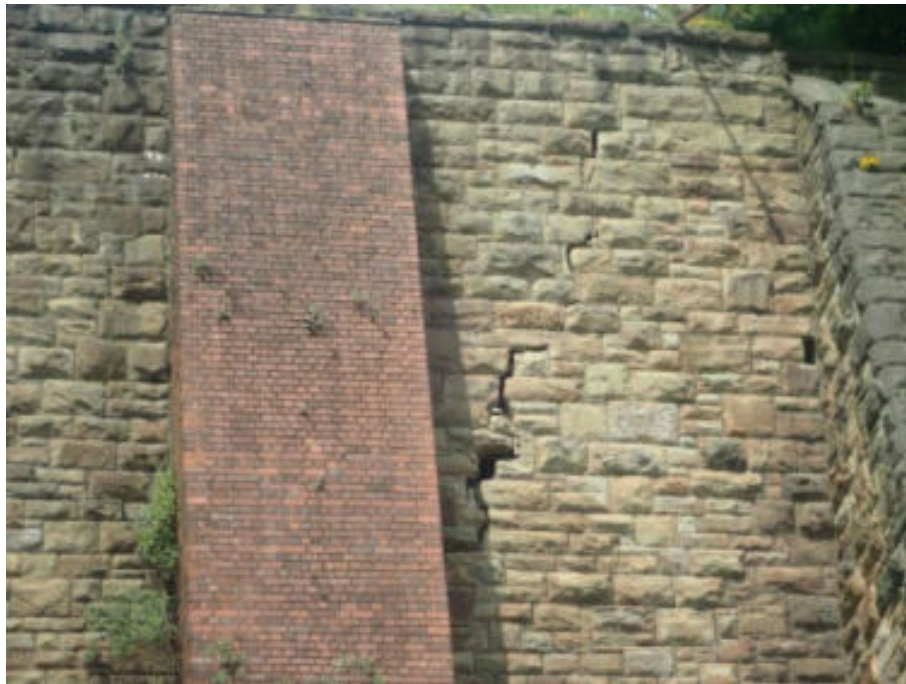
**37.2.2 RW24B – Vertical-diagonal fractures noted on wall (Dimensions not attained).**

*Figure 174. Typical fracture*

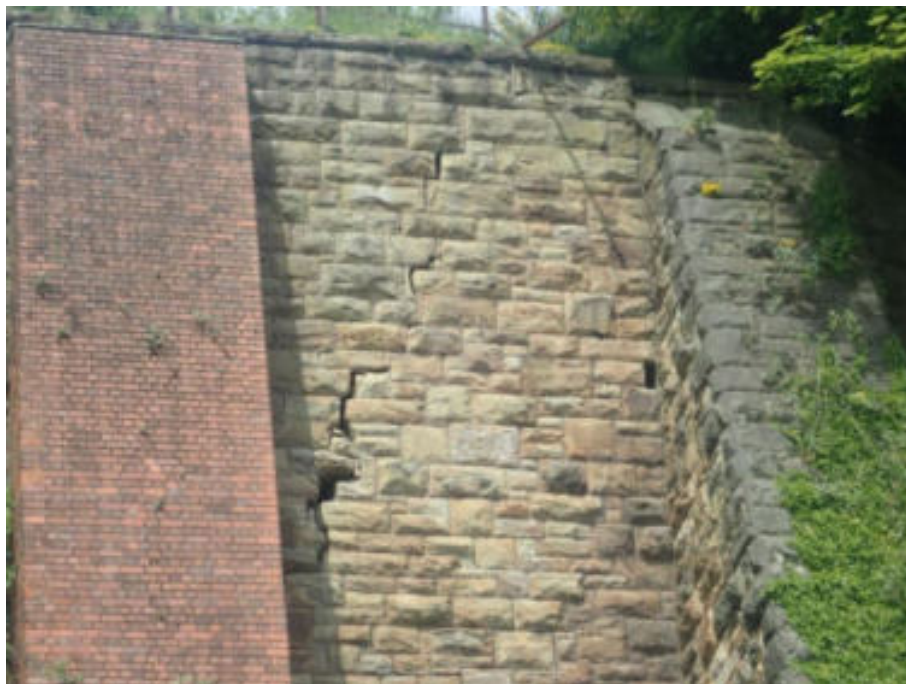
**37.2.3 RW24C – Missing and loose masonry < 5% of total area.**

*Figure 175. Typical missing and loose masonry*

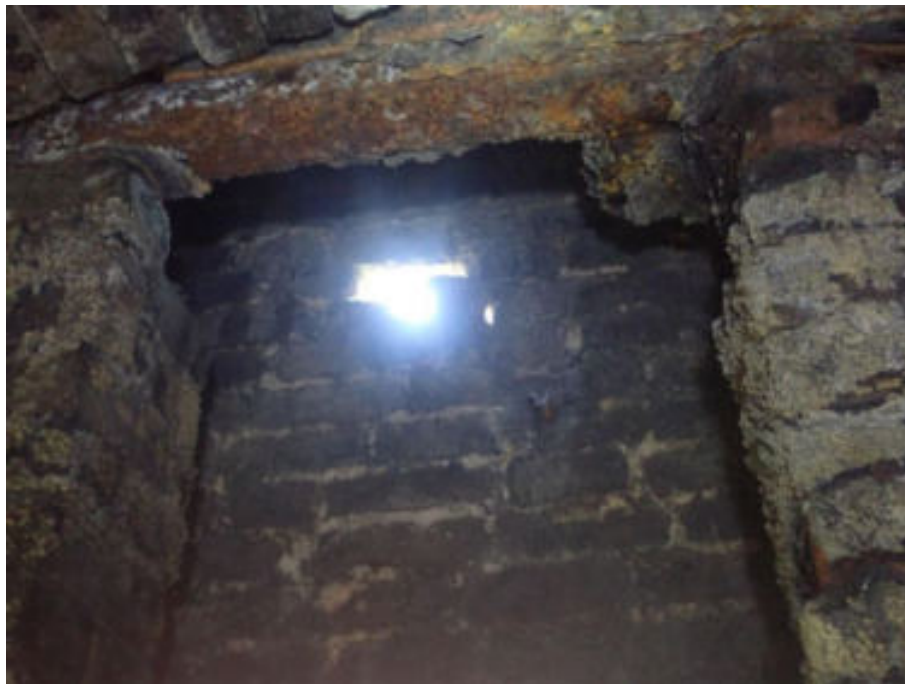
38.2.1 R1A – Severe corrosion noted on iron/steel lintel. Lintel supported by brick pier. Deterioration also noted on brick pier.

*Figure 182. Corroded lintel*

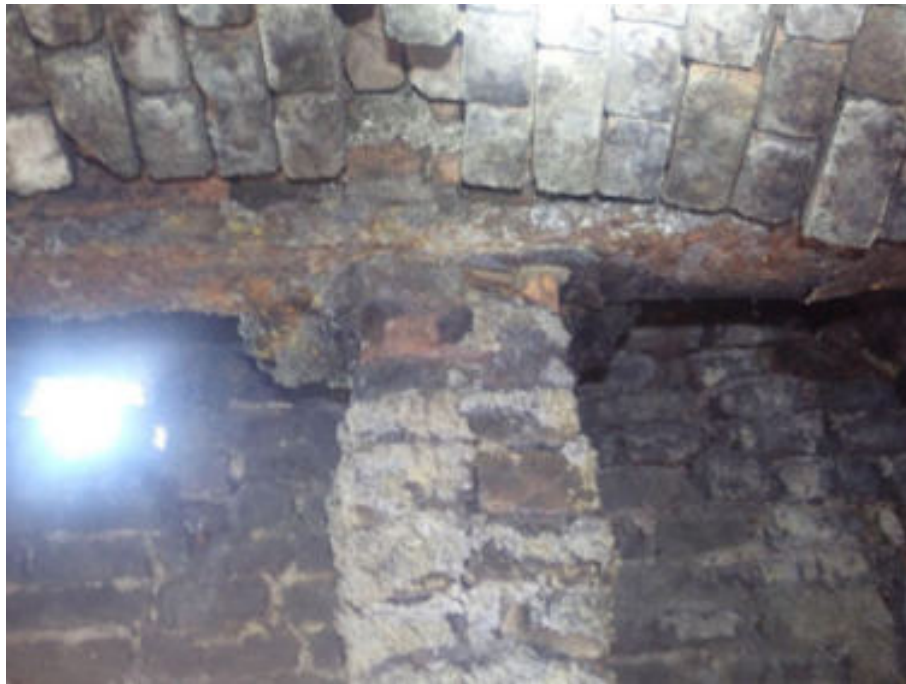
**38.2.2 R1B – Brick support at mid span is in a poor state of repair.**

*Figure 183. Brick pier*

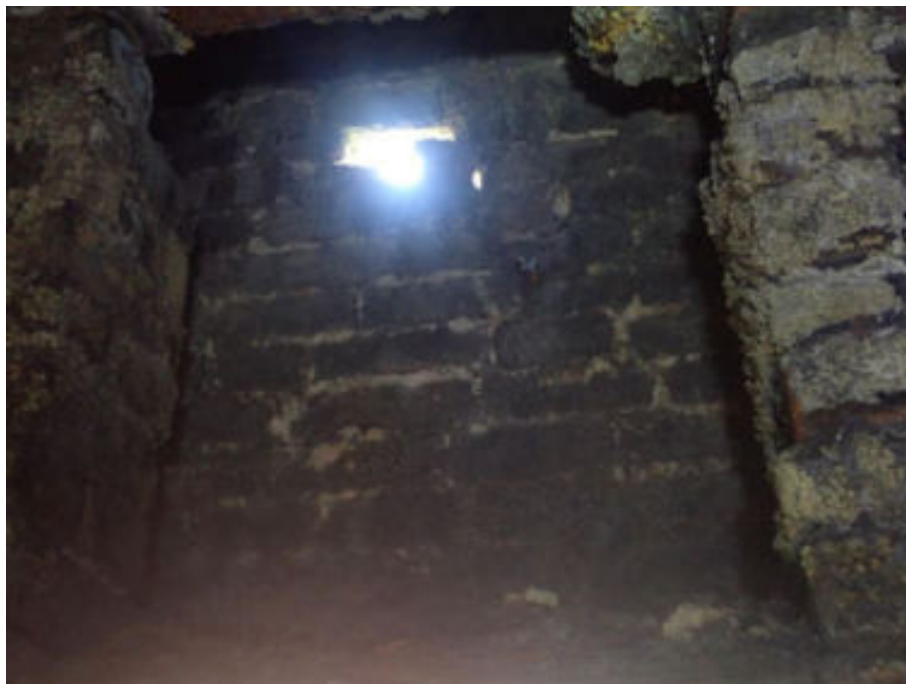
**38.2.3 R2C – Outer brick spandrel has failed.**

*Figure 184. Failed spandrel*

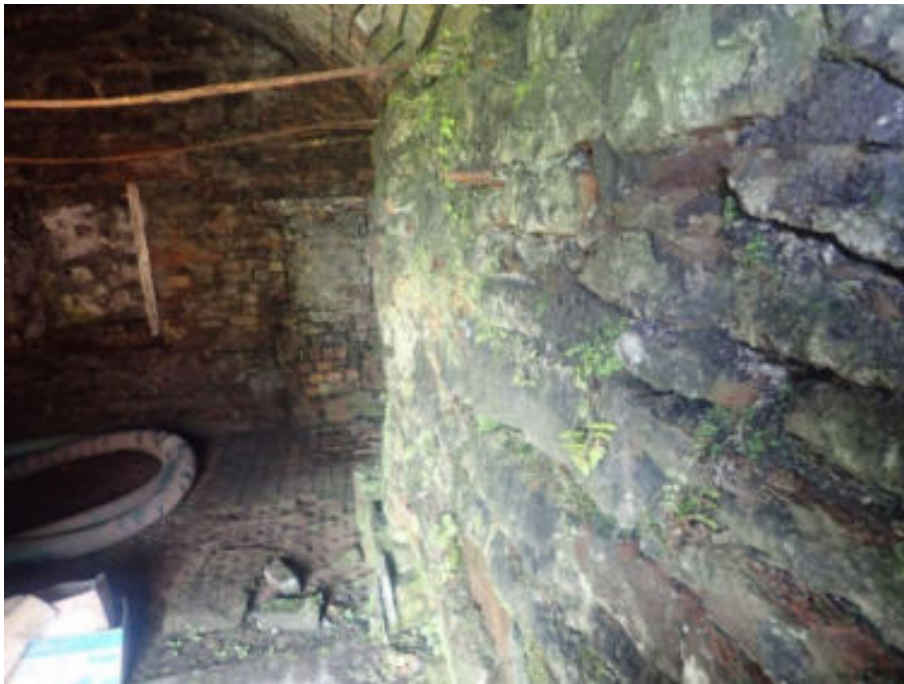
**38.2.4 R1E – Verticality of stone wall is out of plumb with significant bulging.**

*Figure 185. General view of wall*

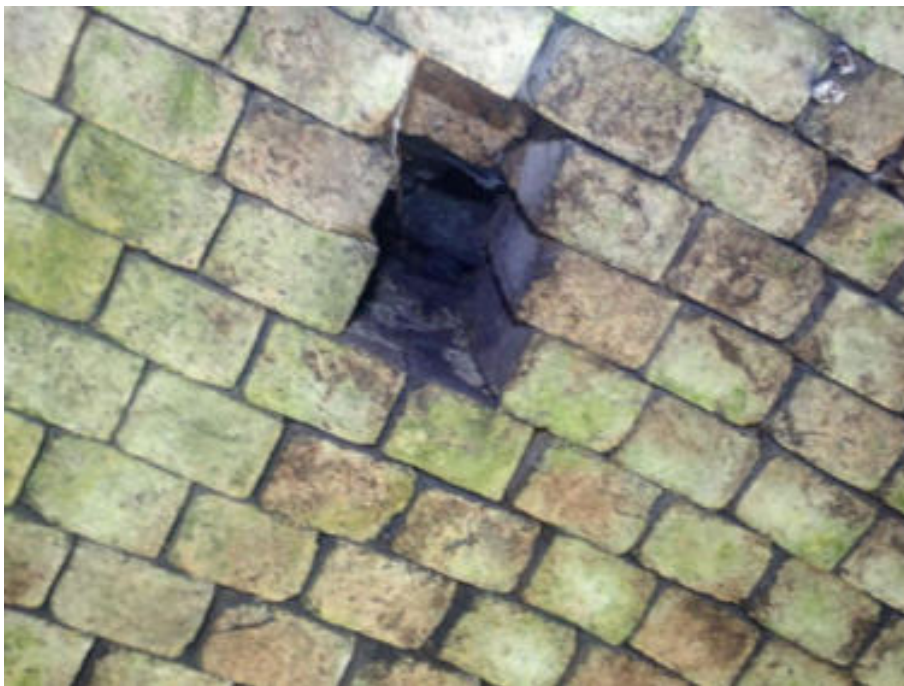
**38.2.5 R1F – Dislodged bricks noted on barrel roof.**

*Figure 186. Dislodged bricks*

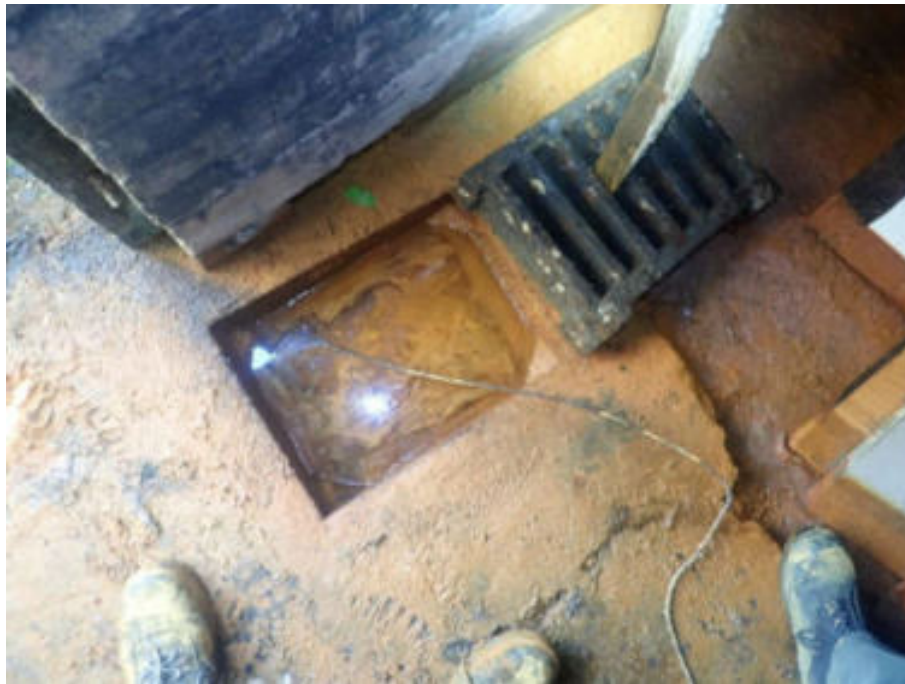
39.2.1 R2A – Debris noted in drainage gully by door.

*Figure 188. Debris in gully*

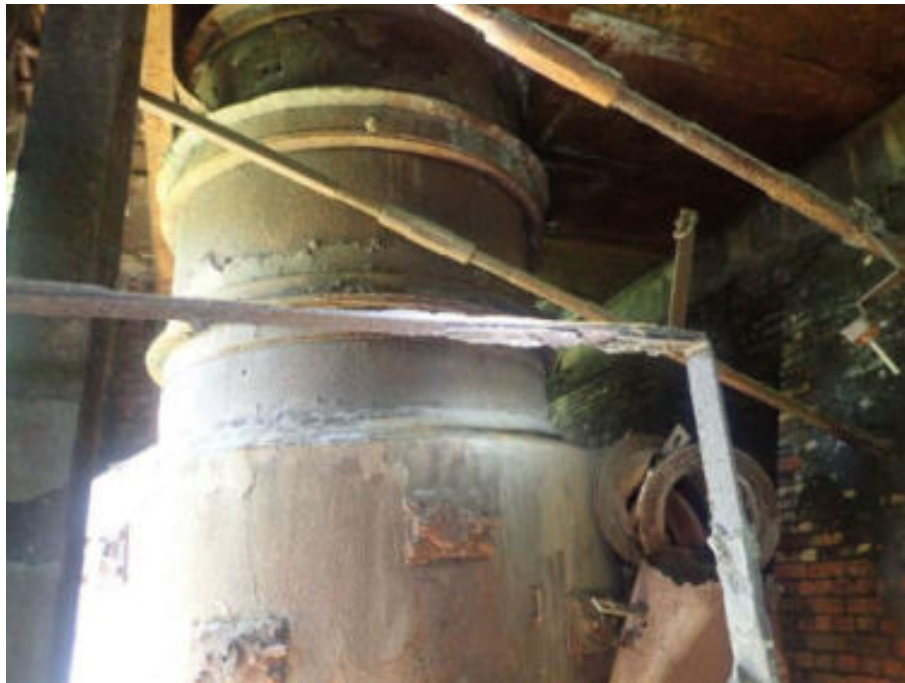
40.2.1 R3A – Significant delamination noted to cupola bases, but is currently in a structurally sound condition.

*Figure 189. Typical delamination to cupola bases*

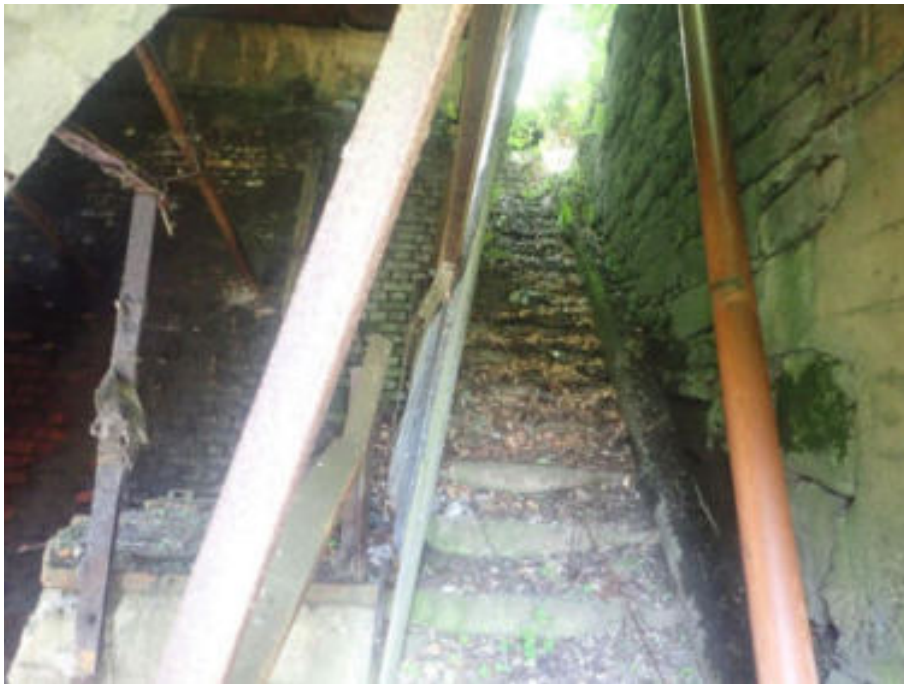
**41.2.2 ST2 – Frame for corrugated steel corroded and deteriorated.**

*Figure 194. Deteriorated frame*

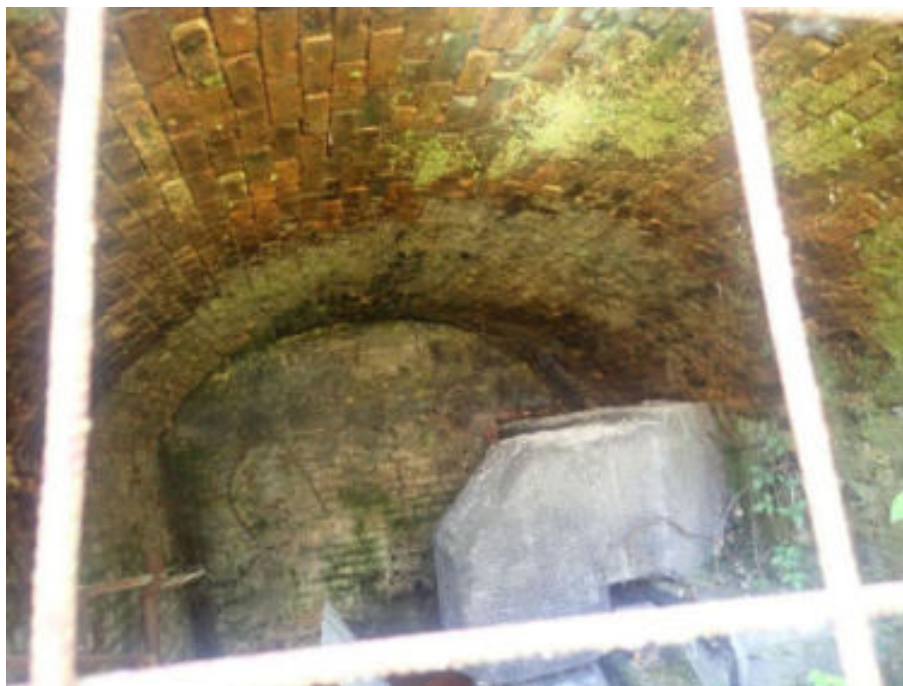
43.2.1 R5Ai/R5Bi – Minor mortar loss noted on brickwork, approx. 10% of total area.

*Figure 200. Typical mortar loss*

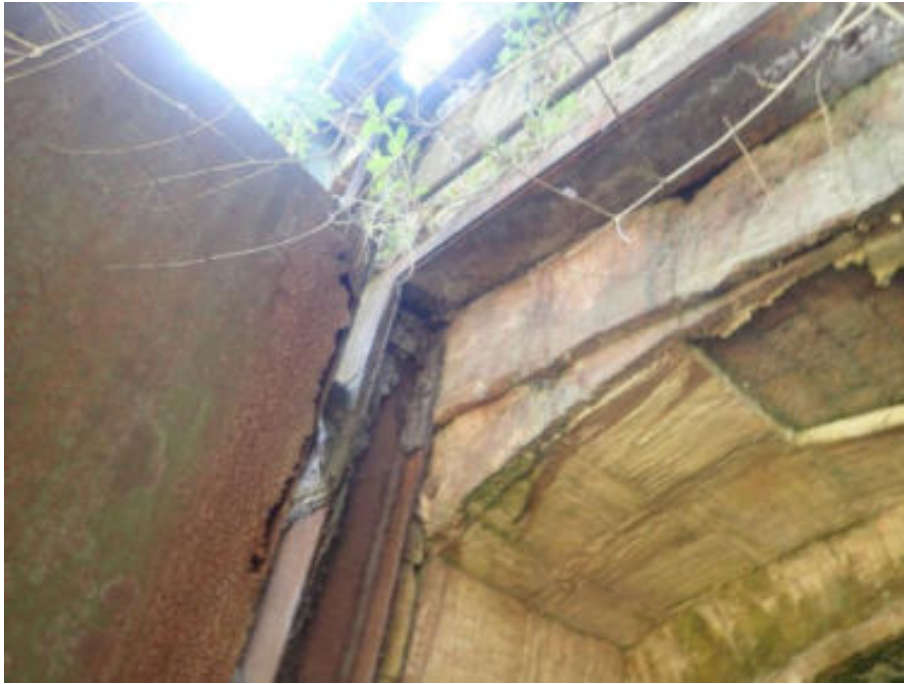
**43.2.6 R5vi – Expansive corrosion noted on door frame.**

*Figure 205. Corroded door frame*

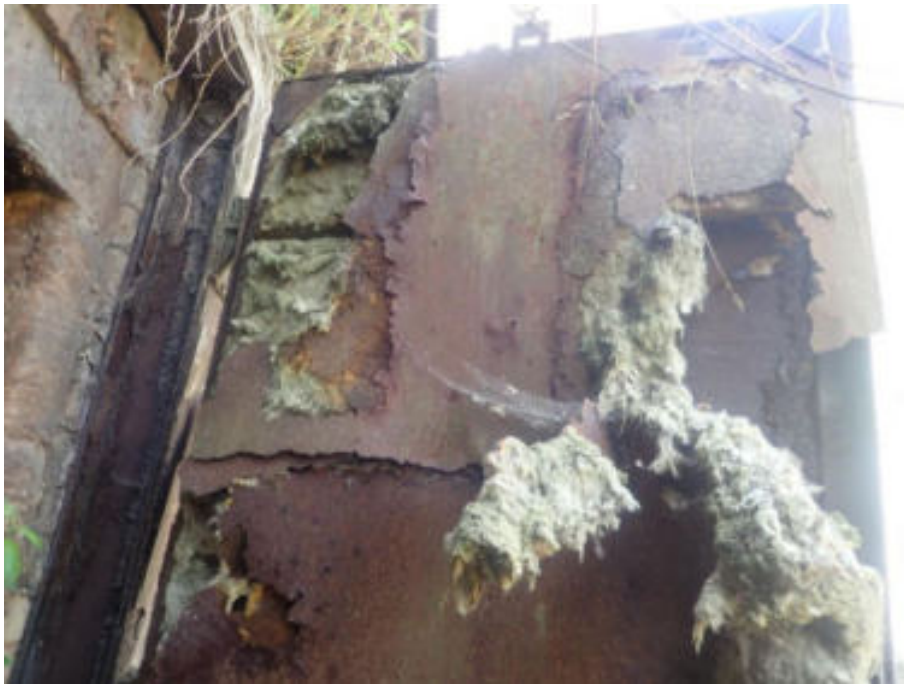
**43.2.7 R5Avii – Access door is significantly deteriorated.**

*Figure 206. Deteriorated door*

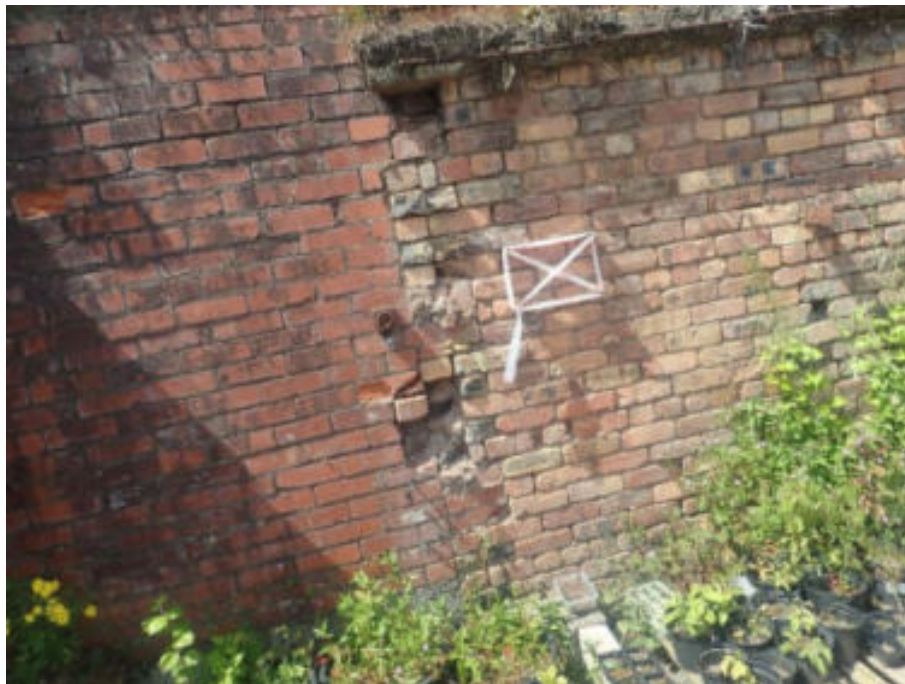
45.2.1 R7A – Missing and loose masonry noted 5-10%.

*Figure 213. Typical loose and missing masonry*

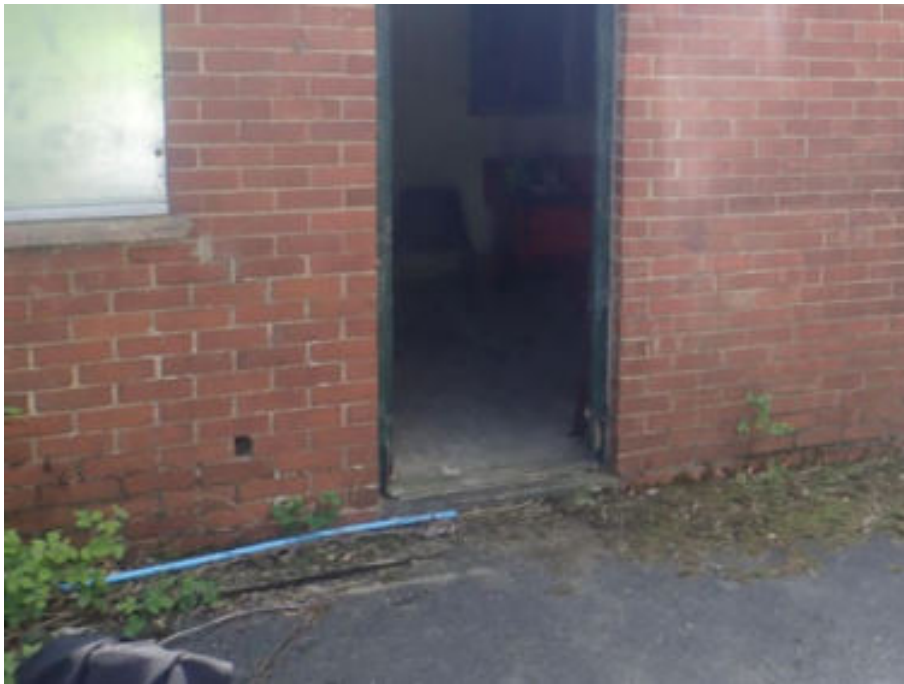
**46.2.2 R8B – Hairline diagonal fracture noted at base of window protruding to floor.**

*Figure 218. Diagonal fracture*

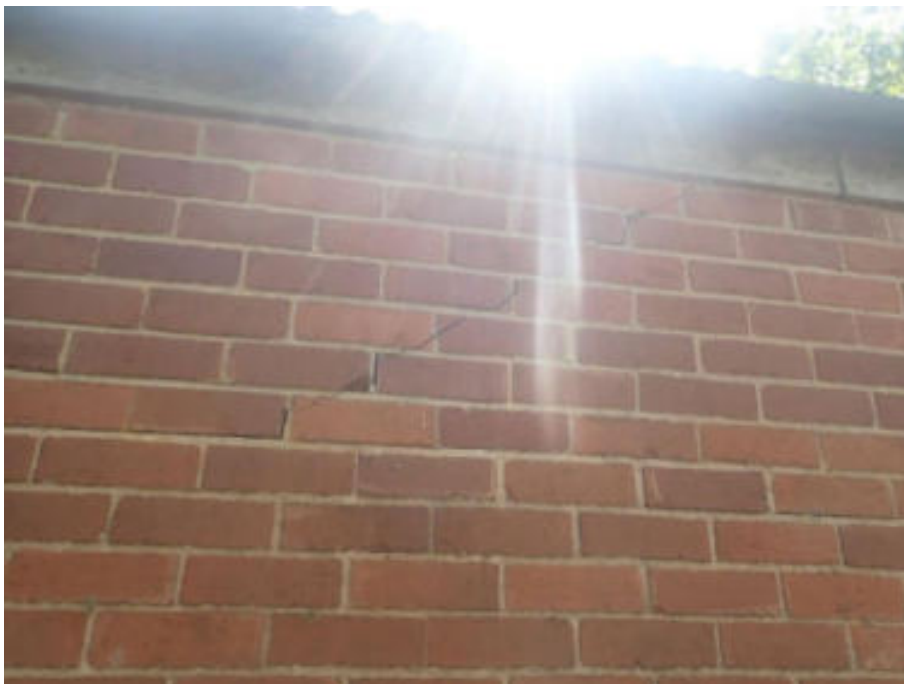
**46.2.3 R8C – Diagonal fracture noted from eaves and terminating 7 courses down.**

*Figure 219. Diagonal fracture*
