## Structural Survey

Timber Frame Barn, Top  
House Farm, Arowry,  
Wrexham, SY13 3EQ.

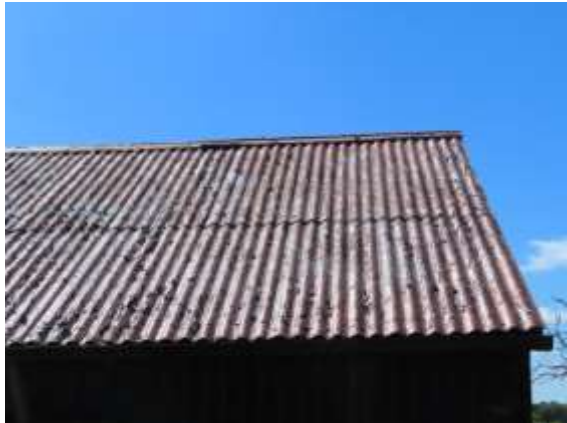
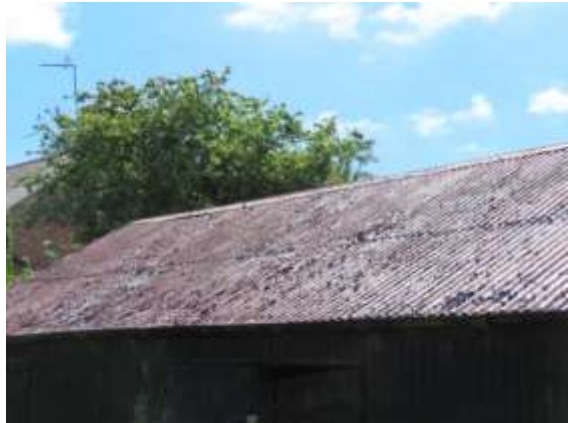
| <b>1 Roof Coverings</b> | |

| Element | Description | Condition | Recommendation |
|---|---|---|---|
| <b>1. Roof Coverings</b> | Corrugated metal sheeting with painted finish. | Sheeting is relatively well formed, although general deterioration is evident such as cracking at overlaps and moss growth.<br><br>Coverings appear to be asbestos cement. | Re-cover roof with suitable lightweight cladding, subject to architectural design.<br><br>Removal of existing coverings in-line with HSE standards. |

| Front roof slope with degraded paint finish | |

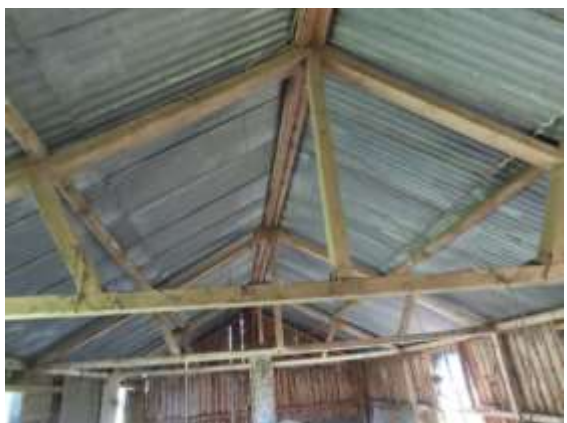
| <b>2 Roof Structure</b> | |

| Element | Description | Condition | Recommendation |
|---|---|---|---|
| <b>2. Roof Structure</b> | <p>The roof incorporates a timber framed structure, formed with five trussed rafters.</p> <p>Gable rafters are supported by the timber frame walling and central truss supported by a central 250mm x 110mm oak beam.</p> <p>Trusses are formed in 75mm x 120mm hardwood beams, spaced at 3m centres.</p> <p>Hardwood purlin and ridge beams provide support between trusses.</p> | <p>Good condition.</p> <p>The structure has adequately supported the coverings and the space remains free from any significant damp ingress.</p> <p>There is evident wood boring beetle attack in localised areas. This appears to be mostly historical.</p> | |

| Hardwood roof trusses | Central oak supporting beam |

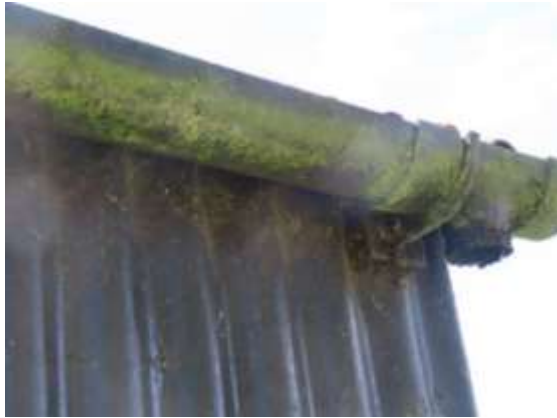
| <b>3 Rainwater Fittings</b> | |

| <b>3. Rainwater Fittings</b> | <p>The rainwater fittings, where present, are formed in plastic gutter sections.</p> | <p>Poor.</p> <p>The gutters are in a neglected state with evident distortions and detachment.</p> | <p>Installation of new rainwater gutters and downpipes; to be connected to soakaway drains via storm gullies.</p> |

| Stained gutter and missing downpipe | Uneven gutter and missing end cap |

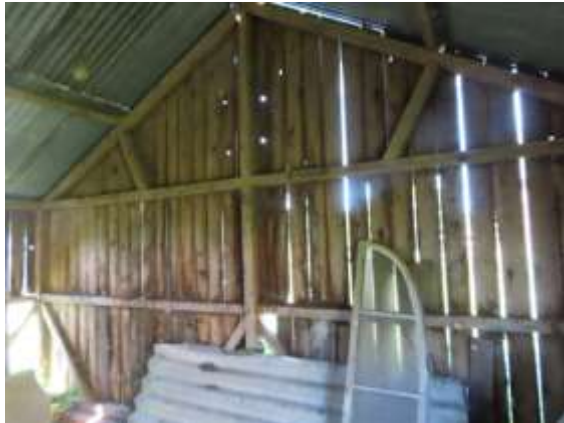
| <b>4 Main Walls</b> | |

| <b>4. Main Walls:</b> | <p>The main walls are constructed with a timber framework of 75mm x 75mm hardwood timbers sat upon brick dwarf walls.</p> <p>Framing is clad with timber boarding and corrugated sheeting.</p> <p>Footings not seen.</p> | <p>Timber framing is largely intact and structural integrity has been largely retained.</p> <p>The rear framing displays significant deterioration and timber decay in a number of areas.</p> <p>Widespread wood boring beetle attack evident. This appears to be mostly historical.</p> <p>Timber cladding is in poor condition and has largely rotted and decayed from weather exposure.</p> <p>Corrugated sheeting used to offer weather protection in areas of advanced decay to cladding. Sheeting offers basic weather protection.</p> | <p>Timber framing requires extensive repair to rear elevation. Localised woodworm treatment required.</p> <p>External timber cladding to be replaced.</p> <p>Strengthening and rebuilding of the existing wall structures required and thermal upgrades.</p> <p>Insertion of new DPC recommended.</p> |

| Timber frame to gable end | Timber framing sections to rear wall |

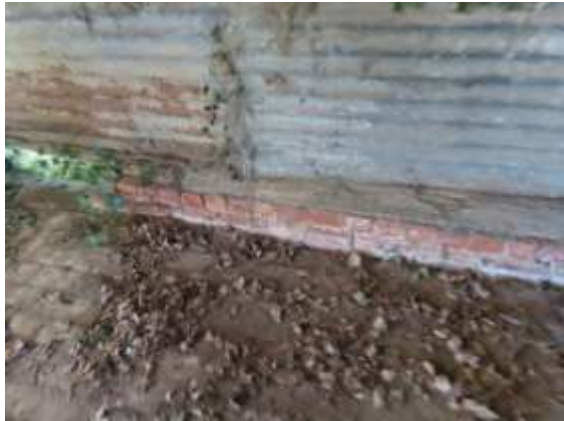
| Brick dwarf wall support to framing | Exterior timber cladding |

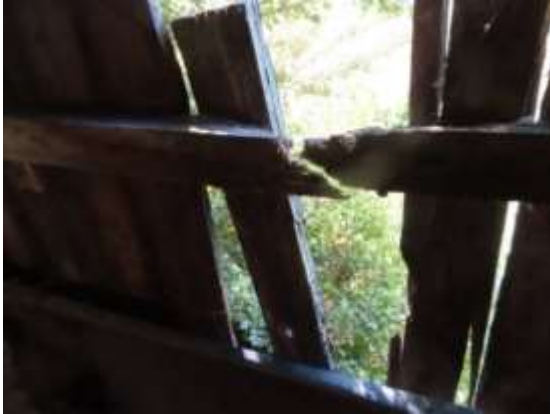
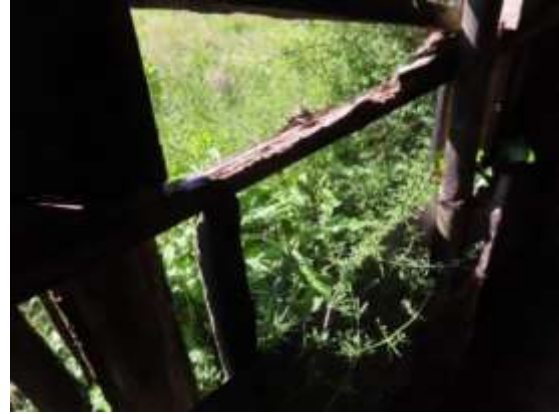
Areas of timber decay to rear elevation frame

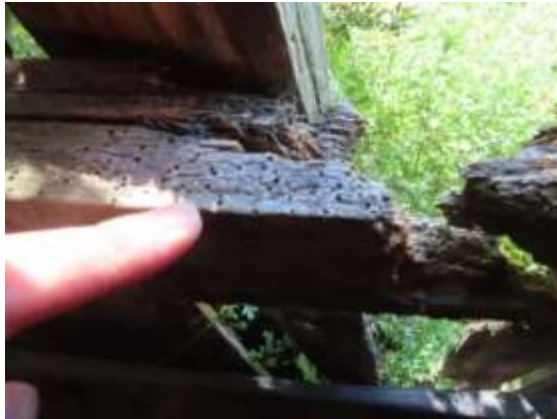
Evidence of wood boring beetle attack

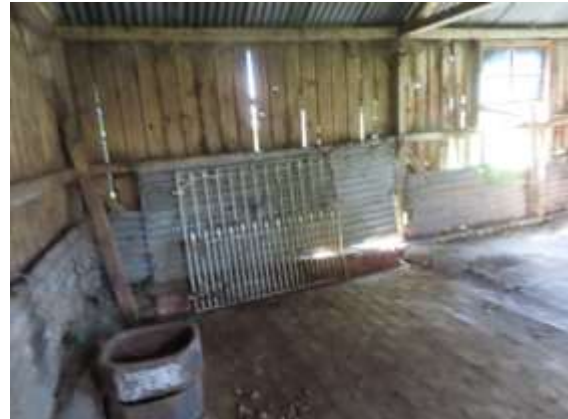
Corrugated sheeting to exterior and gable walls

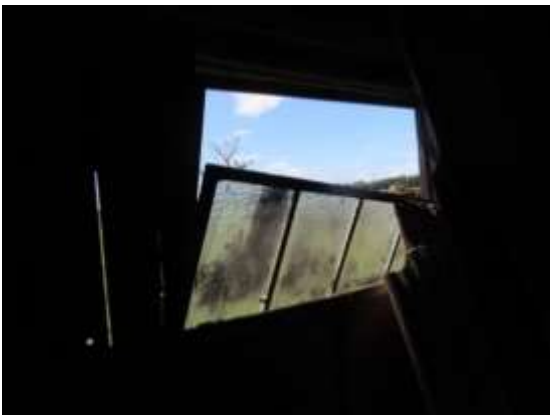
## 6 External Joinery

| <b>5. External Joinery</b> | <p>Door and window openings formed with timber framing.</p> <p>Original ledged and braced doors to front entrance. Includes iron hinges and braces.</p> <p>Metal framed units to the rear elevation windows, incorporating glazed units.</p> | <p>All openings retain their original form.</p> <p>Front doors significantly damaged and unfit for purpose.</p> <p>Metal frames windows detached from timber framing.</p> <p>All joinery is in a neglected state.</p> | <p>New doors and windows will be required, as per project design.</p> <p>Original hinges to be retained for new entrance doors.</p> <p>Additional lintel support to openings will be required.</p> |

Metal framed window disconnected from frame

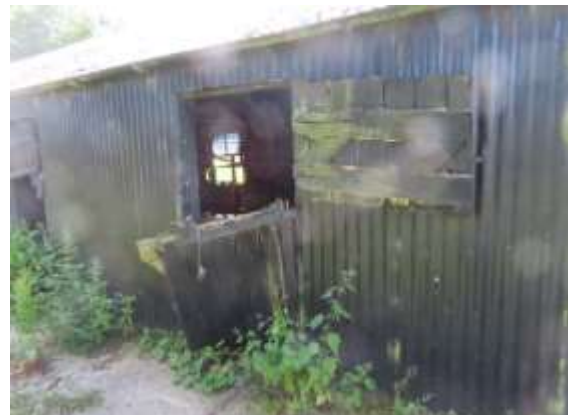
Damaged entrance door

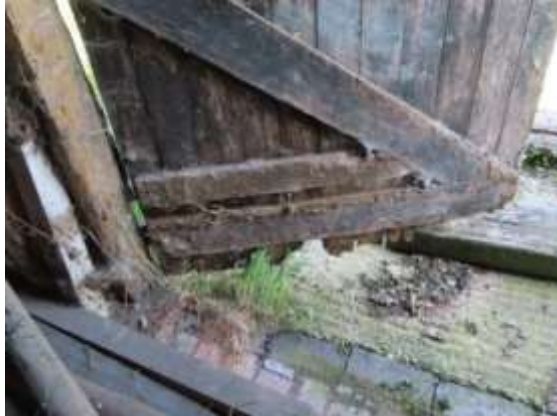
Rot to frame and base of door

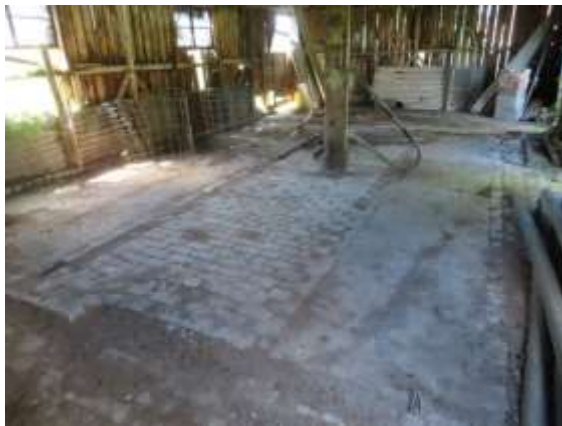
| <b>7. Ground Floor</b> | Part concrete base and part brick finish.. | Uneven flooring throughout. | Replacement floor required to incorporate DPM and insulation. |

Mixture of brick and concrete floor
