## Structural Survey

Top House Farm, Arowry,  
Wrexham, SY13 3EQ.

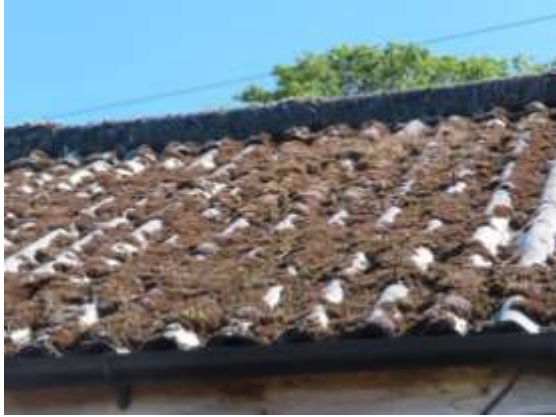
| Element | Description | Condition | Recommendation |
|---|---|---|---|
| <b>1. Roof Coverings</b> | Corrugated metal sheeting. | Sheeting is relatively well formed, although general deterioration is evident such as cracking at overlaps and moss growth.<br><br>Coverings appear to be asbestos cement. | Re-cover roof with suitable lightweight cladding, subject to architectural design.<br><br>Removal of existing coverings in-line with HSE standards. |

| Moss covered asbestos roof sheeting | Cracked verge overlap |

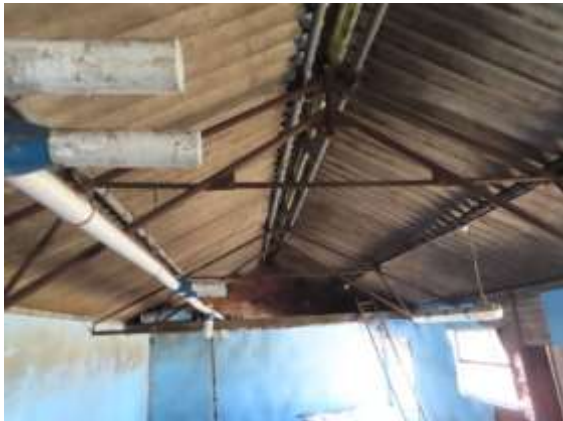
| Element | Description | Condition | Recommendation |
|---|---|---|---|
| <b>2. Roof Structure</b> | The roof incorporates a steel framed structure. This includes steel purlin and ridge beams supported by three steel trusses.<br><br>The extension bay incorporates two timber purlins to each slope supporting the coverings. | Fair condition.<br><br>The structure has adequately supported the coverings and the space remains free from any significant damp ingress.<br><br>Corrosion is evident to steel trusses, although these remain in-tact. | Additional strengthening will be required to the trusses to support new roof coverings. |

| Steel trusses and roof framework | Timber purlin and ridge beams in end bay |

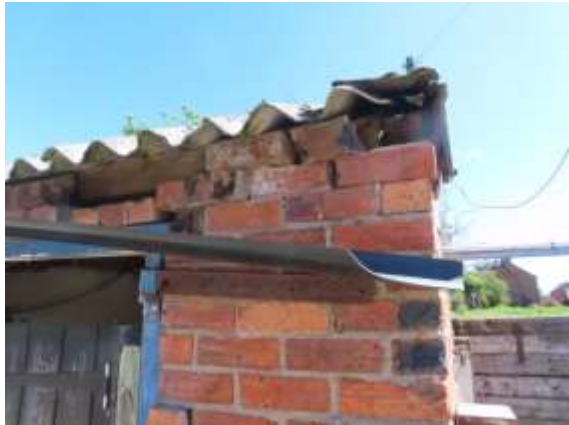
| Element | Description | Condition | Recommendation |
|---|---|---|---|
| <b>3. Rainwater Fittings</b> | The rainwater fittings, where present, are formed in plastic gutter sections. | Poor.<br><br>The gutters are in a neglected state and are detaching at the connections. | Installation of new rainwater gutters and downpipes; to be connected to the existing drainage system. |

| Disconnected gutter | Downpipe missing from front left corner |

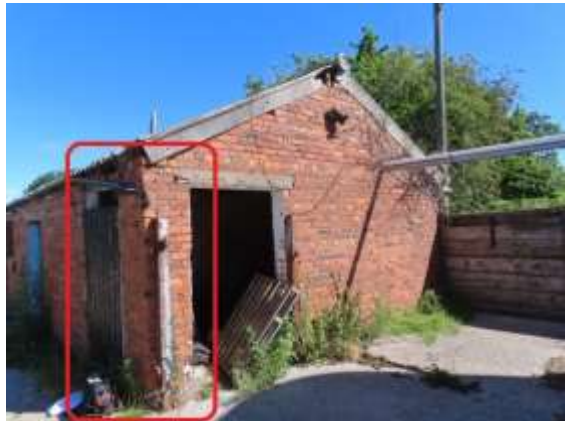
| Element | Description | Condition | Recommendation |
|---|---|---|---|
| <b>4. Main Walls</b> | The main walls are constructed with solid brick (220mm) incorporating a bitumen DPC. | Structural failure and rotational movement evident to front right corner of the building. Possible | Inspection of the underground drain required. Relevant structural repair required to front right corner, |

| Front elevation wall | Damage and rotational movement to front right corner |

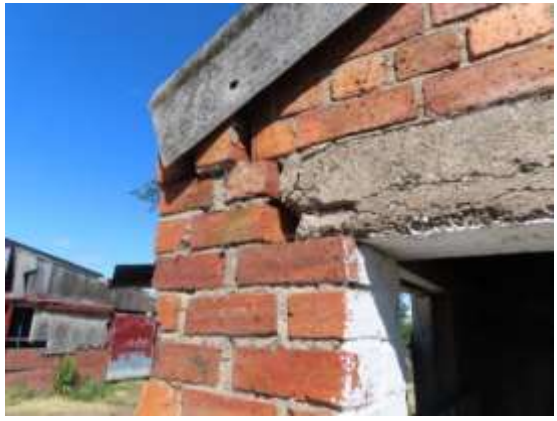
| Dislodging brickwork | Large crack stemming from lintel to verge |

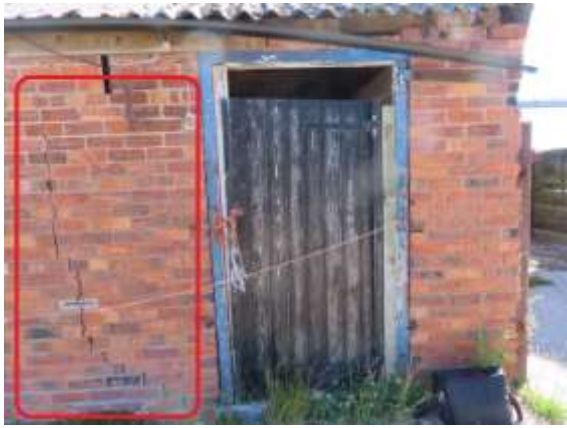
| <p>Large fracture to front wall – linked to movement in corner</p> | <p>Dislodged brickwork over door opening</p> |

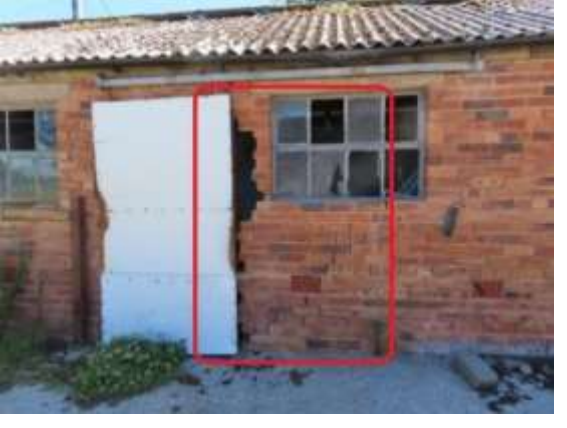
| <p>Disturbance and missing brickwork by central door</p> | |

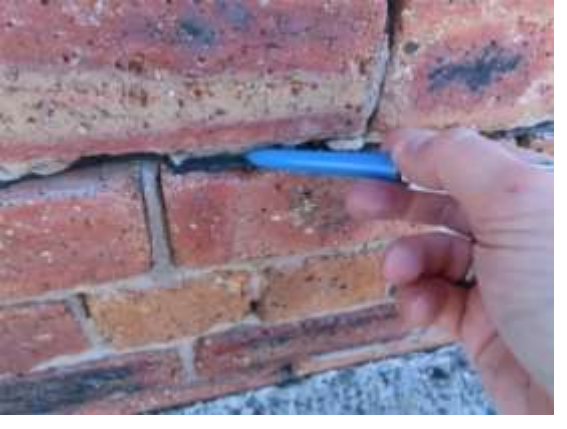
| <p>Bitumen DPC</p> | <p>Mortar erosion below window-sill</p> |

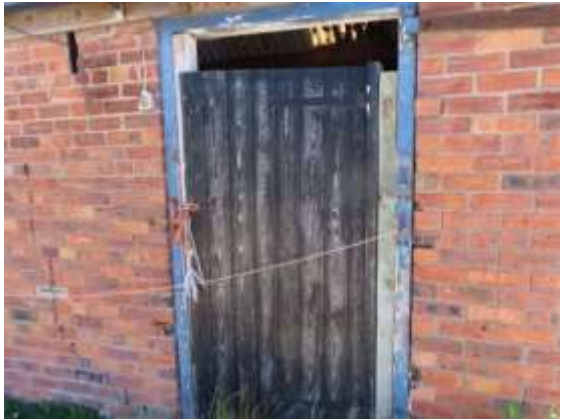
| Metal sliding door entrance to front bay | Makeshift door |

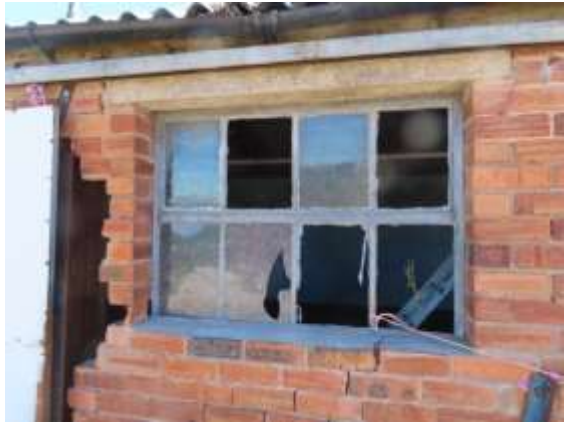
| Window metal frame and damaged and missing units | |
