**BRYMBO STEELWORKS  
HERITAGE AREA:**

**LAND CONTAMINATION REVIEW**

**For: BRYMBO HERITAGE TRUST**

**R2762-R01-v2-Final**

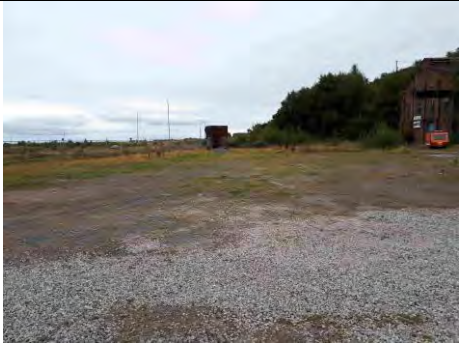
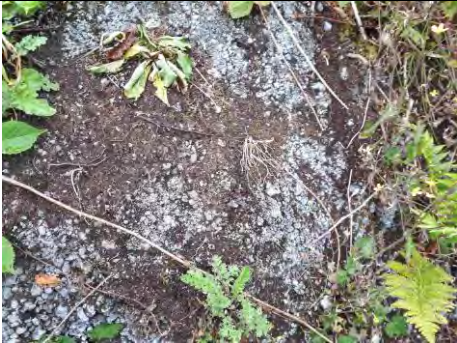
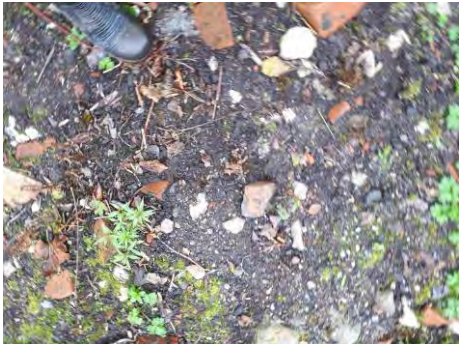
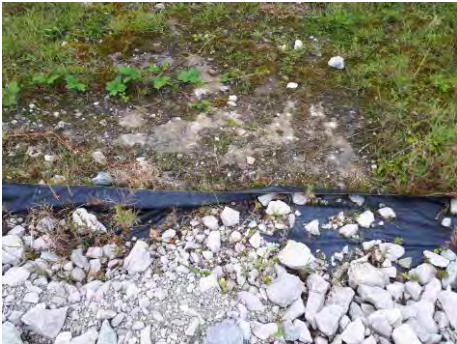
| | <p>In all parts of the site where ground does not have a surface cover of vegetation, or hard surfacing, a mixture of made ground materials were visible, the following records some of the typical materials exposed</p> |
| | <div data-bbox="480 315 940 656"> <p>Limestone gravel over running areas</p> </div> <div data-bbox="994 315 1453 656"> <p>Soil with fine gravel of blast furnace slag</p> </div> <div data-bbox="480 710 940 1052"> <p>Mix of ash, brick, stone and clinker</p> </div> <div data-bbox="994 710 1453 1052"> <p>Limestone gravel over running areas</p> </div> |

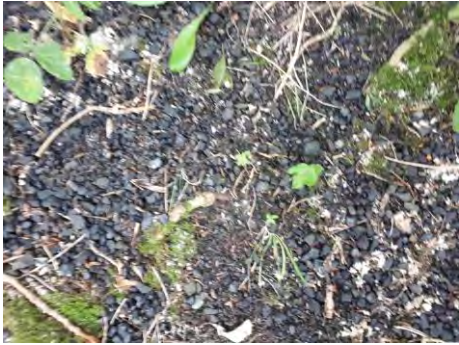
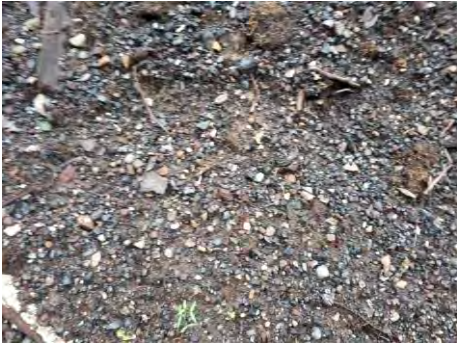
| | <div data-bbox="480 1153 940 1496"> <p>Gravel of coal</p> </div> <div data-bbox="994 1153 1453 1496"> <p>Gravel of coke, breeze, clinker and slags</p> </div> |

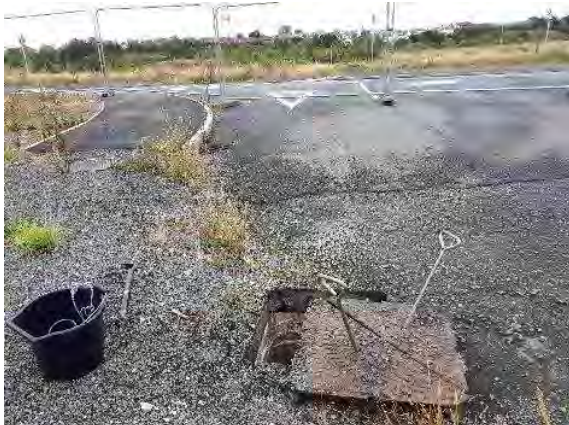
5.

Manhole cover to Foundry Adit drain at site boundary

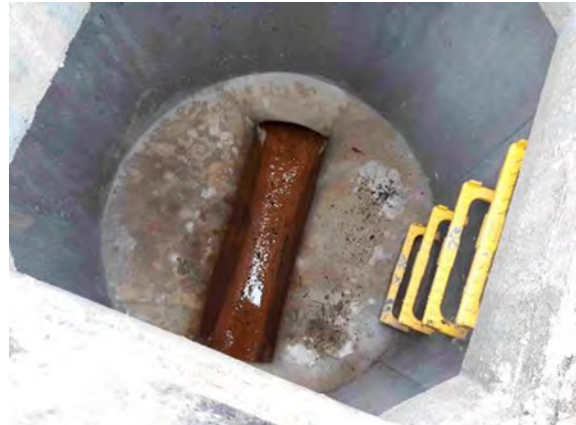
6.

4.8.16. From 2005-2009, samples could only be taken from the Lodge Stream due to the sampling point at the drainage tunnel being inaccessible. Dissolved iron and nickel in the stream remained below the relevant EQS and the pH above the EQS of 6 indicating the acid drainage from the Foundry Adit has not impacted the stream. Isolated exceedances of the discharge consent of 5 mg/l total iron have been reported in the Lodge Stream, although with only one exceedance between January 2007 and April 2008. A site visit on the 7<sup>th</sup> August 2009 confirmed the on-going absence of ochre deposition at the Armco Tunnel outlet to the Lodge Stream.

Slight ochreous flow in Foundry Adit drain

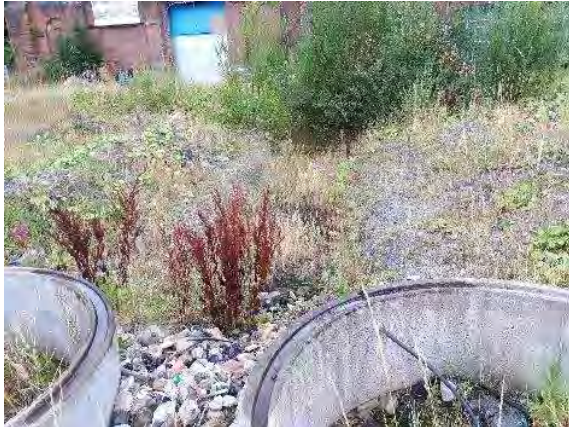
7.

Open ditch containing Foundry Adit drain in Car Park area

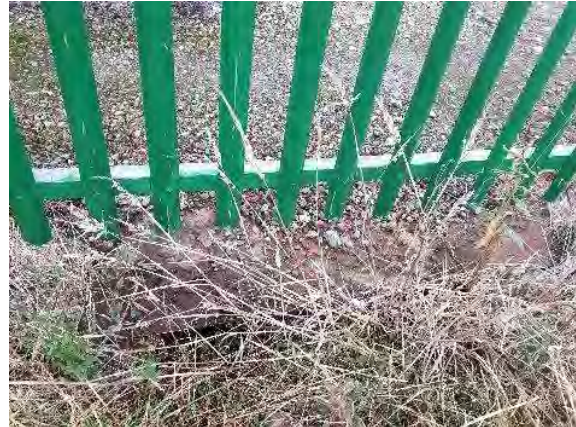
8.

Covered drain containing Foundry Adit drain at southern boundary to central heritage area

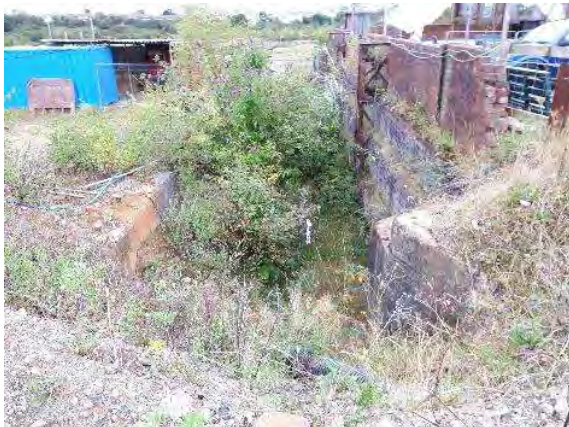
9.

Open ditch containing Foundry Adit drain in Central Heritage Area

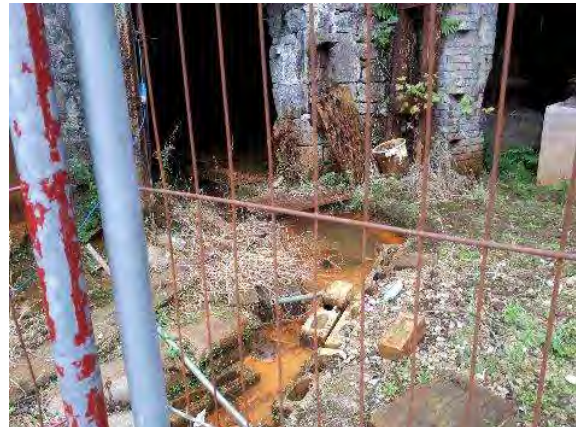
10.

4.8.14. The Foundry Adit was sampled on 22 occasions between 2003-2006. The adit was confirmed as carrying acid mine drainage (~pH3 with high dissolved iron and nickel content at levels in excess of the EQS), particularly at times of low flow, with no evidence of steelworks leachate. No determinands such as lead, cadmium, copper, zinc etc are present in the adit drainage in excess of the relevant EQSs and there are no indications that the site reclamation works had any appreciable impact on the Foundry Adit quality.

Foundry Adit discharge to Foundry Adit Drain

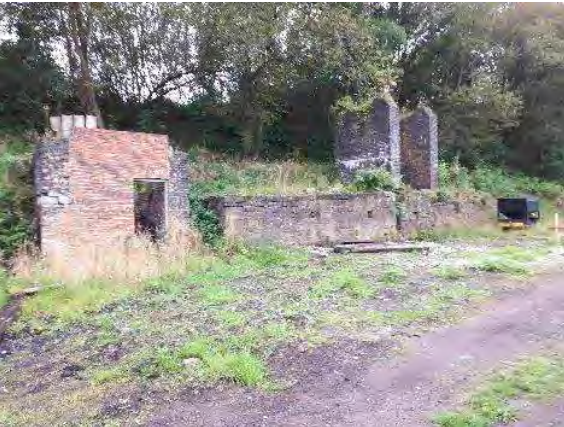
23.

Ruined buildings near boundary between upper Central Heritage Area and Blast Pit Area

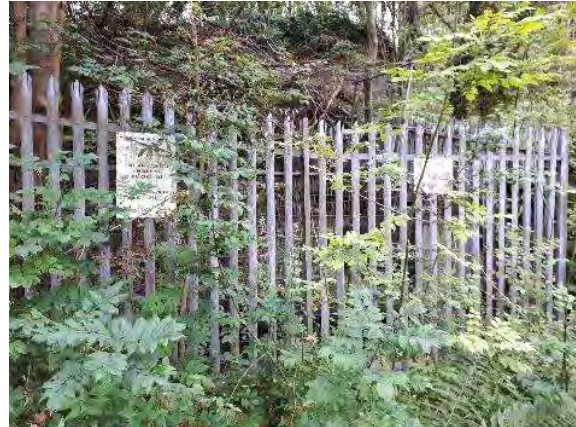
26.

Eastern Blast Pit shaft

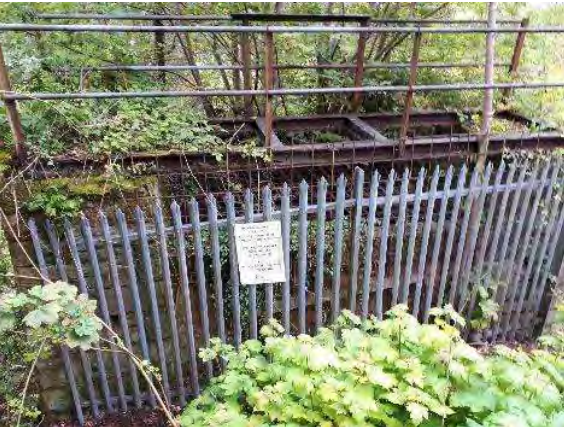
27.

Western Blast Pit shaft

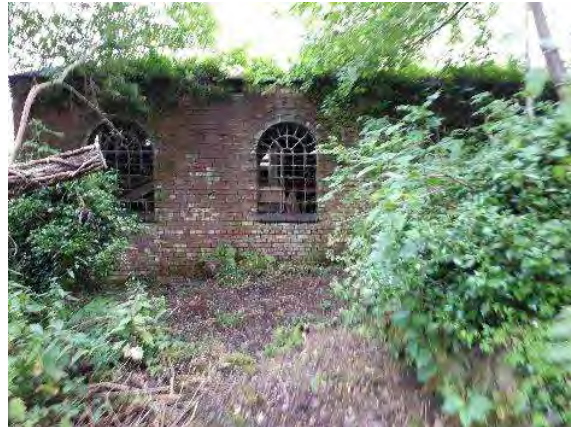
28.

Ruined Blast Pit colliery buildings

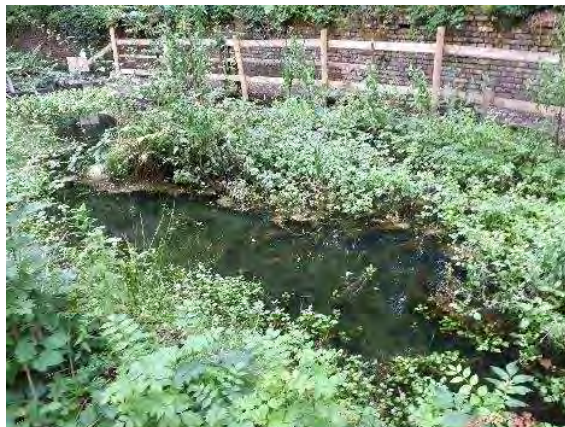
46.

4.8.3. A series of ponds are located within the Blast Pit area which provide a Great Crested Newt Habitat. These were fed by a drain located at the base of the Supply Well building but the more general surface water flows running down through the Heritage Area parallel with Blast Road are also observed to feed these features.

Newt pond at SE of lower Duck Pond area.
