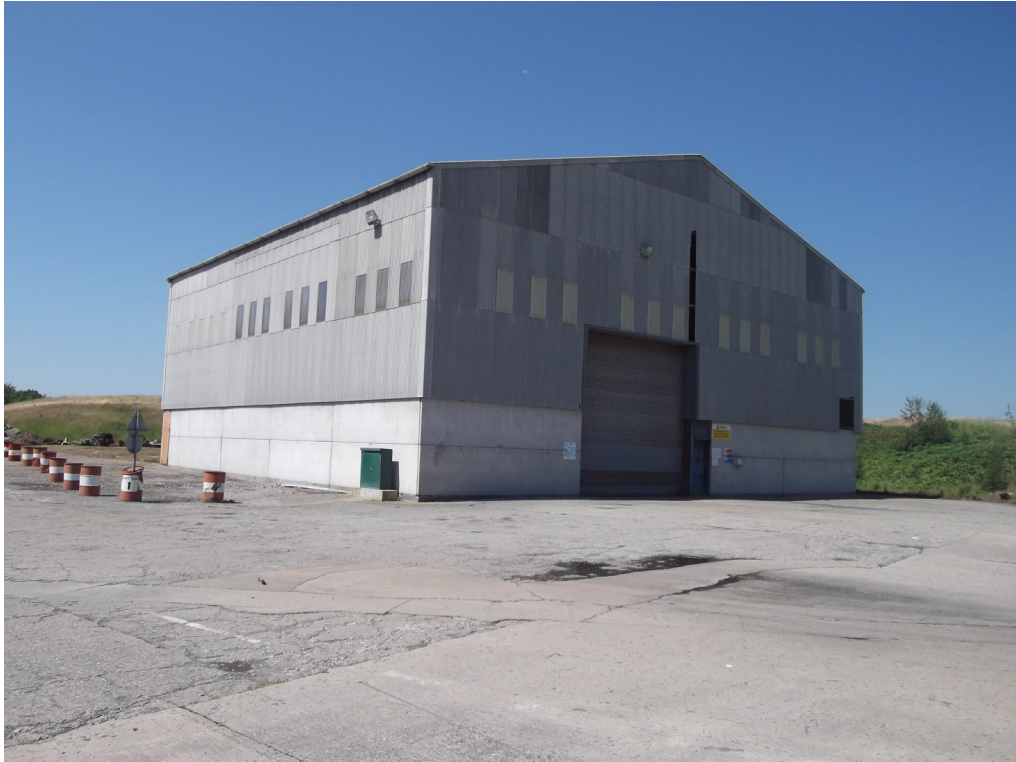
The North Eastern elevation of Unit 5 taken from the roundabout.

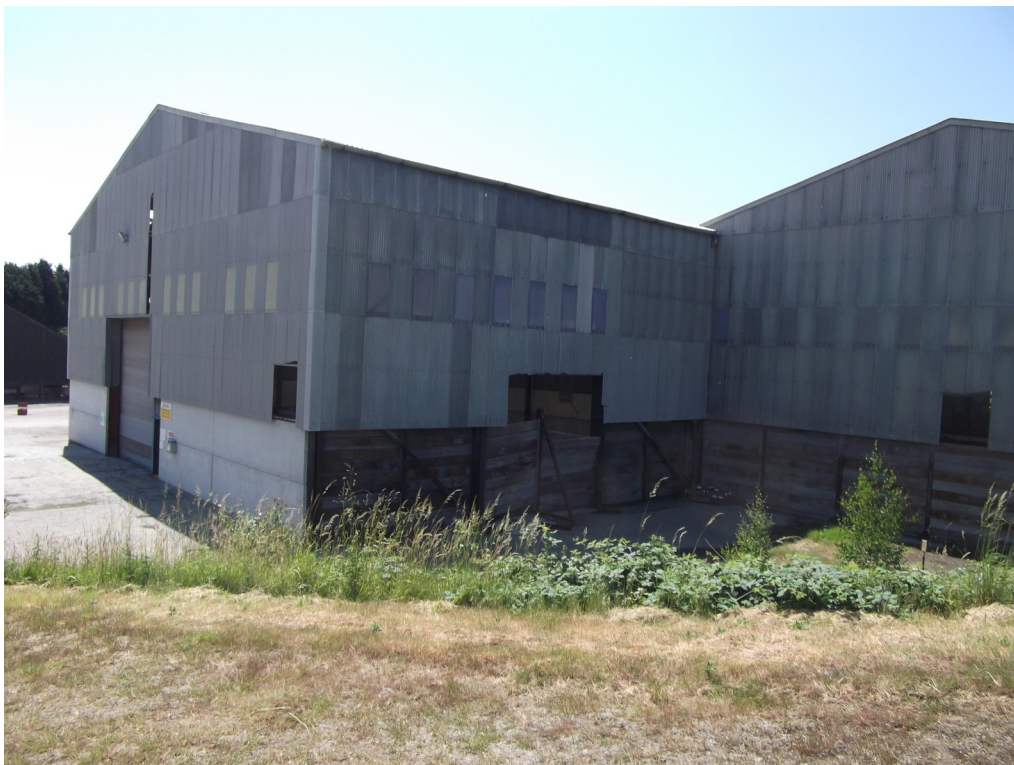
The Northern elevation of Unit 5 and the North Eastern elevation (the gable end) of the adjoining Unit 3 taken from atop The Hill.

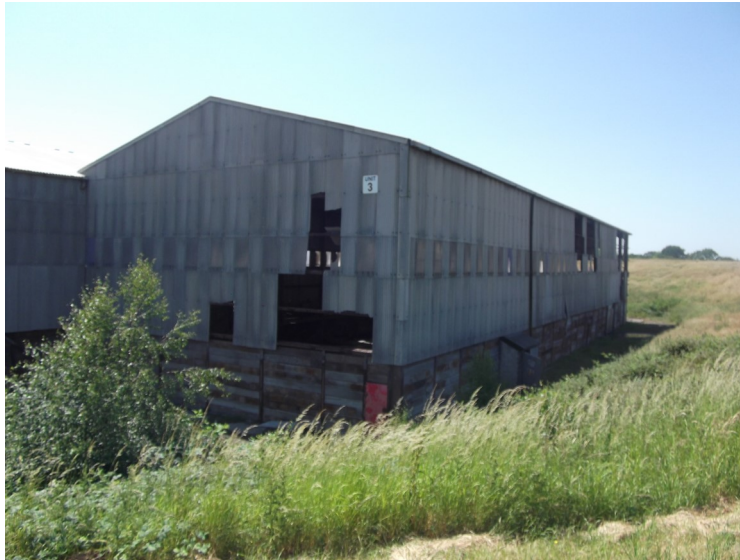
The North Eastern elevation of Unit 3 taken from The Hill.

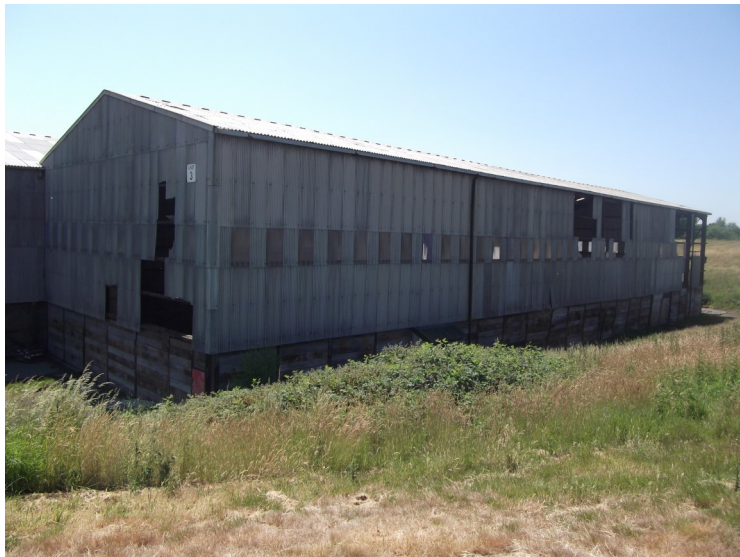
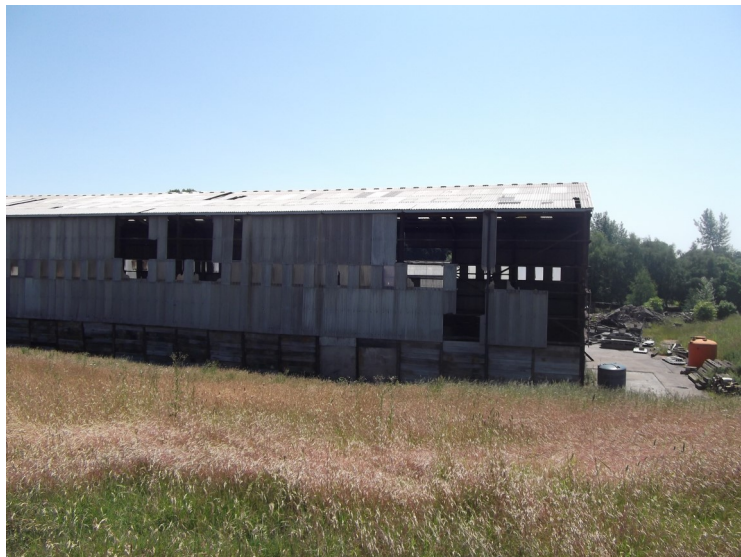
Above and below ... the Northern elevation of Unit 3 taken from on top of The Hill. Note the significant storm damage...

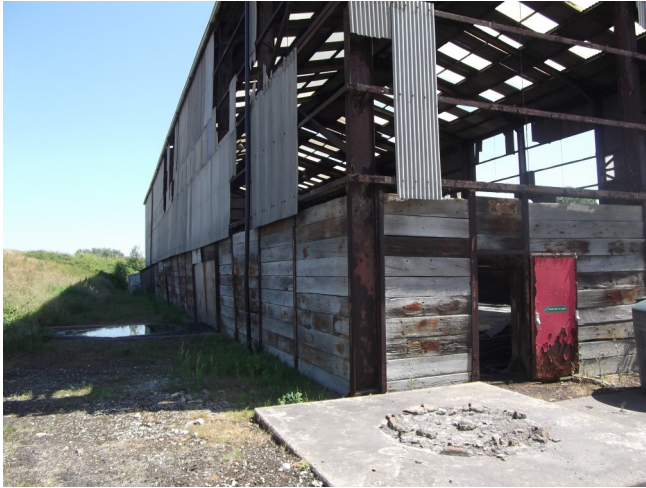
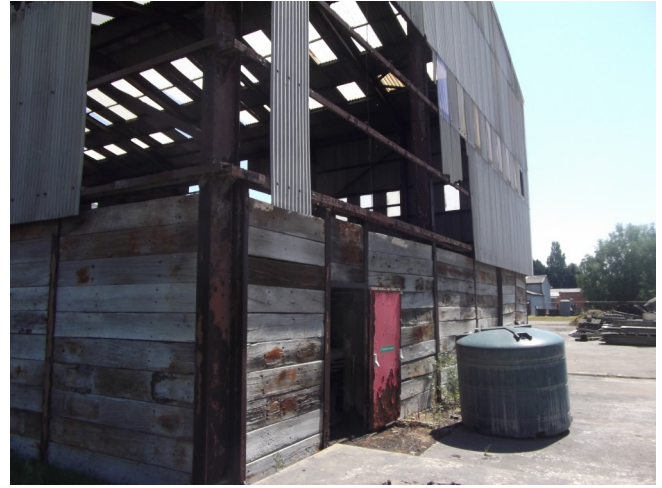
The storm ravaged South Western corner of Unit 3 and its gable end. Note the sleeper walls.

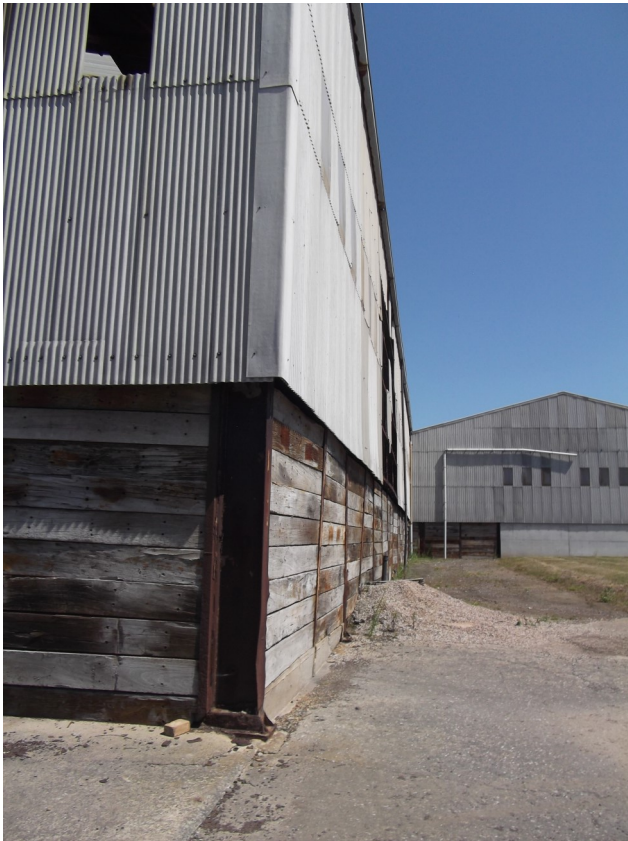
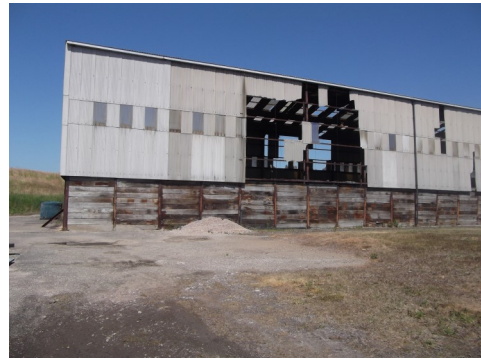
Above and below shows the storm damaged South facing elevation of Unit 3 leading to Unit 5.

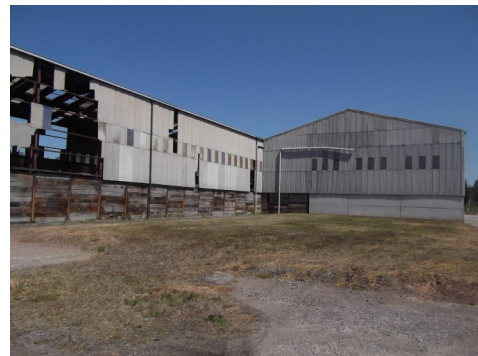
The above photograph shows the South Western corner of Unit 3 (the right hand side) and the South facing elevation of the same leading to the South Western elevation (gable end) of adjoining Unit 5.

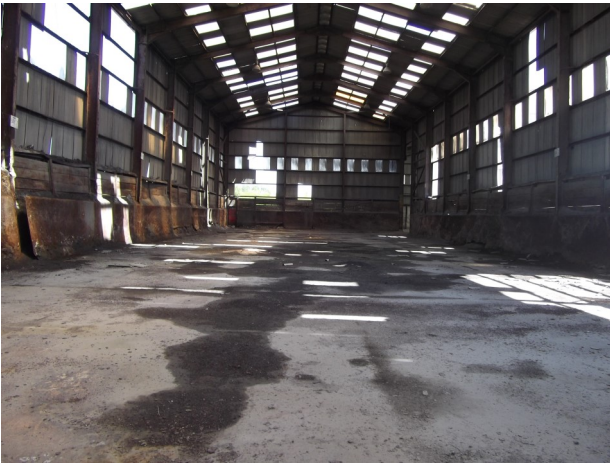
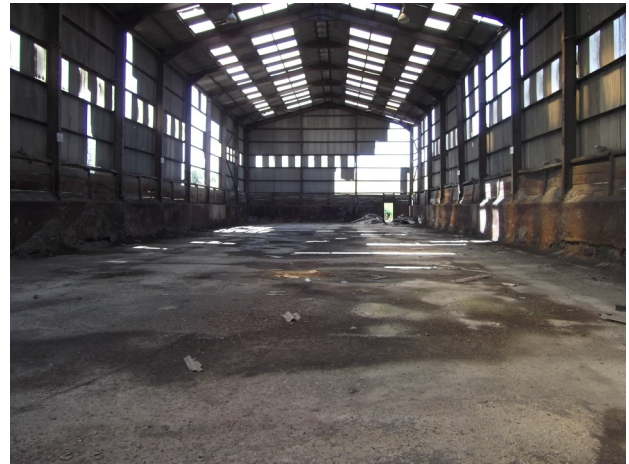
The above photographs show the inside of Unit 3 looking towards the North Eastern gable end (left) and the South Western gable end (right). Note the steel plates around the walls, fitted to 'protect' the sleeper walls.

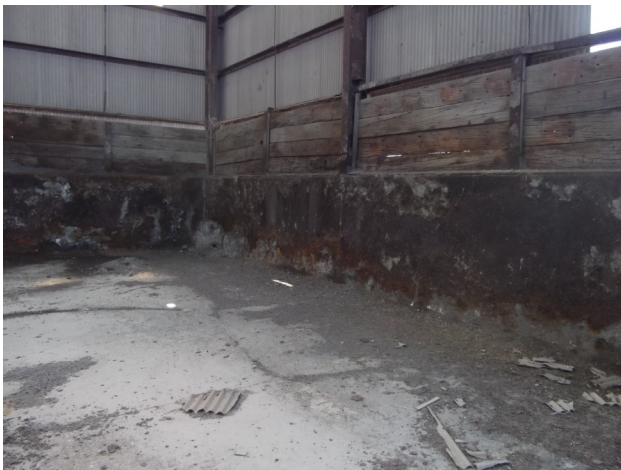
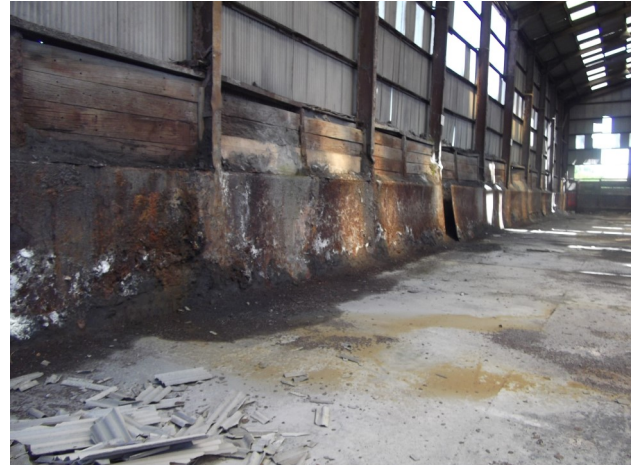
The above two photographs are from inside Unit 3 and show the steel plates and the sleeper walls behind.

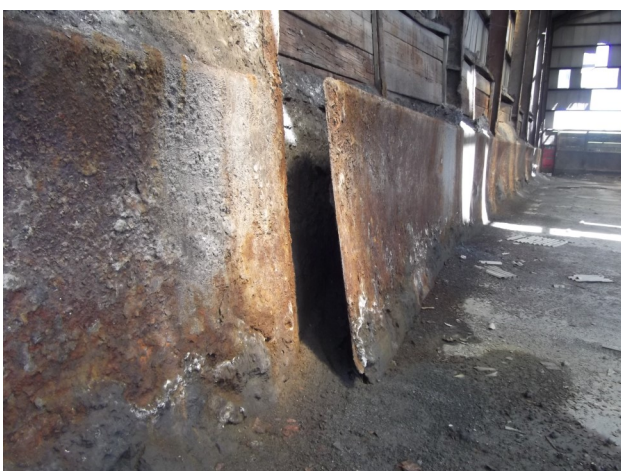
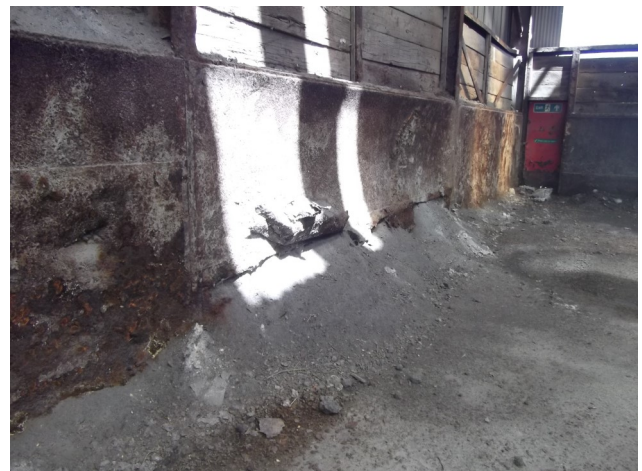
The above two photographs are close ups of the corroded steel plates that make up the bottom section of the walls throughout Unit 3. They show salt slag residue (the cause of all the steel corrosion) emanating from behind them. Please note that although we are asking McAuliffe to dispose of ALL the steelwork, we are going to dispose of both the salt slag residue and the old railway sleepers.

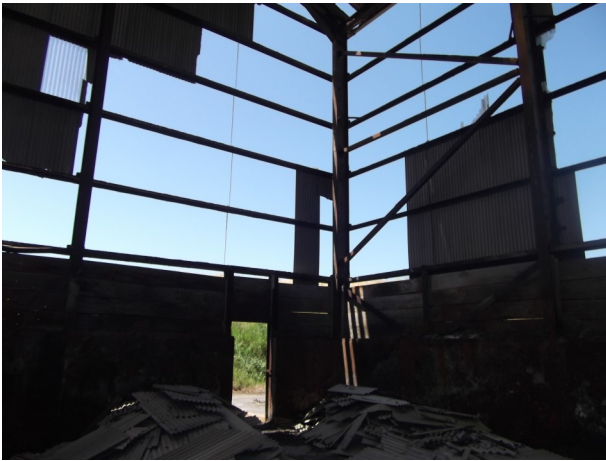
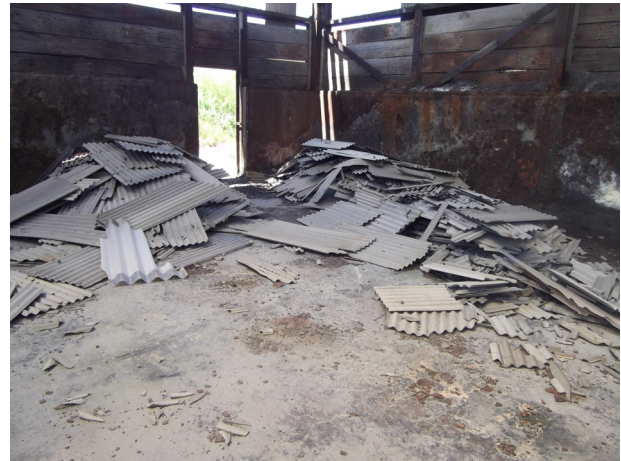
The South Western corner of Unit 3 (from inside) showing the storm damage suffered in December 2021 (Arwen) and February 2022 (Eunice) and the accumulation of broken fibre cement roof/cladding sheets piled up on the floor. The two storms made a good fist at starting the Demolition works for us!!

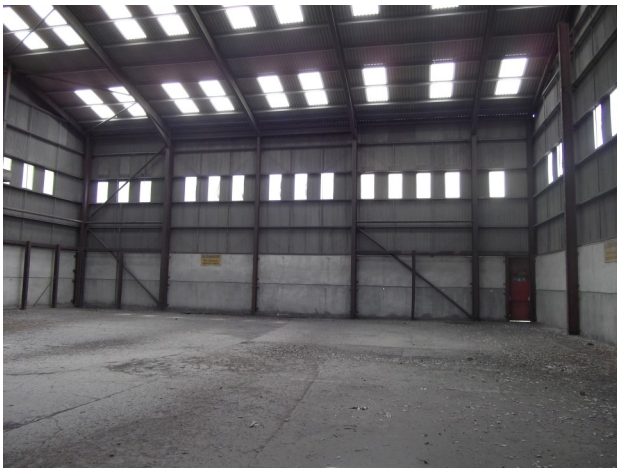
The above photo shows the South facing internal elevation of Unit 5. Please note the concrete panels.

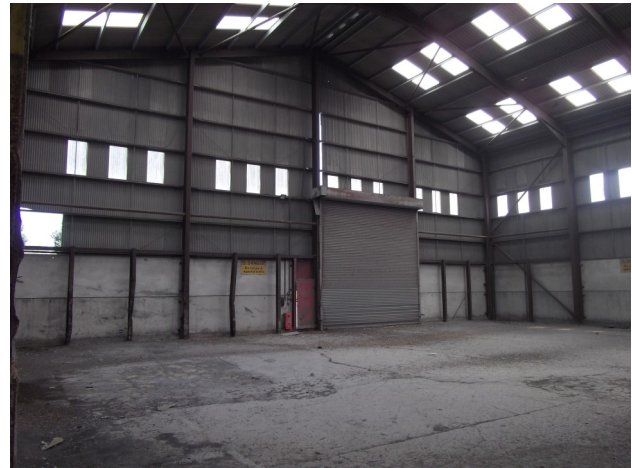
The North Eastern (gable end) internal elevation of Unit 5 showing the roller shutter door &c.

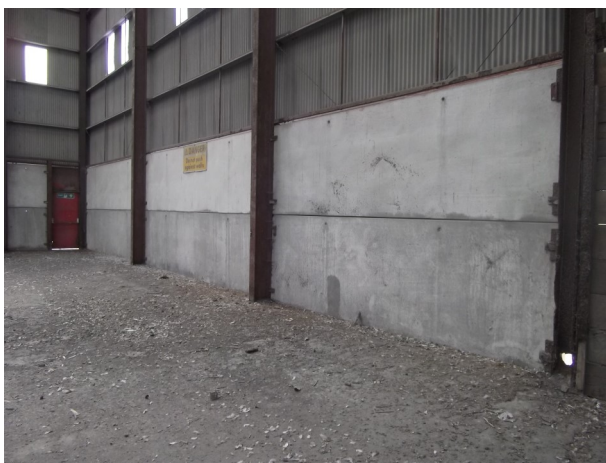
A close up of the South Western (gable end) elevation of Unit 5 showing the abovesaid concrete panels that make up the lower section of the walls. Please note the concrete panels are to be set aside for us to dispose of.

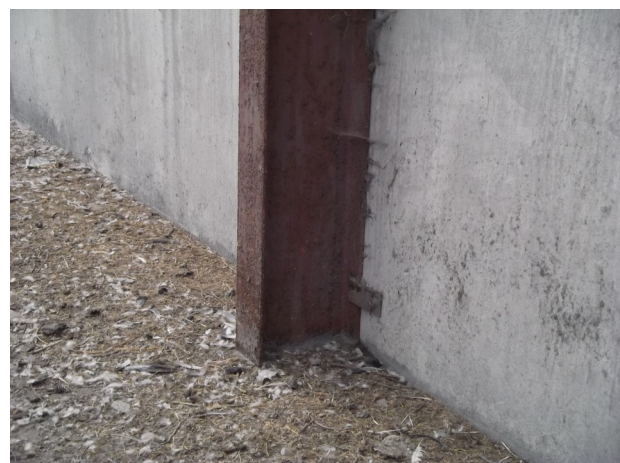
A close up of the same section of wall in Unit 5 which shows the evidence of pigeon infestation...
