# Structural Engineers Report For:

Plas Nantyr, Kennels  
Nantyr. LL20 7DD

## STRUCTURAL SURVEY

**REF: N2815-02**

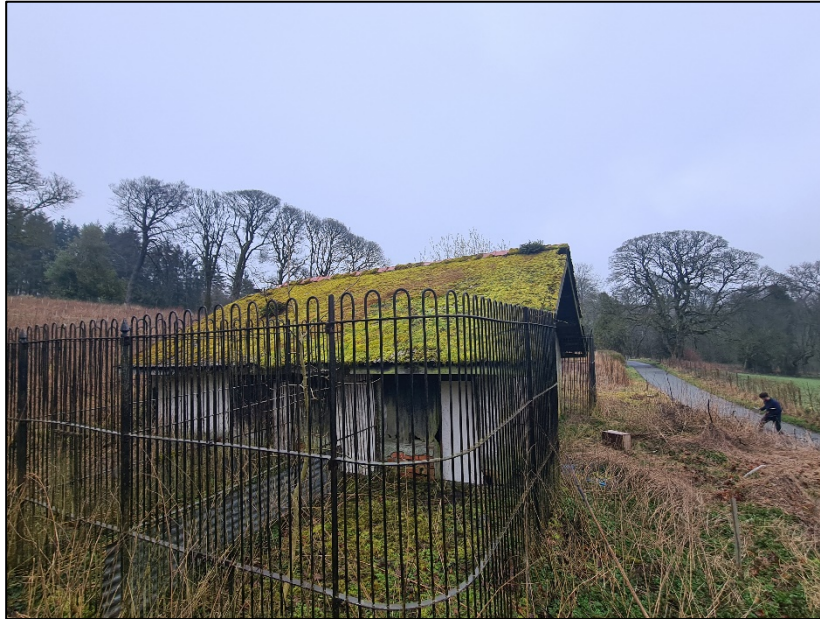
Photograph 1

This kennels are a single storey building with a duo pitched roof located near Plas Nantyr Manor House. The building is a solid masonry building with openings in each front and back elevations for the dogs to be able to access their outdoors pens (**photograph 1**).

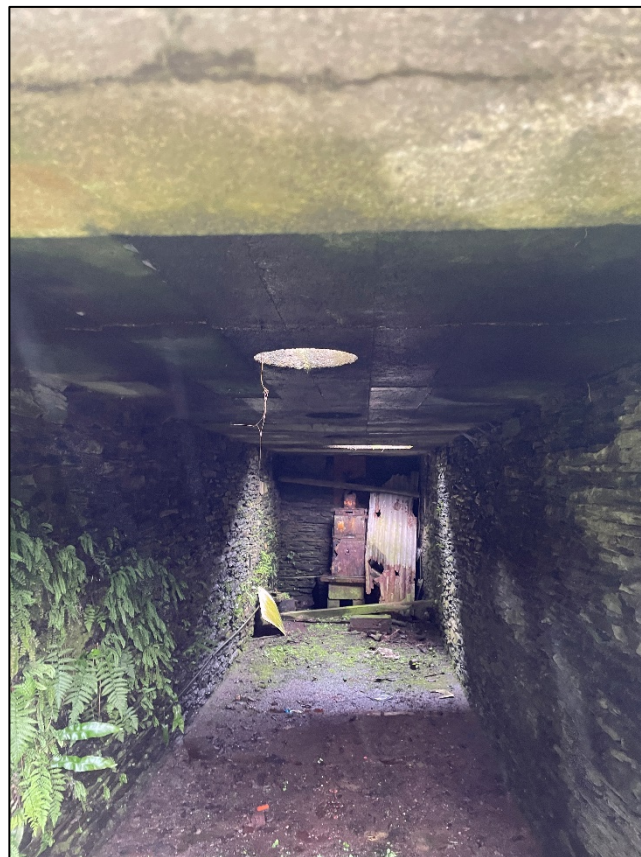
Photograph 2

There is also an underground bunker adjacent to the kennels (**photograph 2**).

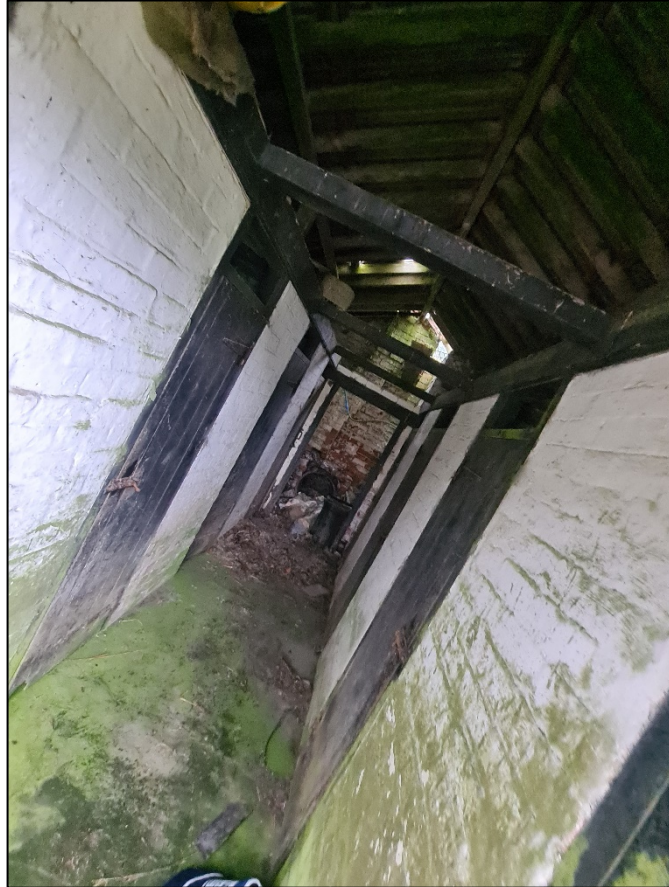
Photograph 3

Internally there are a series of brick built dividing walls which supports the cut roof internally (**photograph 3**).

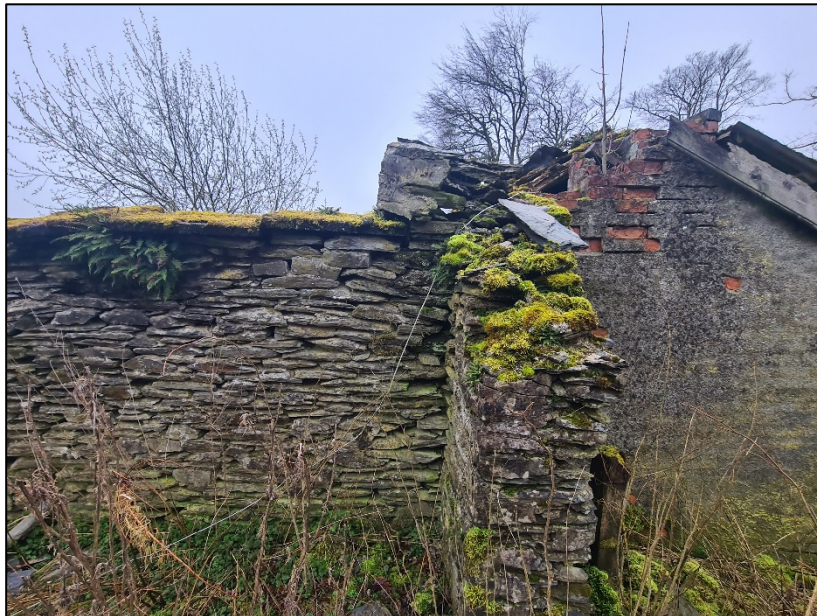
Photograph 4

To the rear of the kennels is an adjoining solid random rubble masonry wall, which is part retaining, although mostly collapsed (**photograph 4**).

- We suggest that the adjoining masonry wall is taken down and rebuilt, if it's required. However, it does appear that there is no current use to this wall.
