Unit 2 concrete pour

| Site name: Portal Cons Pacific Park Bridge Rd,<br>North Wrexham | | Units/ plots checked: Full footprint (excluding office)<br>Unit 1 | |
| Date: 10/06/2022 | | | |

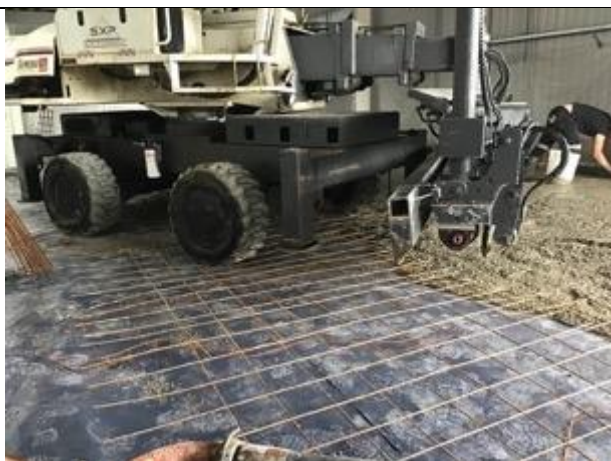
Damages caused by driving on the membrane

Laser screed on top of mesh / membrane

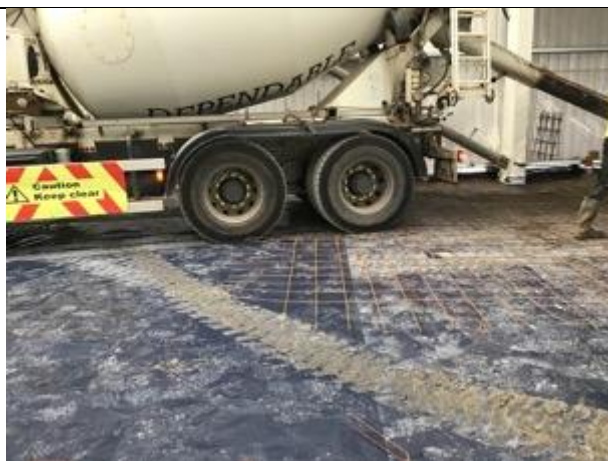
Lorry reversing on the membrane

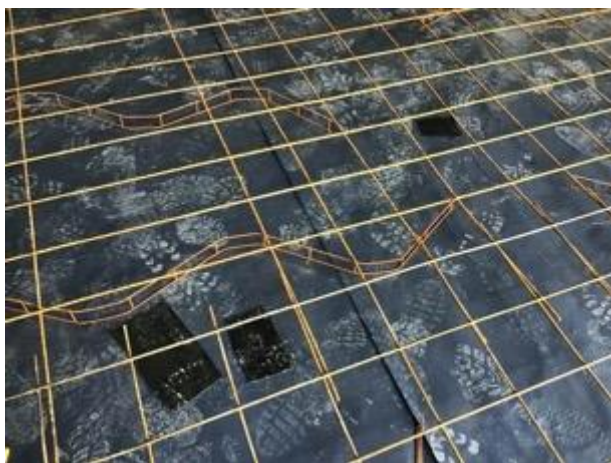
Patch repairs made following damage by steel mesh

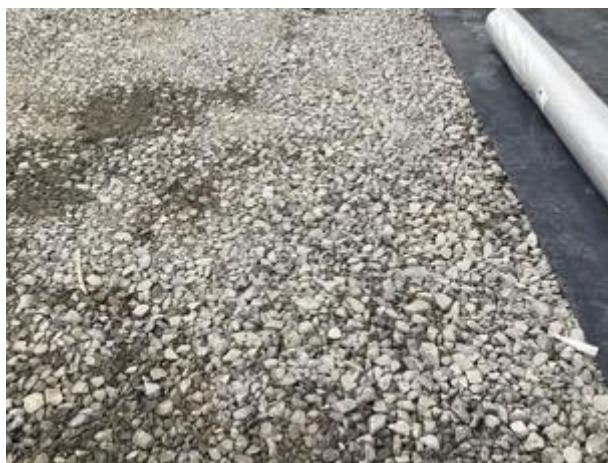
Sub grade prior to membrane installation

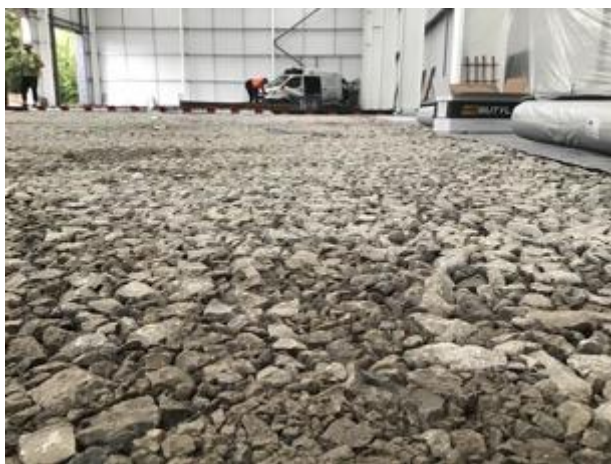
Sub grade prior to membrane installation

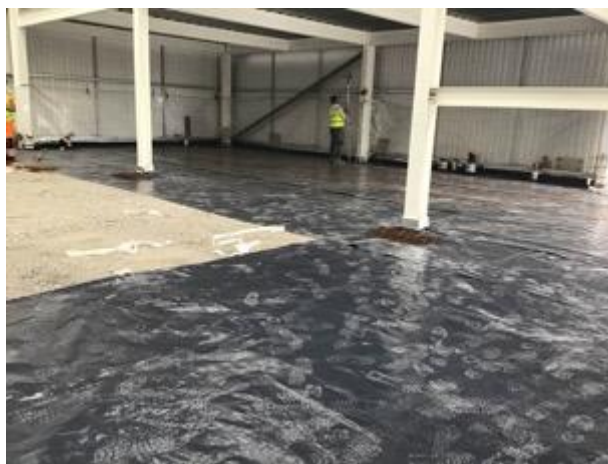
Unit 2 membrane installation

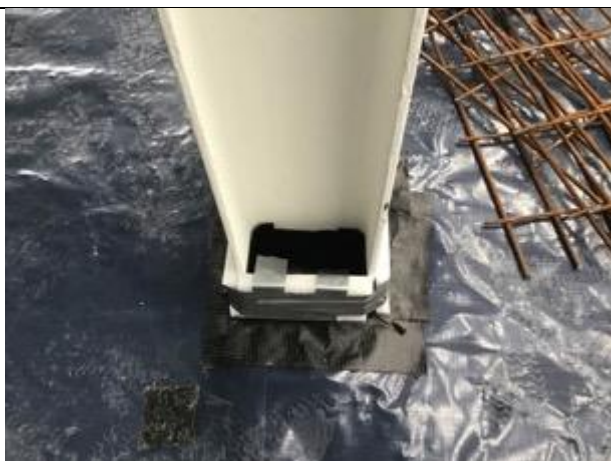
Sealed stanchion detail

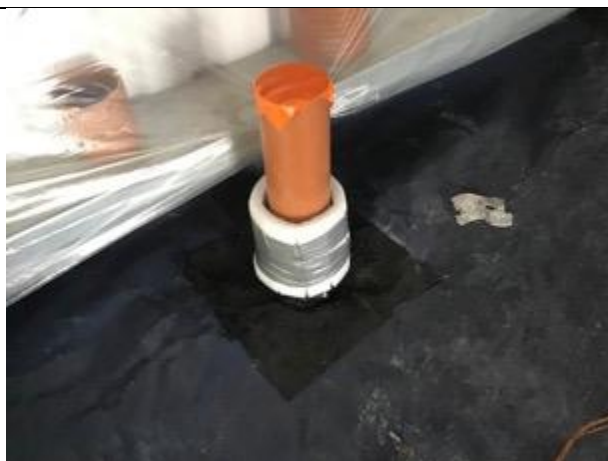
Sealed pipe penetration

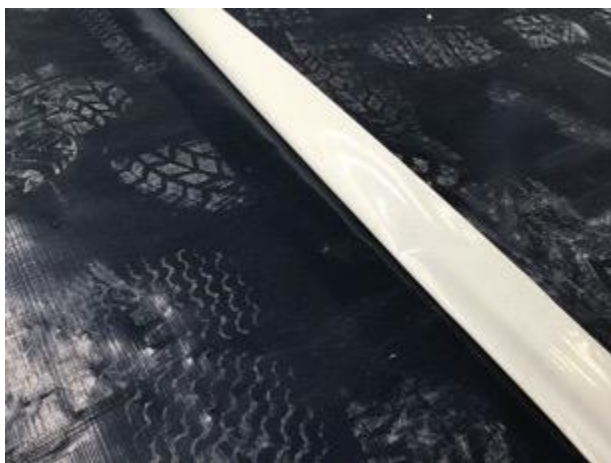
Sealed tape joint

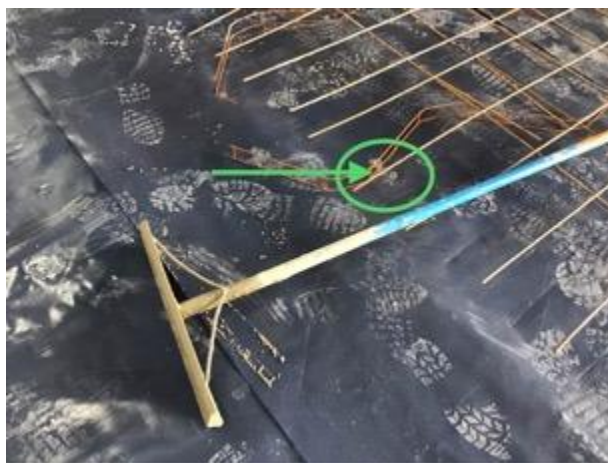
Tool thrown and damaged membrane

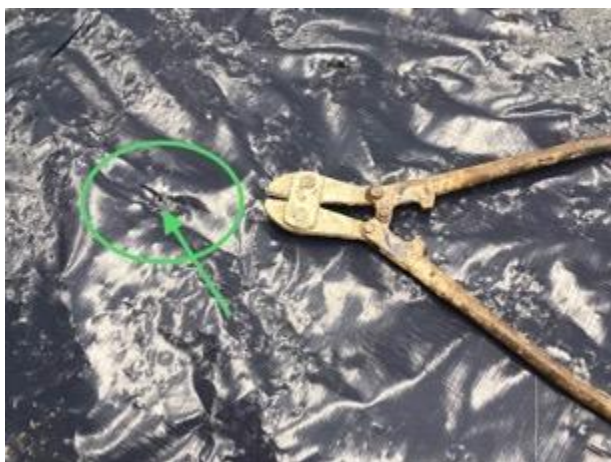
Tool dropped and damaged membrane

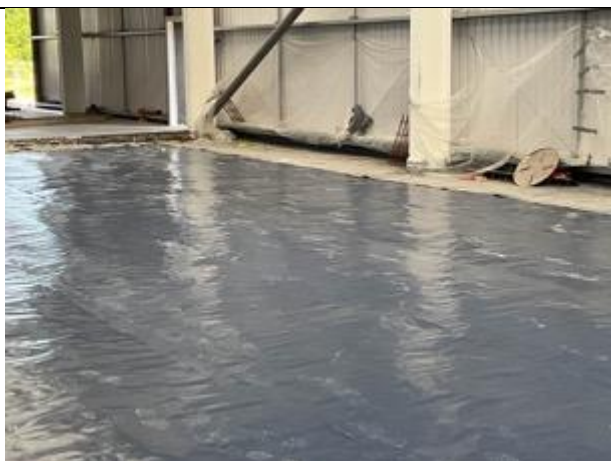
General overview

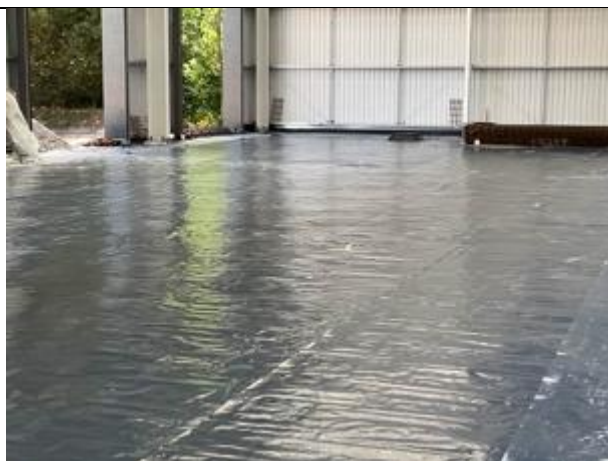
General overview

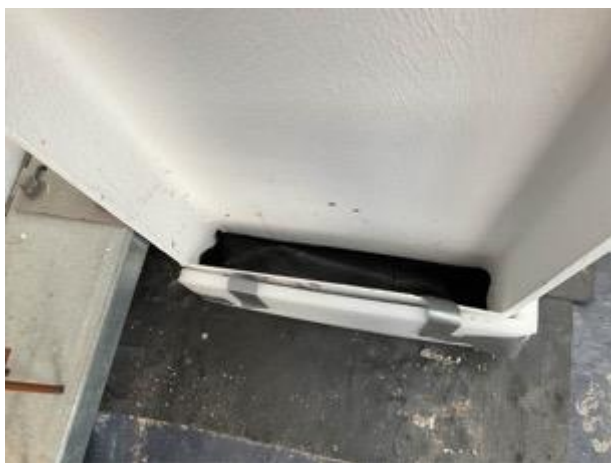
Stanchion seal

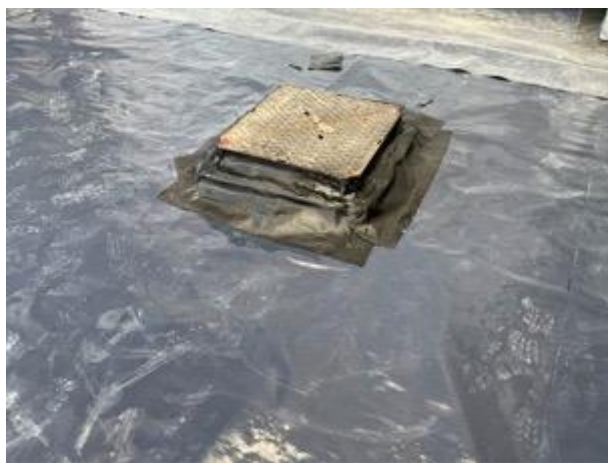
Manhole seal

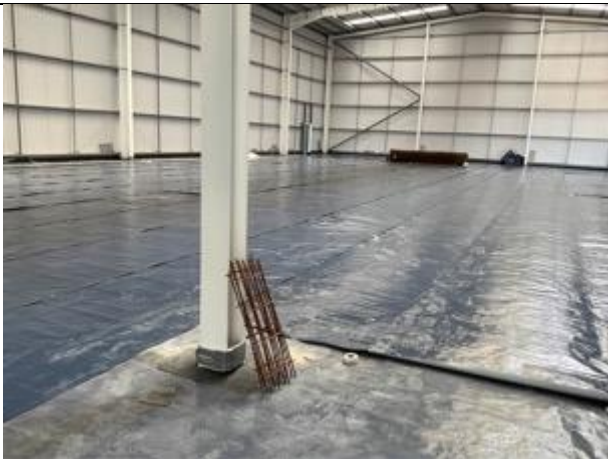
General overview

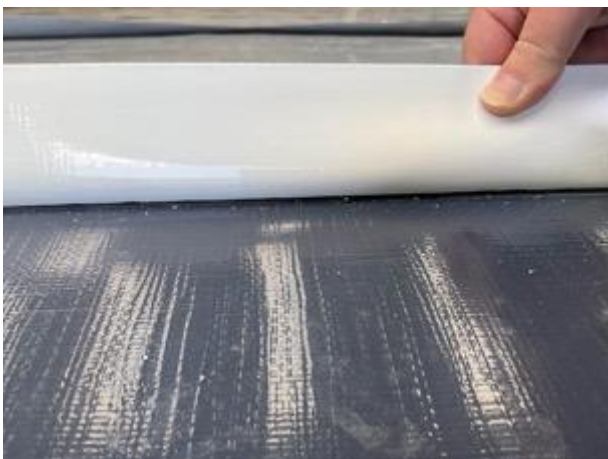
Double sided tape to joint

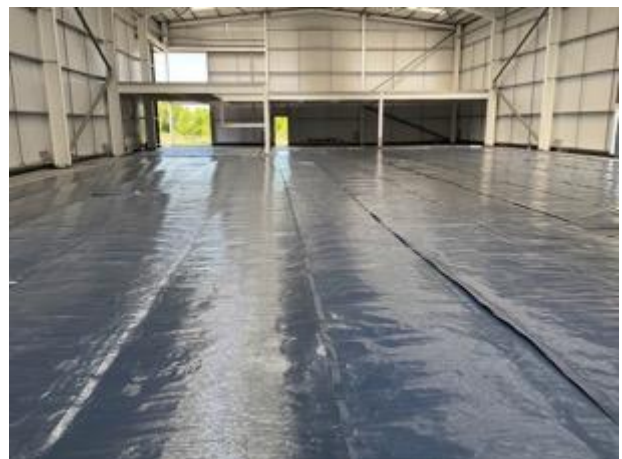
General overview opposite direction

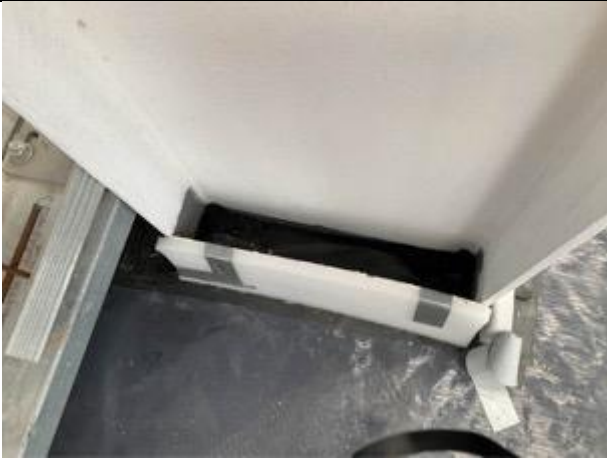
Sealed stanchion
