**Willington Lodge, Horseman's Green, Whitchurch SY13 3BZ – Structural Condition Report**

## **STRUCTURAL CONDITION REPORT FOR THE**

### **PROPOSED BARN CONVERSION PROJECT**

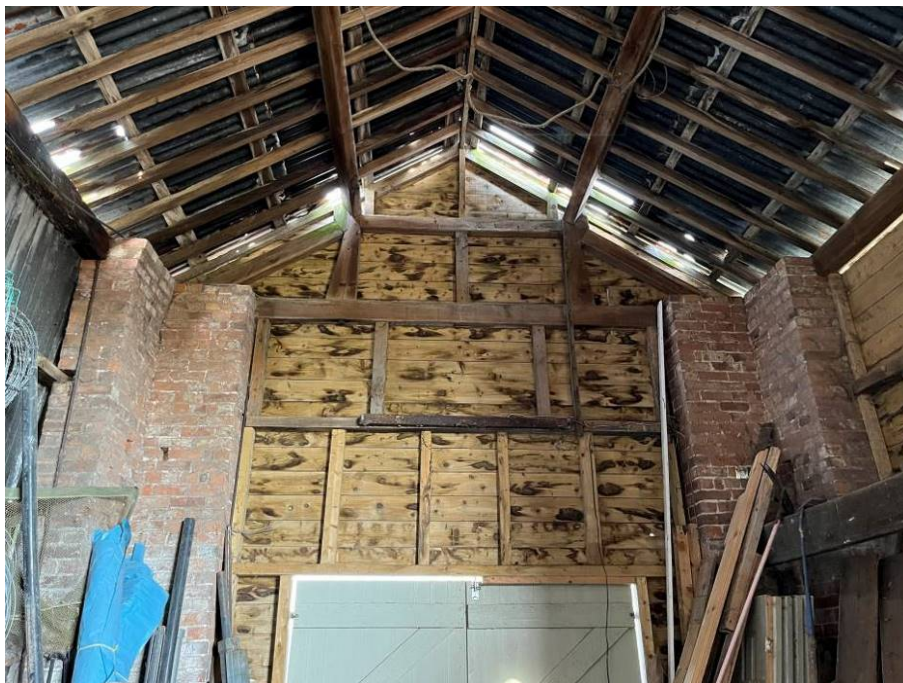
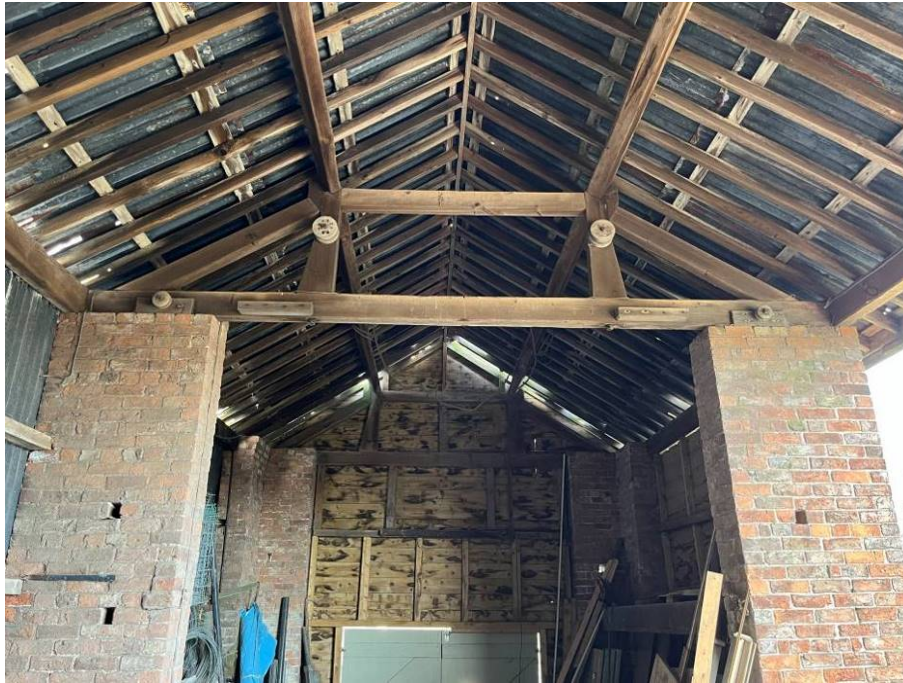
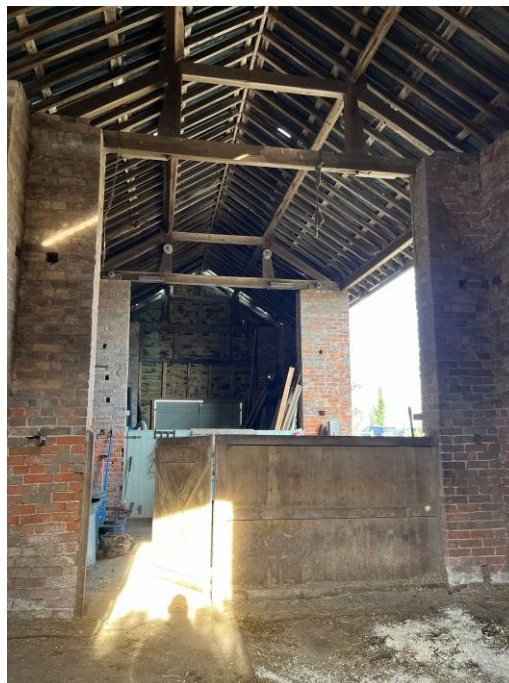
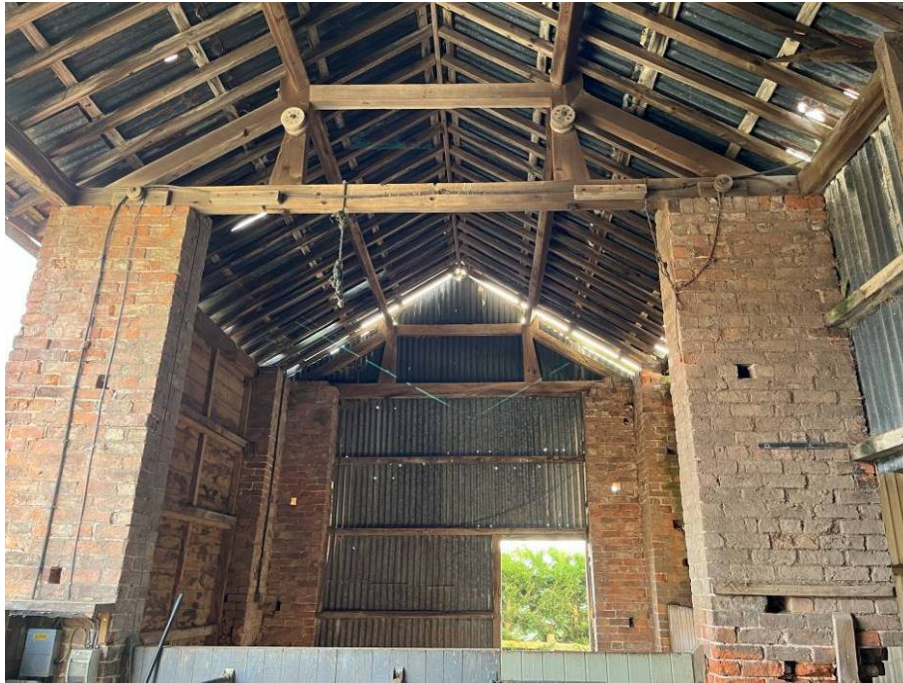
The existing duo pitch roof construction of the main barn comprises of metal corrugated sheets spanning between timber purlins which are supported by a series of timber queen post trusses. The roof trusses are supported on the existing external solid masonry walls. Refer to the attached Photographs P.06 to P.09 in Appendix A.

The timber queen post trusses appear to be in relatively good condition however this was only based on a visual inspection from ground floor level. Given the age of the building and their environmental exposure they are in a reasonable state of repair.

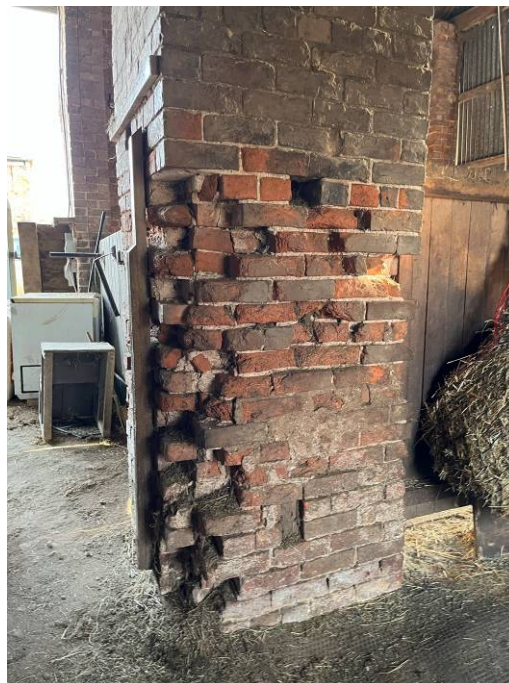
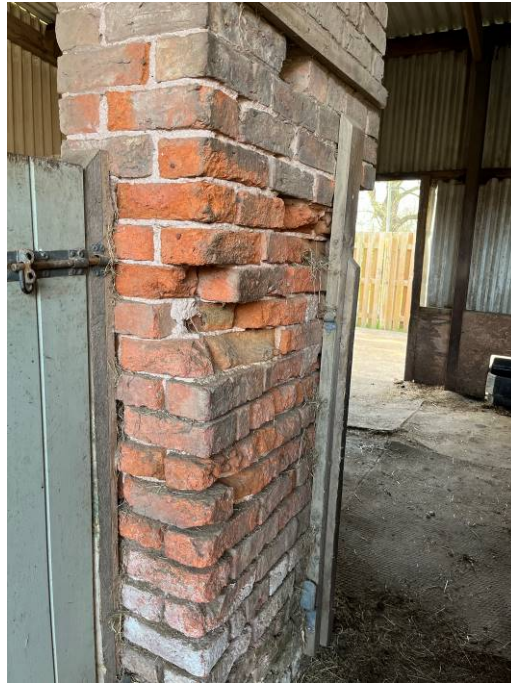
The external exposed face of the existing brickwork can be seen to have weathered which is not unusual given the exposed rural location, however it is generally in reasonable condition. This is not uncommon for a building of this age. Refer to Photographs P.10 to P.12 in Appendix A.

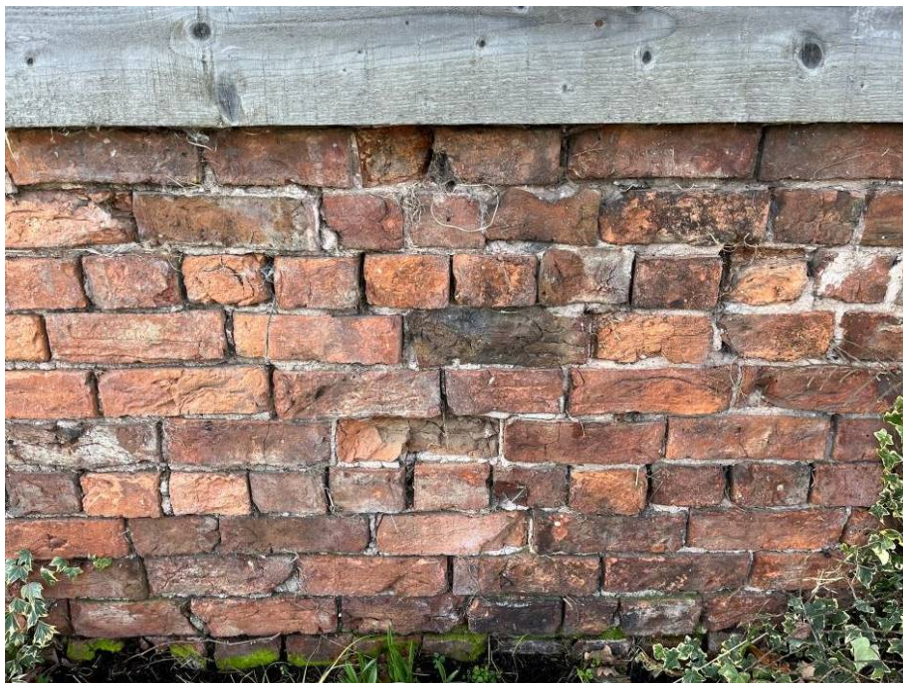
The mortar bed joints to the external walls can be seen to have weathered which is not unusual given the exposed rural location, however they are generally in reasonable condition. This is not uncommon for a building of this age. Refer to Photograph P.12 in Appendix A.

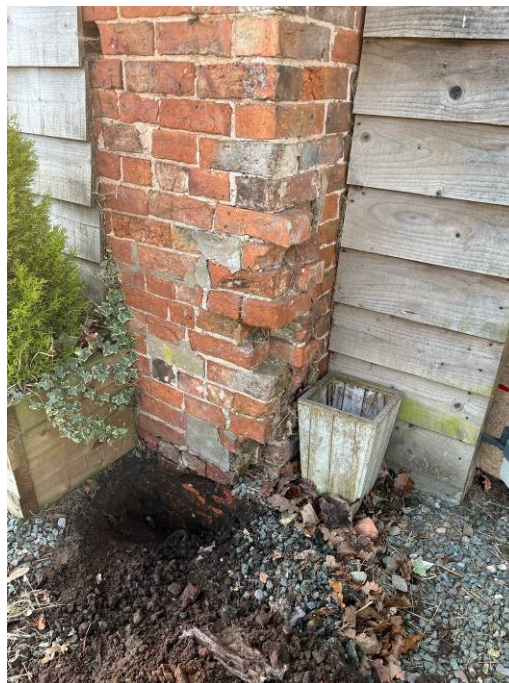
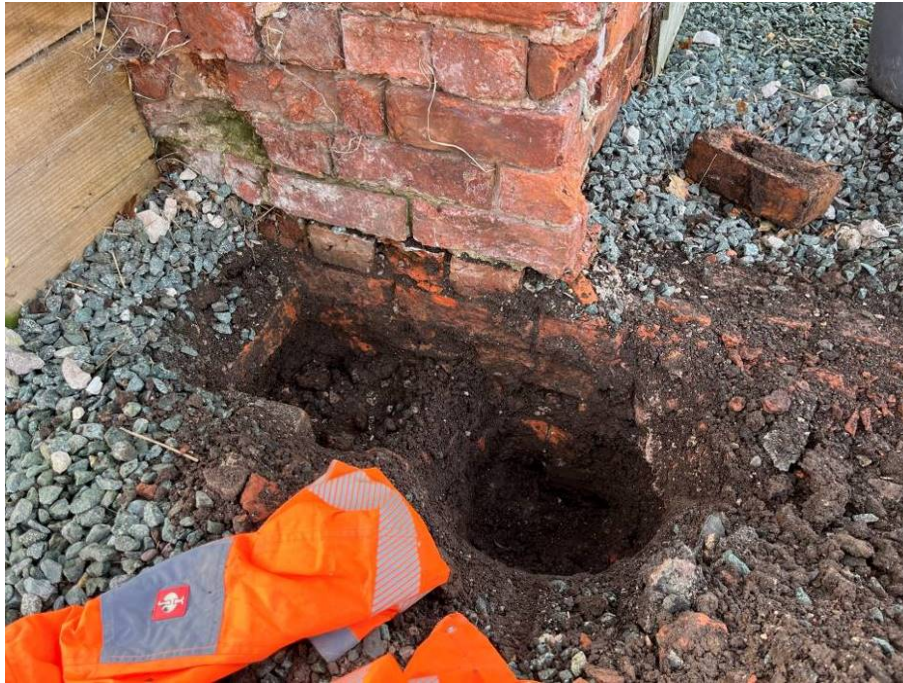
Two trial pits were undertaken in order determine the depth and form of the existing barn wall foundations. The first trial pit was dug on the east elevation on the left hand side of the main entrance, and the second trial pit was dug on the south east corner of the building. Both trial pits confirmed that the base of the walls were approximately 400mm below existing ground level and that no stepped footings were present in either location. Refer to Photographs P.14 & P.17 in Appendix A.

The two trial pits dug confirmed that the existing walls do not have any formal footings and given that fact that additional vertical weight would be added to the walls once converted it is our recommendation that the walls should be underpinned.

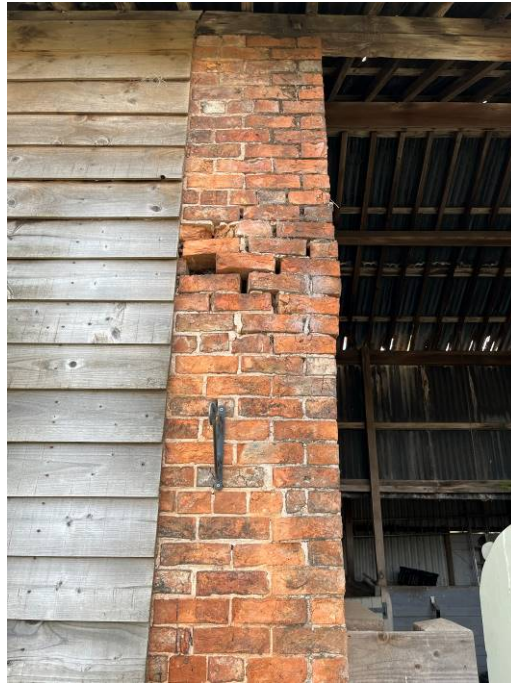
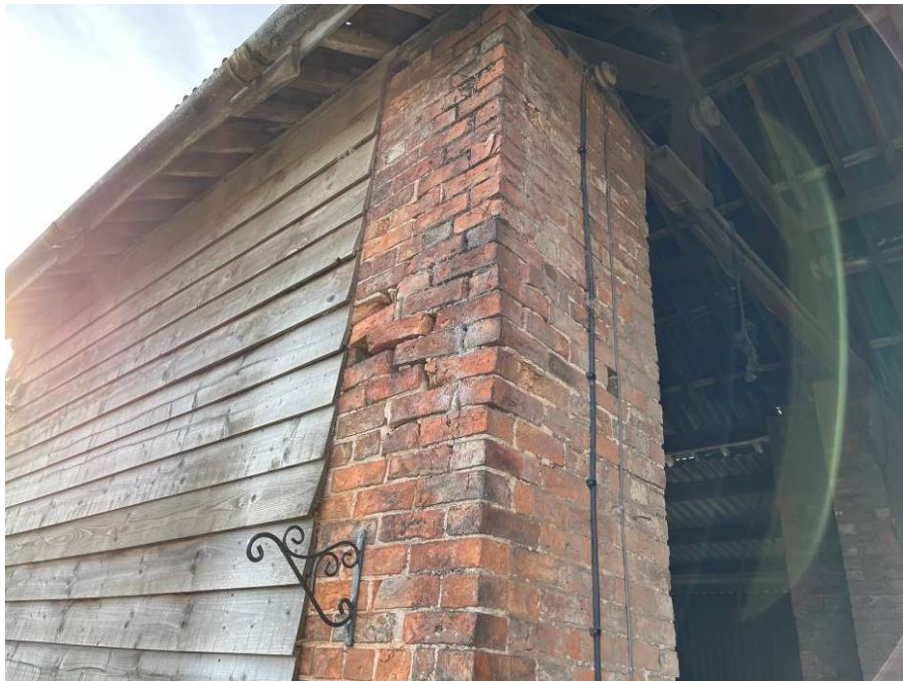
On the east elevation of the barn there is an isolated area of the external wall that appears to have been struck which has caused movement of the brickwork. Refer to Photographs P.15 & P.16 in Appendix A.
