Building 2 Demolition Extents

Bryn Farm, Hanmer

| DRAWN | WL | DRG No. | 23012 SK03 | REV | |

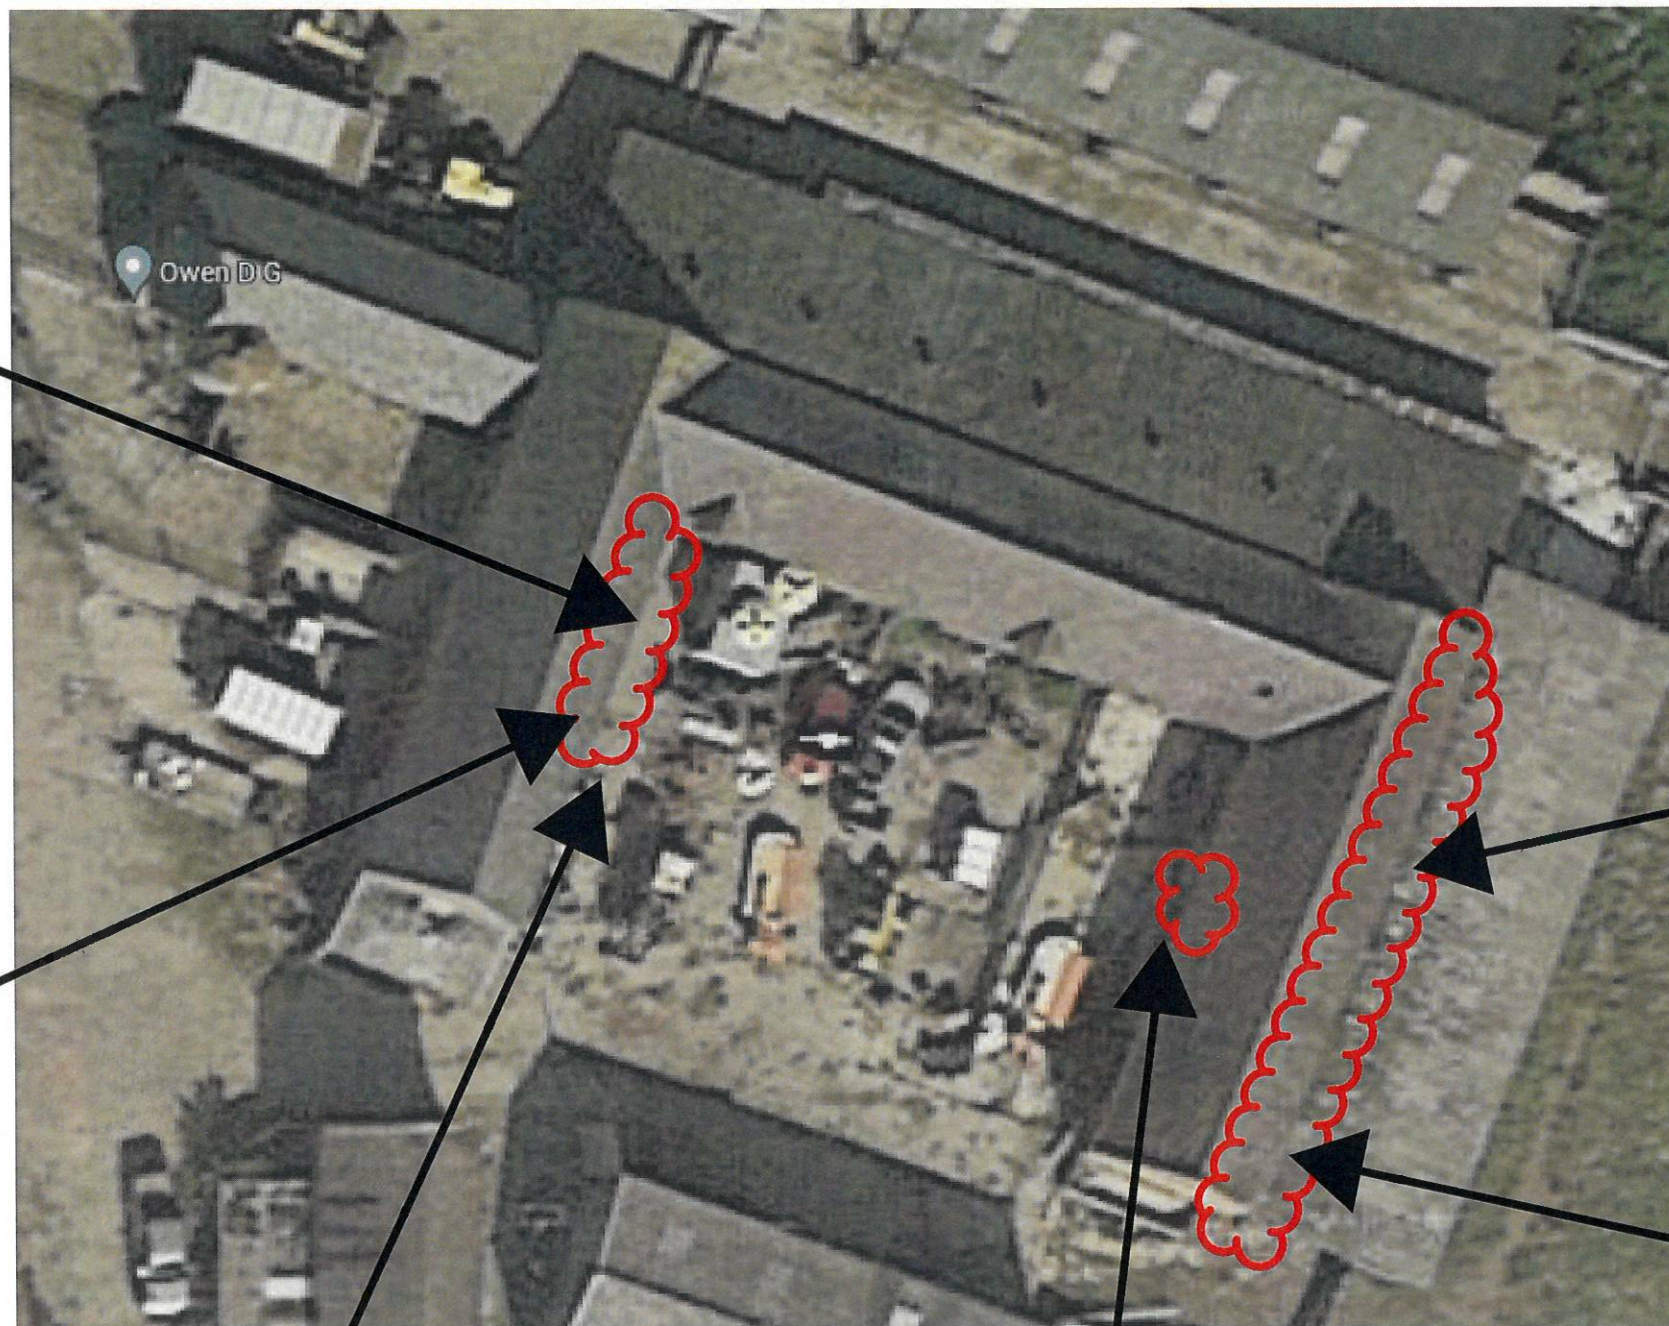
THIS WALL IS LEANING SIGNIFICANTLY AND THE CONCERN IS THAT THE WALL WILL BE UNSTABLE DURING THE REPLACEMENT OF THE ROOF AND ALLOWANCE SHOULD BE MADE FOR ITS DEMOLITION AND REBUILDING

THIS WALL IS LEANING SIGNIFICANTLY AND THE CONCERN IS THAT THE NEWER BARN STRUCTURE IS GIVING IT SUPPORT. WHEN THIS IS REMOVED, THE WALL MAY BE UNSTABLE SO ALLOW FOR DEMOLITION AND REBUILDING

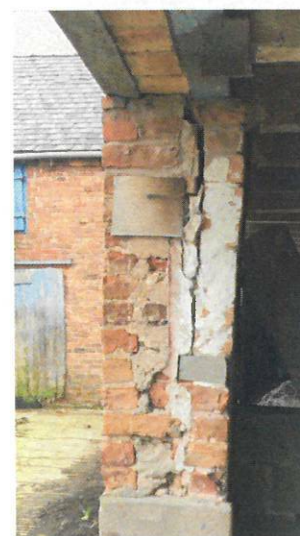
PIER HAS SEPERATED AND NEEDS TO BE REBUILT LOCALLY
