## **Window Schedule**

Ty Llwyd  
Glyn Ceiriog  
LL20 7EH

Ref: 2018

Date of Inspection: August 16, 2023

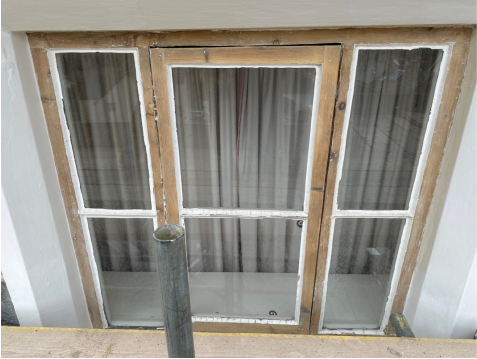
| Ref | Photo | Comments |
|---|---|---|
| 1 | | No frame repairs<br>Glazing heritage double glazing 12mm<br>Chamfered timber glazing beads to hold in new units.<br>Decoration |

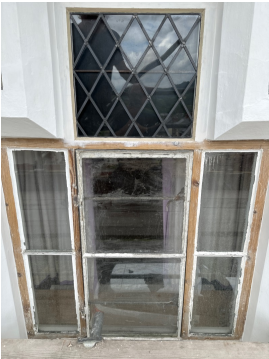
| Ref | Photo | Comments |
|---|---|---|
| 2 | | No frame repairs metal frame<br>Remaining single glazed<br>Re-putty<br>Decoration |

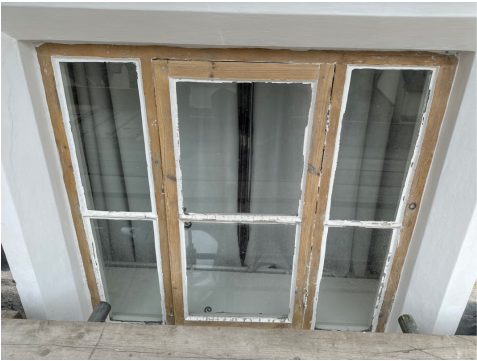
| Ref | Photo | Comments |
|---|---|---|
| 3 | | No frame repairs<br>Re-glazed double glazing 12mm heritage<br>Timber chamfered bead external<br>Decoration |

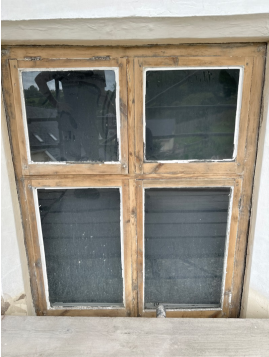
| Ref | Photo | Comments |
|---|---|---|
| 4 | | No frame repairs<br>Heritage double glazing<br>Timber glazing bead<br>Decoration |

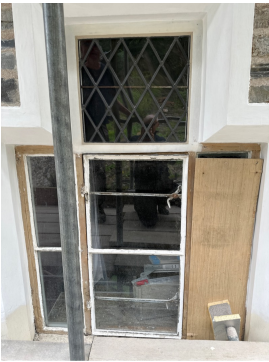
| Ref | Photo | Comments |
|---|---|---|
| 5 | A photograph of a window with a white frame and a small transom above it. The window is set in a white wall. A wooden board is leaning against the right side of the window. | No frame repairs<br>Re-glazed double glazing 12mm heritage<br>Timber chamfered bead external<br>Decoration<br>Drip rail required |

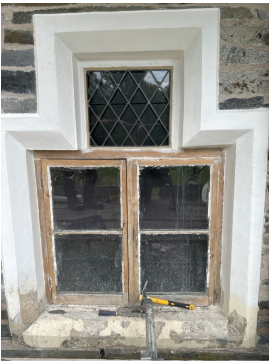
| Ref | Photo | Comments |
|---|---|---|
| 6 | A photograph of a window with a white frame and a small transom above it. The window is set in a white wall. A yellow tool is visible on the sill. | No frame repairs<br>Heritage double glazing<br>Timber glazing bead exteriors<br>Decoration |

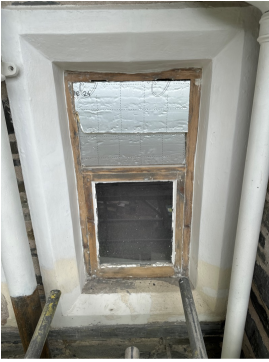
| Ref | Photo | Comments |
|---|---|---|
| 7 | A photograph of a window with a white frame and a small transom above it. The window is set in a white wall. A wooden board is leaning against the left side of the window. | No frame repair<br>Heritage double glazing<br>Timber ext beads chamfered<br>Decoration |

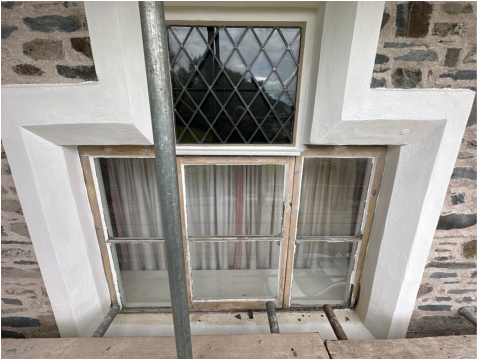
| Ref | Photo | Comments |
|---|---|---|
| 8 | A photograph of a window with a white frame and a small transom above it. The window is set in a white wall. A wooden board is leaning against the left side of the window. | New stub cill<br>Repair left right lower part of frame see next item |

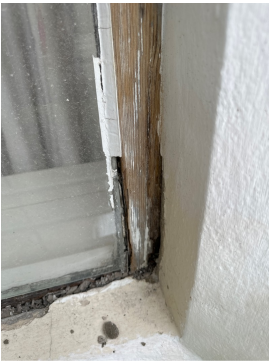
| Ref | Photo | Comments |
|---|---|---|
| 9 | | Frame requires repair<br>Splice new piece of Redwood |

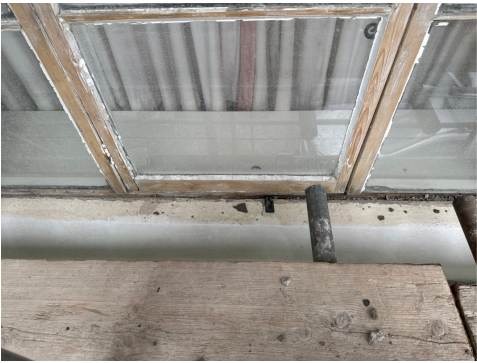
| Ref | Photo | Comments |
|---|---|---|
| 10 | | Stub cill repair<br>New redwood timber to be planted |

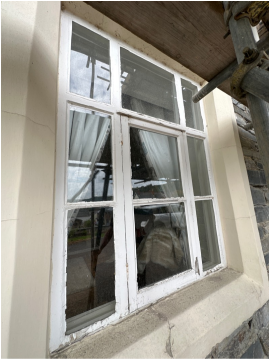
| Ref | Photo | Comments |
|---|---|---|
| 11 | | No frame repairs<br>Heritage glazing<br>Timber chamfered glazing bead<br>Decoration |

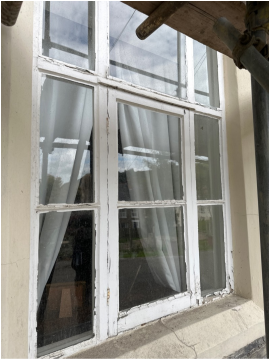
| Ref | Photo | Comments |
|---|---|---|
| 12 | | No frame repairs<br>Heritage glazing<br>Timber chamfered glazing bead<br>Decoration |

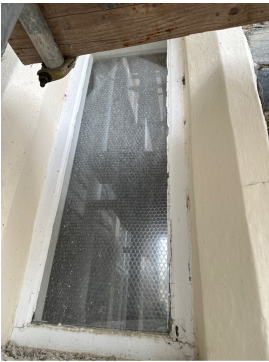
| Ref | Photo | Comments |
|---|---|---|
| 13 | | No frame repairs<br>Heritage glazing<br>Timber chamfered glazing bead<br>Decoration |

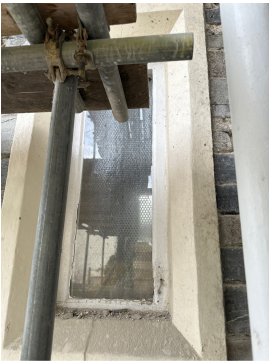
| Ref | Photo | Comments |
|---|---|---|
| 14 | | No frame repairs<br>Heritage glazing<br>Timber chamfered glazing bead<br>Decoration |

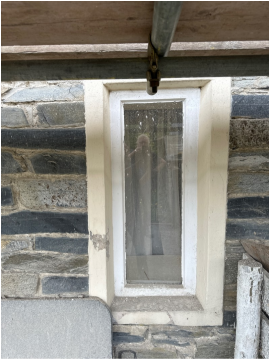
| Ref | Photo | Comments |
|---|---|---|
| 15 | | No frame repairs<br>Heritage glazing<br>Timber chamfered glazing bead<br>Decoration |

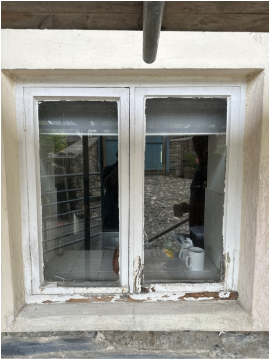
| Ref | Photo | Comments |
|---|---|---|
| 16 | | frame repairs to bottom see next item timber splice<br>Heritage glazing<br>Timber chamfered glazing bead<br>Decoration |

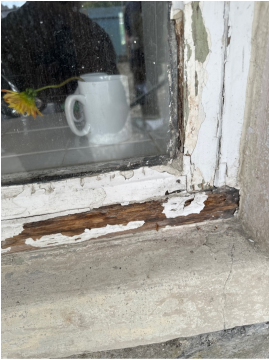
| Ref | Photo | Comments |
|---|---|---|
| 17 | | Timber splice repair |

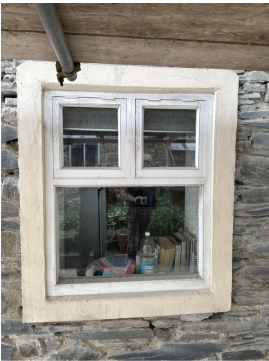
| Ref | Photo | Comments |
|---|---|---|
| 18 | | No frame repairs<br>Glazing beads to be re-used<br>Heritage glazing<br>Decoration |

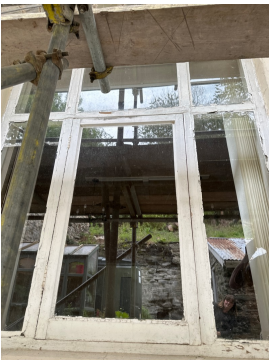
| Ref | Photo | Comments |
|---|---|---|
| 19 | | No frame repairs<br>Heritage glazing<br>Timber chamfered glazing bead<br>Decoration |

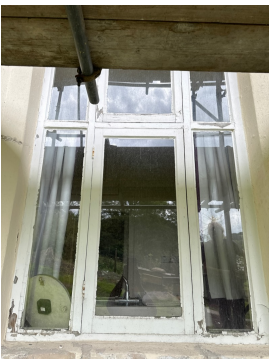
| Ref | Photo | Comments |
|---|---|---|
| 20 | | No frame repairs<br>Heritage glazing<br>Timber chamfered glazing bead<br>Decoration |

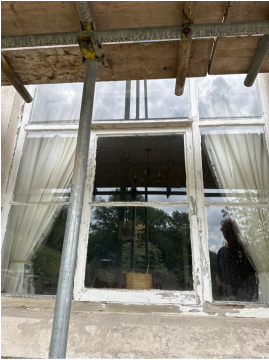
| Ref | Photo | Comments |
|---|---|---|
| 21 | | Heritage glazing<br>Timber chamfered glazing bead<br>Decoration<br>See next item for cill repair |

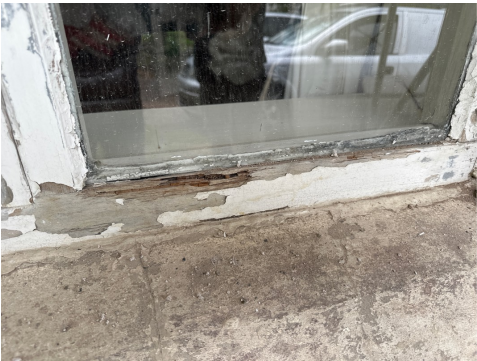
| Ref | Photo | Comments |
|---|---|---|
| 22 | | cill to be timber spliced in redwood |

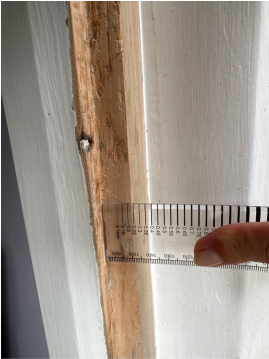
| Ref | Photo | Comments |
|---|---|---|
| 23 | | 20mm rebate.<br>Total depth of glazing bar 40mm |

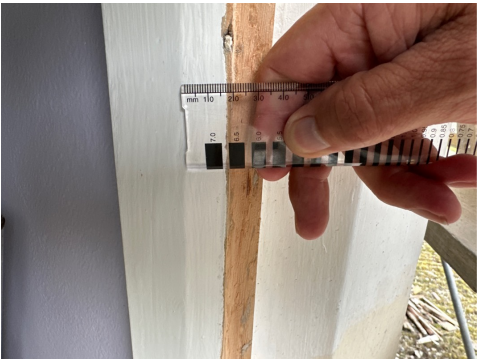
| Ref | Photo | Comments |
|---|---|---|
| 24 | | 15mm set to frame. From back edge |

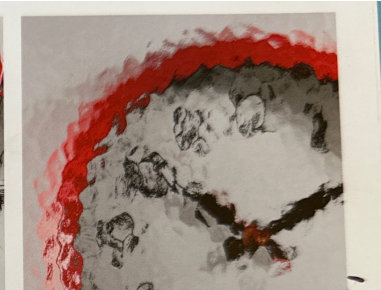
| Ref | Photo | Comments |
|---|---|---|
| 25 | <div><p>Minster™ Privacy Level 2</p></div> | Glazing pattern for Bathroom windows. Numbers 6&7 |
