# Heritage, Design and Access Statement | Hollybush Lane Farm list building consent for fireplace removal, restoration of existing conditions, and installation of new wood burner

## 1.0 Introduction

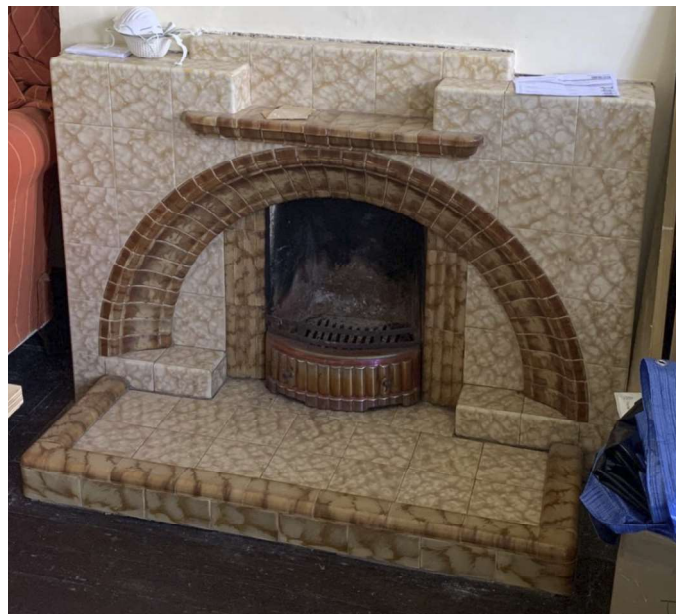
Figure 2 - Fireplace detail

The fireplace itself is positioned centrally to the West wall. Based on the design and style, it is presumed to be an addition to the farmhouse circa 1950/60 - *Figure 2*.

The fireplace will be carefully removed, first by removing the laid tiles using hand tools and then deconstructing the structure that is understood to exist under the tiles. Best practice historical methods per SPAB/Historic England/Cadw will be used to mitigate any potential damage to the surrounding material - such as floorboards, lime plaster, and the chimney hearth behind the fire surround.

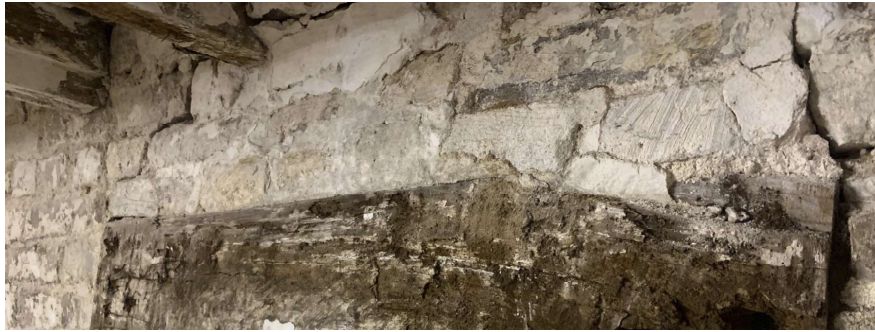
It is believed that the fireplace had been constructed of tile laid onto brick or concrete. The weight of the fireplace appears to have resulted in movement in the structure around and below the fireplace surround as seen in *Figures 3, 4 and 5*. The joists below the Dining Room floor require repair and as such we wish to limit structural loading on the repaired joists while balancing the heating requirements of the room and house.

*Figure 3 - Structural failure below fireplace*

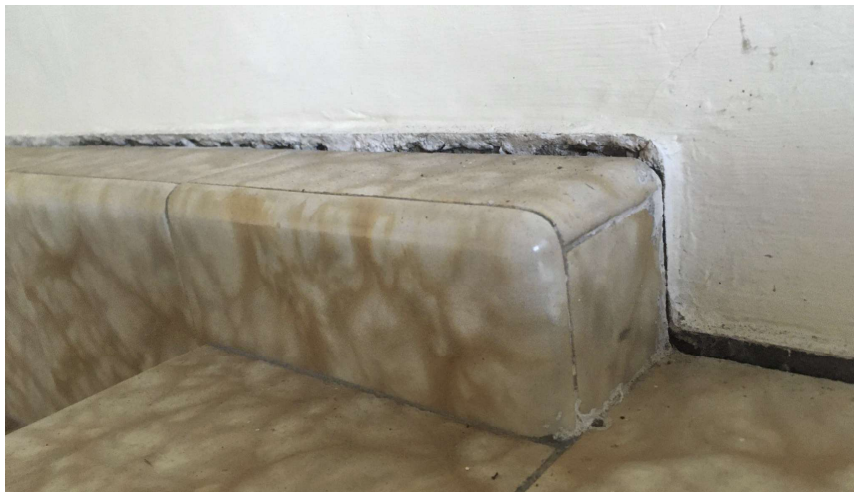
*Figure 4 - Detail showing movement of fireplace due to overloading of floor*

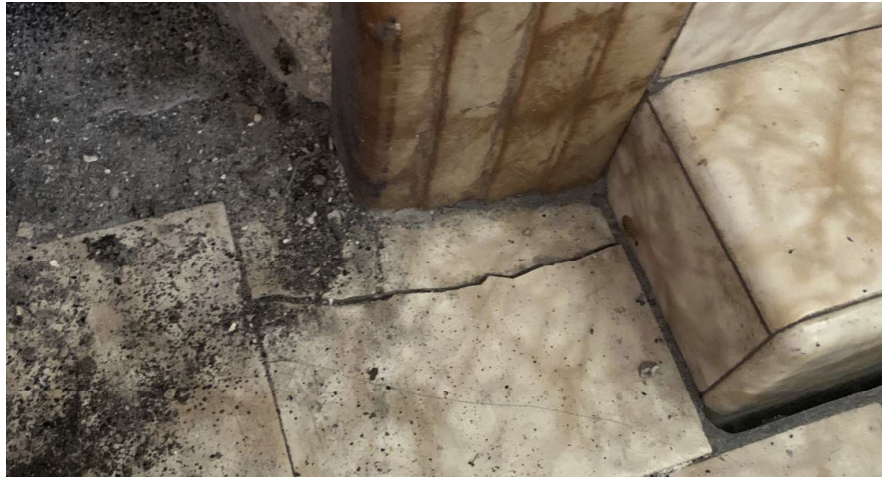
*Figure 5 - Detail showing movement of fireplace due to overloading of floor*

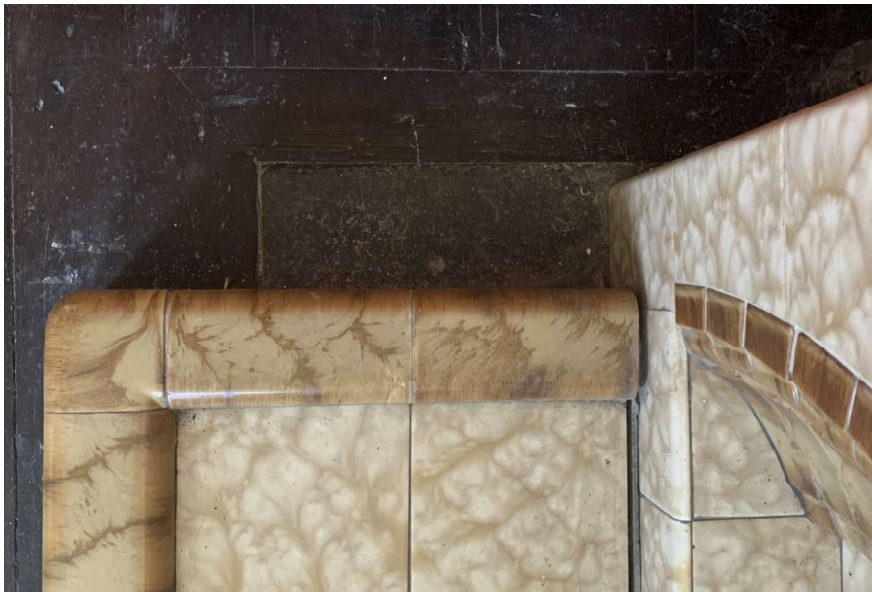
There is evidence under the existing 1950's fireplace that the original slate outer hearth is in place - *Figure 6*. Given the extent to which the original chimney remains in place is unknown, approval is sought for two approaches to restore the original opening based on what is found during removal/investigation.

*Figure 6 - Detail of slate hearth revealed under fireplace*

1. Should the original fabric of the inner hearth, throat, and firebox remain in place, it is proposed to restore the original condition. Non-corrosive slate cleaning methods will be used as needed so as to not damage the underlying stone. Any repointing or replastering that is required will be done in appropriate lime materials.

2. Should the original materials not be present when the fireplace is removed and the recess exposed, we propose to repair and extend the lime plaster to the edge of the fire opening, expose the brick, and then repoint in lime mortar. It is our intent to maintain as much of the original material as possible however, should the brick be spalled beyond reasonable repair, the chimney opening would be lined with an appropriate fireproof backing.
