## **Summary of discussions in respect of the façade to The Old Croft, Green Street, Holt.**

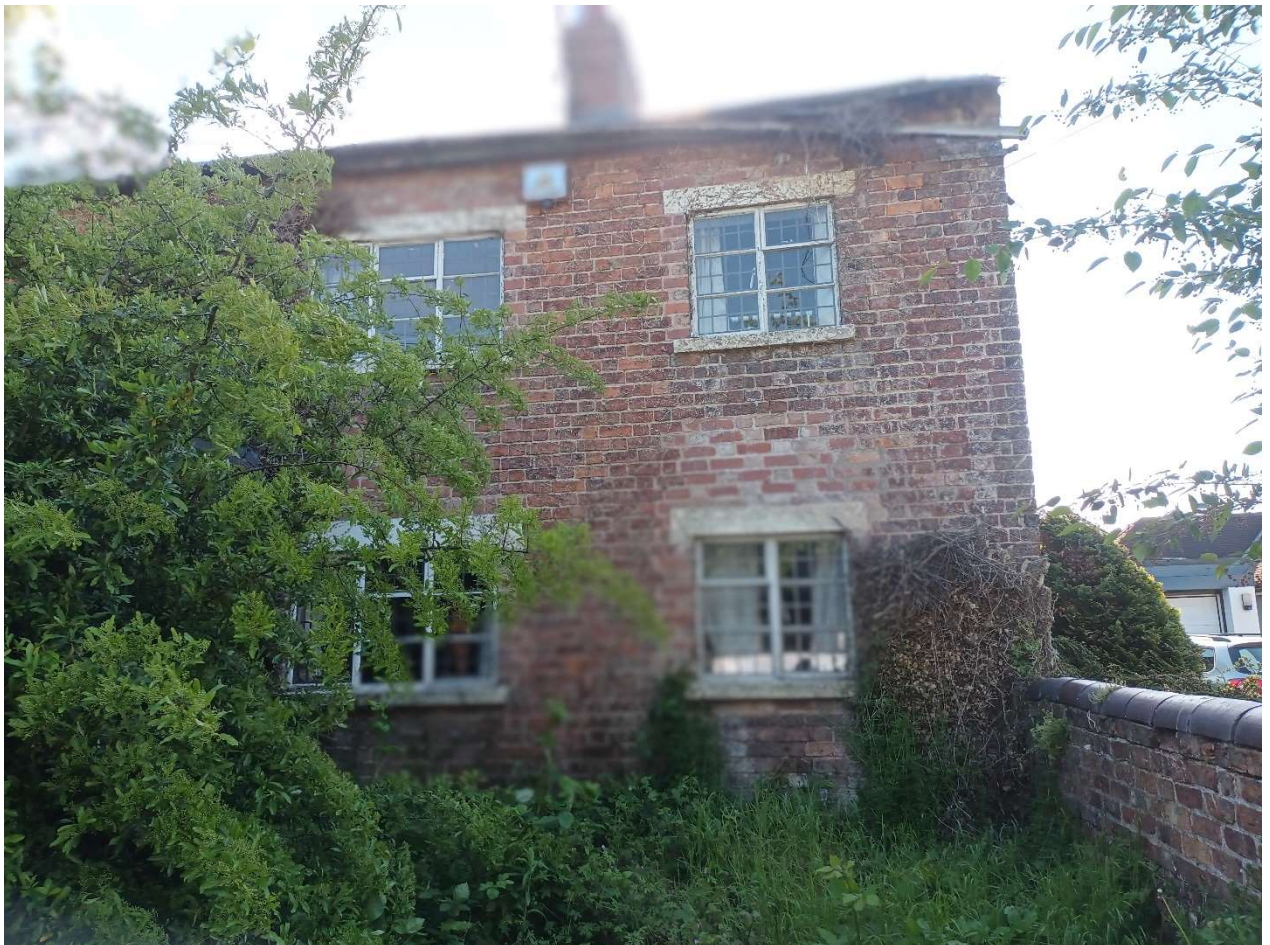
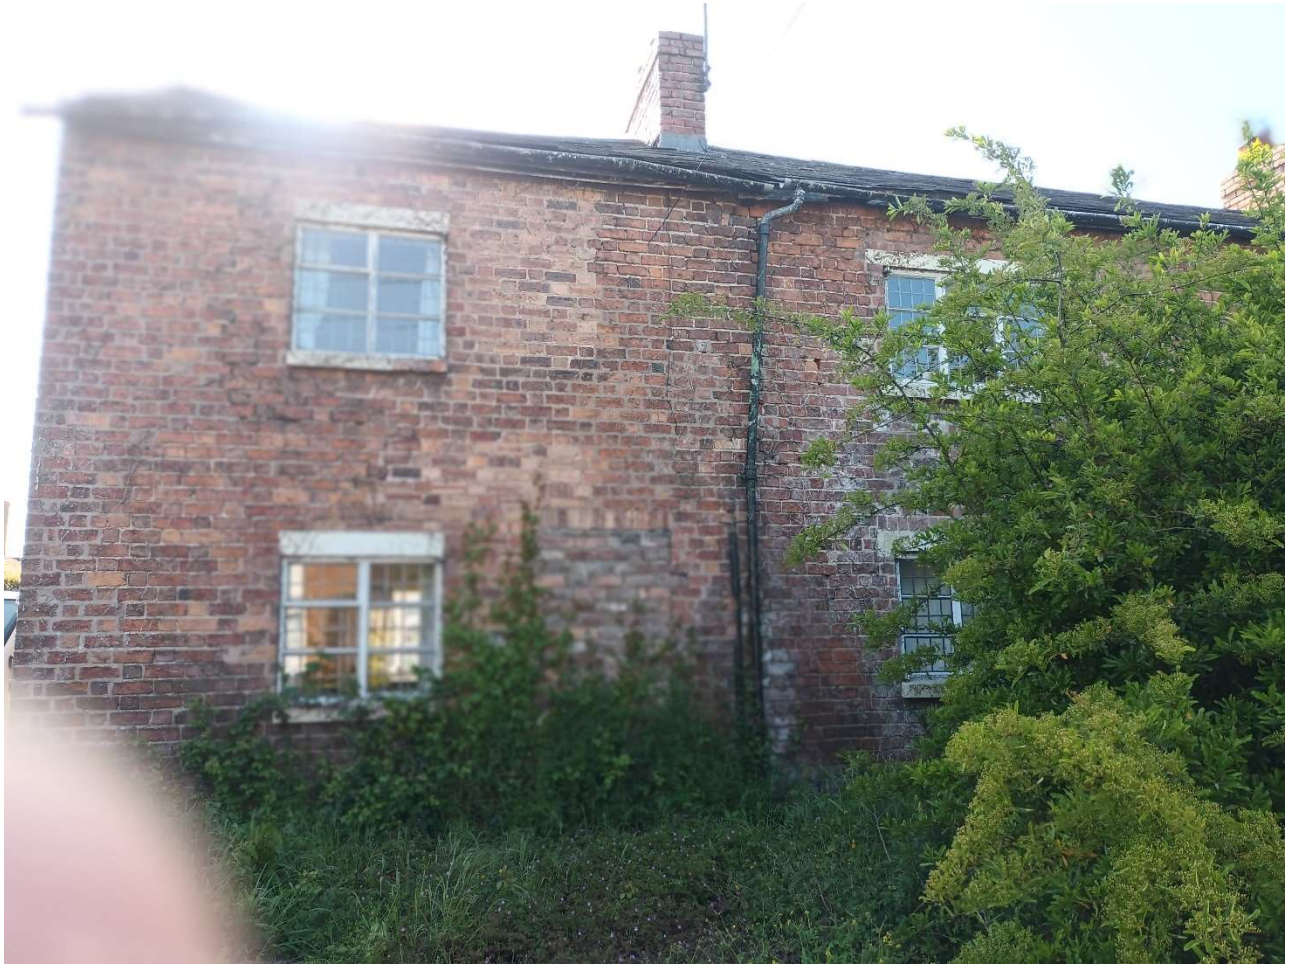
The patched areas are very uneven and have been carelessly undertaken with little attempt to course in, match the brick or relate horizontal mortar lines. Additionally modern mortar in various differing forms has been used and if the discussed new heritage brick skin is not to be favoured by Daniel Jones then I would propose we revert to the alternative method already considered, which is to take out the poorly patched brickwork and the areas where modern mortars have been used and replace with reclaimed bricks to closely match the original and to rake and repoint the whole façade with a lime mortar which would have a unifying impact.

The façade does have varying brick sizes and the left hand section is of a different brick in size and gauge to the right.

I attach below two photos that give the general impression of the current condition which may assist in considering the above.

I am familiar with the necessary methodology and can specify the appropriate techniques but would wish to discuss the same to agree the areas to be removed and re-built and the approach to repointing the remaining areas of differing gauge brickwork.
