## RSA Designer Response

### ROAD SAFETY AUDIT STAGE 1/2

| <b>Project Title</b> | Llay S278 |

## **STAGE 1/2 ROAD SAFETY AUDIT**

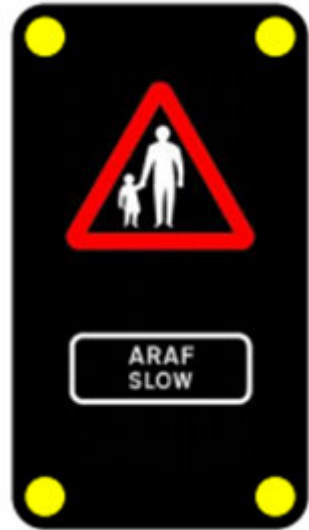
| Problem Identified (Paragraph No) | Problem Accepted (YES/NO) | Recommendation Accepted (YES/NO/PART) | Action (describe) |
|---|---|---|---|
| 9.2 The proposed traffic sign on Gresford Road associated with the northern most refuge is shown on the drawing as Diag. 544.1. This sign is to be used where pedestrians are walking longitudinally along the carriageway where there are no footways. The signs to be used in the proposed situation would usually be Diag. 562 with the supplementary plate "Pedestrians crossing". | N | N | <p>Not raised by the auditor as a safety issue.</p> <p>Clarification sought from WCBC Road Safety Officer and WCBC preference is for VAS to have Diag. 544.1 with ARAF SLOW beneath:</p> |

**9.2** The proposed traffic sign on Gresford Road associated with the northern most refuge is shown on the drawing as Diag. 544.1. This sign is to be used where pedestrians are walking longitudinally along the carriageway where there are no footways. The signs to be used in the proposed situation would usually be Diag. 562 with the supplementary plate "Pedestrians crossing".

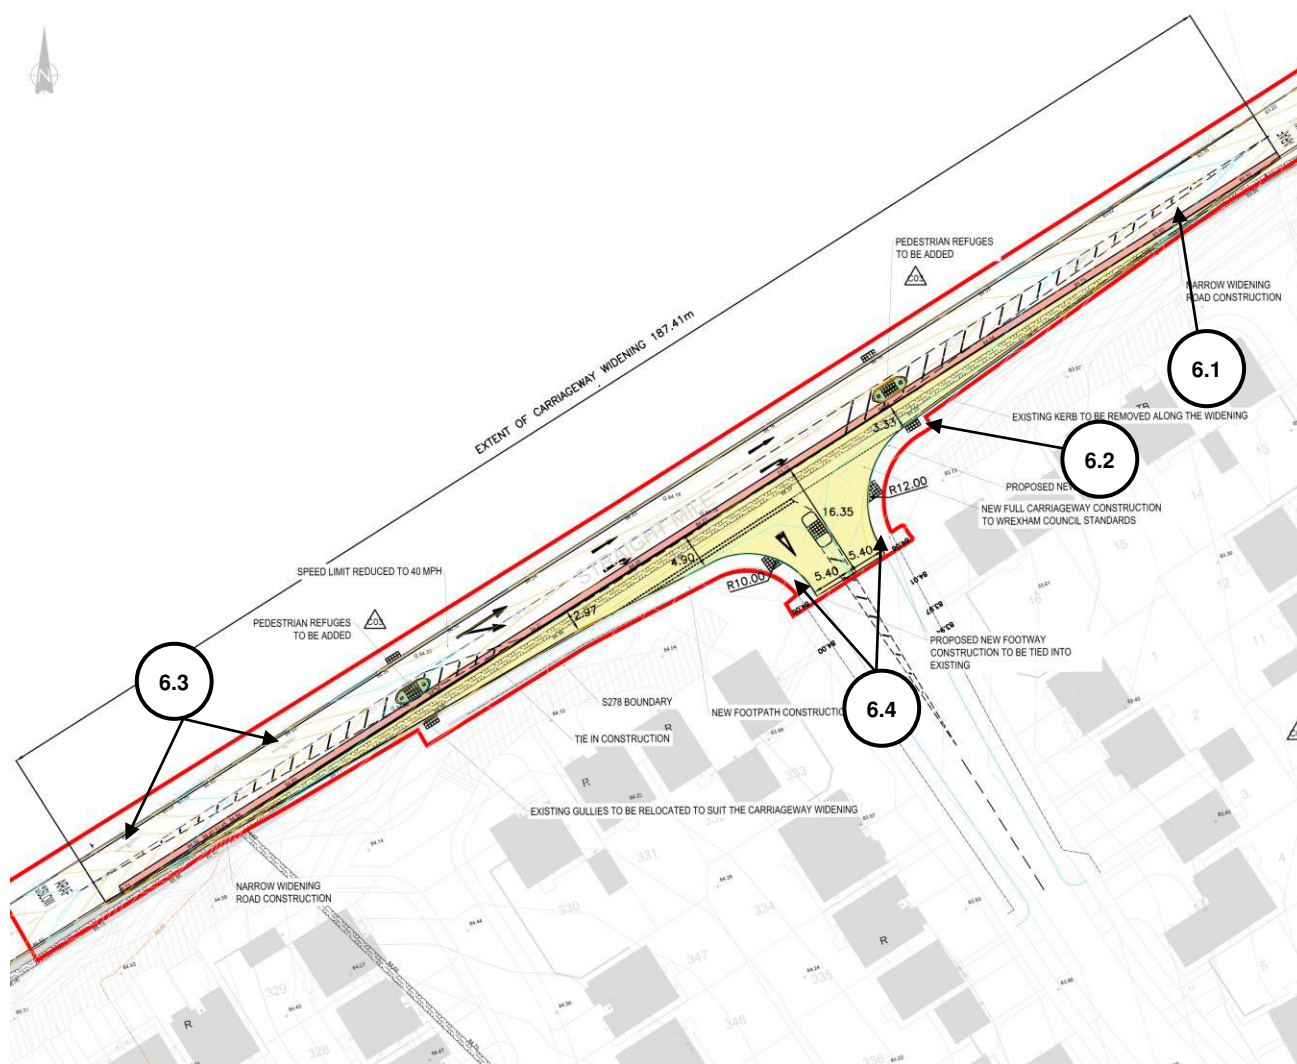
12.1 STRAIGHT MILE

It was observed during the site visit that the proposed junction is located to the west of an existing blind summit on Straight Mile. This may result in the visibility splay to the east of the junction being reduced due to the blind summit. A reduction in intervisibility at the proposed junction may increase the risk of collisions between those turning out of the access road and those travelling along Straight Mile. Additionally, this may also increase the risk of rear end shunt collisions on Straight Mile due to westbound drivers unaware of vehicles braking for the junction just over the blind summit.

It was observed during the site visit that the proposed uncontrolled pedestrian crossing to the east of the junction is located to the west of an existing blind summit on Straight Mile. This may result in the intervisibility between pedestrians crossing from the south and drivers travelling westbound being reduced due to the blind summit. A reduction in intervisibility between pedestrians and drivers may increase the risk of pedestrian/vehicular collisions.

Two ahead/turn-right road marking arrows are proposed on the eastbound approach to the junction. The provision of these arrows on a single lane approach to this type of junction is non-standard. This may lead to drivers being confused assuming they need to enter the hatched area in order to turn right and they may collide with the pedestrian refuge island. It is also noted there is a lack of deflection arrows on both approaches to the hatched road markings, which could increase the risk of drivers colliding with the central islands.

The drawings provided for audit do not show any terminal speed limit signs at the junction of the proposed access road and Straight Mile. It is noted from the drawings for the Crown Crossroads that the speed limit on Straight Mile is being reduced to 40mph, and it is assumed that the access road will have a lower speed limit. If appropriate terminal speed limit signs are not provided, then vehicles may enter the access road at excessive speeds and may increase the severity of any collisions that may occur.

The appropriate junction intervisibility splays in both the horizontal and vertical planes should be checked to ensure suitable intervisibility is provided between the proposed access and those travelling along Straight Mile. Amendments to the junction location should be carried out if appropriate intervisibility cannot be provided at its current location.

In association with item 6.2 above the appropriate pedestrian/driver intervisibility splays in both the horizontal and vertical planes should be checked to ensure suitable intervisibility is provided between these users. Amendments to the uncontrolled crossing location should be carried out if appropriate intervisibility cannot be provided at its current location.

The two ahead/turn-right road marking arrows on the eastbound approach to the junction should be removed from the design. Deflection arrows at appropriate locations should be provided on the Straight Mile approaches to the hatched road markings.

Appropriate terminal speed limit signs should be provided on the access road at the junction with Straight Mile.

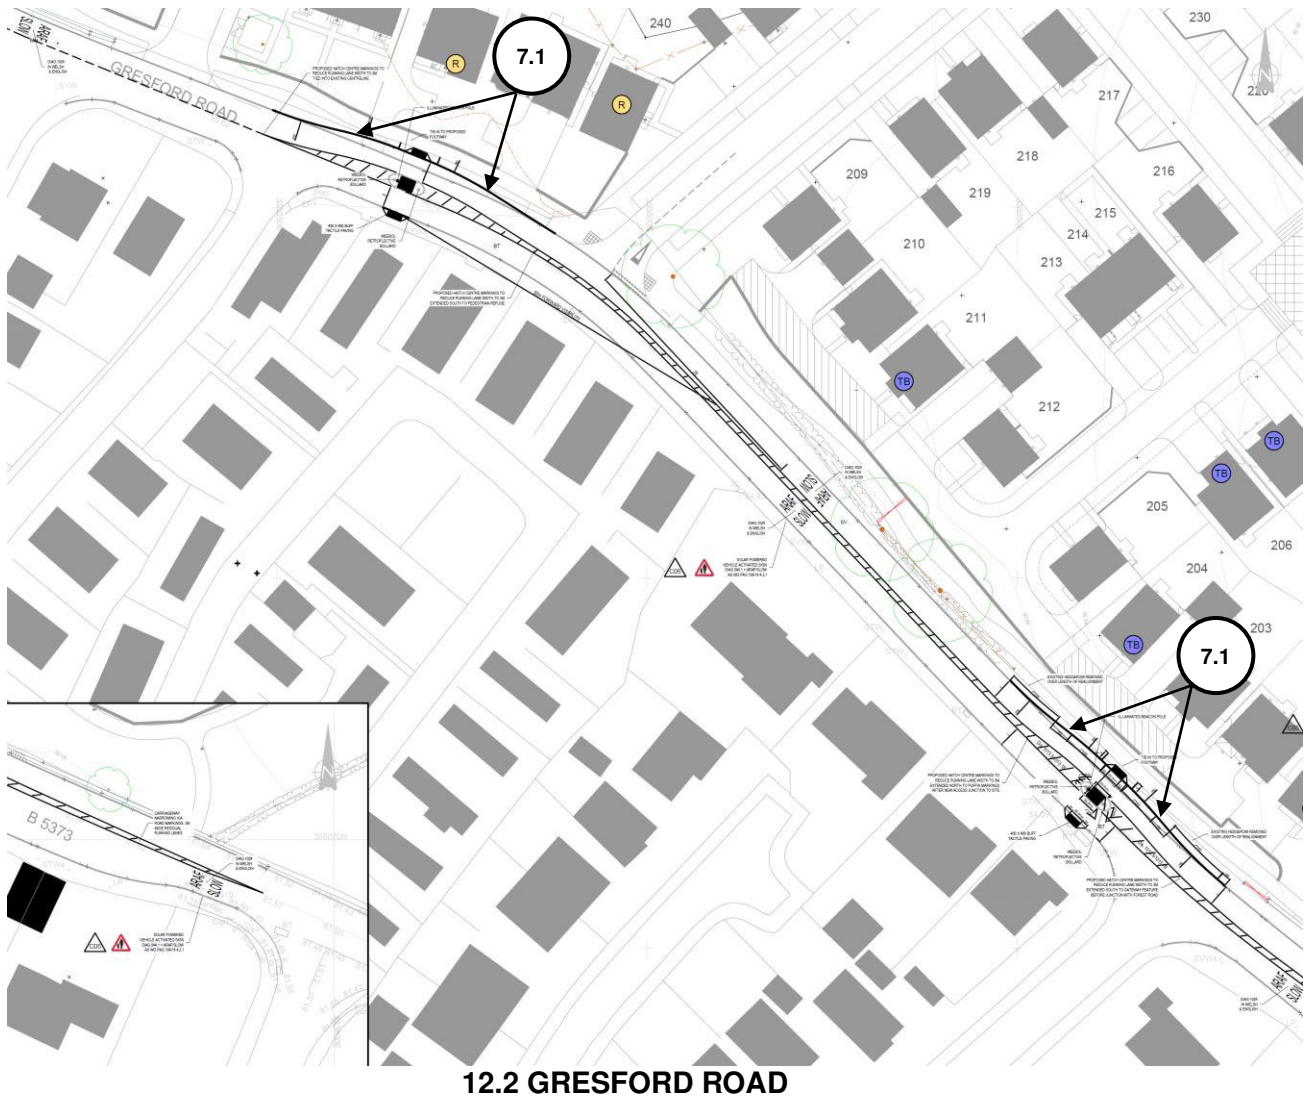
The proposed carriageway alignment on the south-eastbound carriageway both sides of the pedestrian refuge islands creates a severe change in horizontal alignment with relatively short taper lengths. This may increase the risk of vehicles colliding with the main kerblines or the refuge island.

The taper lengths both before and after the proposed refuge islands should be increased to provide a smoother horizontal alignment for south-eastbound vehicles.

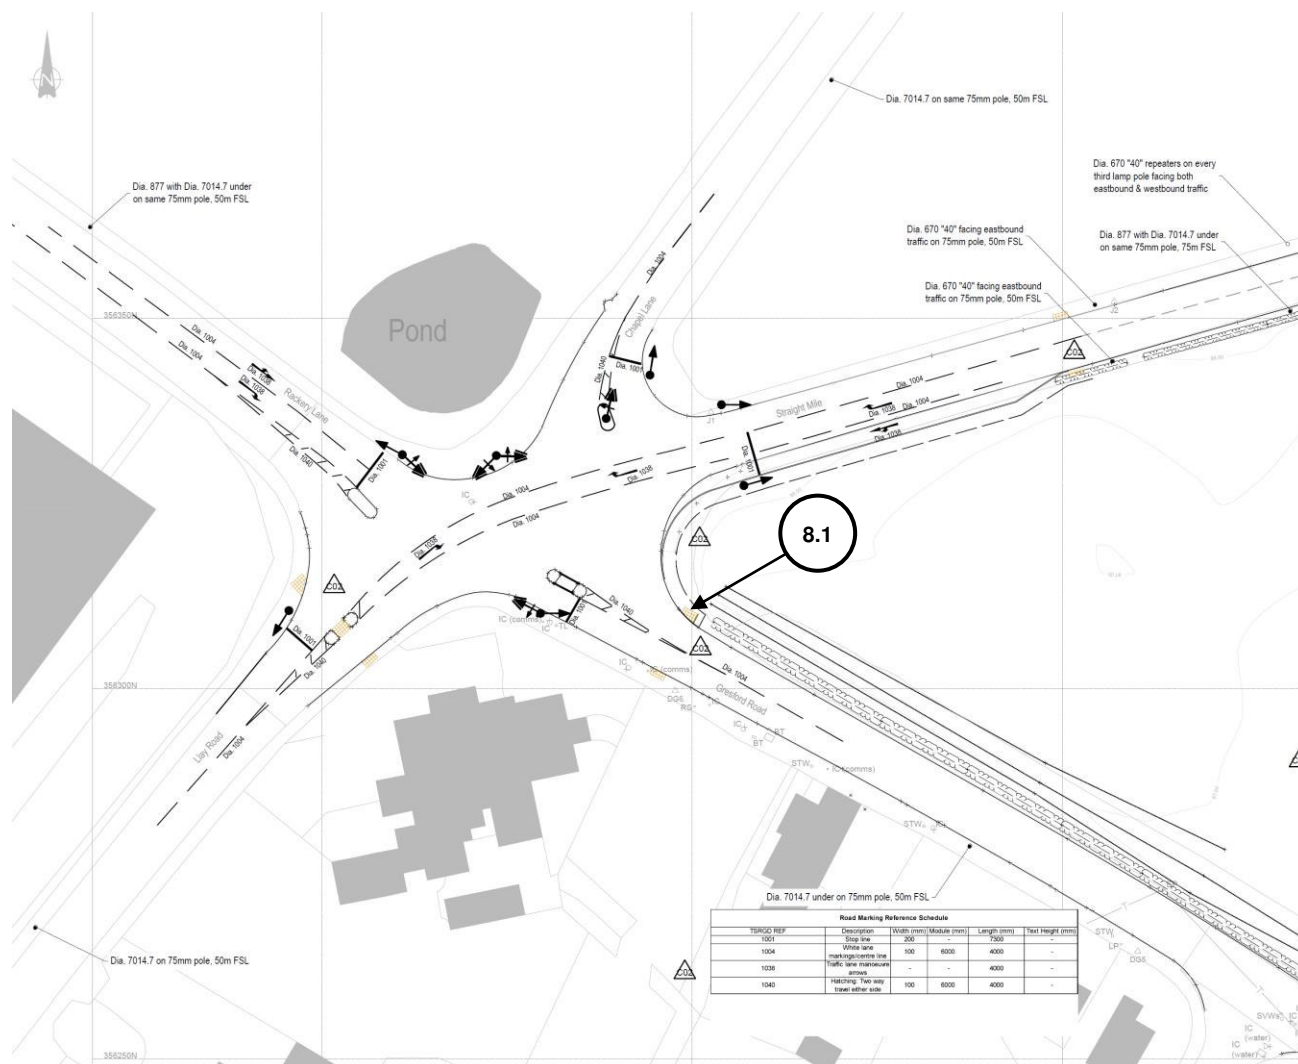
## 12.3 CROWN CROSSROADS

The location of the uncontrolled pedestrian crossing point on the northern side of Gresford Road may result in the intervisibility between pedestrians crossing from the north and drivers turning left from Straight Mile being reduced due to the boundary treatment on the east side of the junction. A reduction in intervisibility between pedestrians and drivers may increase the risk of pedestrian/vehicular collisions.

The appropriate pedestrian/driver intervisibility splays should be checked to ensure suitable intervisibility is provided between these users. The proposed boundary treatment should not obscure the intervisibility splay and the uncontrolled crossing should be relocated if required.
