**Mulsford Farm, Malpas SY14 7LP – Structural Condition Report**

## **STRUCTURAL CONDITION REPORT FOR THE**

### **PROPOSED BARN CONVERSION PROJECT**

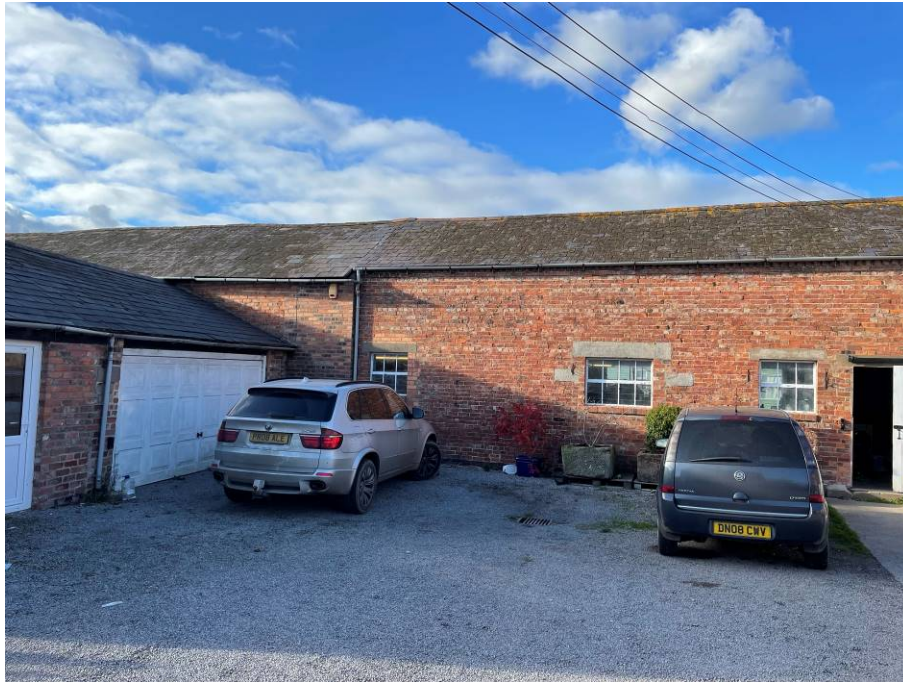
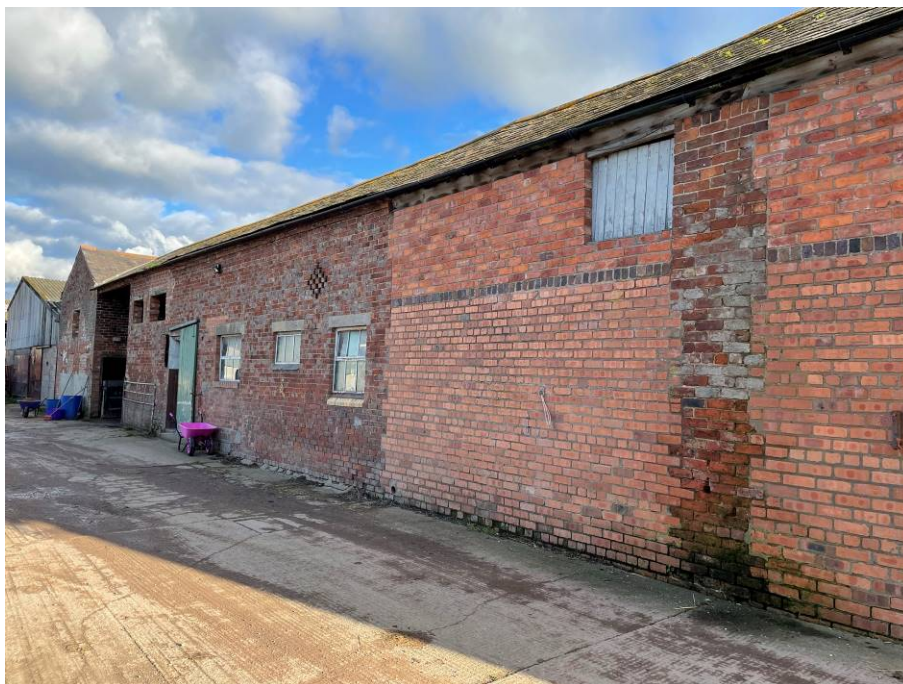
The external exposed face of the existing brickwork can be seen to have weathered which is not unusual given the exposed rural location, however it is generally in reasonable condition. There are areas of the external wall which have been rebuilt around window and door openings for example.

The mortar bed joints to the external walls can be seen to have weathered which is not unusual given the exposed rural location, however they are generally in reasonable condition.

Refer to Photographs P.01, P02 & P.13 in Appendix A.

5. All timber lintels will need to be replaced.
6. All external walls should be repointed.
7. All brickwork cross walls should be either rebuilt so that they are toothed into the external walls or effectively tied to them with restraint straps.

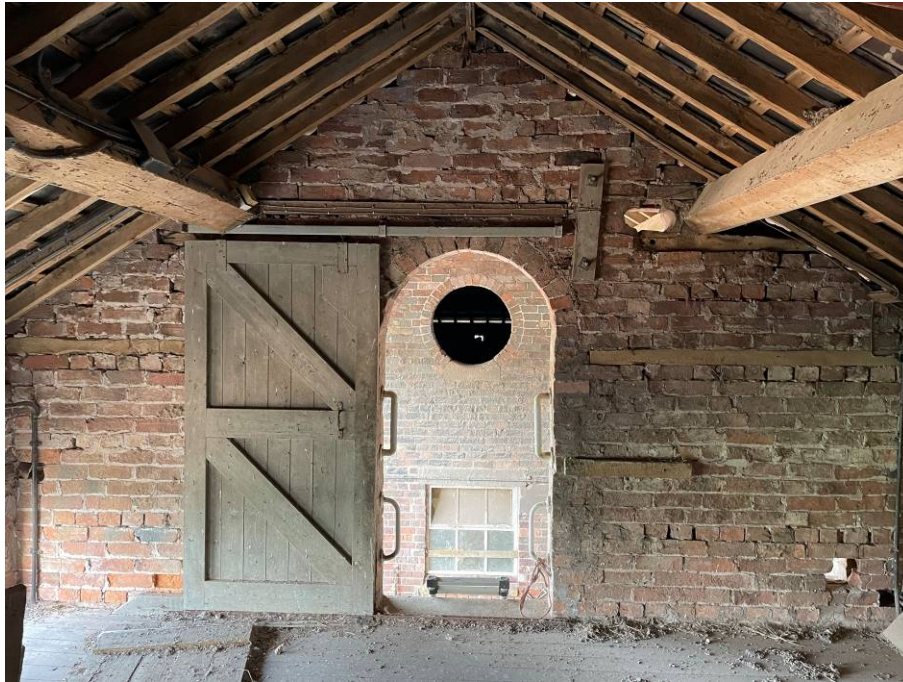
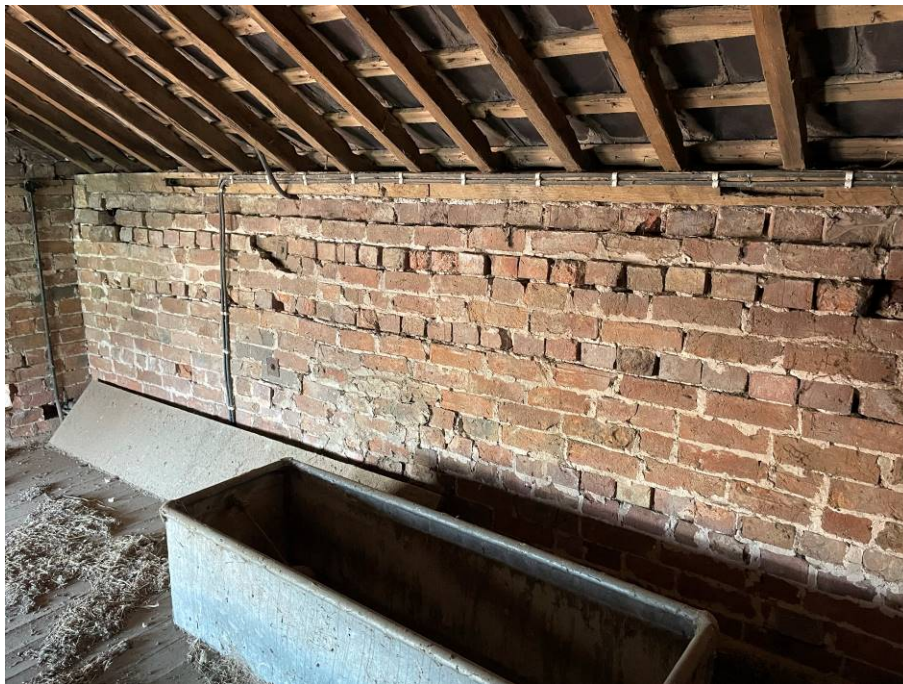
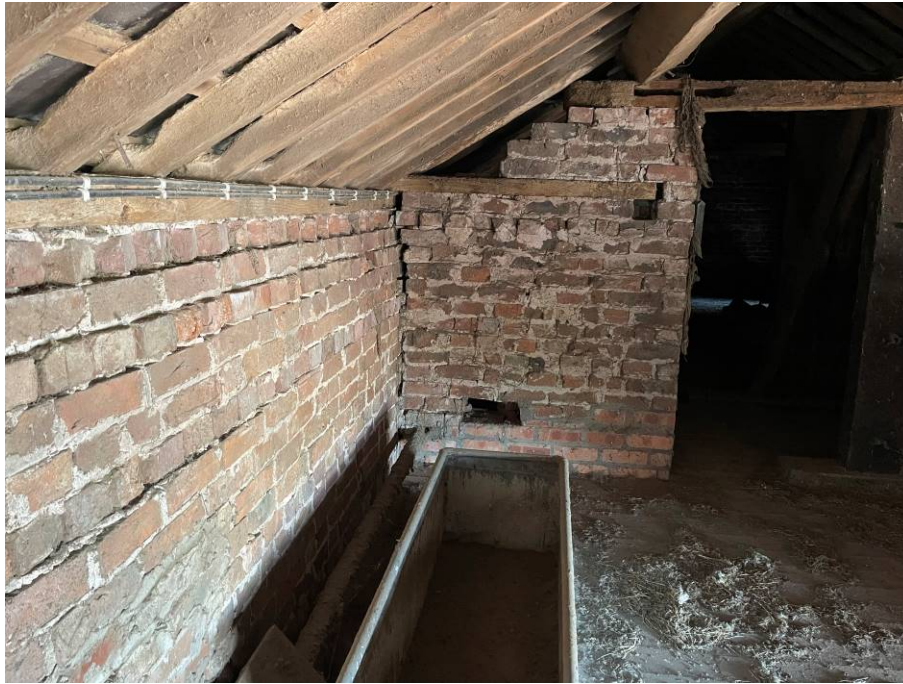
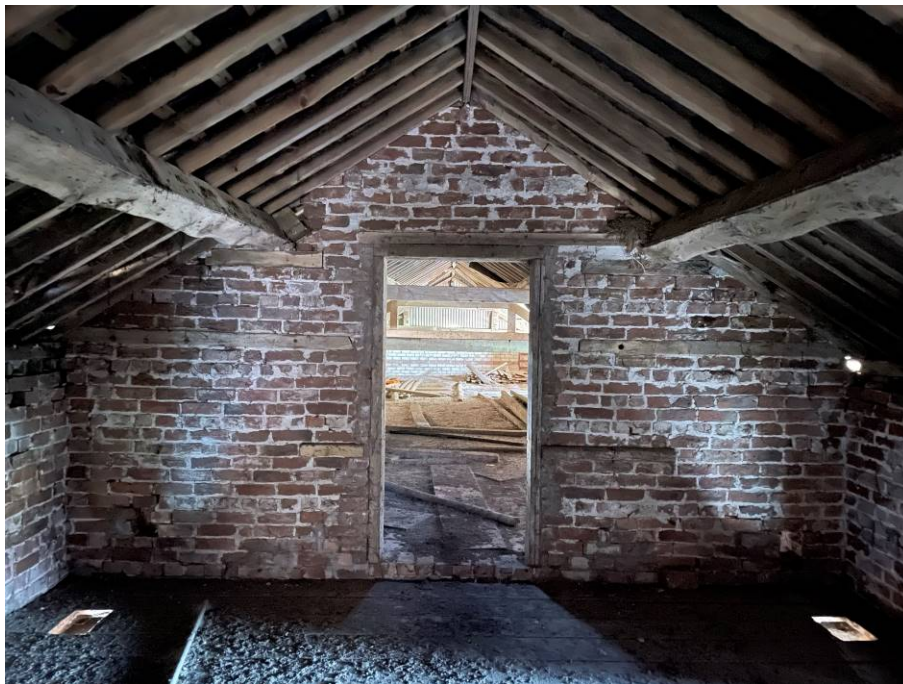
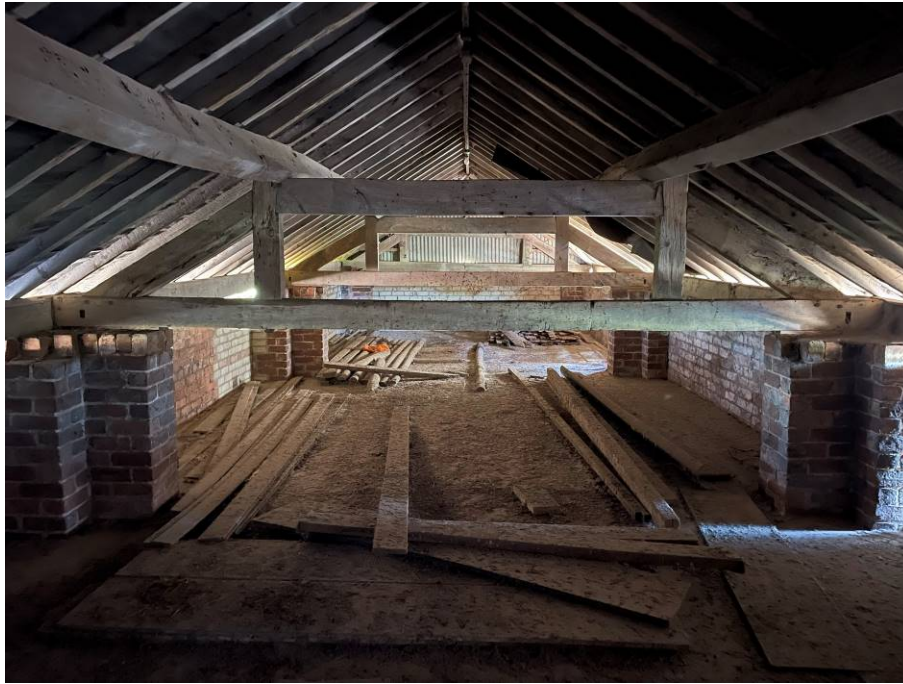
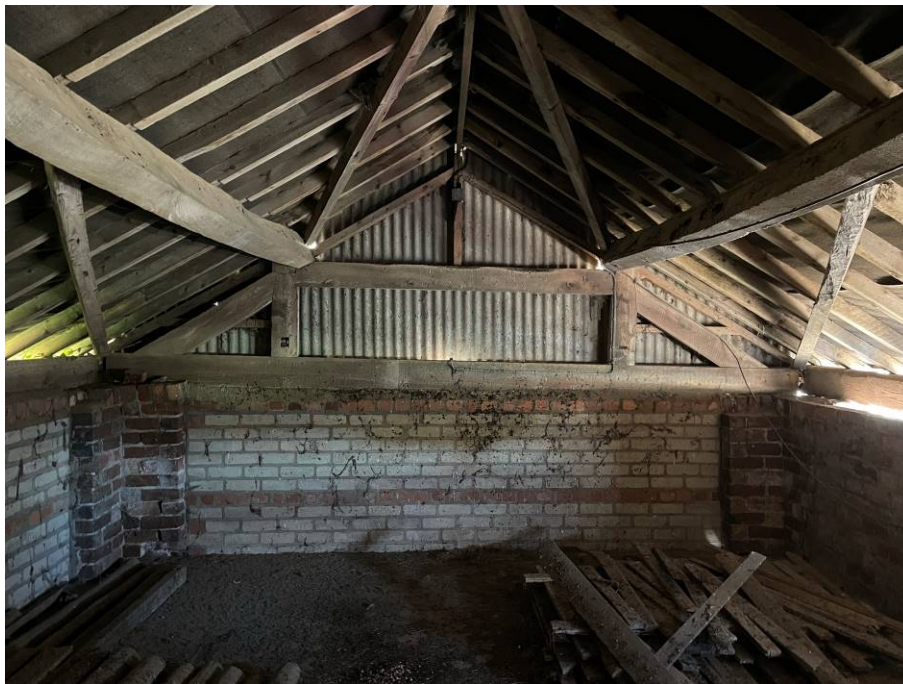
The existing duo pitch roof construction comprises of traditional slate roof tiles supported by soft timber rafters supported by a single oak purlin on each pitch. The oak purlins span between loadbearing masonry walls at the north end of the barn and oak trusses at the south end of the barn.

Refer to the attached Photographs P.03 to P.08 in Appendix A.

The roof timbers appear to be in good condition given the age of the property and in a reasonable state of repair. In general there were no signs of any prolonged moisture issues or visual evidence of wet or dry rot to the roof structure.

The roof to the north end of the barn does not have any roofing membrane below the slate tiles, however on the south end of the barn there is a roof membrane present although its condition is unknown.

4. The adequacy of the existing roof structure should, at the appropriate time, be verified to confirm that it complies with current building regulations.

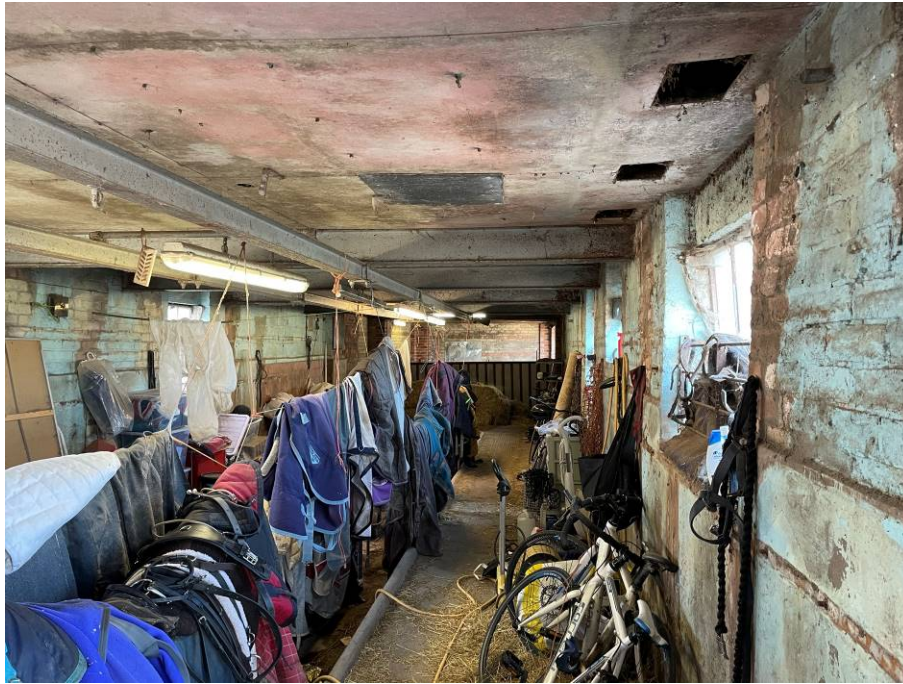
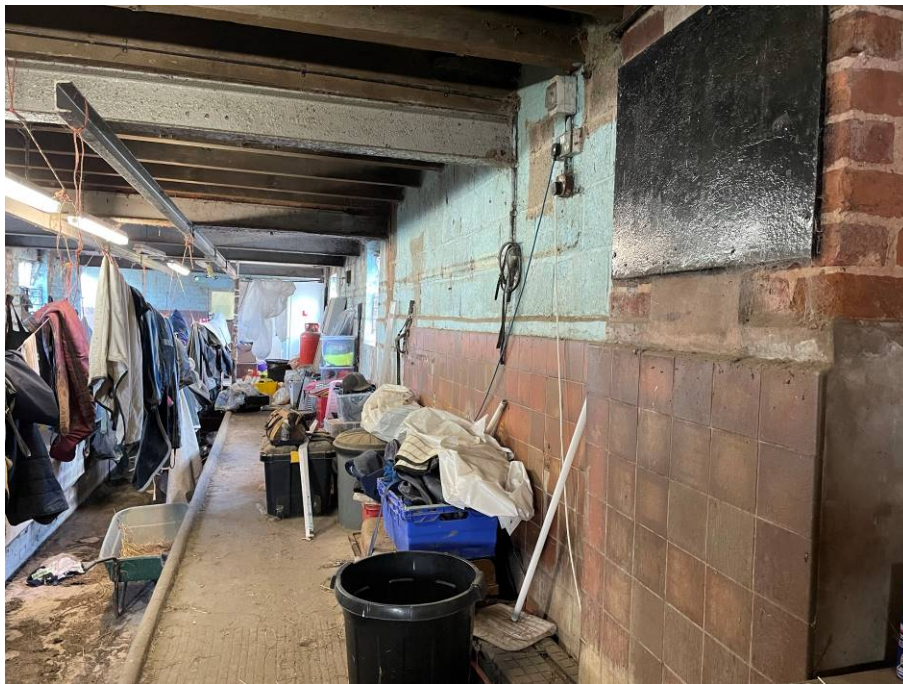
At the north end of the barn the timber joists span between steel beams which in turn span between the external walls. In this area the joists are underdrawn by a ceiling with the construction material unknown. Refer to the attached Photographs P.09 to P.10 in Appendix A.

The exposed steel beams have surface corrosion visible but generally appear to be in reasonable condition.

The existing ground floor construction comprises of a concrete slab of which the thickness is unknown. Running down the centre of the barn is a lowered section presumably used for animal welfare in the past.

Refer to Photographs P.09 & P.10 in Appendix A.

There were no specific signs of deterioration or structural movement in the existing concrete floor.

3. The adequacy of the existing first floor structure should, at the appropriate time, be verified to confirm that it complies with current building regulations.

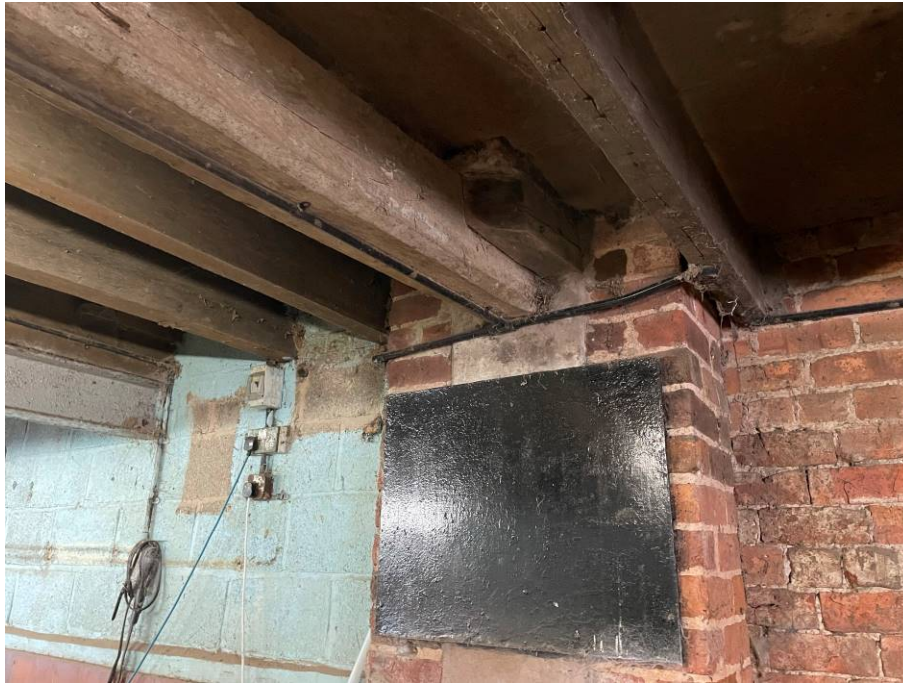
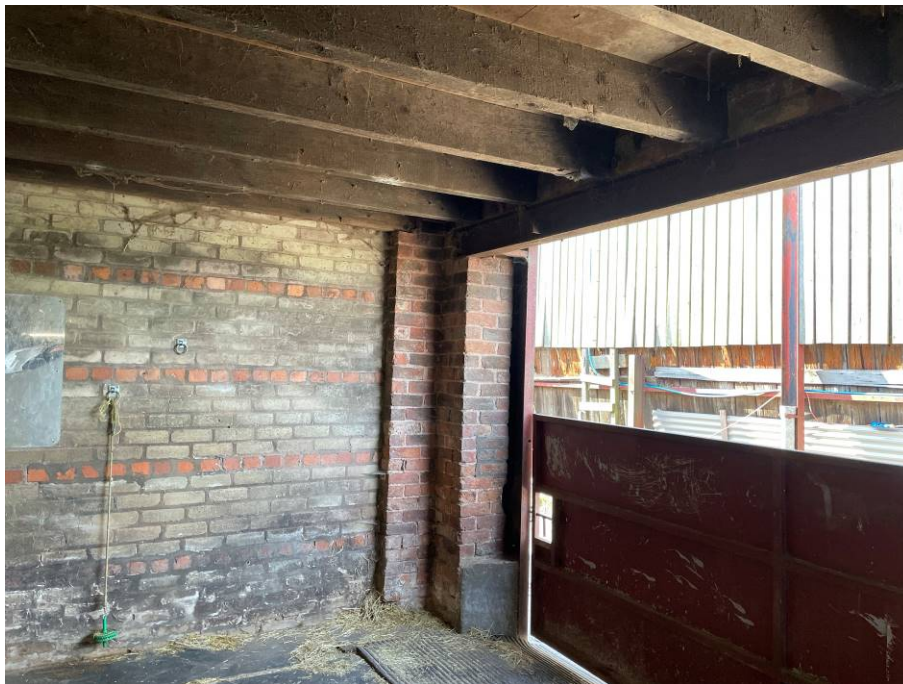
At the south end of the barn the timber joists span directly between the external walls and there are no steel beams present. Refer to the attached Photographs P.11 to P.12 in Appendix A.

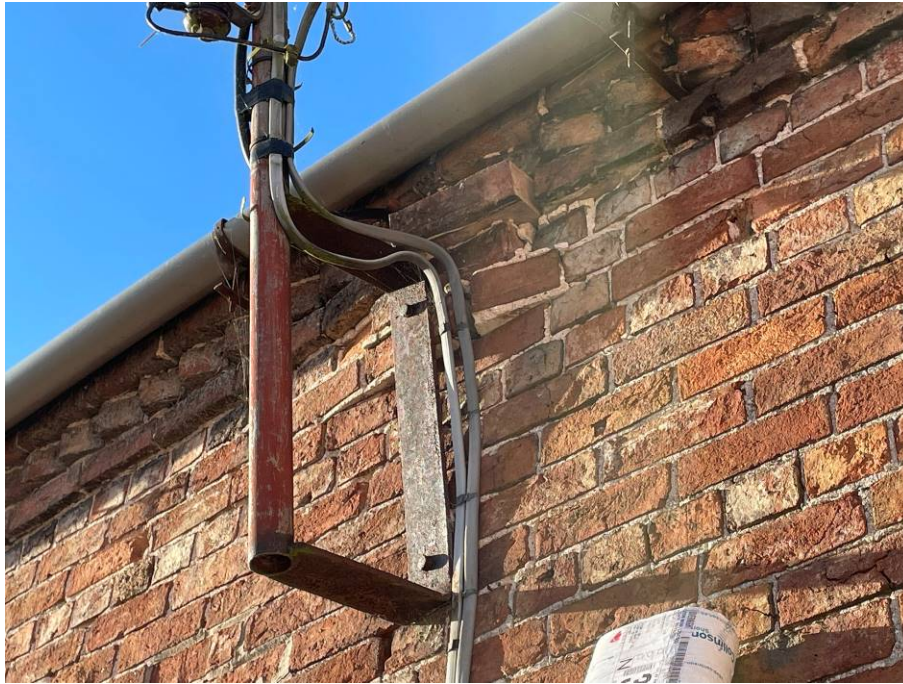
There is evidence of localised bowing and movement where the telecoms overhead lines have been secured back to the external wall on the south elevation. Refer to Photograph P.13 in Appendix A.
