## Structural appraisal – Pont y Blew Chapel

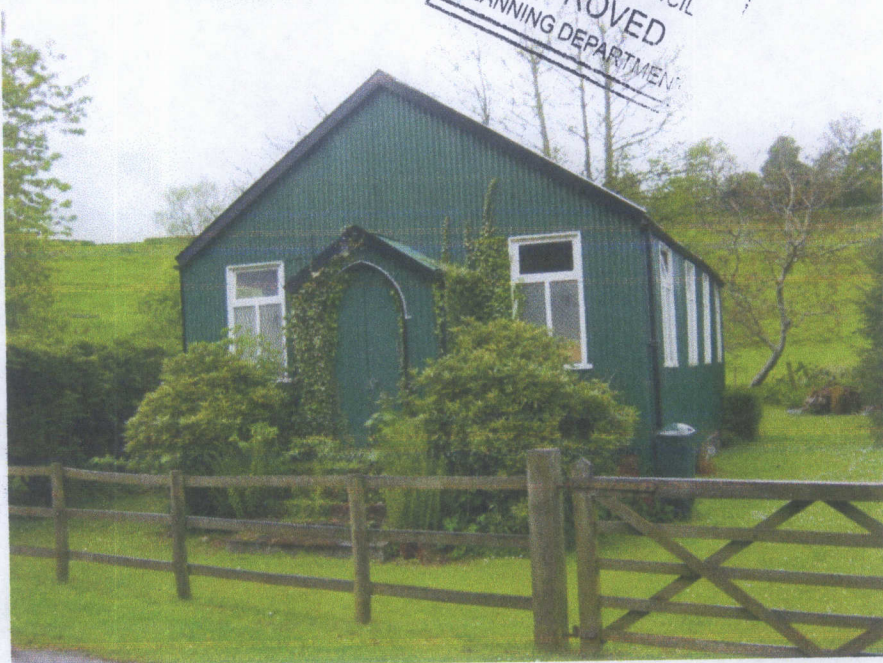
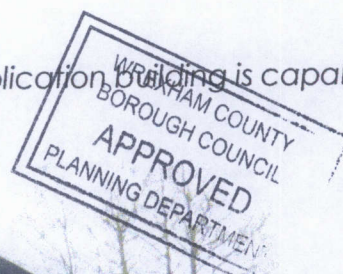
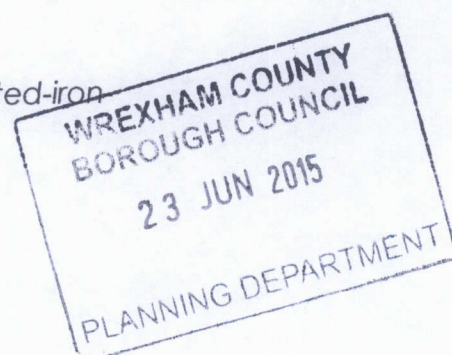
Walls

The timber stud walls are faced in corrugated iron to the outside and tongued and grooved vertical boarding, to the inside. It should be noted that this building has been well-maintained over the years; it has been regularly painted; the gutters and down-pipes have been maintained and the roof has been attended to whenever needed. Accordingly it has been kept dry and free from water-ingress.

Although it has not been possible to remove the claddings to view the studwork, it is noted that the internal boarding is free from rot and insect infestation and this is a good guide as to the condition of the studwork inside. The sole plate is raised well off the ground level (by between 800mm and 300mm), so the sole plate will have been kept clear of damp and splashing.

In particular, good conservation techniques should be employed throughout its restoration. Following the removal of the cladding, the stud walls should be treated for worm infestation and any rotten/badly infested sections should be repaired by splicing in new sections as required.

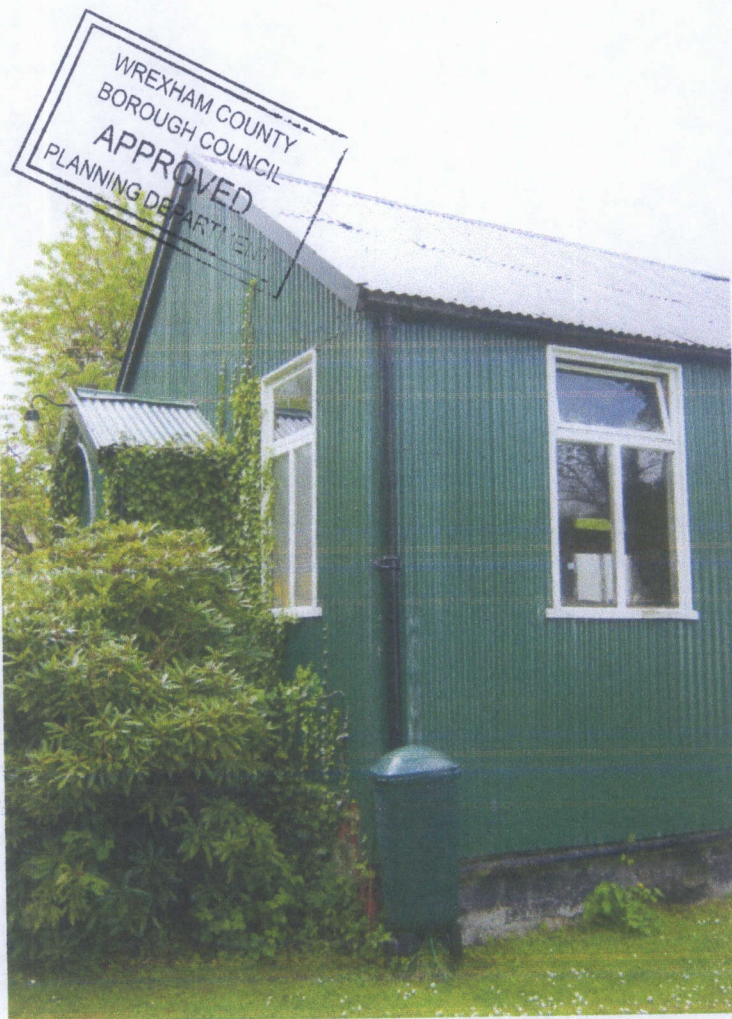
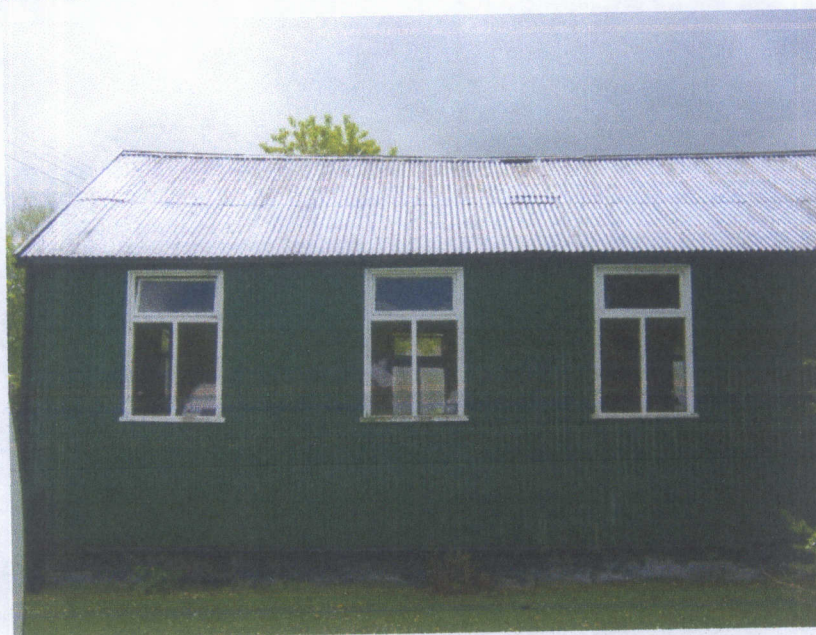
## Roof

The roof sheets have been replaced over the years and are in places uneven and loose.

Meanwhile the centre truss appears to have spread and this in turn has caused the wall to push out at the eaves, particularly on the north east elevation. The south west elevation has the existing brick chimney stack which has acted as a buttress against the movement.

The outward movement can be arrested by either tightening the steel tie rod within the truss and/or inserting a new steel tie rod across the building, below the existing truss.

The splayed wall to the north-east can be brought back into line through the use of a tie-rod and/or tightening the existing steel tie, as necessary. The roof sheets should be carefully stripped and set aside...those sheets which are in sound condition should be re-used and the shortfall made up in a gauge and corrugation to match the existing. New roll-cap ridge sheets should replace the existing.
