## NORTH WALES TREE CONSULTANCY

### Maes Y Pant QTRA 2023

**Date:** Thursday, 30 March  
2023

**Report Ref:**  
NWTC\_QTRA\_23\_01\_MYP

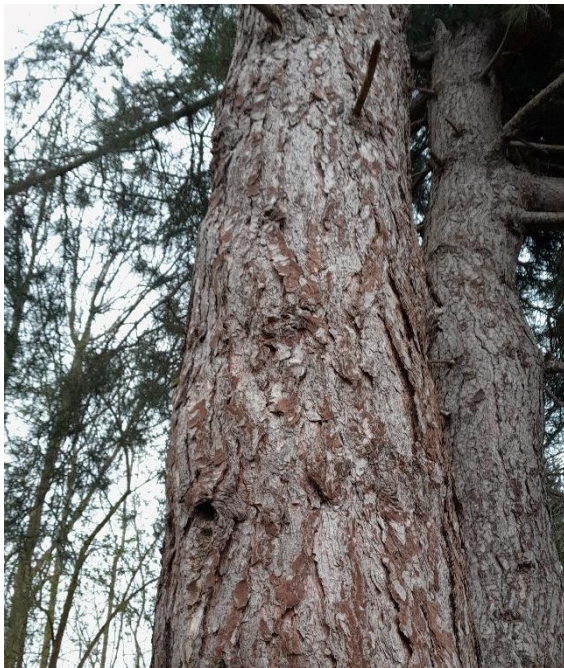
Figure 2 236 spiral bark pattern from torsional wind loading

mechanically dependent upon one another in the wind therefore any management of individuals must consider the potential for exposing and destabilising other trees along the boundary which may increase the risk they pose. No wind damaged limbs were observed during the survey indicating the tree crowns are well adapted to the site conditions. Tree 237 and 243 have both suffered wind snap of the main stem leaving a ~10m stem. Tree 236 shows evidence of torsional wind loading on the stem through the spiral bark pattern (figure 2). This is the tree reacting to high wind forces acting on a large lateral branch which is more extreme of the crown than the other lateral branches (figure 3). Reduction of this limb to make a more aerodynamic crown shape will reduce the wind loading on this limb and the torsional wind loading on the main stem.

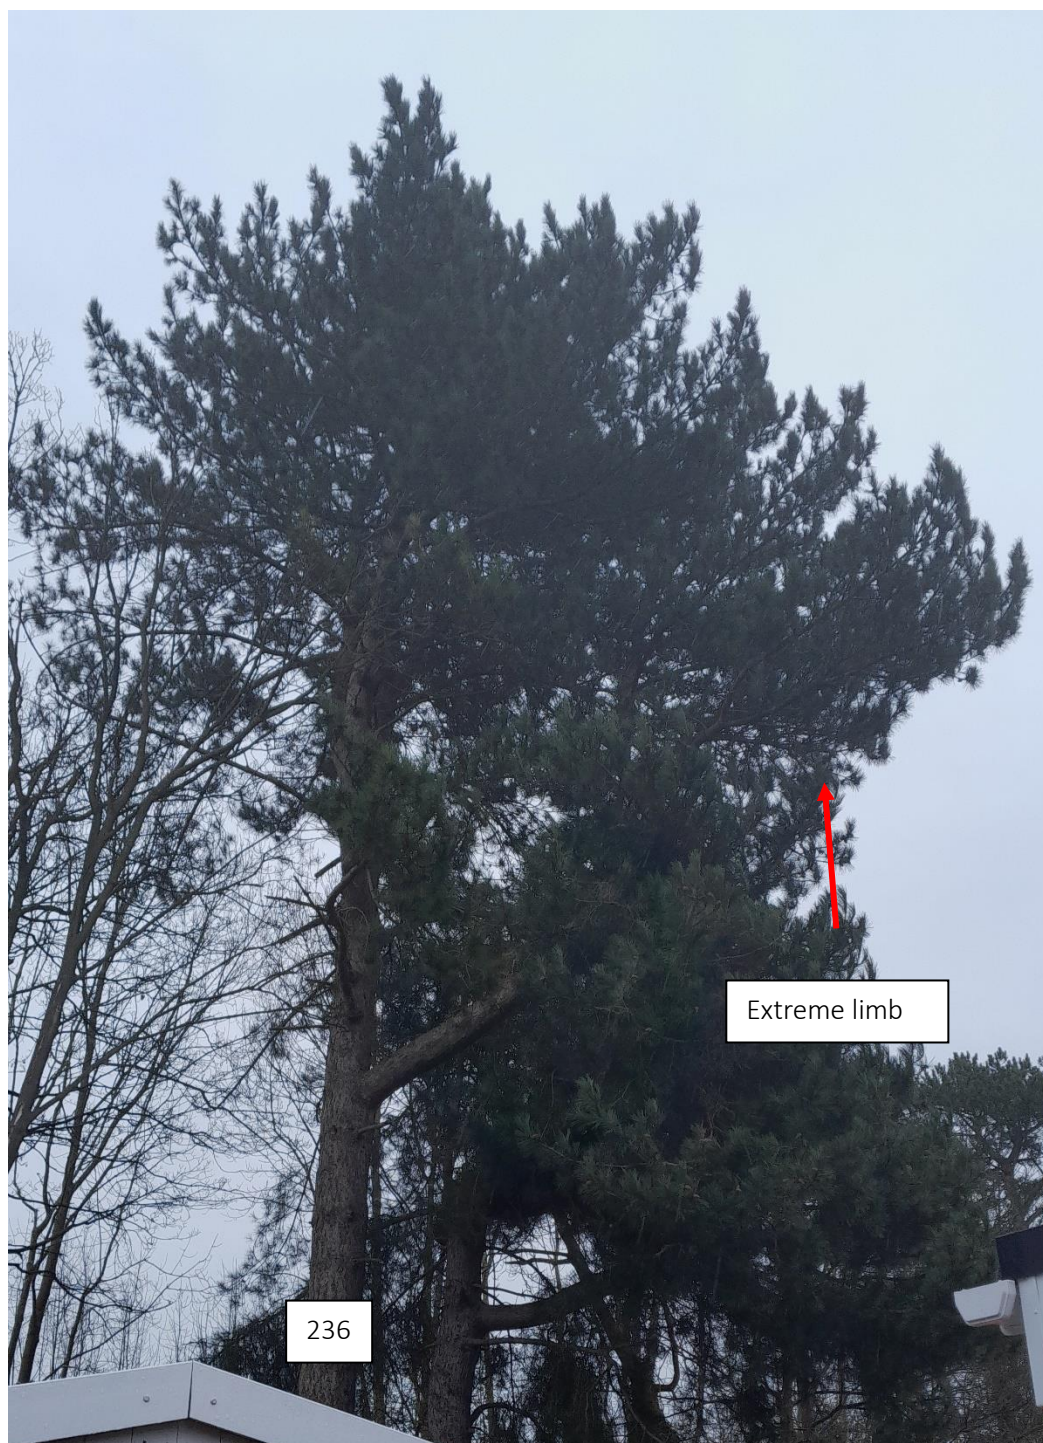
Figure 3 Tree 236 extreme lateral limb subject to high wind loading

| Tree ID | Recommendation |
|---|---|
| 236 | Reduce lateral at 8m to appropriate growth point at first 90 degree kink to decrease torsional wind loading and increase light to garden manage long-term. (Figure 6) |

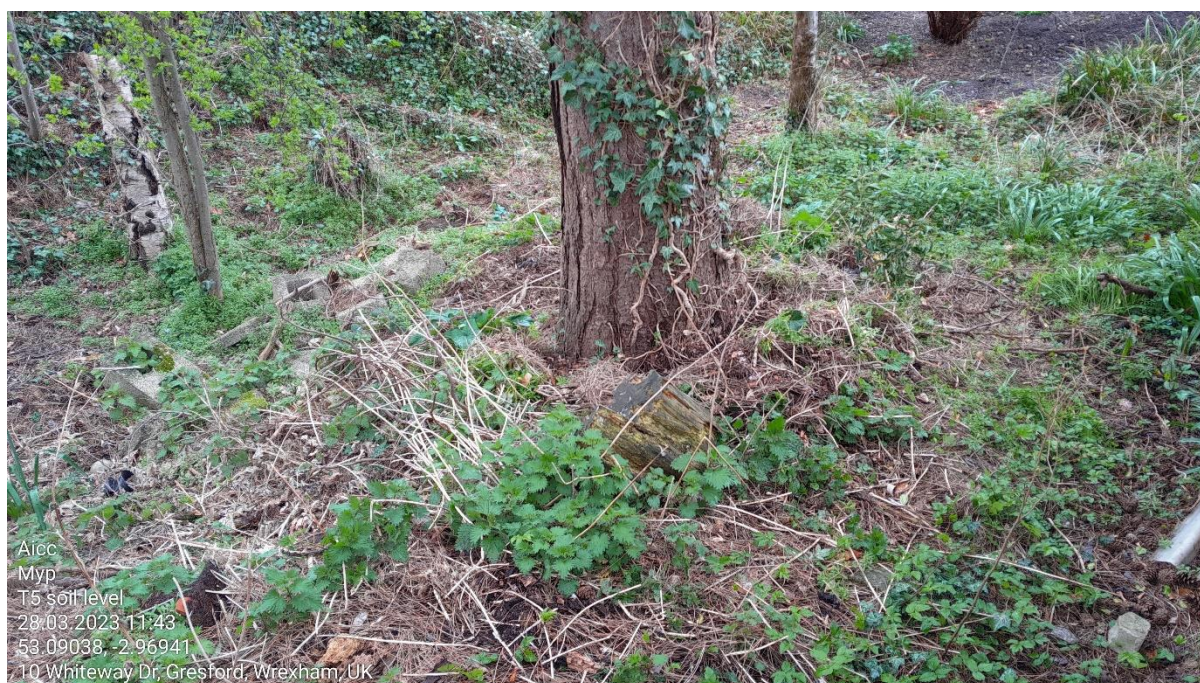
Several trees, 240, 243 & 247 have had the ground level within the rooting zone (RZ) increased through the dumping of garden waste and rubble (figure 4). Significantly increasing the ground level within the

Figure 4 Tree 240 increased ground levels

tree RZ can compact the soil reducing the pore space for oxygen within the soil required by tree roots to survive. This may account for the sparse needle density observed in tree 240 as fine root mortality can be mirrored in the crown through defoliation.

| Tag No. | Species | Age Class | Height (m) | DBH (mm) | Tree Data<br>Comments | QTRA Calculations | | | | | | | Management | |
|---|---|---|---|---|---|---|---|---|---|---|---|---|---|---|
| 240 | Corsican pine<br><i>Pinus nigra</i><br>var.<br><i>maritima</i> | Semi Mature | 16 | 560 | Crown consists of small/ medium diameter laterals biased SW over property.<br>Needle density slightly sparse, evidence of ground level change at base, dumped building waste may be a cause.<br>Branches overhang property fence by 2m pose low risk<br>Junctions well-formed throughout<br>Ivy on stem to 6m<br>No sign of basal decay | Property | Whole Tree | 1 | 100% | Property | 7 | <1/1m | Ameliorate soil levels at base of tree, remove rubble and waste from rooting zone | Low |

| Tree ID | Recommendation |
|---|---|
| 240 | Ameliorate soil levels at base of tree, remove rubble and waste from rooting zone. |

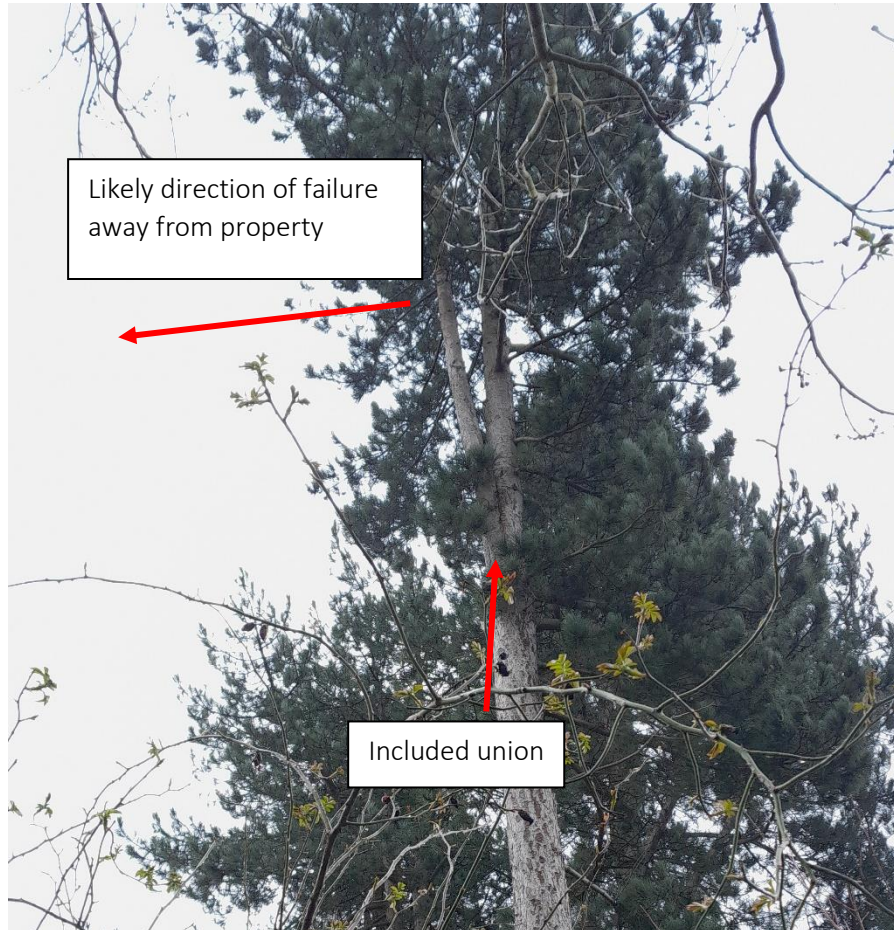
Trees 253 (figure 5) and 244 both have bark inclusions at major stem unions, these unions are weak and can fail in high winds (Lonsdale, 2020). However due to the orientation of these junctions and the likely direction of failure they both pose a low risk to the residential properties as they would likely fail away from the properties. For both trees these failures would pose a risk to the footpath however this

Figure 5 Tree 253 included union

risk is considered low because the footpath is not constantly occupied, furthermore it is a weather affected target i.e. the occupancy of the footpath will be lower during extreme weather conditions required to make the stems fail.

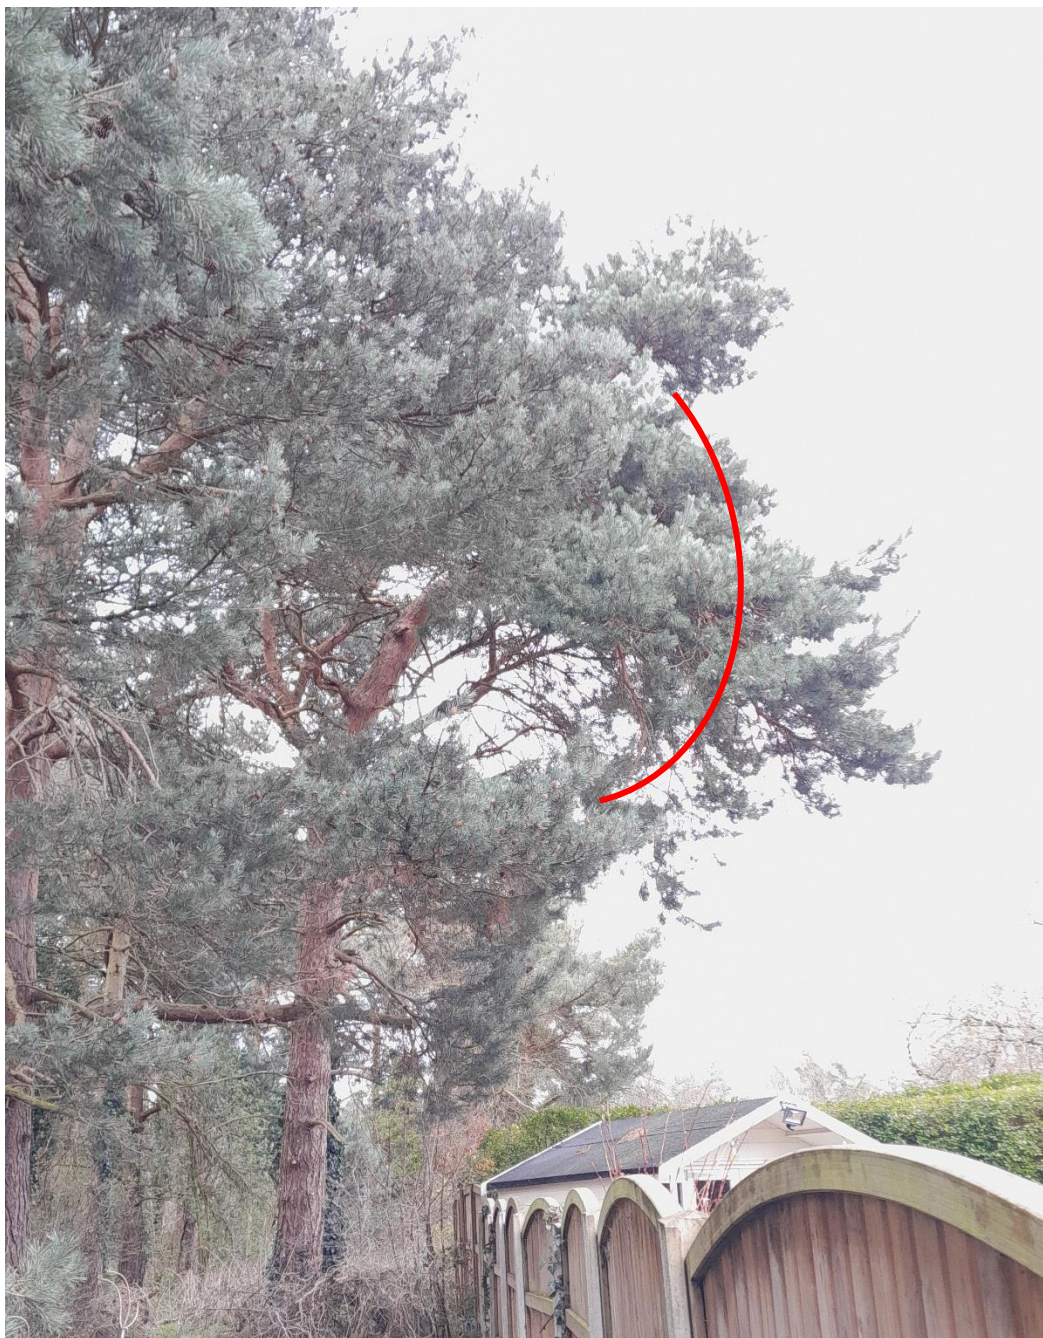
| 252 | Scots pine<br><i>Pinus sylvestris</i> | Semi Mature | 12 | 445 | Crown asymmetric biased SE over garden shed<br>Majority of growth overhangs property and is subject to wind loading from SW, suppression from adjacent trees has forced unbalanced crown shape that will likely suffer branch loss in the future.<br>Junctions are well formed and there is no major deadwood of concern<br>Stem and base in good condition | Property | Branch | 3 | 100% | Property | 4 | 1/300k | Reduce overhanging limbs by up to 3m to prevent failure over summer house. | Medium |

| Tree ID | Recommendation |
|---|---|
| 252 | Reduce overhanging limbs by up to 3m to prevent failure over summer house (Figure 7) |

Figure 7 Tree 252 reduce crown over hanging shed by up to 3m, re line as guide
