PHOTOGRAPHIC SURVEY

58 HOPE STREET, WREXHAM

AINSLEY GOMMON ARCHITECTS AGA

This Photographic Record supports the Full Planning and Listed Building Consent Application for the reordering and restoration of the existing shop front, basement, ground floor and upper floors to. **No.58 Hope Street, Wrexham, LL11 1BE** for a commercial unit to the lower floors and 3no. 2 bedroom apartments to the upper floors.

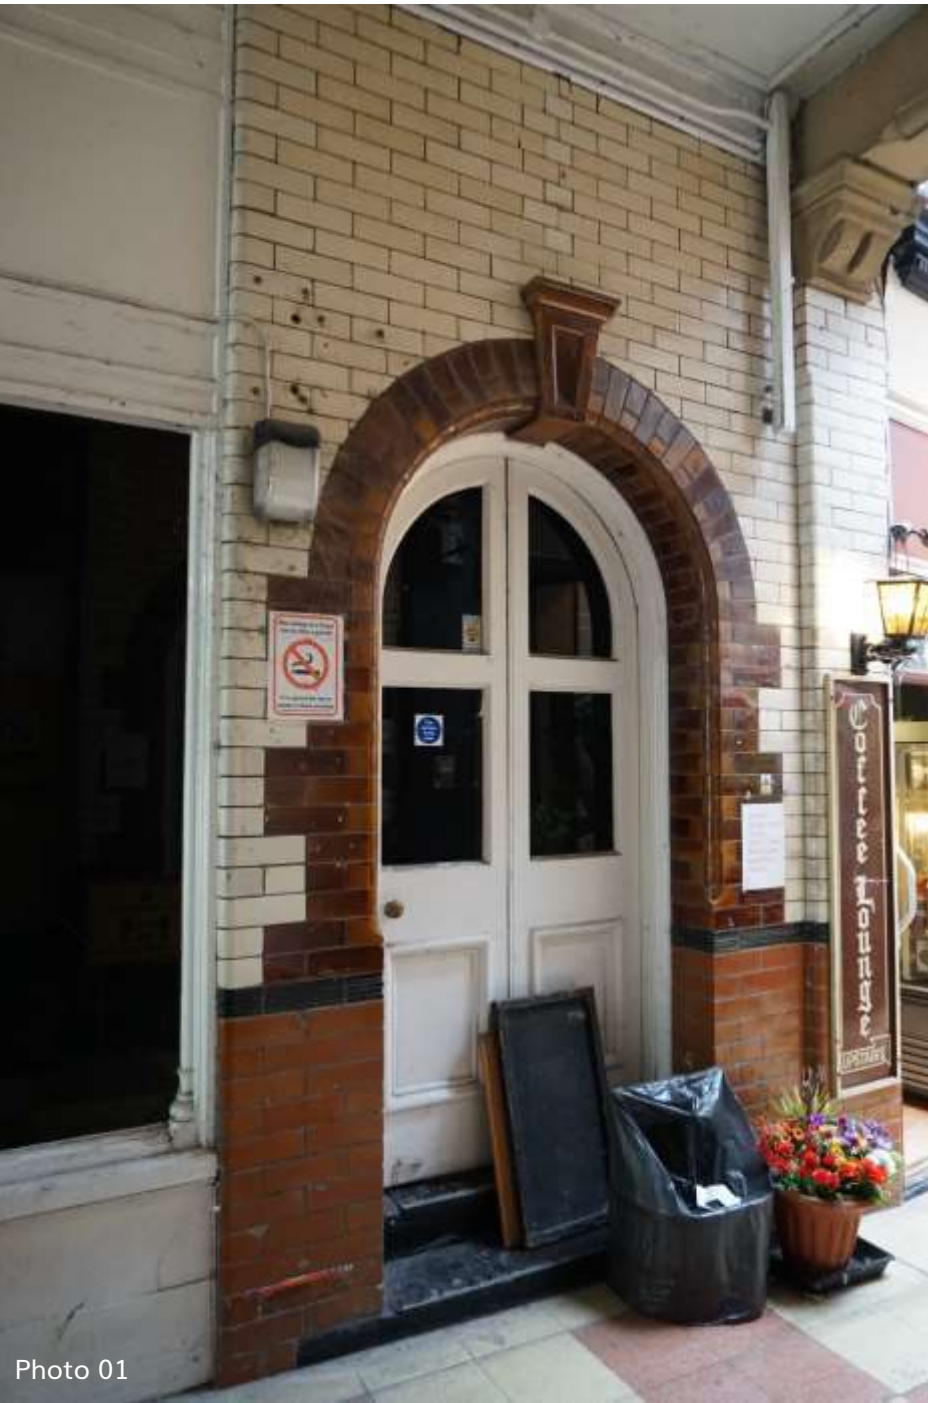
Photo 01

PHOTO 01 - Existing door within atrium of building  
PHOTO 02 - Elevation of Wrexham Central Arcade  
PHOTO 03 - Entranceway through to central atrium

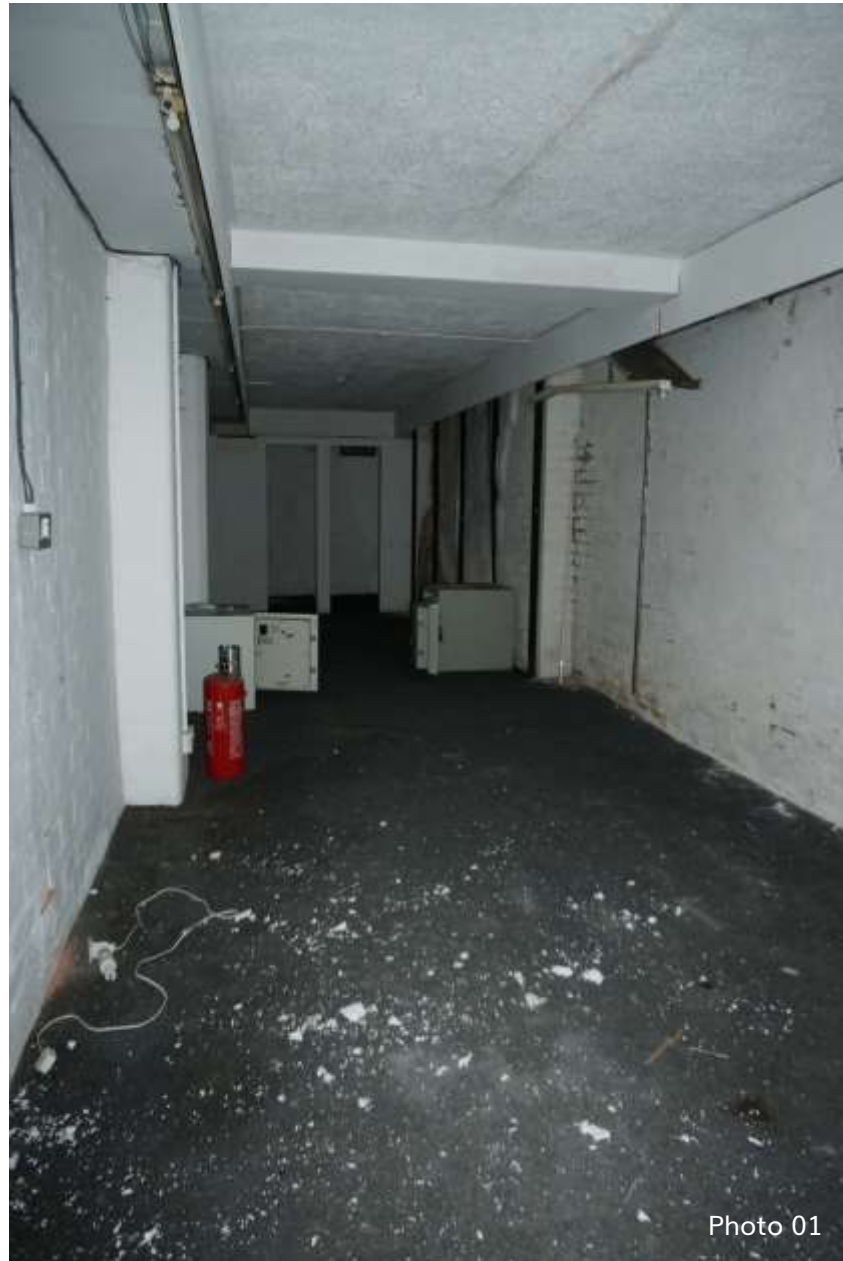
Photo 01

PHOTO 01 - General condition of basement  
 PHOTO 02 - Existing door  
 PHOTO 03 - Existing boxing out of pipes

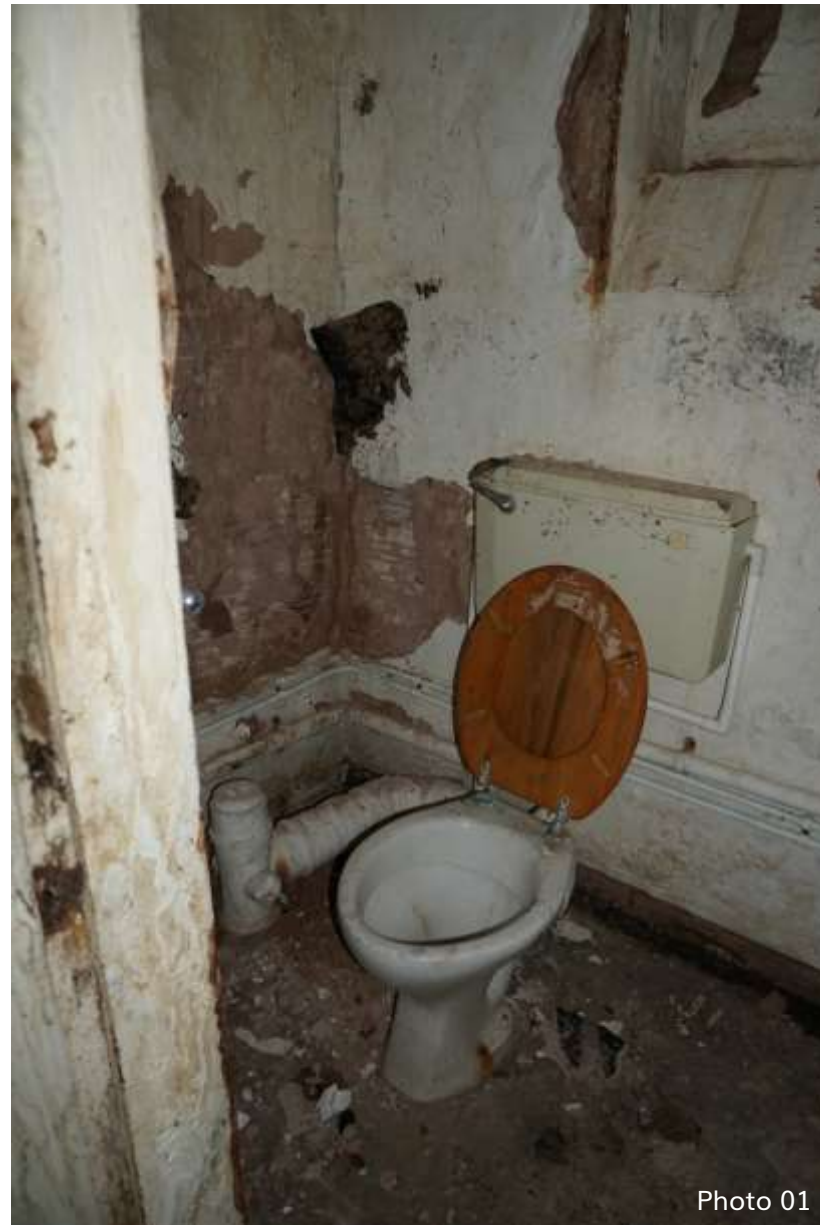
Photo 01

PHOTO 01 - Current condition of basement bathroom and existing toilet  
 PHOTO 02 - Current condition of basement bathroom  
 PHOTO 03 - Current condition of basement bathroom and existing sink  
 PHOTO 04 - Current condition of basement bathroom

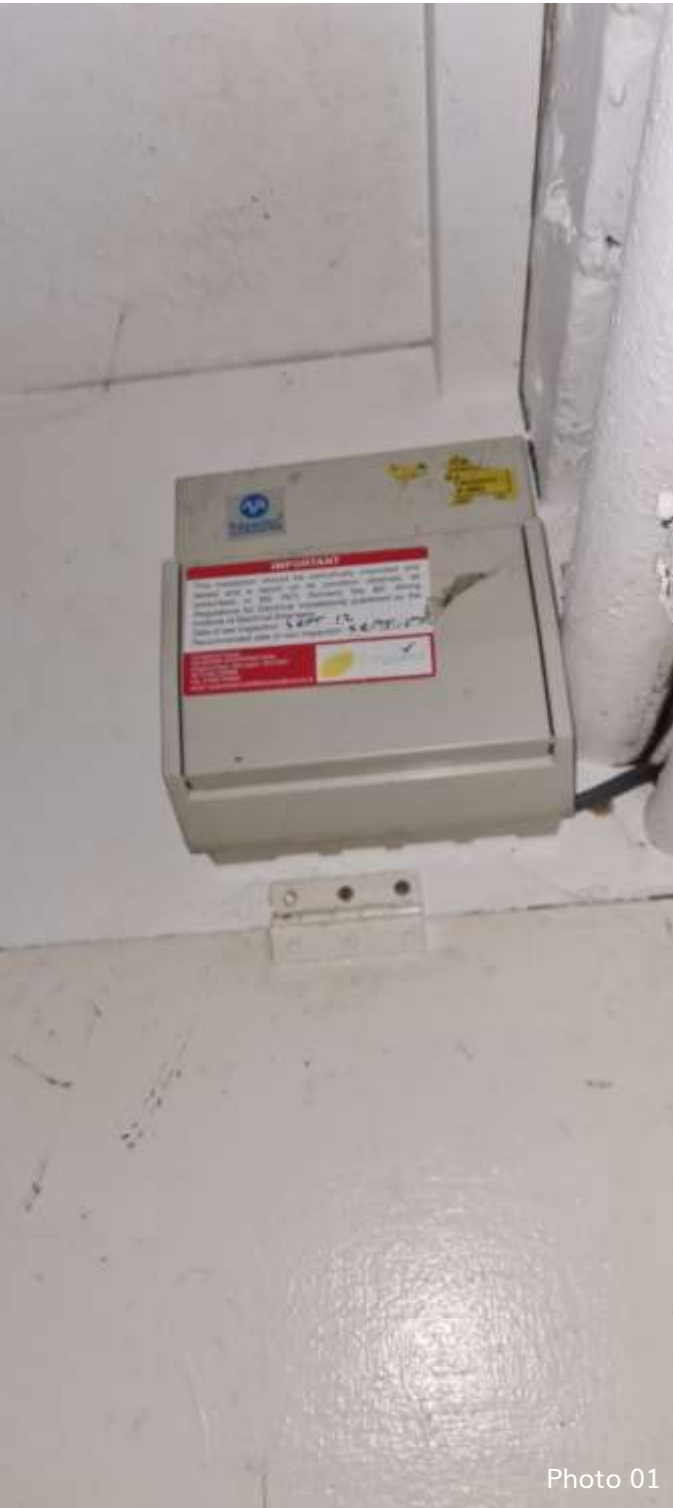
Photo 01

PHOTO 01 - Existing electrical box  
PHOTO 02 - Existing unit and sink  
PHOTO 03 - Exposed pipework  
PHOTO 04 - Existing side board/ unit and walls

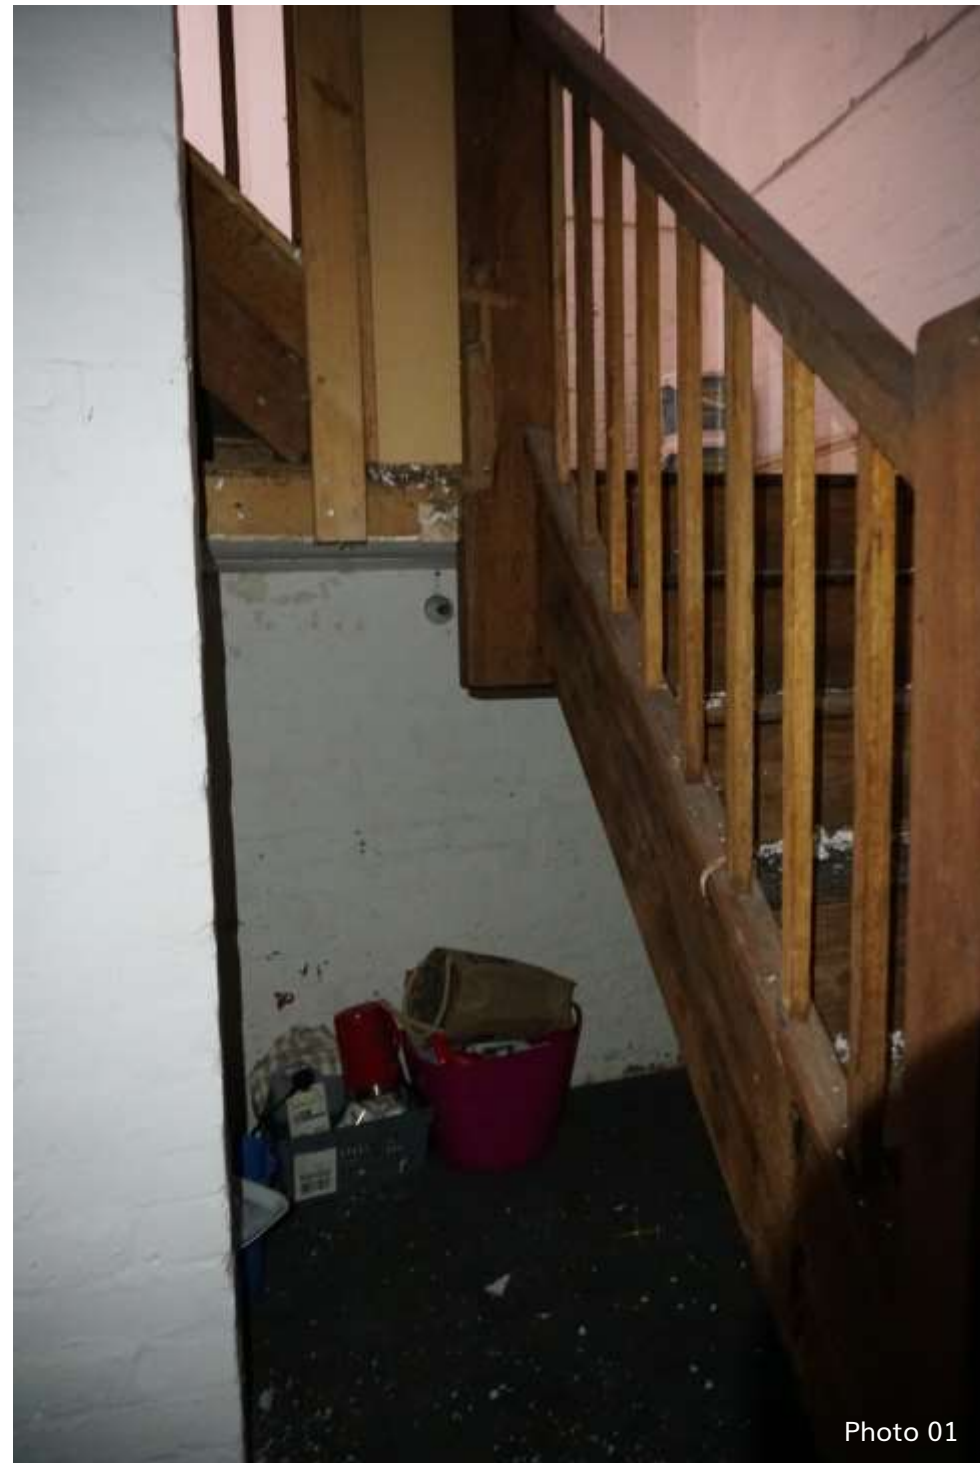
Photo 01

PHOTO 01 - Current condition under staircase  
 PHOTO 02 - Current condition of stairs and hand rail  
 PHOTO 03 - Current condition of staircase

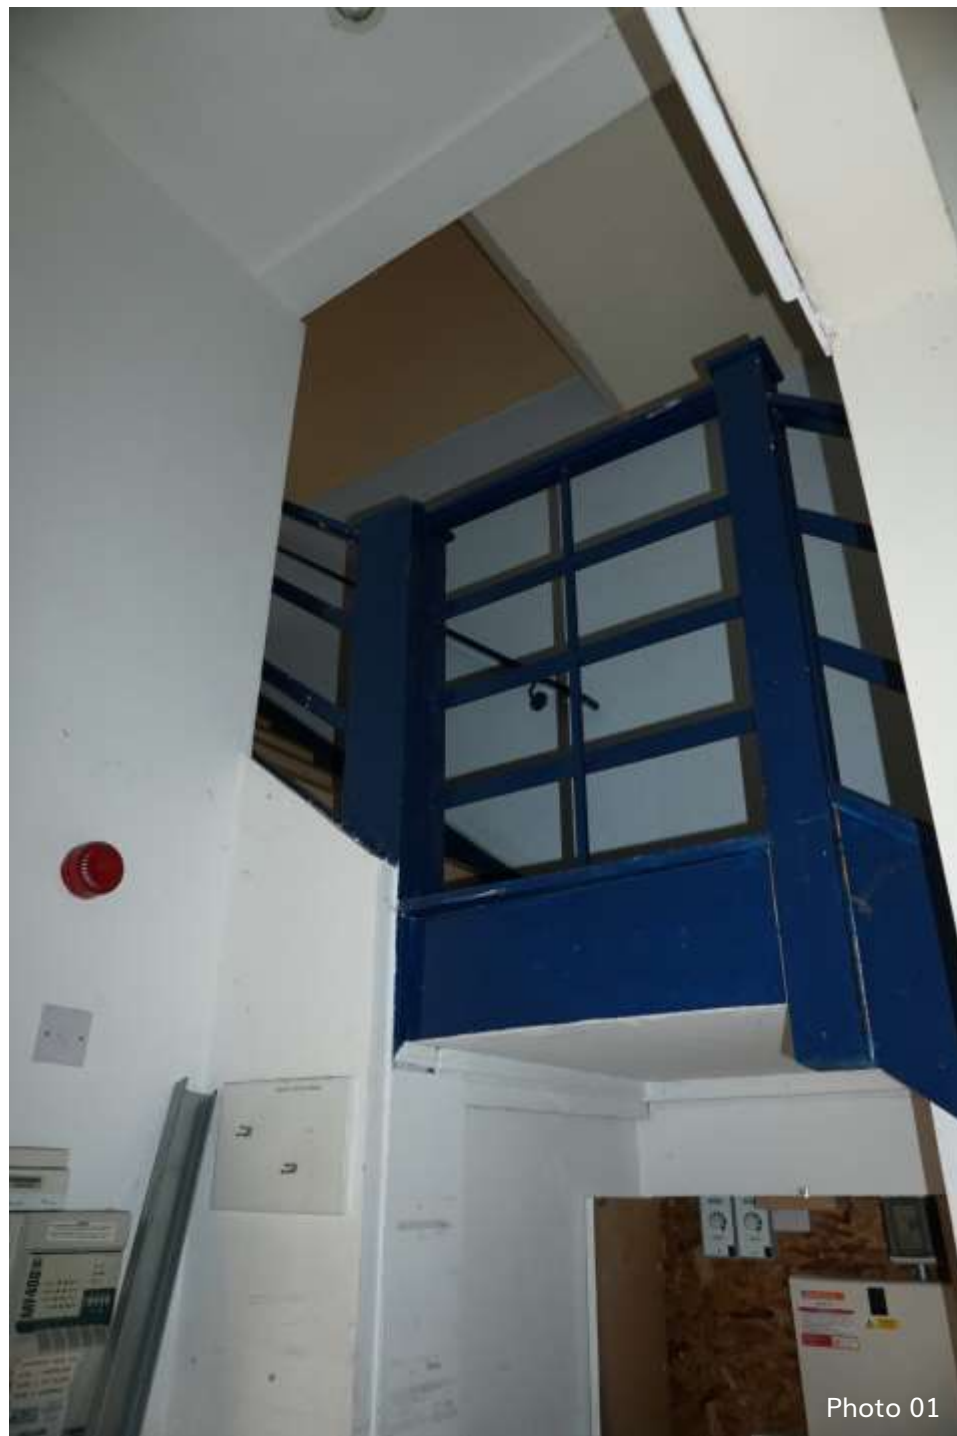
Photo 01

PHOTO 01 - Existing staircase  
 PHOTO 02 - Electrical cupboard and stairwell leading into basement  
 PHOTO 03 - Current condition of existing staircase

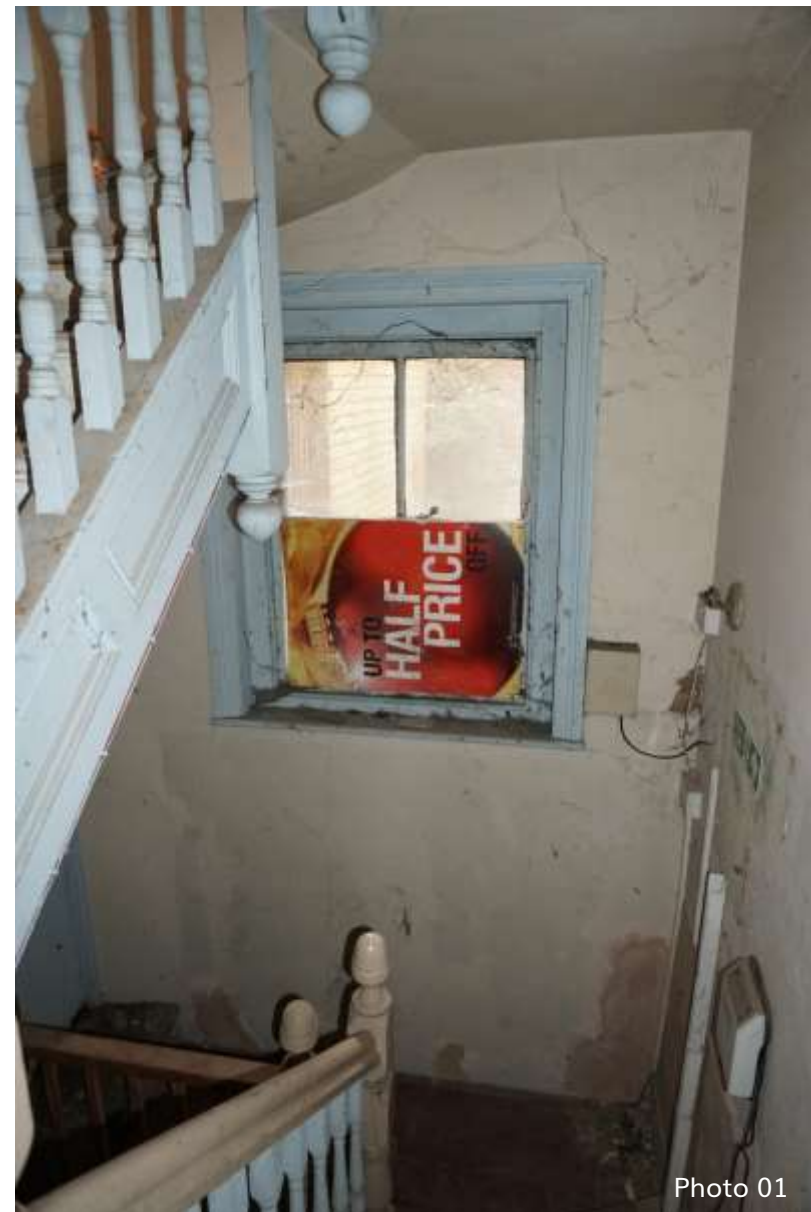
Photo 01

PHOTO 01 - Current condition of room 10  
 PHOTO 02 - Current condition of floor and fire exit door  
 PHOTO 03 - Current condition of existing banister/handrail

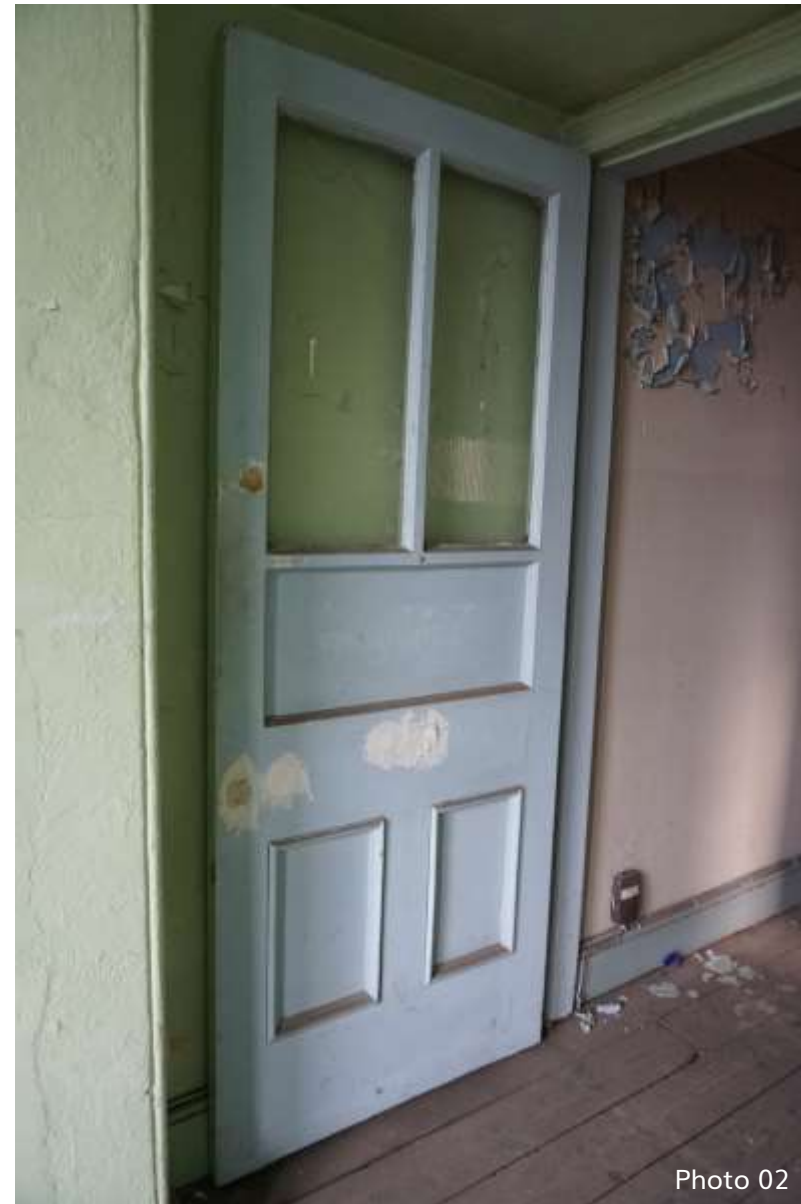
Photo 02

PHOTO 01 - Current condition of room 12  
 PHOTO 02 - Current condition of existing door leading into room 12  
 PHOTO 03 - Current condition of walls

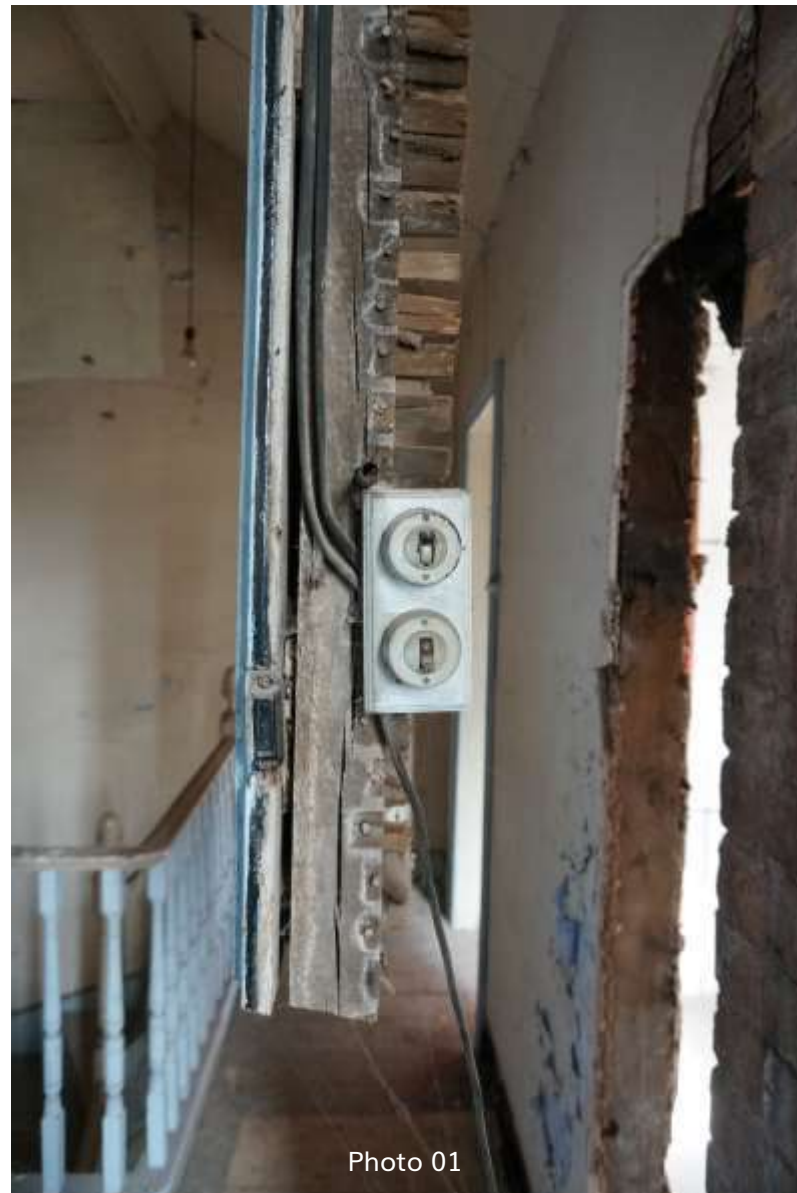
Photo 01

PHOTO 01 - Current condition of walls  
 PHOTO 02 - Current condition of walls  
 PHOTO 03 - Current condition of bay window area

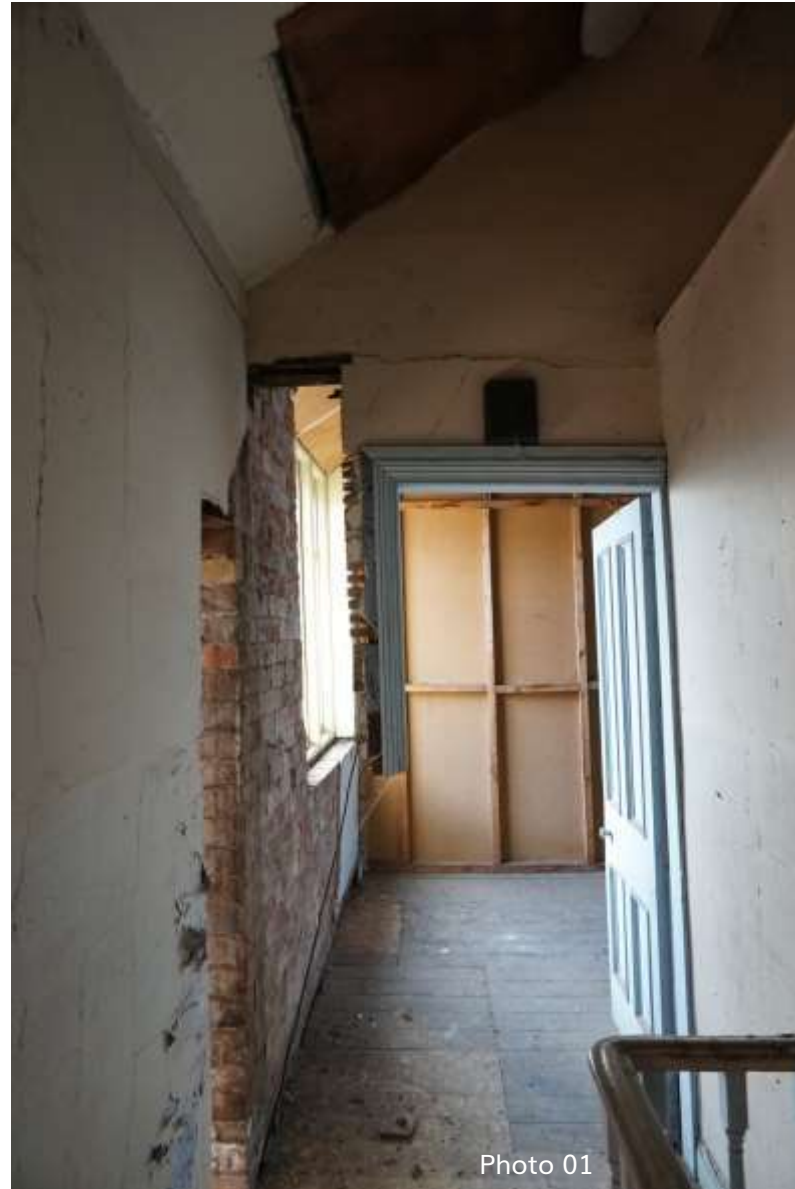
Photo 01

PHOTO 01 - Current condition of room 19  
 PHOTO 02 - Current condition of walls  
 PHOTO 03 - Current condition of ceiling
