## SOAKAWAY ASSESSMENT

**Project Number:**  
PT1293

**Site Address:**  
Coed Derwen, Erbistock, LL13 0DN

**Date Of Testing:**  
07/06/2022

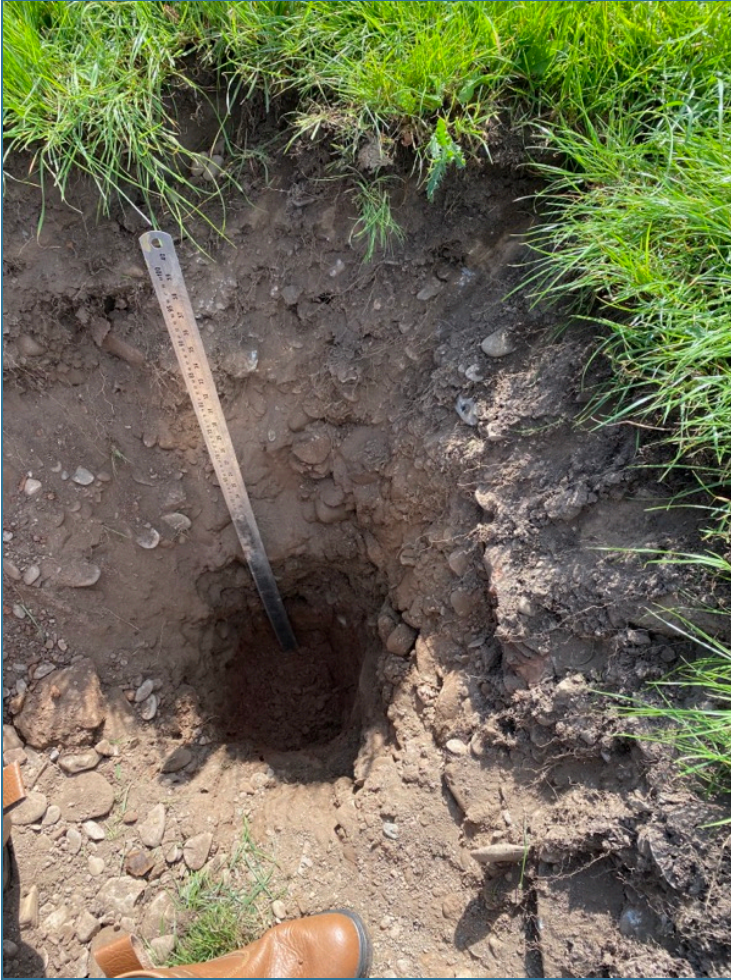
Trial Pit A

Excavated to 1000mm

Ground Water Encroached During Excavation

No

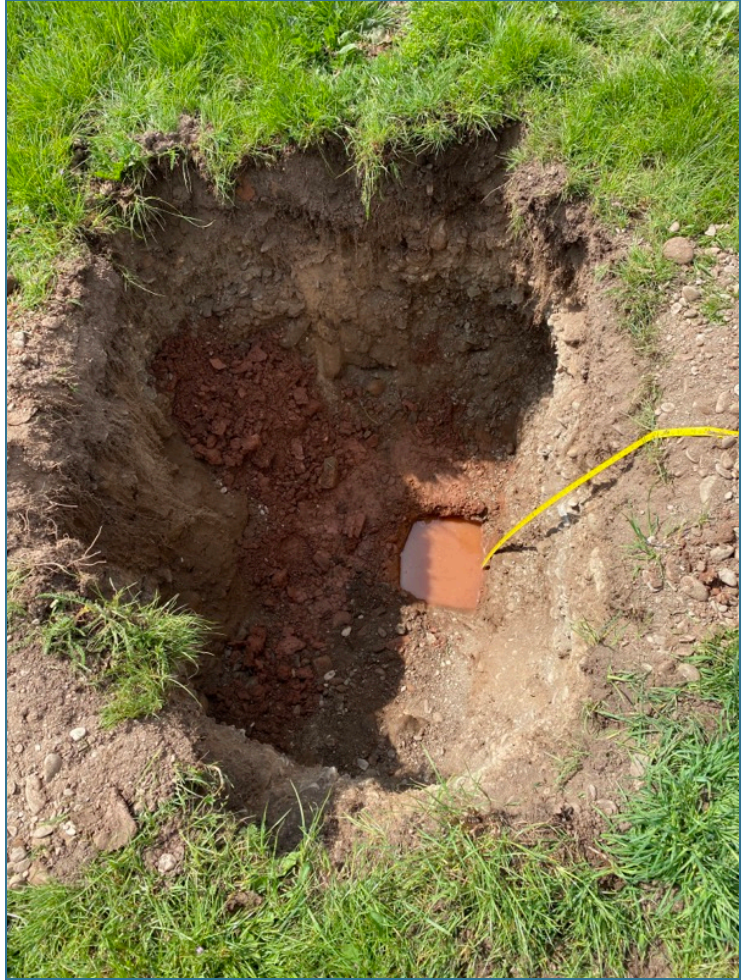
Trial Pit B

Excavated to 1200mm

Ground Water Encroached During Excavation

No

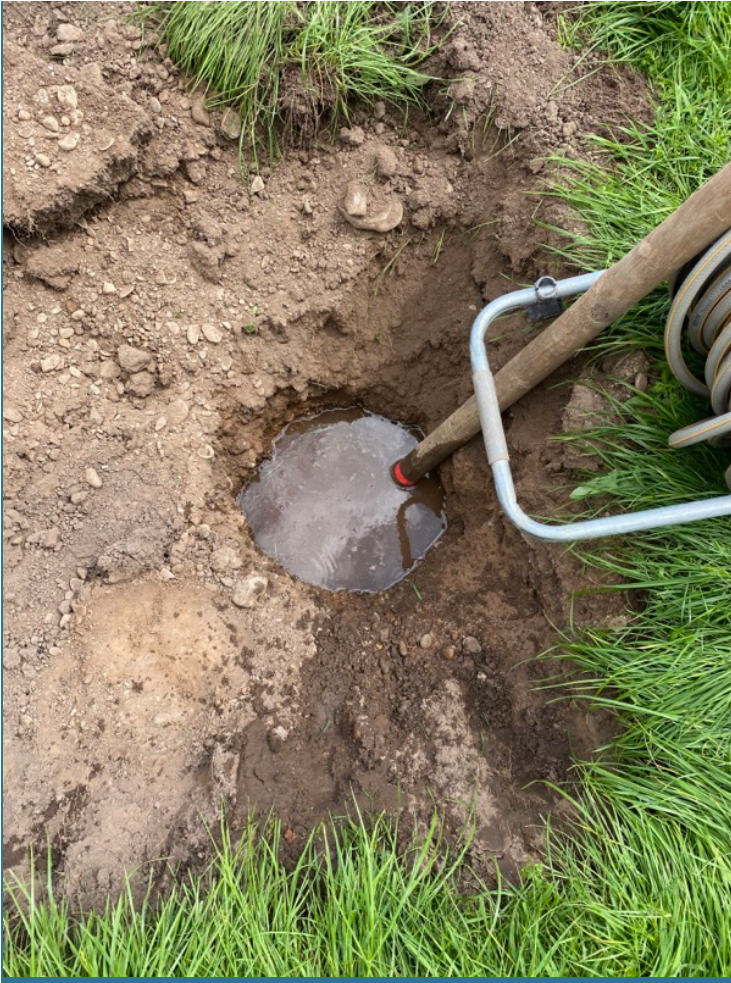
Trial Pit C

Excavated to 400mm

Ground Water Encroached During Excavation

No

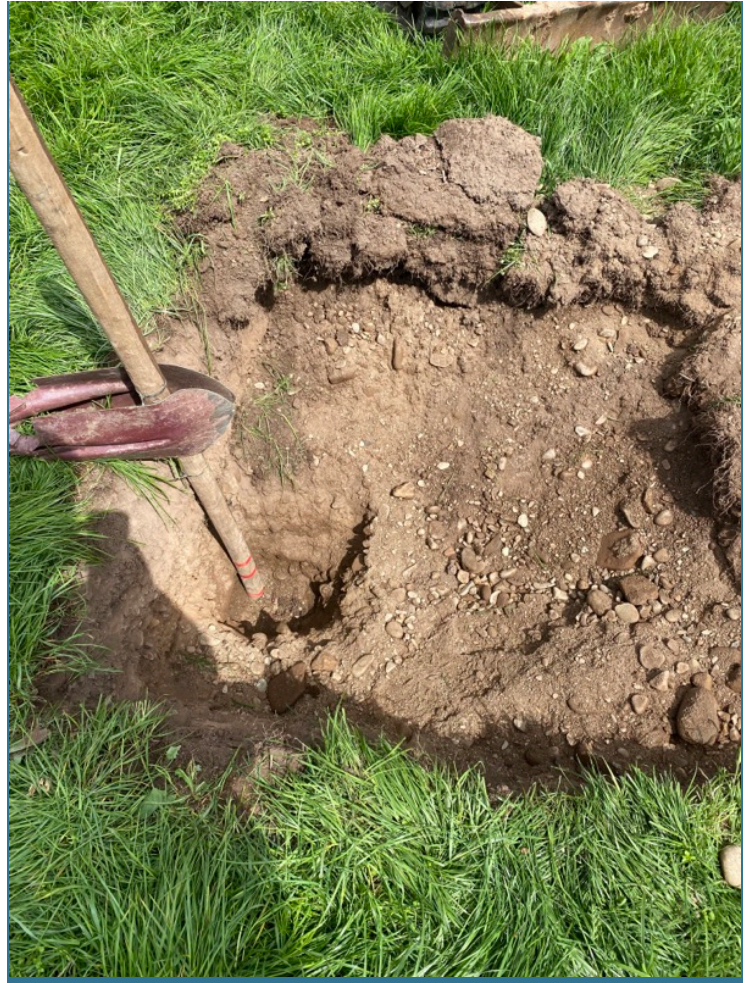
Trail Pit D:

Excavated to 500mm

**Ground Water Encroached During Excavation**

No

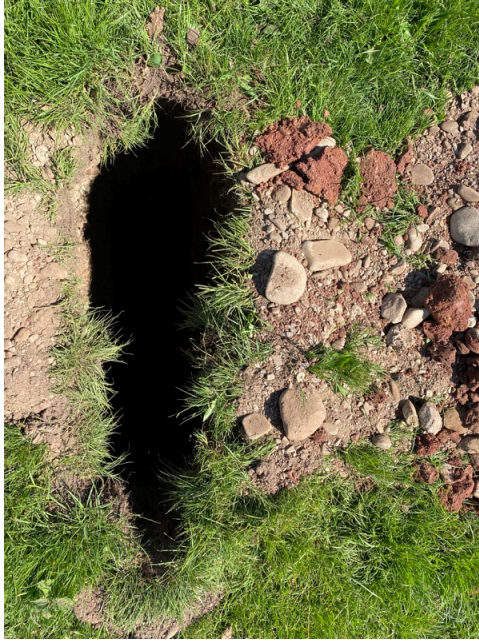
#### PHOTO

Whilst on site, a deeper trial pit was excavated with the purpose of identifying the ground water table, the pit was left open during the course of the day and the following information was recorded.

**Ground Water Encroached**

No

**Depth Of Excavation**

2400
