| TITLE | PROJECT | Bryn Farm, Hanmer | <div>DATRYSMODELU DYLUNIO PEIRIANNEG<br/>MODEL DESIGN ENGINEERING</div> | Job No. | 23012 | DATE | 16.03.23 | SCALE | NTS |
| | | | | DRAWN | WL | DRG No. | 23012 SK02 | REV | |

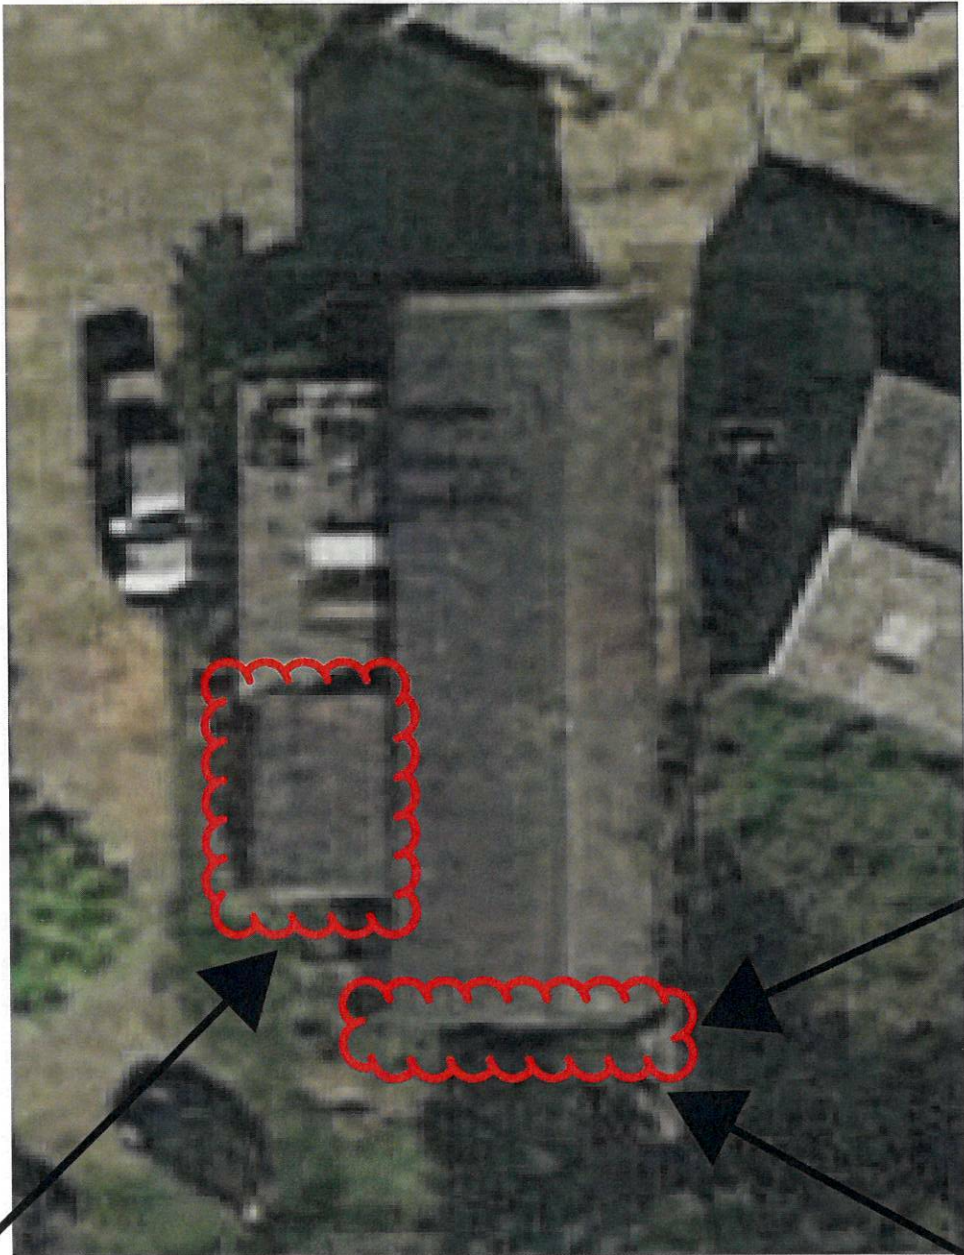
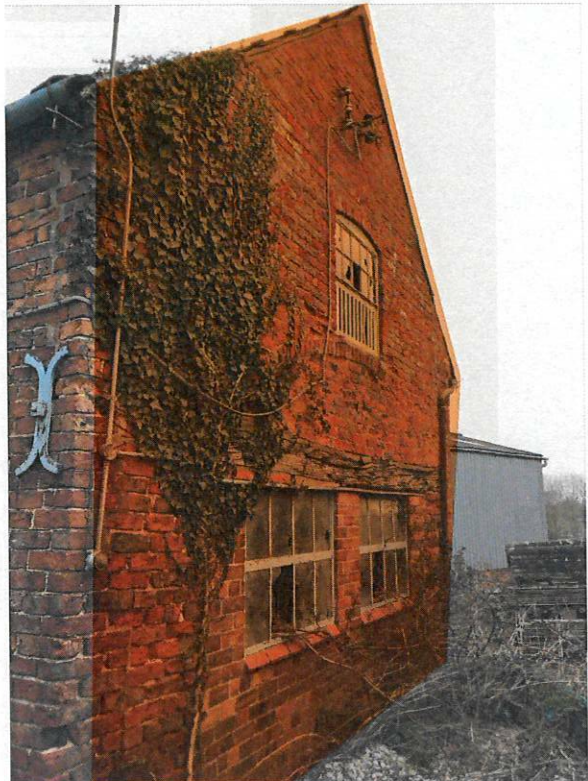
SOUTH GABLE IS SIGNIFICANTLY DISTORTED, NUMEROUS BRICKS ARE WEATHERED AND THE TIMBER WITHIN THE WALL IS SUBJECT TO ONGOING DECAY. PREFERABLE TO DEMOLISH AND REBUILD

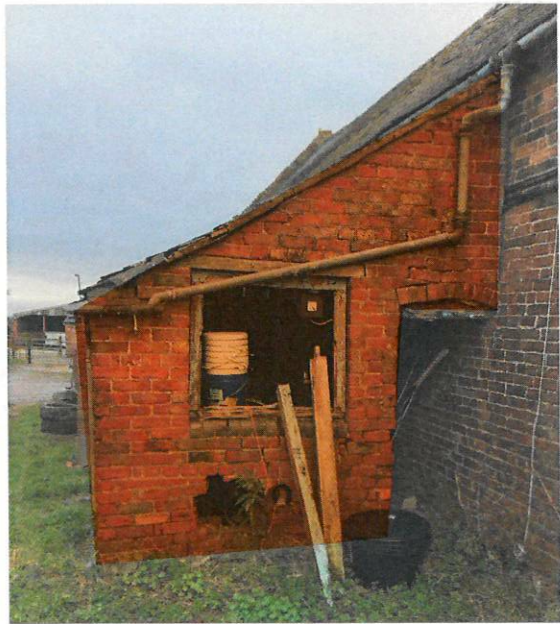
LEAN-TO ANNEX IS IN POOR CONDITION AND NEEDS TO BE DEMOLISHED

Percentage of total building area needing to be demolished and replaced = 12%

Approximate percentage of total external wall area needing to be demolished and replaced = 26%

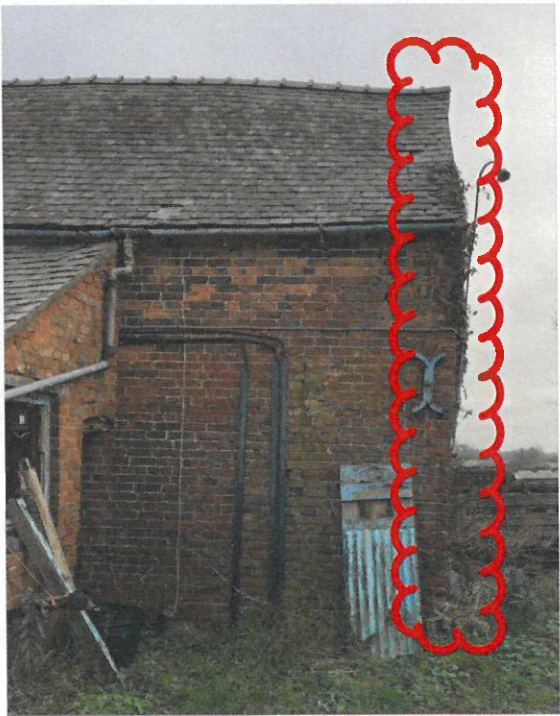
SOUTH GABLE IS SIGNIFICANTLY DISTORTED, NUMEROUS BRICKS ARE WEATHERED AND THE TIMBER WITHIN THE WALL IS SUBJECT TO ONGOING DECAY. PREFERABLE TO DEMOLISH AND REBUILD
