## 9 SHERBOURNE AVENUE; BAT AND NESTING BIRD SURVEYS

Report Ref: EE.1156.22.A KW

| <b>Site</b> | 9 Sherbourne Avenue, Bradley, Wrexham, LL11 4AZ<br>Approx. OS Grid Ref: SJ3245653648 |
| <b>Type of survey</b> | Bats - Preliminary Roost Assessment (PRA) and Emergence Survey (19/07/2022)<br>Birds – Nesting Bird Survey |

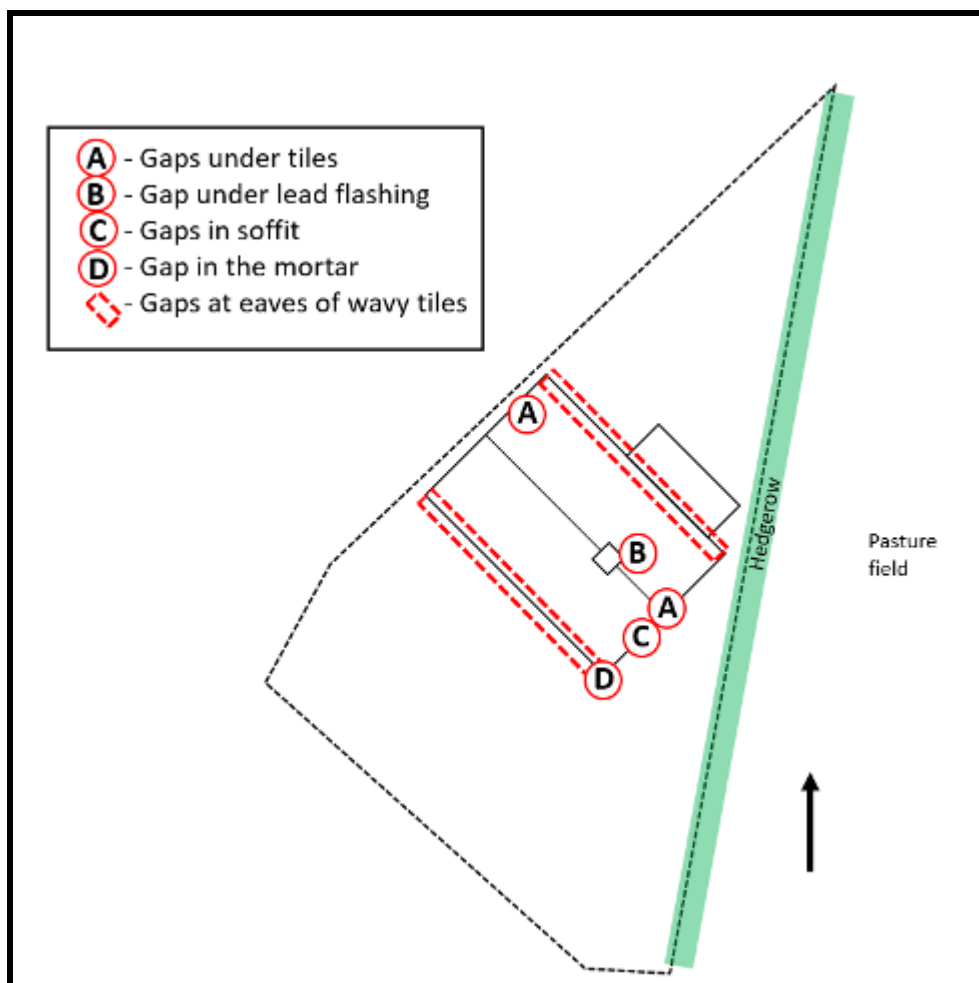
4.2.1 There were several potential access points and Potential Roosting Features (PRF's) for crevice dwelling bats into the building, primarily via gaps at the eaves due to the tile's wavy design; though these gaps were quite shallow and exposed and appeared to only be the depth of the bottom tile. There were limited PRF's in broken tiles and gaps in the mortar, but otherwise the building and remaining tiles was largely well sealed. There was no available access for horseshoe bats. Internally the building was light and draughty as a result of being stripped and exposed to the windows and sky lights. There were limited roosting opportunities for crevice dwelling bats within the building, aside from against the felt underneath the tiles. The majority of the ceiling/loft floor had been removed, with just a small boarded area being retained that was open to the ground floor around the edges. No evidence of bats was found anywhere inside or outside the buildings, or around the potential features. The locations of potential features for bats are shown in Figure 4.2 and are described in Table 4.2.

**FIGURE 4.2: PLAN OF BUILDINGS (NOT TO SCALE) AND LOCATIONS OF POTENTIAL BAT FEATURES (LETTERS RELATE TO FEATURES IN TABLE 4.2 BELOW)**

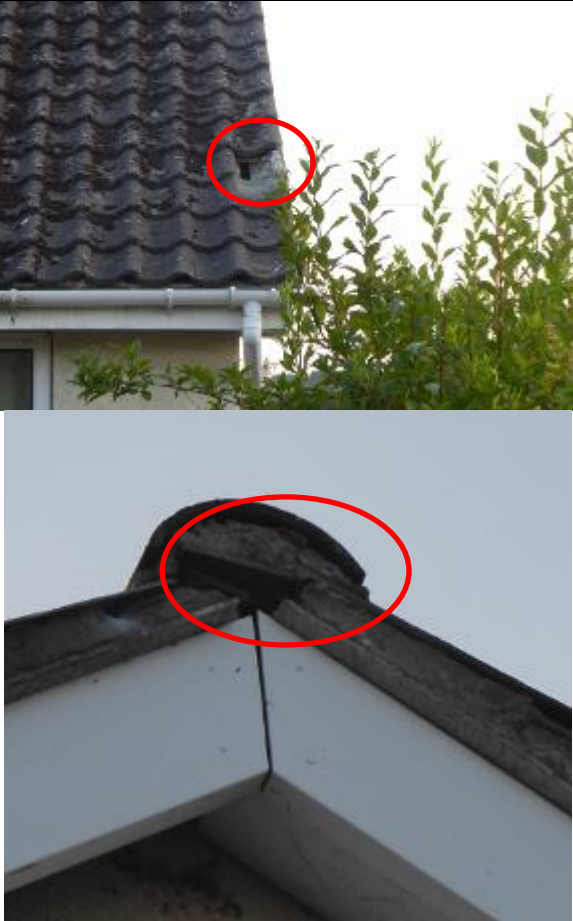
| Feature | Description | Example Photos |
|---|---|---|
| <b>A</b> | Gaps underneath tiles - There was a missing tile on the northern-most corner of the roof and a gap under the ridge tile on the south eastern apex. | |

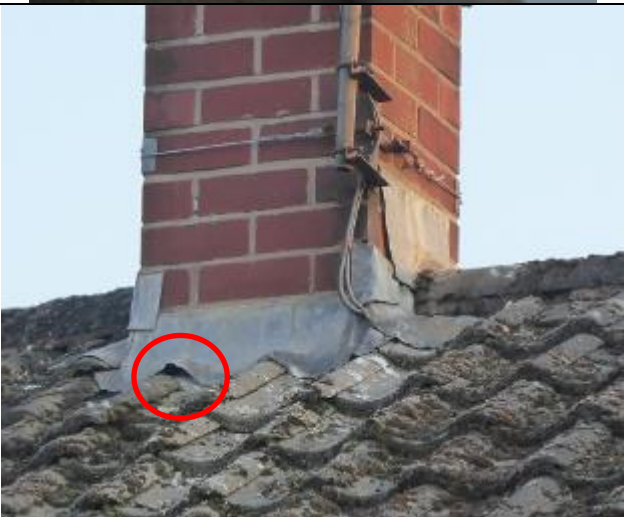
| Feature | Description | Example Photos |
|---|---|---|
| <b>B</b> | Gap under the lead flashing on the chimney | |

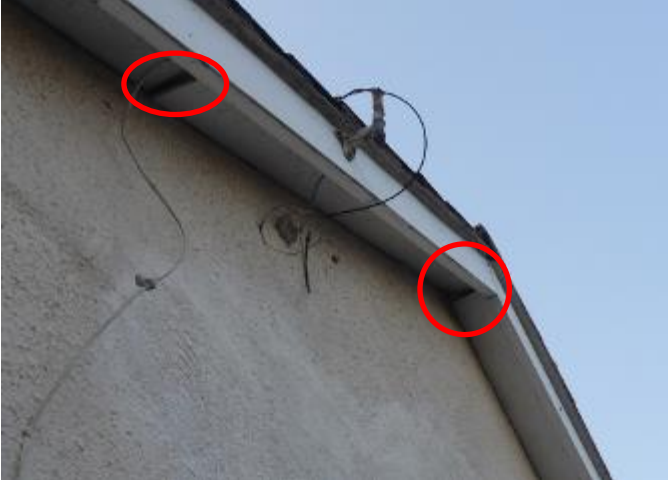
| Feature | Description | Example Photos |
|---|---|---|
| C | <p>There were two narrow gaps in the soffit box on the south eastern gable. The gaps were cobwebbed over at the time of survey.</p> | |

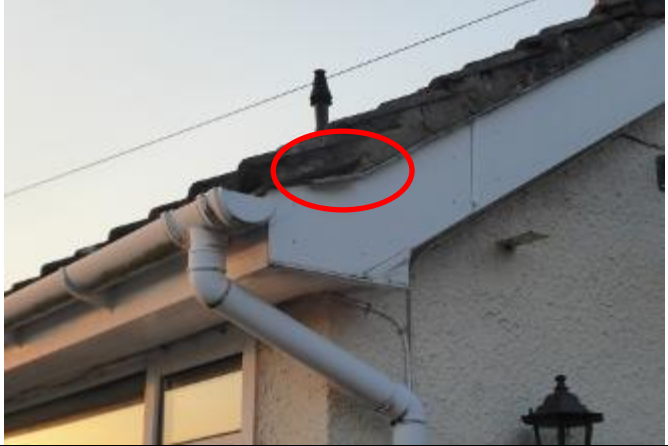
| Feature | Description | Example Photos |
|---|---|---|
| D | <p>Gap in the mortar on the south eastern gable – space underneath appeared to be shallow.</p> | |

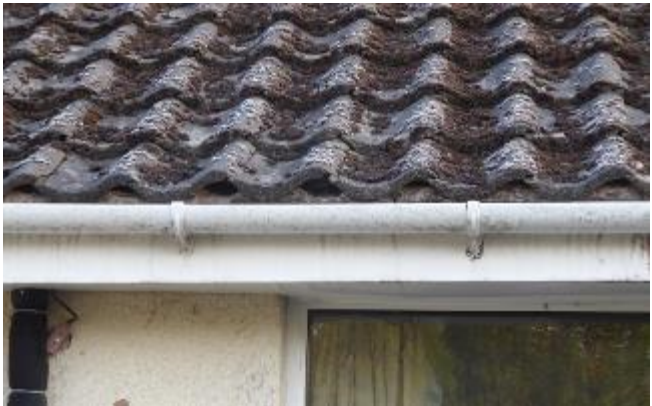
| Feature | Description | Example Photos |
|---|---|---|
| E | <p>Gaps at the eaves underneath the wavy tiles. The gaps stretched the length of the building on both elevations but appeared to be shallow (~15cm) and quite exposed as they did not appear to go further than the bottom tile of the roof pitch in the ones that could be inspected.</p> | |

6.1.2 While bats were not observed using the building, there was bat activity within and around the site and bats can move into buildings at any time. The existing roof should be stripped by hand and with caution, to reduce the risk to bats (or any other animals) that may have moved in underneath the tiles.

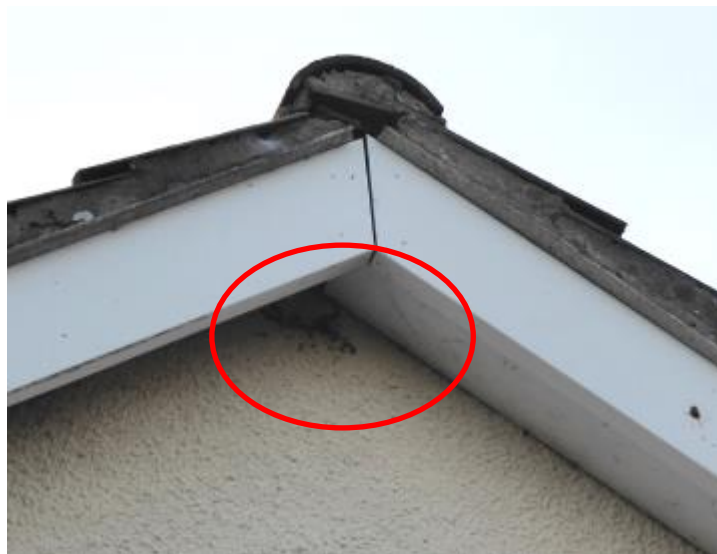
**PHOTO 4.1: POSSIBLE REMNANTS OF A HOUSE MARTIN NEST**

- 5.4.1 The building proposed for conversion provided suitable bird nesting habitat and there did appear to be remnants of a house martin nest on the north eastern gable. Therefore, any

- 6.2.1 The building provided suitable habitat for nesting birds and there were possible remnants of a house martin nest on the south eastern gable. The destructive works should therefore be undertaken outside of the bird nesting season (which is March - September inclusive) to reduce the risk of disturbance to nesting birds. Should it be necessary to carry out works within the nesting bird season, a nesting bird check should be carried out by an ecologist immediately prior to (no more than 48hrs before) works commencing to ensure that no active nests will be affected. If active nests are found then all work in the vicinity of the nest **must be delayed** until all chicks have fledged.

- 6.2.2 To compensate for the loss of bird nesting habitat in the conversion works, and enhance the site for birds, bird nesting opportunities will be provided by including bird boxes around the site. A minimum of two artificial double house martin nests should be erected on the north western and south eastern elevations, as high as possible and away from the bat boxes (see Figure 6.3 for an example and Figure 6.4 for locations). Boxes suitable for small birds should also be erected within the site, either on the building or in the garden – at least one suitable for house sparrows (*Passer domesticus*) with a 32 mm entrance and one for smaller birds (28 mm). Examples of suitable bird boxes are: vivara pro woodstone house sparrow nest-box and vivara pro seville 28mm woodstone nest-box. Woodstone nest boxes are more durable and require less maintenance than wooden boxes.
