**BUILDING CONDITION SURVEY  
WITH RESPECT TO  
CHAPEL FARM, NEWBRIDGE ROAD, NEWBRIDGE, WREXHAM, LL14 3JA**

**MR & MRS J. EDWARDS**

FISHER GERMAN LLP  
4 Vicars Lane  
Chester  
Cheshire  
CH1 1QU  
Tel: 01244 409660

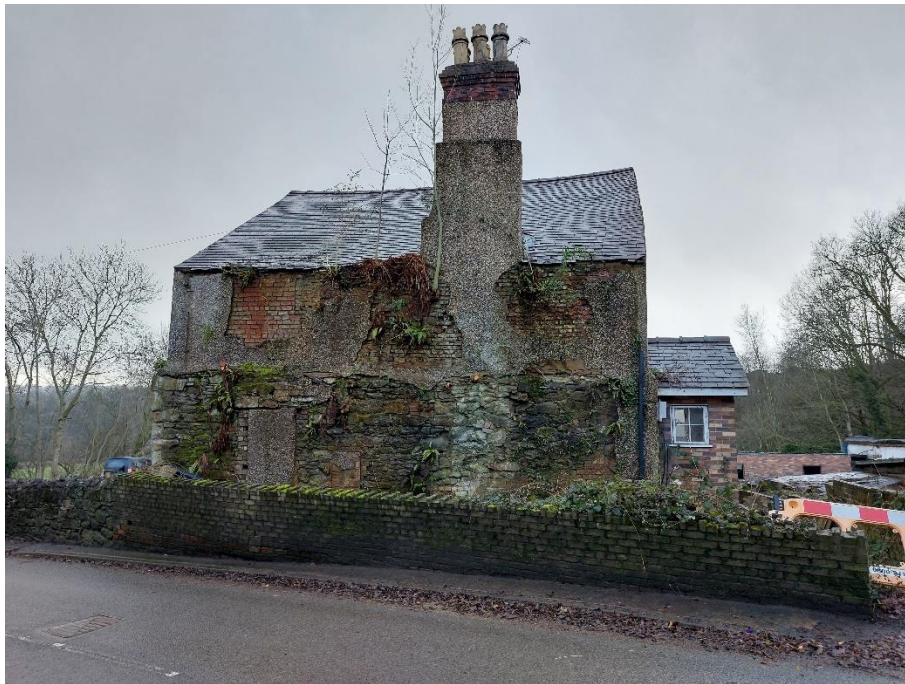
Figure 1 – Chapel Farm, roadside elevation
