## Arboricultural Report

Whitewalls

Station Road, Chirk

Date of Issue: 19<sup>th</sup> February 2018

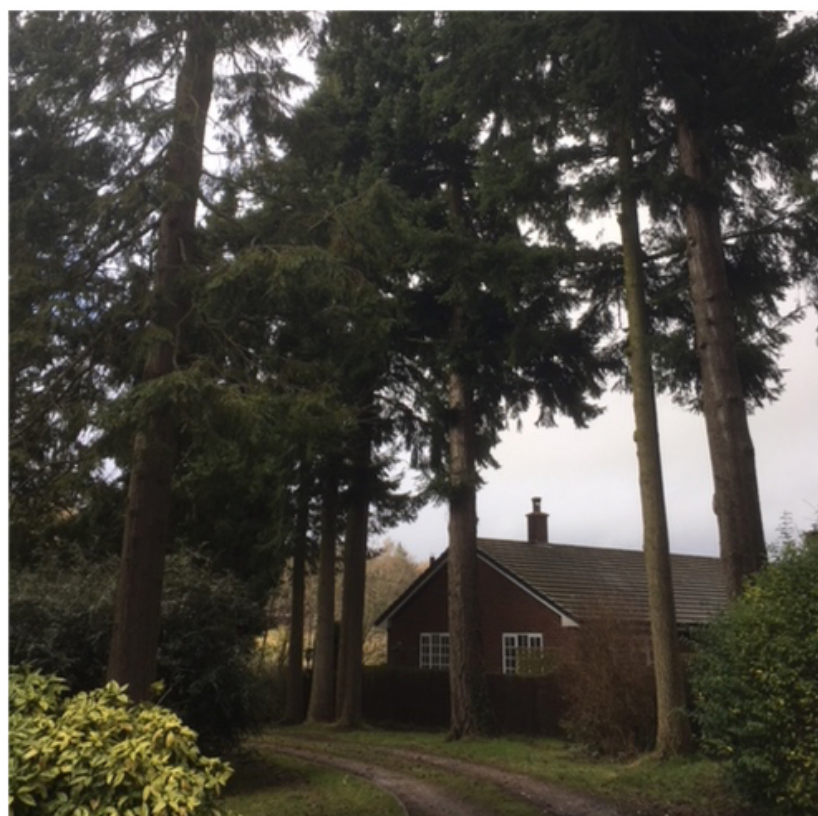
P1 - Driveway Douglas fir

residential plot. The majority of the trees are of a similar age however there are 3 (T11, T13, T18) that appear to have been established first given their larger stem diameter. (Photograph 1)

- 3.2 T1 – T19 run along the access driveway and border the site. Epicormic growth was noted in several of the trees and recorded where excessive. In addition, T18 and T19 both have several minor deadwood branches. Both epicormic growth and deadwood are likely to have been caused by soil compaction occurring as vehicles utilise the adjacent gravel driveway. Soil compaction can be extremely detrimental to trees as it creates anaerobic conditions impairing tree root function. (LONSDALE 1999) No remedial action has been specified at this time however, the trees have been scheduled for a more regular inspection regime to monitor the situation. (Photographs 1 & 2)

- 4.3 Trees need to be inspected regularly and as such recommendations for re-survey are made here. Given their condition and location it is recommended that T1 – T19 are inspected in two years from the date of this report.

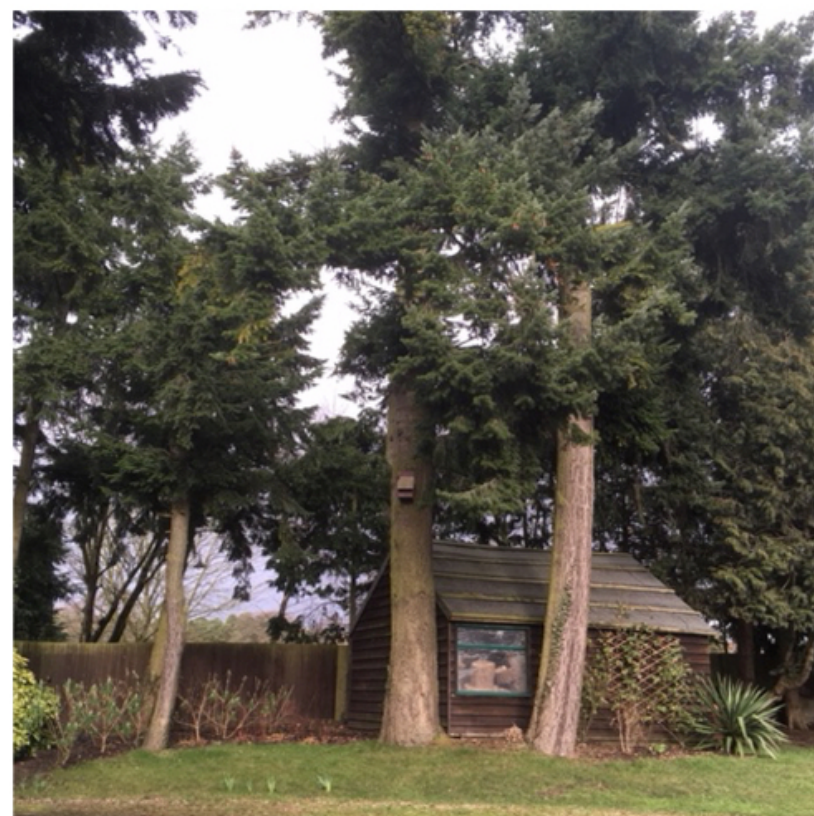
P2 - T18 & T19

| Tree ID | Botanical Name | Common Name | Height (m) | DBH (cm) | Age Class | Comments | Management Prescriptions |
|---|---|---|---|---|---|---|---|
| 18 | <i>Pseudotsuga menziesii</i> | Douglas fir | 20 | 72 | SM | Ivy growth on main stem. Shed growing against buttress. Habitat box on main stem. Crown epicormics. Minor deadwood over shed. | Maintain control of ivy keeping main stem clear. |
| 19 | <i>Pseudotsuga menziesii</i> | Douglas fir | 21 | 49 | SM | Shed at 50cm from stem base. Minor deadwood. Ivy growth on main stem. | Maintain control of ivy keeping main stem clear. |

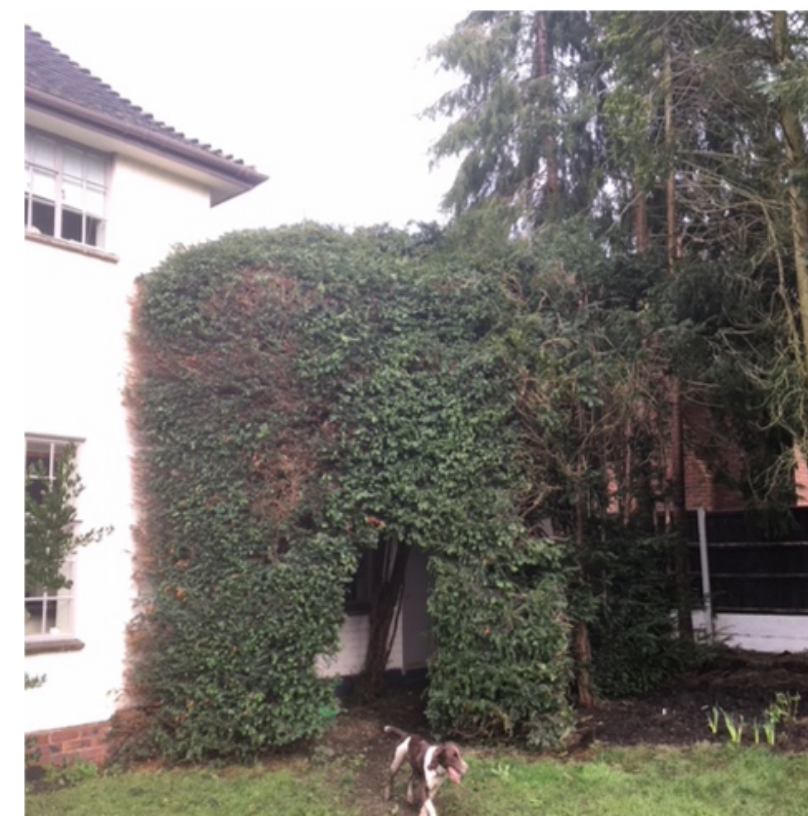
P3 - Group 6 Yew

- 3.11 G6 is a small group of Yew that has been pruned to create a hedge, arch and screen against the house. Two of the trees are in close proximity to the house with a visible surface root growing directly under the house. One tree in particular makes up the majority of the effective screening and as such its loss would impact greatly on the aesthetic value of this feature however, its removal has been recommended to prevent the likelihood of damage to the property. (Photographs 3 & 4)

| Group ID | Botanical Name | Common Name | Height (m) | DBH (cm) | Age Class | Comments | Management Prescriptions |
|---|---|---|---|---|---|---|---|
| 6 | <i>Taxus baccata</i> | Yew | 4 | 10 | SM | Maintained hedge creating arch and screening. 2 trees at 30cm from house wall with one surface root beneath house. | Remove two trees in close proximity to structure to avoid the potential for damage. |

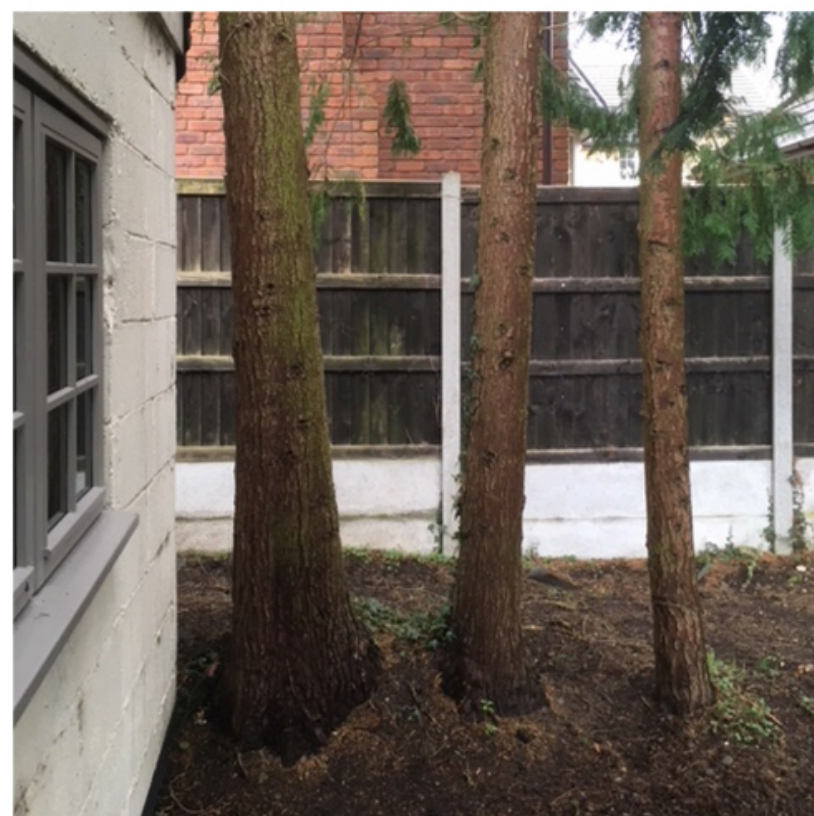
P5 - Group 5 Cypress for Removal

- 3.9 Group 5 has three Lawson cypress trees situated adjacent to the garage at close proximity to it and each other, the three trees are in a straight line. Their removal

has been recommended given their proximity to a permanent structure.  
(Photograph 5)

| Group ID | Botanical Name | Common Name | Height (m) | DBH (cm) | Age Class | Comments | Management Prescriptions |
|---|---|---|---|---|---|---|---|
| 5 | <i>Chamaecyparis lawsoniana</i> , <i>Taxus baccata</i> | Lawson cypress, Yew | 11 | 20 | SM | Linear woodland type group. Suppressed cypress. 3 Cypress in close proximity to garage, closest at 10cm. Made up soil at front of group over flower and shrub bed. Ivy growth on main stems. | Remove 3 Cypress trees adjacent to garage. Maintain ivy control. Consider removal of suppressed cypress to allow for alternative replacement planting. |

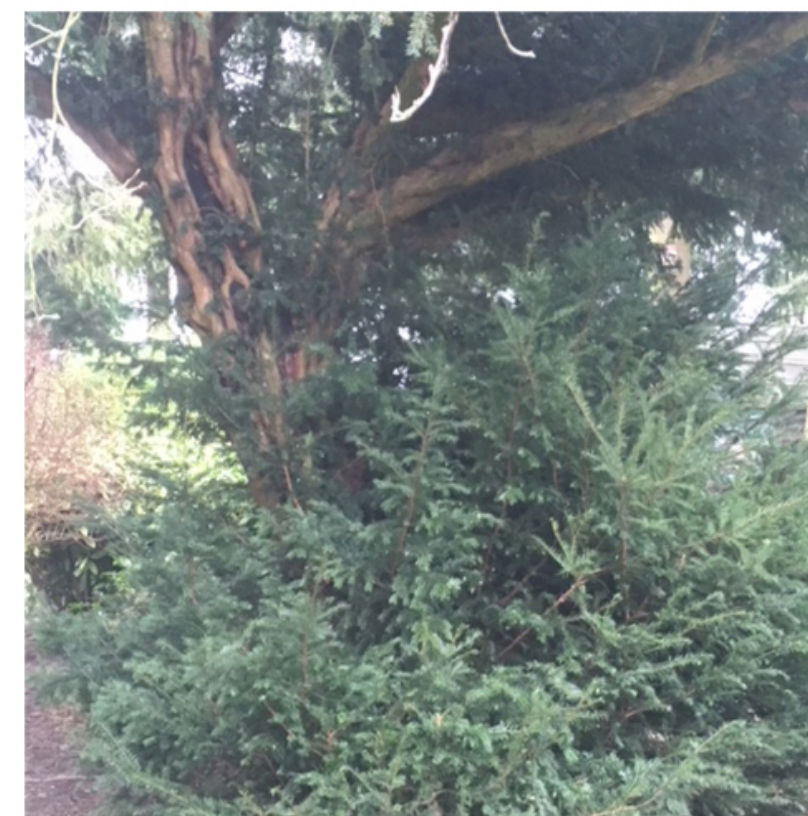
P6 - T35 Yew with Epicormic Growth

- 3.7 T35, Yew, has stem and crown epicormics that appear to be as a result of soil compaction. The epicormic growth has been pruned to shape the lower canopy. Its removal has not been recommended at this time. (Photograph 6)

| Tree ID | Botanical Name | Common Name | Height (m) | DBH (cm) | Age Class | Comments | Management Prescriptions |
|---|---|---|---|---|---|---|---|
| 35 | <i>Taxus baccata</i> | Yew | 7 | 46 | SM | Stem and crown epicormics restricting assessment. Pruning wounds. | No works required. |
