**OUTBUILDINGS PLAS EYTON EYTON WREXHAM LL13 0YD**

As requested, we carried out a structural appraisal on the outbuildings to Plas Eyton on Tuesday 27 September 2022. The report was commissioned to satisfy a planning condition to assess the suitability of the building for conversion into a habitable dwelling.

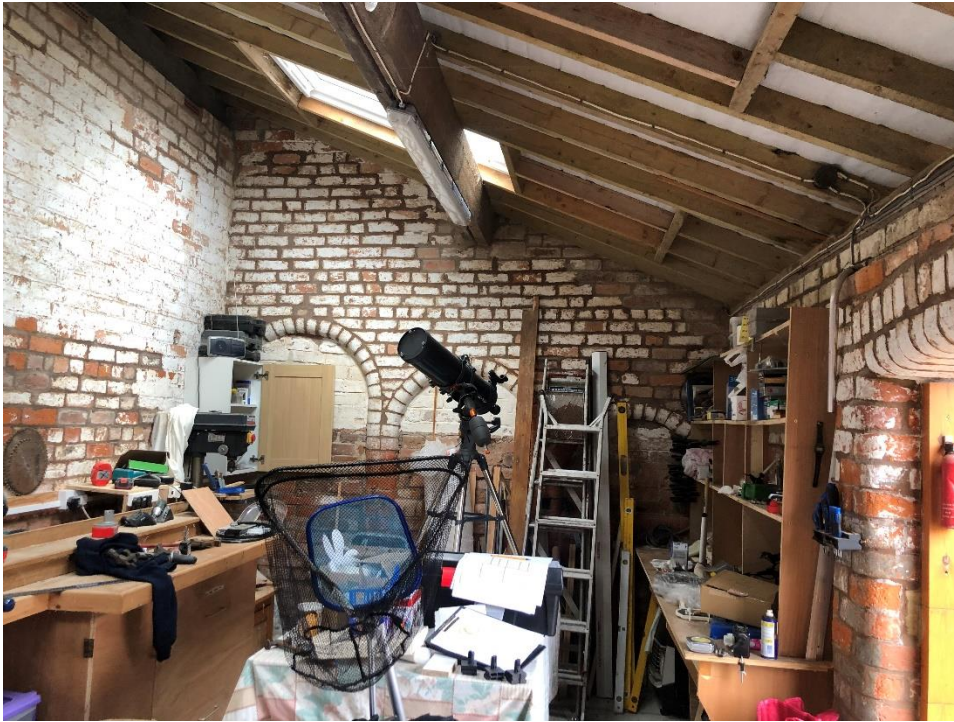
Photograph P1

The outbuildings have been maintained over the years to a very high standard. The workshop walls internally have been repointed throughout and a new replacement roof construction added, see photograph P1.

All walls are relatively plumb and show no evidence of cracking, movement or distress.

The white painted render coat to the internal wall elevations shows no evidence of cracking, movement or distress.

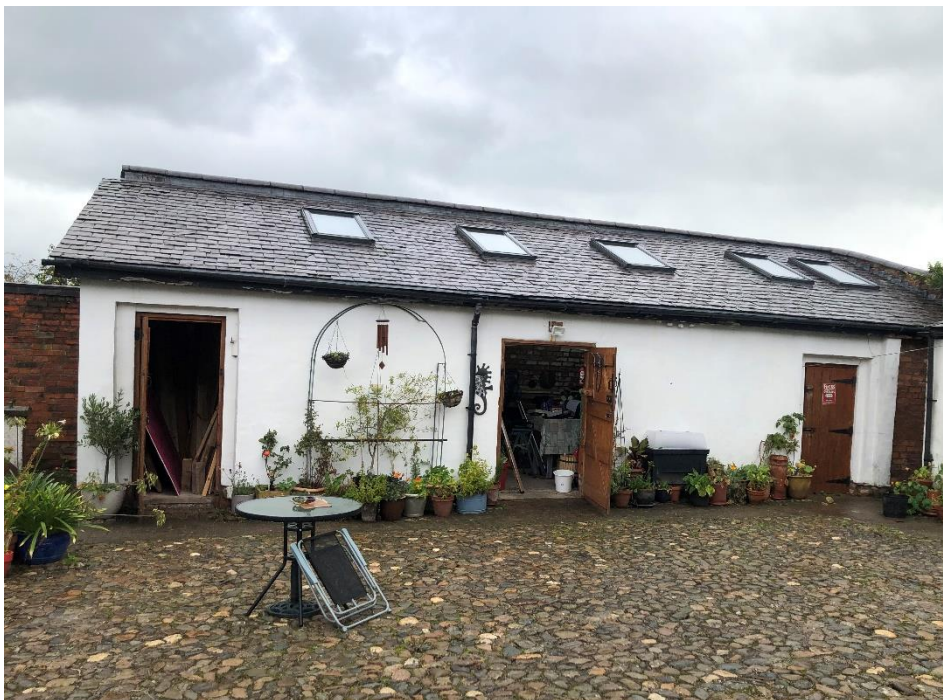
Photograph P2

Velux roof lights have been introduced into the monopitched roof construction, see photograph P2.

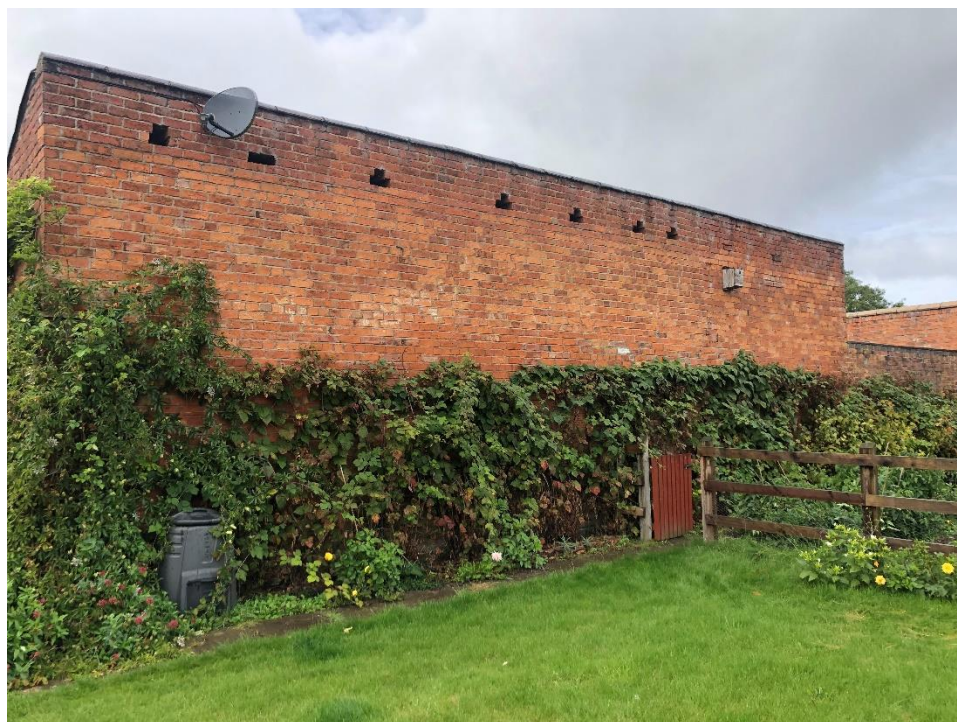
Photograph P3

The external wall to the rear of the outbuildings forms the boundary to the garden/allotment area, see photograph P3.

Once again, the brickwork elevation is relatively plumb and shows no evidence of cracking, movement or distress.

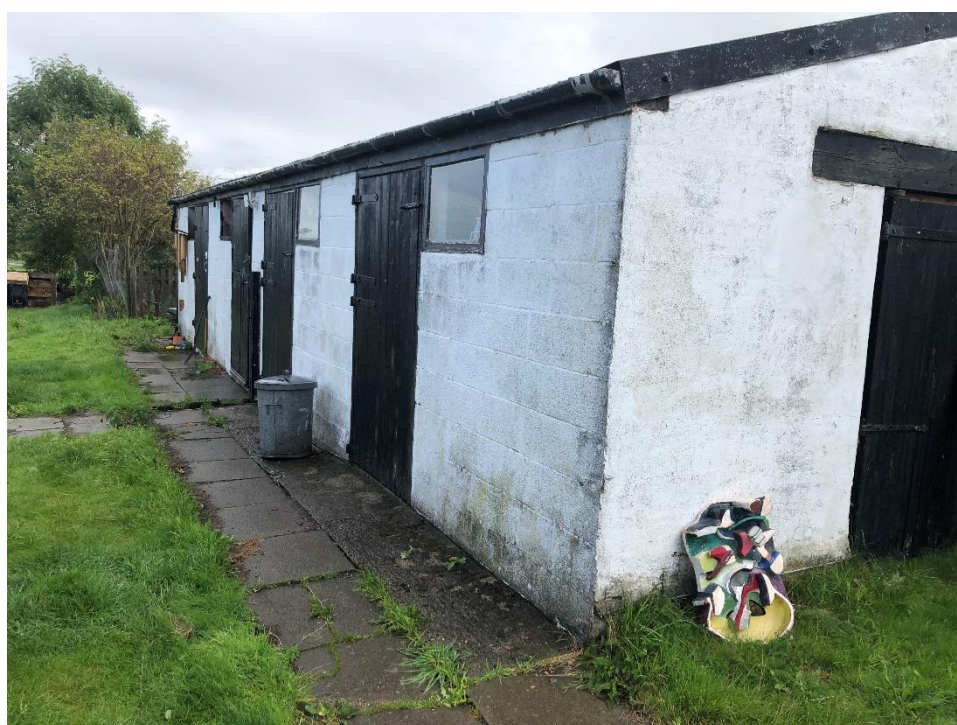
Photograph P4

The rear stable block is constructed in single skin blockwork, see photograph P4.

The wall is plumb and shows no evidence of cracking, movement or distress. It is not possible to see if the blockwork has been constructed off the ground floor slab or whether it goes down to a foundation.

The more recent stable block will require strengthening to the external wall panels and a new roof construction to replace the steel sheeting.
