Our ref: 7791si-A

Site Investigation Report

for land off

Gatewen Road,

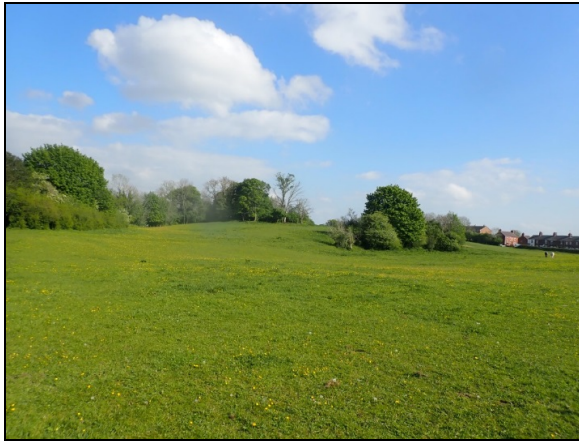
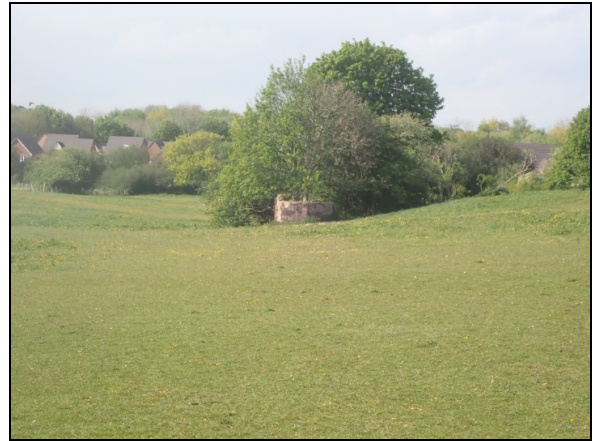
*Photographs 1 and 2: Showing the general nature of the site, and the central wooded copse and miscellaneous brick structure*

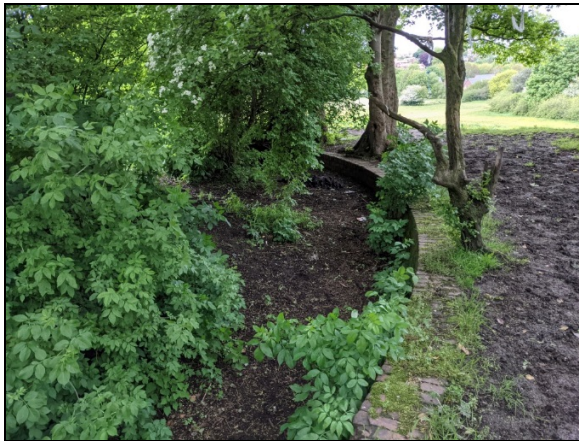
A second wooded copse was present adjacent to the eastern site boundary, with evidence of made ground at the surface and uneven ground. This relates to a historic reservoir, which was partially infilled (or covered) and was still visible on site. The reservoir structure was circular and the external walls were of brick construction. A smaller circular feature immediately adjacent to the east of the reservoir was also of brick construction, and a metal pipe was visible inside of it penetrating the brick wall toward the historic reservoir. The smaller circular feature was not infilled to the surface, and contained predominantly tree branches and miscellaneous anthropogenic waste.

*Photograph 3: Showing the partially infilled reservoir and the eastern wooded copse*

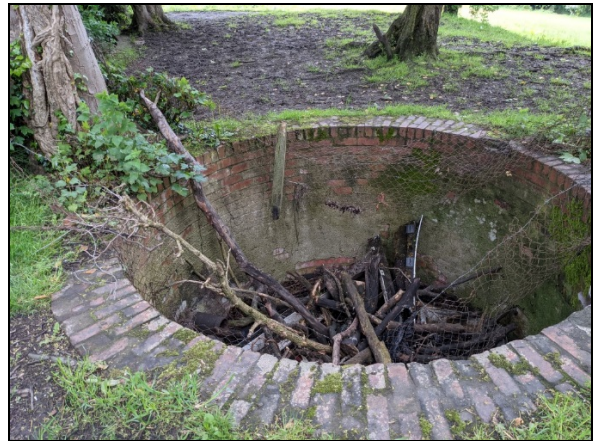
*Photograph 4: Showing the smaller circular brick structure adjacent to the infilled reservoir*
