**Report No. DJ220210A**  
**Asbestos Refurb/Demo Survey**

**Bronydd, Quarry Road,**  
**Glyn Ceiriog, Llangollen LL20 7DA**

**Date of survey:** 10/02/22

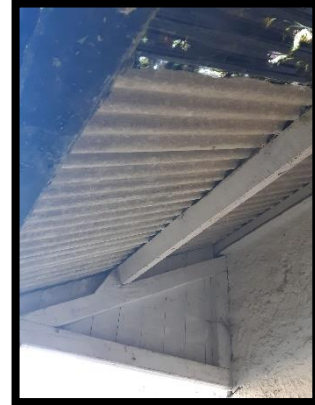
**Sample no:** 01  
**Room no:** external  
**Location:** front porch  
**Item:** roof sheets  
**Accessibility:** easy  
**Sample Taken:** yes  
**Lab Result:** chrysotile asbestos  
**Quantity:** 4sq.m & 1sq.m  
**Surface Treatment:** cement  
**Areas of Damage:** none

**Comments:** Asbestos material. Two portions of the roof sheets to the front porch are asbestos cement. Asbestos cement is a low risk non-licensed material that may be removed by a suitably trained general contractor wearing appropriate RPE/PPE and following HSE guidance work methods. Once removed, this material must be disposed as hazardous waste.

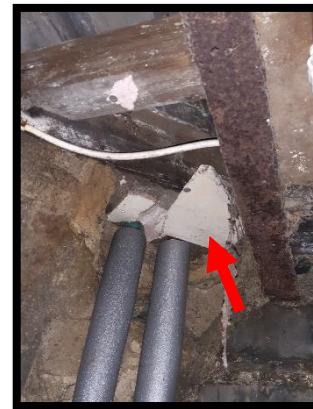
**Sample no:** 02  
**Room no:** 0/02  
**Location:** boiler room  
**Item:** ceiling panel remnants  
**Accessibility:** easy  
**Sample Taken:** yes  
**Lab Result:** chrysotile asbestos  
**Quantity:** 0.1sq.m  
**Surface Treatment:** unsealed  
**Areas of Damage:** broken edges

**Comments:** Asbestos material. A small area (remnants only) of asbestos insulation board (AIB) is present to the boiler room ceiling. AIB is a high risk material. As the area to be removed is less than 1sq.m, the remnants may be removed by a suitably trained general contractor wearing appropriate RPE/PPE and following HSE guidance work methods. Once removed, this material must be disposed as hazardous waste.

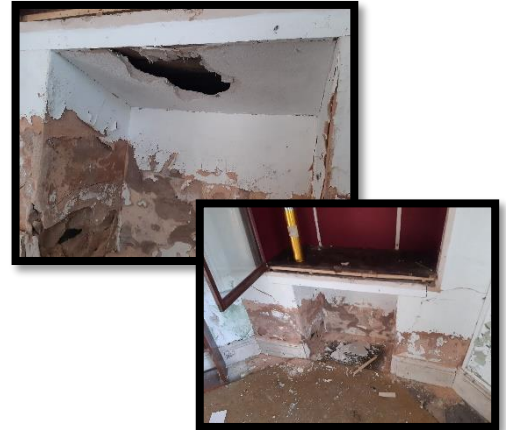
**Sample no:** 03  
**Room no:** 0/05  
**Location:** lounge  
**Item:** insulation panels & debris  
**Accessibility:** easy  
**Sample Taken:** yes  
**Lab Result:** amosite & chrysotile  
**Quantity:** 0.5sq.m & debris  
**Surface Treatment:** unsealed  
**Areas of Damage:** debris to floor

**Comments:** Asbestos material. The built-in unit in the lounge comprises asbestos insulation board (AIB). AIB is a high risk material. Due to the debris present, we recommend removal by a HSE-licensed contractor. Once removed, this material must be disposed as hazardous waste.

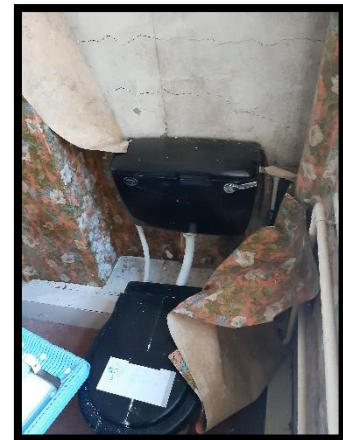
**Sample no:** 04  
**Room no:** 1/08  
**Location:** first floor WC  
**Item:** toilet cistern  
**Accessibility:** easy  
**Sample Taken:** yes  
**Lab Result:** amosite asbestos  
**Quantity:** 1No.  
**Surface Treatment:** composite  
**Areas of Damage:** none

**Comments:** Asbestos material. The toilet cistern to the first floor WC contains asbestos fibres. Asbestos toilet cisterns are a low risk non-licensed material that may be removed by a suitably trained general contractor wearing appropriate RPE/PPE and following HSE guidance work methods. Once removed, this item must be disposed as hazardous waste.

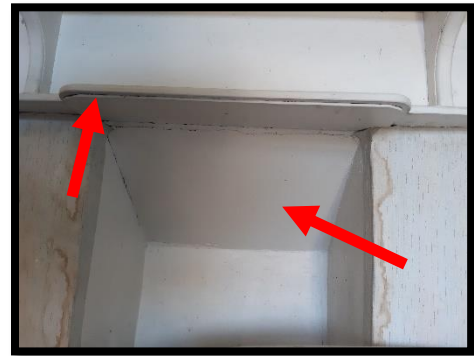
**Sample no:** 05  
**Room no:** 1/14  
**Location:** first floor bedroom  
**Item:** panels to fireplace  
**Accessibility:** easy  
**Sample Taken:** yes  
**Lab Result:** chrysotile asbestos  
**Quantity:** 1sq.m  
**Surface Treatment:** paint  
**Areas of Damage:** none

**Comments:** Asbestos material. The panels to the fireplace in the rear bedroom are asbestos cement. Asbestos cement is a low risk non-licensed material that may be removed by a suitably trained general contractor wearing appropriate RPE/PPE and following HSE guidance work methods. Once removed, this material must be disposed as hazardous waste.

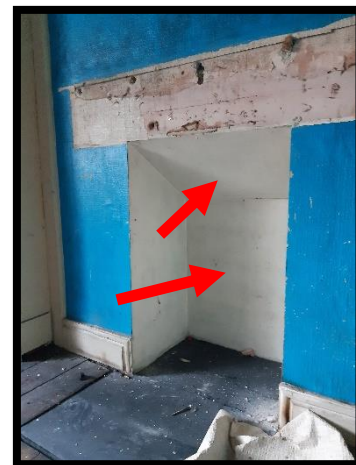
**Sample no:** 06  
**Room no:** 1/13  
**Location:** first floor bedroom  
**Item:** panels to fireplace  
**Accessibility:** easy  
**Sample Taken:** yes  
**Lab Result:** amosite & chrysotile  
**Quantity:** 1sq.m & debris  
**Surface Treatment:** paint  
**Areas of Damage:** none

**Comments:** Asbestos material. The panels to the fireplace in the central bedroom are asbestos insulation board (AIB). AIB is a high risk material. We recommend removal by a HSE-licensed contractor. Once removed, this material must be disposed as hazardous waste.

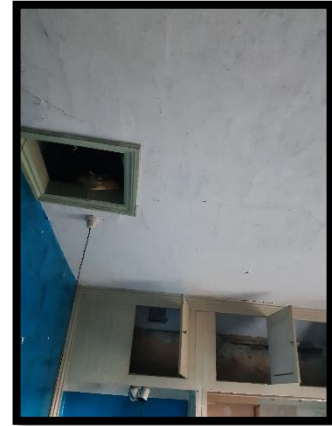
**Sample no:** 07  
**Room no:** 1/13  
**Location:** first floor bedroom  
**Item:** textured coating to ceiling  
**Accessibility:** easy  
**Sample Taken:** yes  
**Lab Result:** non-asbestos  
**Quantity:** N/A  
**Surface Treatment:** N/A  
**Areas of Damage:** N/A

**Comments:** Non-asbestos material.

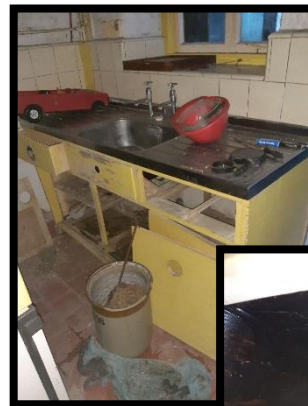
**Sample no:** 08  
**Room no:** 0/11  
**Location:** kitchen  
**Item:** sink pad  
**Accessibility:** easy  
**Sample Taken:** yes  
**Lab Result:** non-asbestos  
**Quantity:** N/A  
**Surface Treatment:** N/A  
**Areas of Damage:** N/A

**Comments:** Non-asbestos material.

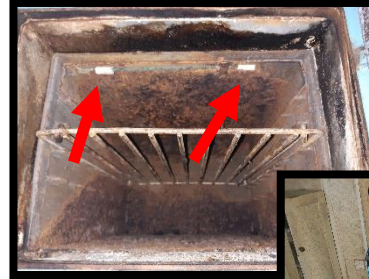
**Sample no:** 09  
**Room no:** 0/10  
**Location:** kitchen  
**Item:** insulation in Aga  
**Accessibility:** easy  
**Sample Taken:** yes  
**Lab Result:** chrysotile asbestos  
**Quantity:** 1No. Aga  
**Surface Treatment:** unsealed  
**Areas of Damage:** none

**Comments:** Asbestos material. The Aga in the kitchen was found to contain asbestos materials. Along with the material sampled (highlighted in photo), the hotplate covers are framed with asbestos rope seals. We recommend the Aga is removed as a whole unit and disposed as hazardous waste. This is non-licensed work.

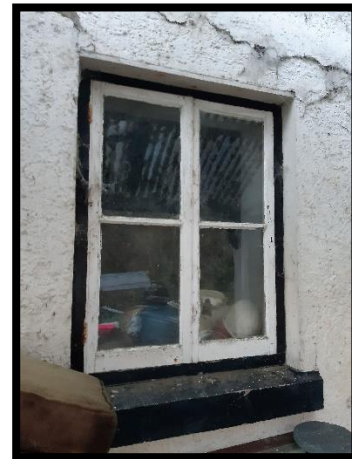
**Sample no:** 10  
**Room no:** external  
**Location:** front elevation  
**Item:** window putty  
**Accessibility:** easy  
**Sample Taken:** yes  
**Lab Result:** non-asbestos  
**Quantity:** N/A  
**Surface Treatment:** N/A  
**Areas of Damage:** N/A

**Comments:** Non-asbestos material.

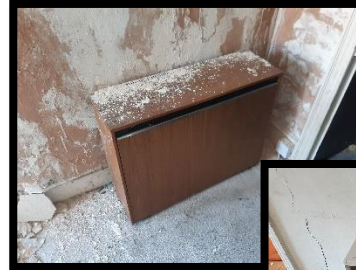
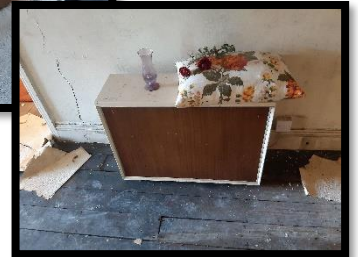
**Presumption:** A  
**Room no:** 0/07 & 0/12  
**Location:** hallway & bedroom  
**Item:** electric storage heaters  
**Accessibility:** easy  
**Sample Taken:** no  
**Presumption:** asbestos components  
**Quantity:** 2No.  
**Surface Treatment:** enclosed  
**Areas of Damage:** unknown

**Comments:** Presumed asbestos material. The electric storage heaters to the hallway and one of the bedrooms are of an age whereby they may contain asbestos components. We recommend the storage heaters are removed as whole units and disposed as hazardous waste. This is non-licensed work.
