# **BS5837 (2012) Arboricultural Impact Assessment.**

**Agricultural Land adjacent to Pen Draw'r y Garth Ucha,  
Llansantffraid Glyn Ceiriog, Glyn Ceiriog, Wrexham, Wales, LL20 7NE**

**15<sup>th</sup> August 2022**

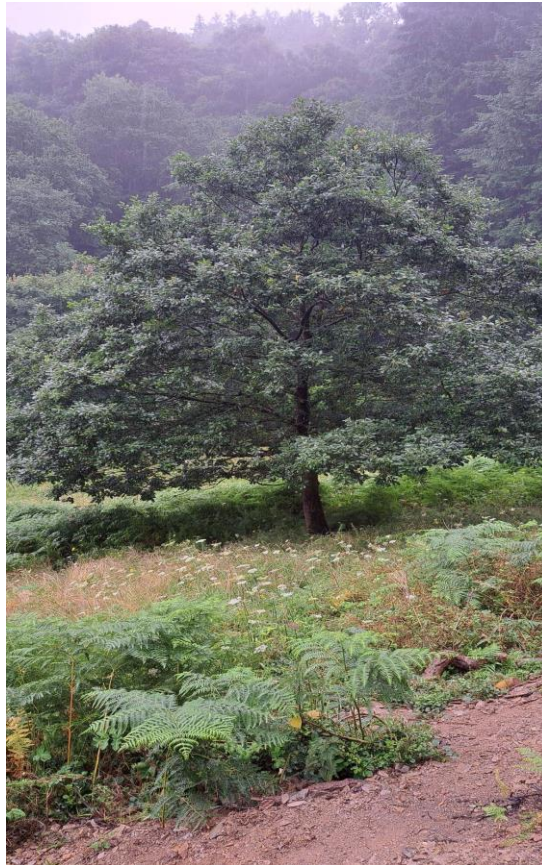
**21.1 Sessile Oak T11**

| Ref. | Other Reference | Common | Botanical | Structure | Num. Stems | Height (m) | DBH (mm) | Crown Spread (m) | | | | Canopy Height (m) | Lowest Significant Branch (m) + Cardinal point | Life Stage | Condition | BS 5837 Retention Category | Root Protection Area m² and (Nominal Radius m) | Tree Condition and Management (Recommendations) |
|---|---|---|---|---|---|---|---|---|---|---|---|---|---|---|---|---|---|---|
| T011 | 0134 | Sessile Oak | <i>Quercus petraea</i> | Tree | 1 | 9 | 340 | 5 | 5 | 5 | 5 | 1.5 | 1.8 S | Semi Mature | Good | A2 | 52 (4.08) | No significant observable defects <b>(Retain)</b> |

10.5 Sessile Oaks (*Quercus petraea*) T002 (Mature) T010 and T011 are good examples of their species, particularly T002 which has a more significant amenity value and should be retained. T011 is pristine in its overall condition and should be protected from livestock and any development as its potential to become an exceptional mature tree is noted.

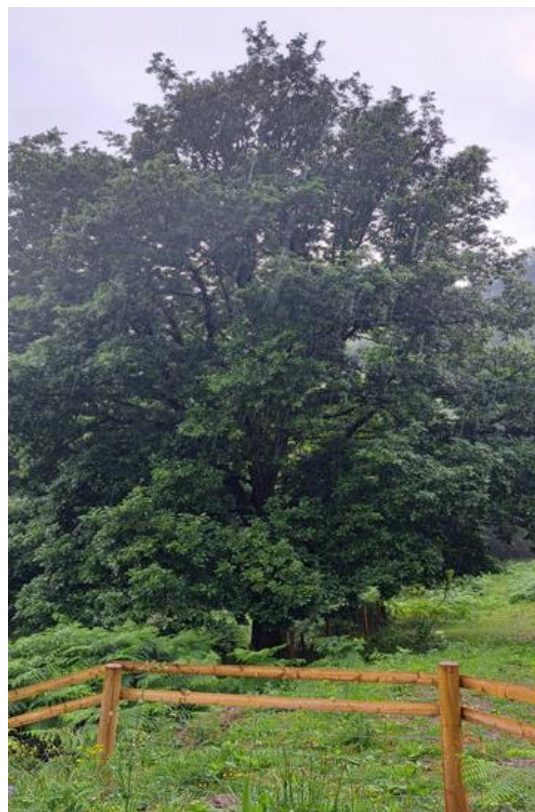
**21.2 Sessile Oak T002**

12.3 Sessile Oaks (*Quercus petraea*) T002 (Mature) T010 and T011 are good examples of their species, particularly T002 which has a more significant amenity value and should be retained. T011 is pristine in its overall condition and should be protected from livestock and any development as its potential to become an exceptional mature tree is noted.

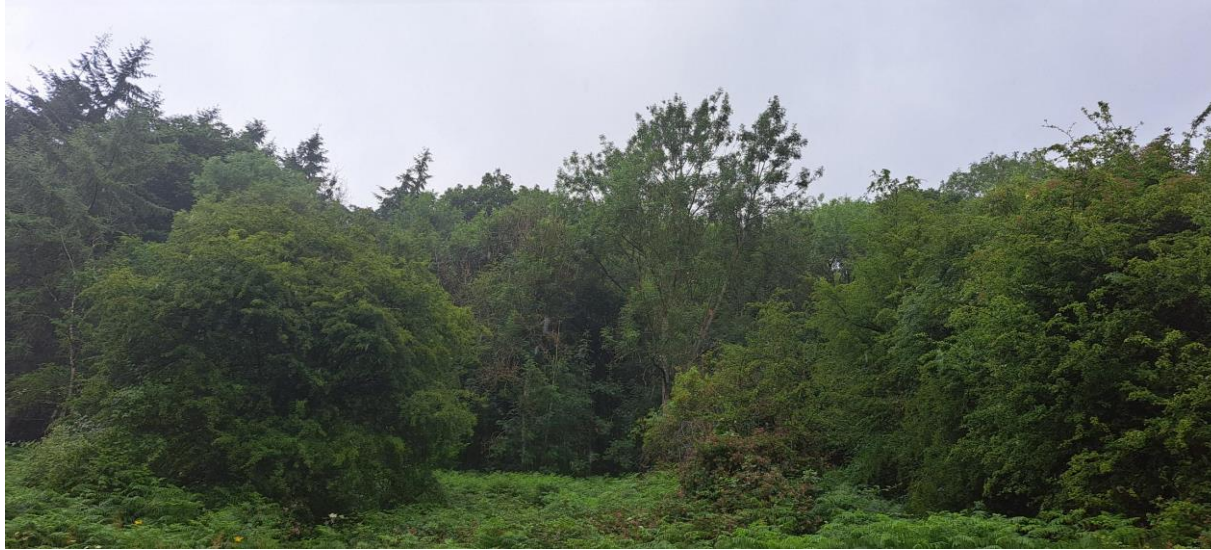
**21.3 North Aspect View toward Groups G15, G19 and G 22**

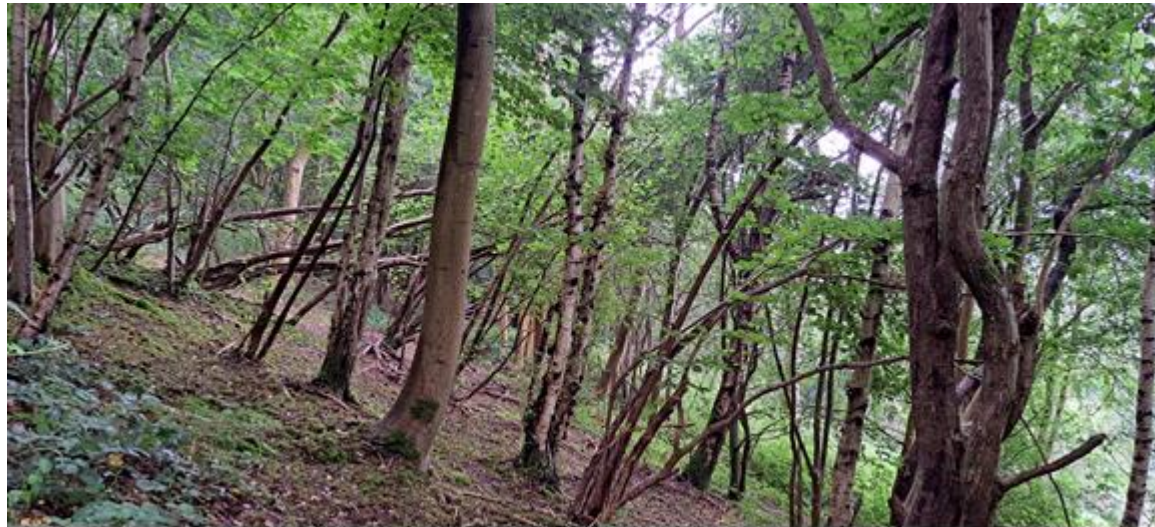
**21.4 Coppice and Standards with Group G 19**
