## Tree Condition Assessment

7 Derwen Court  
Sontley Road  
Erddig  
Wrexham

TCA/DCE/07/22

## Tree Condition, Risk & Impact Assessment

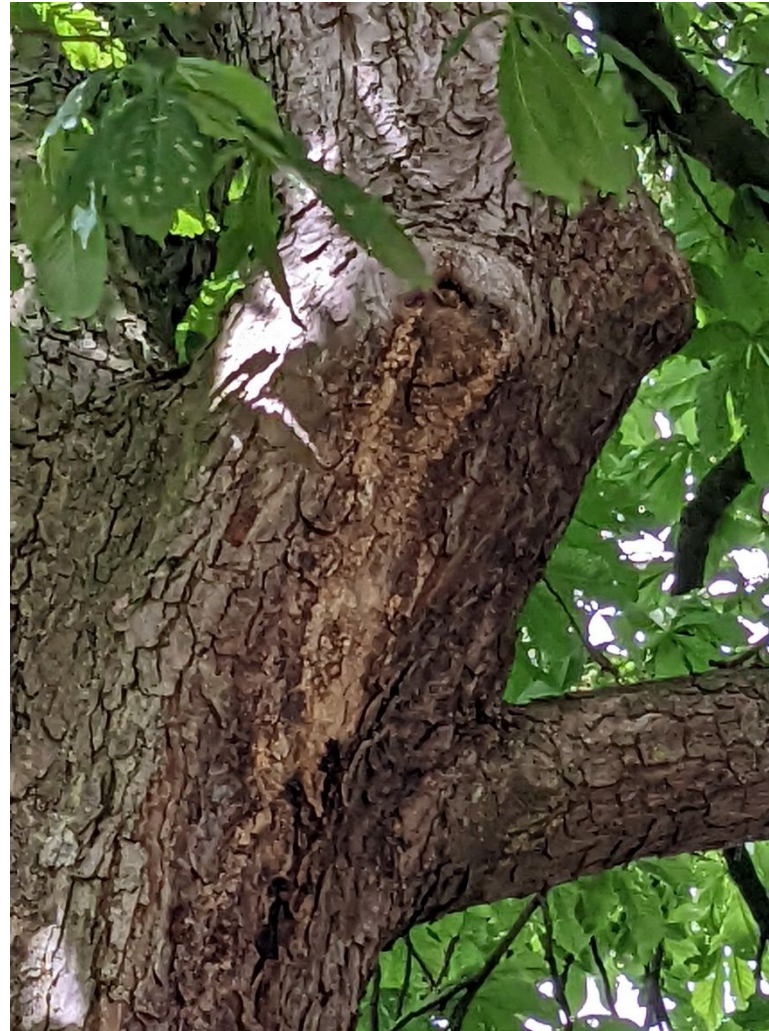
Photo 1

| Tree # | Species | Size Class* | Age Class* | Structural Condition | Health & Vitality | Previous Inspection Notes | Notes | QTRA Score* |
|---|---|---|---|---|---|---|---|---|
| T1 | <i>Aesculus hippocastanum</i><br>(Horse Chestnut) | L | M | G | F | <p><b>Target Zone:</b> T1 is situated close to south boundary of the garden area and is within falling distance of two residential dwellings. The target zone is assessed as high value target zone for total failure and moderate value for branch failure.</p> <p><b>Environment:</b> No recent changes to the tree's environment were noted.</p> <p><b>General Description:</b> T1 is a large, mature specimen. Past works undertaken to T1 have included the pruning of branches from the stem. Tree is host to leaf miner insect pest and there is some indication of minor die-back in the tips of the upper crown.</p> | <p><b>Target Zone:</b> No changes to target zone.</p> <p><b>Environment:</b> No recent changes to the tree's environment were noted.</p> <p><b>General Description:</b> There is now a notable change in the overall condition of the tree. There is evidence of dieback and reduced foliage density in the upper crown, considered to be a result of the Horse Chestnut Leaf miner impacting on the tree's energy reserves exacerbated by the stress of bleeding canker.</p> <p><b>Structural Condition:</b></p> <p><i>Root System</i></p> <p>No significant changes noted.</p> | 10k<br>(Mod - High) |

| | | | | | <p><b>Structural Condition:</b></p> <p><i>Root System</i></p> <p>No indication of any significant decay or structural faults were identified during the examination of the root plate and stem base. There was no indication of instability and no impediments to rooting were identified. Historically there has been some disturbance within the root zone associated with the construction of the property, its garage and garden landscape features. It is also considered that the soil level around the tree has been raised, presumably during the construction of the dwelling.</p> <p><i>Root Buttress</i></p> <p>No evidence of decay or cavities.</p> <p><i>Main Stem &amp; Scaffold Limbs</i></p> <p>Strip wound on south side of tree, possibly from past lightning strike. Pruning wounds on the scaffold limbs indicated that branches have previously been removed. Old pruning wounds can sometimes become courts for infection by wood decay organisms, which in turn can degrade wood in the stem of the tree. However the tree is</p> | <p><i>Root Buttress</i></p> <p>No significant changes.</p> <p><i>Main Stem &amp; Scaffold Limbs</i></p> <p>Bleeding canker is beginning to spread with new areas of exudation noted on the main stem. Callus growth around old pruning wounds and areas of missing bark is beginning to slow.</p> <p><i>Crown Structure</i></p> <p>Some limbs are now becoming over-extended, particularly on the northern side of the crown. There is reasonable indication that secondary thickening has slowed or stopped on the upper side of some of the branches. Significant exudation from old pruning wound on a major scaffold limb on south side of crown over adjacent garden (photo1) with evidence of branch subsidence, indicative of significant decay in structural wood.</p> <p>Die-back in upper crown progressing.</p> <p><i>Foliage</i></p> <p>Reduced foliage density in upper crown.</p> <p><b>Health &amp; Vitality:</b> Tree is showing a more pronounced</p> | |

| | | | | | <p>responding to this and there is no evidence that its structural integrity is in any way compromised. The strip wound on the tree extends down the main scaffold limb on the south side of the crown. There is reasonable callous growth around the wound and, where wood is exposed, this appears not to have deteriorated. There is evidence of bleeding canker on the stem. This occurs as a result of bacteria infecting the outer layers of the tree. There is also some evidence of loose and damaged bark plates. This does not appear to have arisen from excessive flexing of the tree and may be the result of squirrel damage.</p> <p><i>Crown Structure</i></p> <p>T1 has a reasonably well balanced and symmetrical crown. A number of past pruning wounds were identified and there is evidence of some cavities associated with these. The extent of the cavities is not considered significant and there is no indication that the structural integrity of the tree has been degraded, however it would be prudent to undertake a climbing inspection at the time of tree surgery works to other trees in the</p> | <p>reduction in vitality from previous inspections.</p> <p><b>Other Considerations:</b> The tree's owners have expressed concern as to the impact of the tree on the reasonable enjoyment of the property. This, in the main related to the impact of shading and dominance. The tree is to the south of the house and garden and of a size and spread that it would cast considerable shade over the garden area and also obstruct sunlight and daylight to the main living rooms of the house. Additionally, the tree impacts on a neighbouring property to the south. The crown spreads across a significant portion of the garden and its physical presence exacerbated by its elevated position.</p> <p><b>Recommendations:</b> Given the potential for structural failure of primary and secondary branches resulting from internal decay and reduced vitality, it is recommended that either a significant crown reduction, 20% - 30%, is undertaken or that the tree is removed and replaced. There is a potential for a canopy reduction to further impact the tree's vitality. Removing the tree before it is absolutely necessary</p> | |

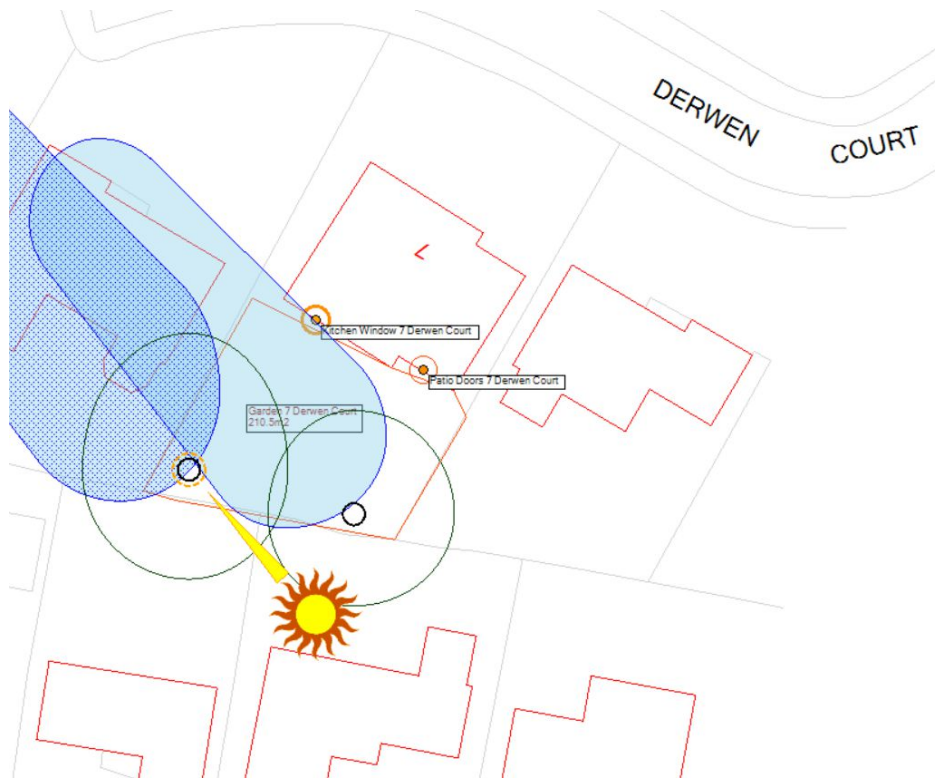
Tree Shadows 10am March 21<sup>st</sup>

for 21<sup>st</sup> March (equinox) and 21<sup>st</sup> June (sun at highest point in northern hemisphere) and tree shadows plotted on to the site layout plan to show shading for every two hours between 10:00 & 18:00. The shadow plans are attached to this report at appendix B and include an area analysis for the garden, indicating the extent and time of shading of this area. As can be seen, the trees cast shade over a considerable portion of the garden for the majority of the day, falling well short of the BRE requirements and casting deep shade well into the evening during the summer months. This not only restricts the use of the area for recreation but also limits cultivation of the flower beds and lawn. The shade also affects the main living room windows and patio doors, shading these from noon onwards.
