**Building Survey**  
**12/01/22**

**Dymock Arms**  
**Penley, Wrexham**  
**LL13 0LS**

Date of first issue : 19<sup>th</sup> January 2022

## **BUILDING CONDITION REPORT**

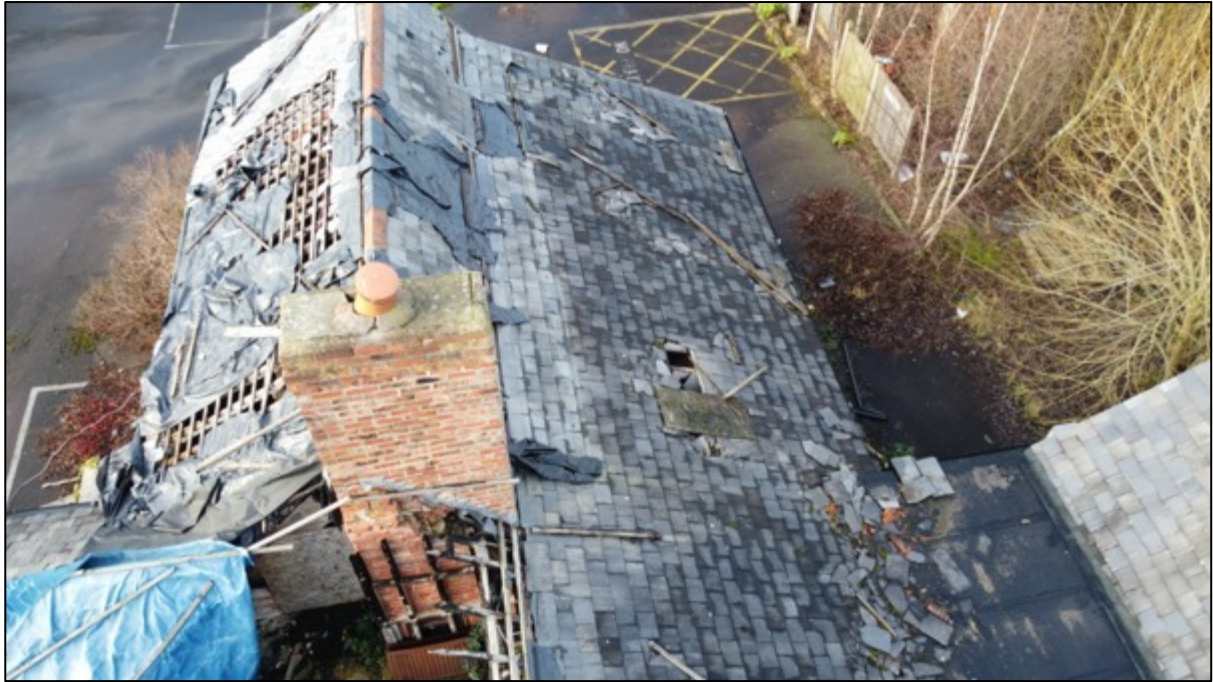
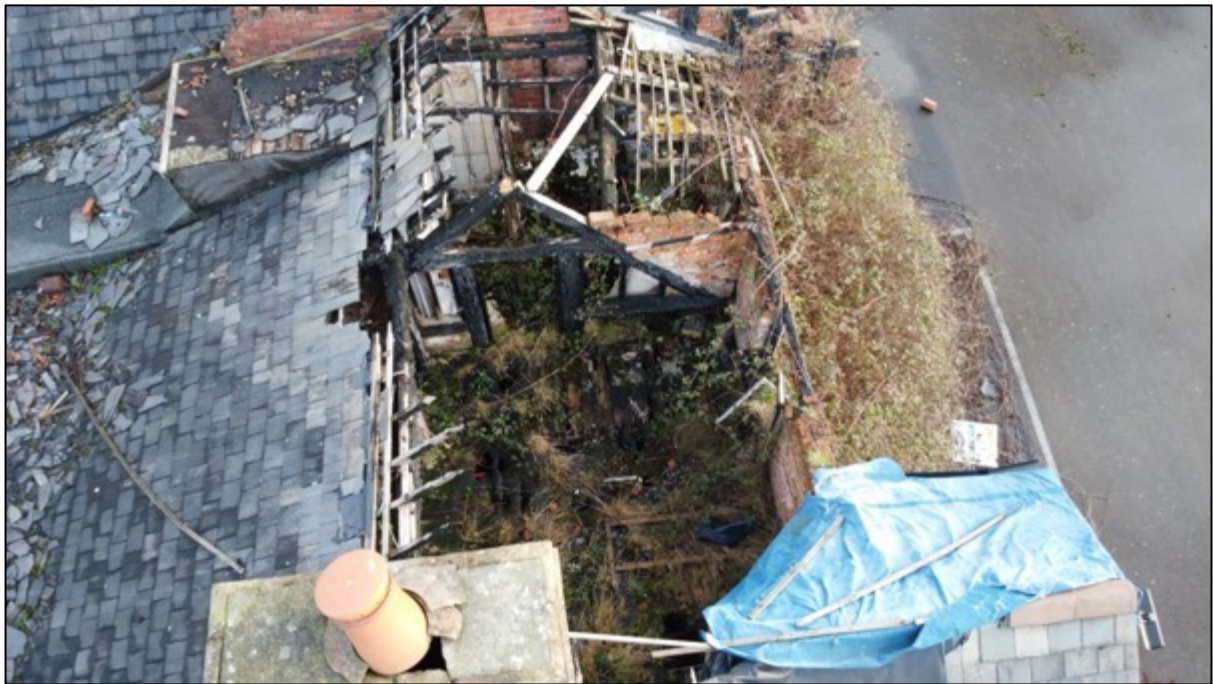
**Condition** – Roofs A,B,C,D,J were not present. Remaining roofs E,F,G,H contained many slipped slates. Underfelt was noted to some roof surfaces. Extensive water ingress was noted to open areas of the remaining roofs, and may be advisable to install covers to protect the integrity of the structure. Significant fire damage to purlins within roofs F,G,H will render their structural reuse not possible, but may be adequate for the support of temporary sheeting.

**Action** – Install temporary waterproof sheeting above roofs E,F,G,H (Rating D2)

Full re-roofing and reconstruction of structure will be required subject to decisions on works to structures below. (Rating D3 - budget)

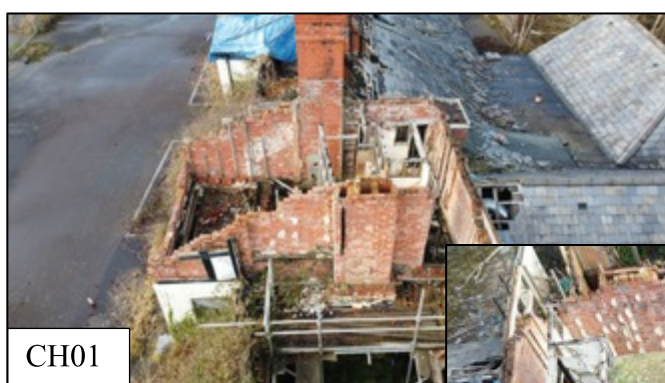
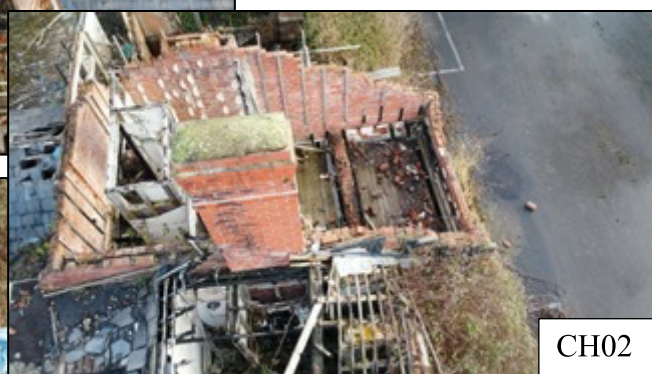
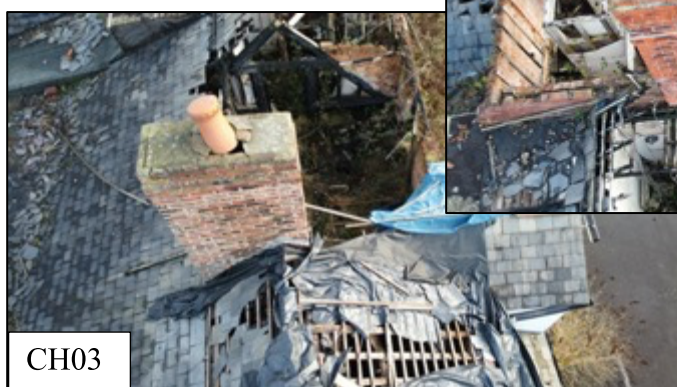
**Condition** – CH01 – The top of the chimney is missing from the mid first floor level. The remaining stack is visible.

CH02 – Adjacent timber roof structures have been removed, and the slender brick structure is exposed making it liable for collapse in high winds. This chimney should also be noted as being supported by a steel beam in the bar of GF04-GF03 and has no foundations with minimal lateral restraint. The brickwork structure appears to be satisfactory.

CH03 – The flaunching has failed and the clay flue pot is misaligned. The brickwork main structure appears stable and satisfactory.

**Action** – Undertake safe access to CH02 to stabilise with scaffold or remove upper sections to prevent collapse in high winds (Rating D2)

Undertake safe access to CH03 to cap or reinstate flue (Rating D2)

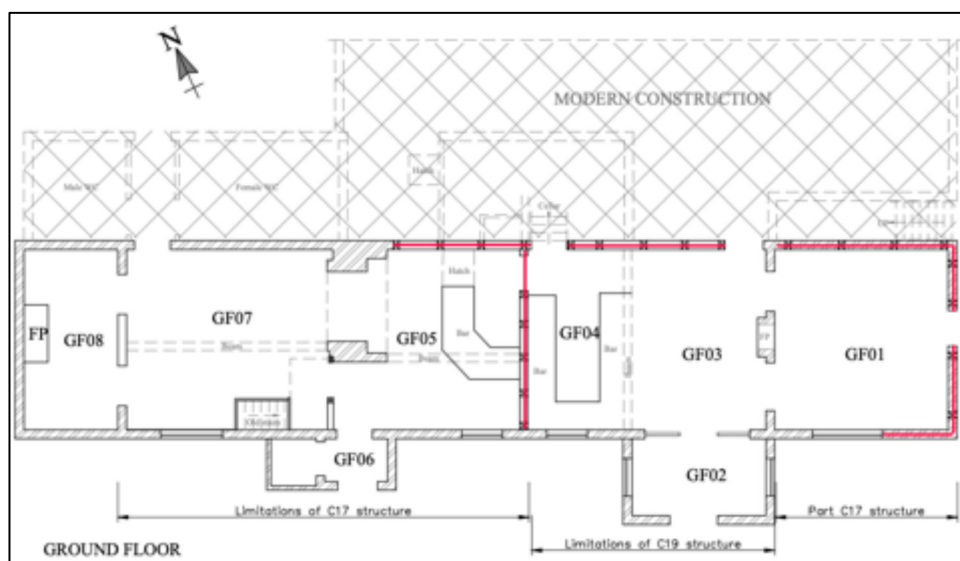
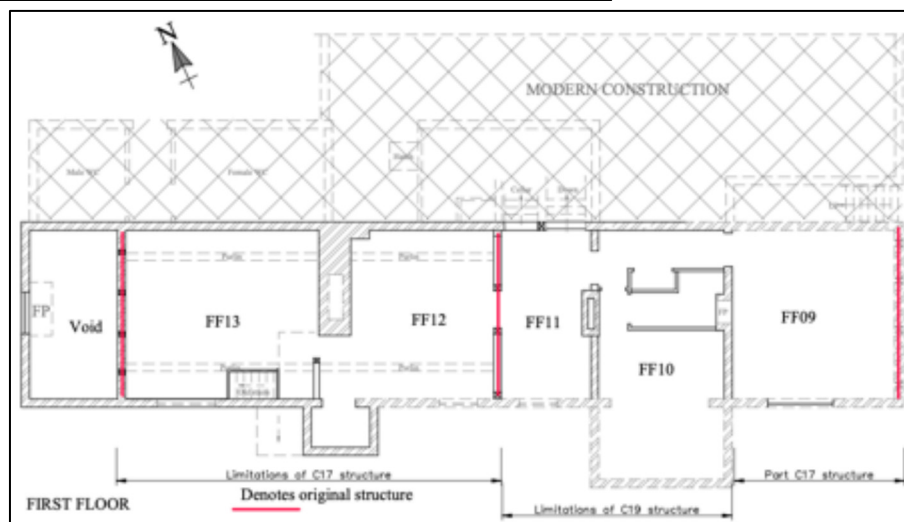
**Condition** – Many wall units were in disrepair, especially at first floor level. Timber framing collapse was noted to GF01. Ground floor walls were mostly adequate.

**Action** – Allowance for rebuilding upper sections (Rating D3)

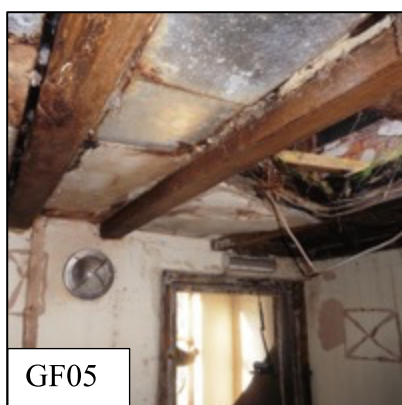
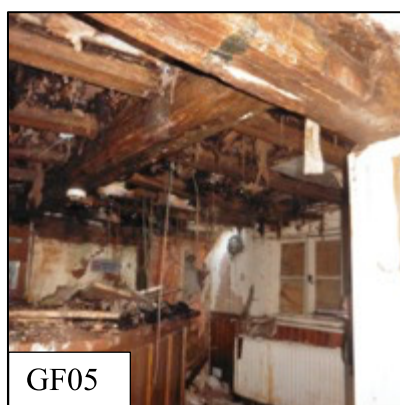
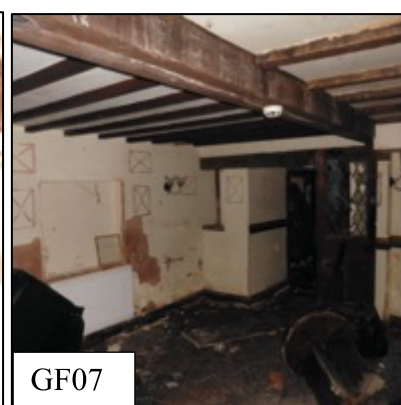
**Condition** – Exposed building areas GF01, GF02, GF03, GF04 contained very little or no ceiling structure. The ceiling was present in GF05, GF06, GF07 and GF08 but extensive damage to plasterwork was noted due to the water ingress.

**Action** – Allowance for replacement of ceilings (Rating D3)

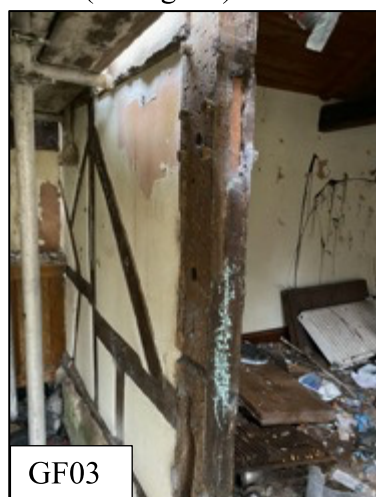
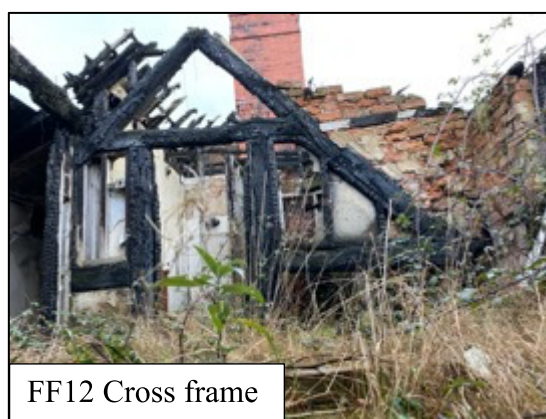
**Condition** – First floor units had been heavily damaged by fire, water or collapse. Ground floor constructions to the west were present, and in many areas repairable. The structural cross frame between GF04 and GF05 was heavily damaged by water ingress. The upper section of this frame between FF11 and FF12 was heavily fire damaged and beyond repair.

**Action** – Allowance for construction of new partitions (Rating D3)

Allowance for the replacement of the upper section of cross frame FF11-FF12 (Rating D3)

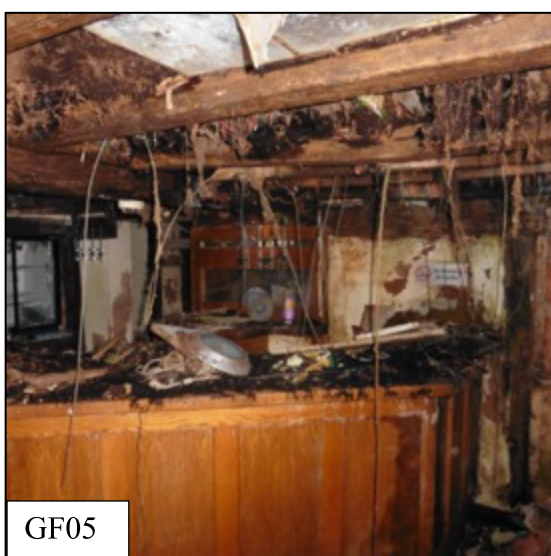
**Condition** – No full structural analysis of the beam in GF05 could be undertaken due to surrounding building debris, however its integrity may have been compromised from significant water from the fire damage and openness of the structure above. The modern beam to GF07 appeared satisfactory.

**Action** – Allowance for assessment and replacement of beam to GF05 (Rating D3)

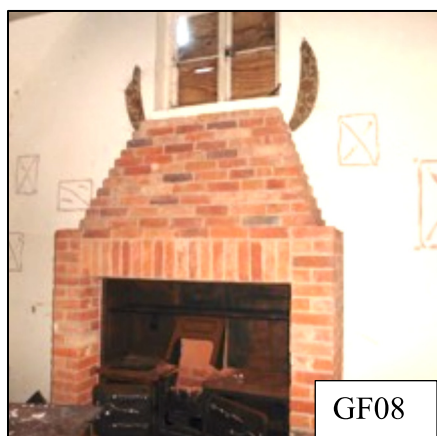
**Condition** – The cast iron grate to GF08 was still present. The flue detail for this fire could not be ascertained.

**Action** – Assess and certify for reuse (Rating D3)
