**Project Name:** R&R Engineering, Wreham Ind Est 21-04-2021

**Project Date:** 4/21/2021

**Inspection Standard:** MSCC4 Sewers & Drainage GB (SRM4 Scoring)

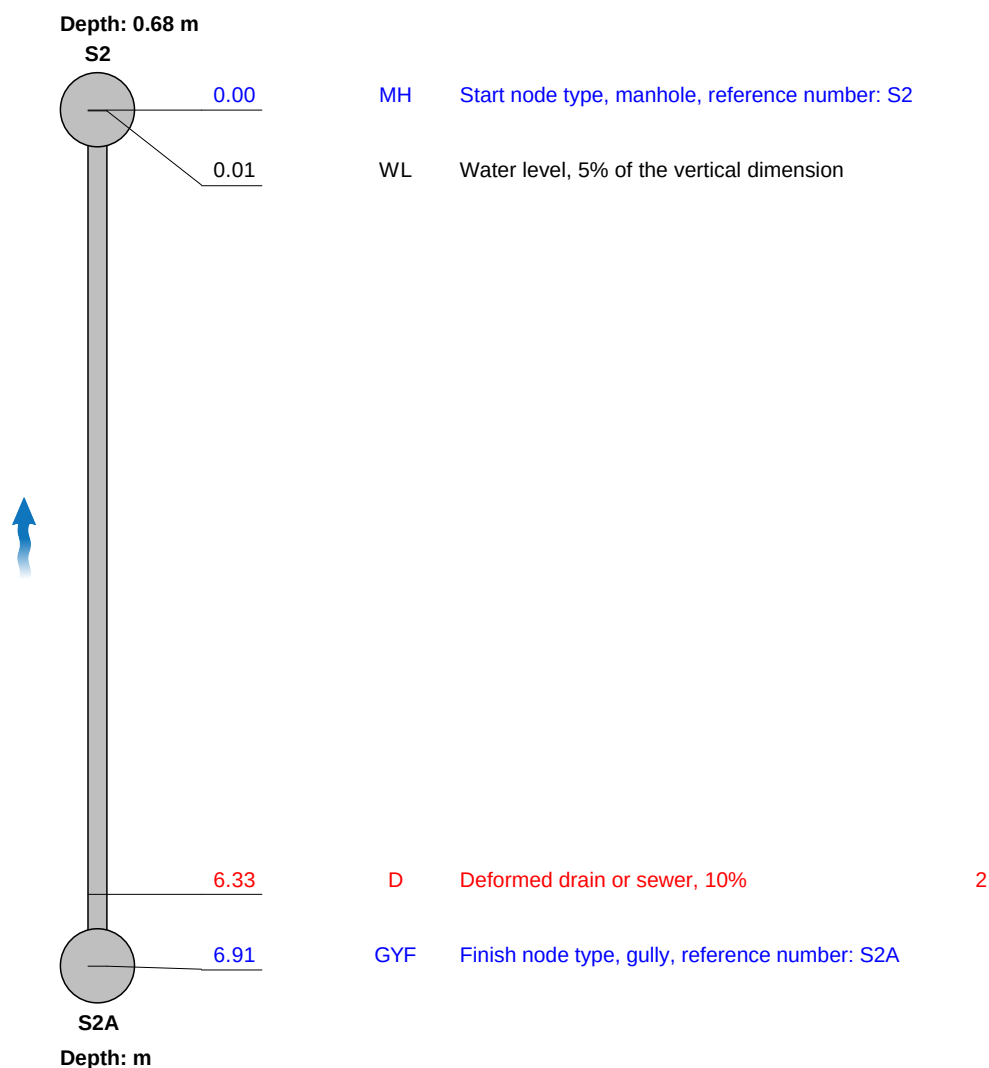
## Section Inspection - 4/21/2021 - S2AX

| 3 | 6.33 | D | Deformed drain or sewer, 10% | | | | |
