## CCTV Inspection Report

**Gwersyllt Park Cricket Club  
The Park  
Gwersyllt  
Wrexham  
LL11 4DX**

## Metro Rod Deeside

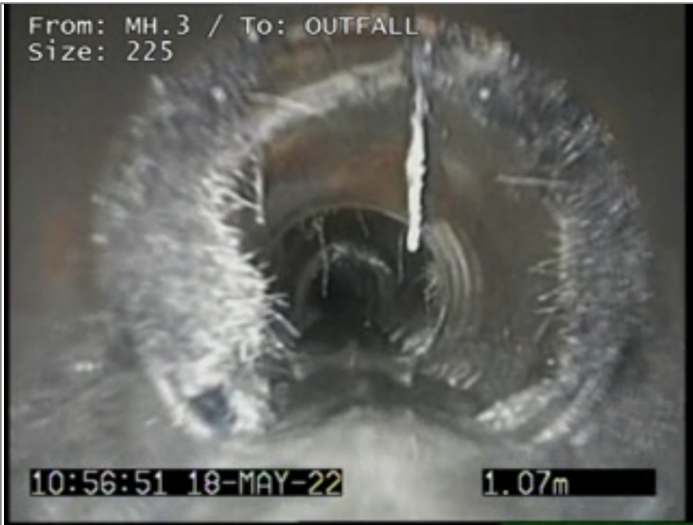
| Position | Code | Description | Photo | Type/Grade |
|---|---|---|---|---|
| 1.07 | RFJ | Roots fine at joint | 6395172 | Service / 2 |

| Job Number<br>399040 | Surveyed by (Operator)<br>Jordan Jones | Base Unit<br>X7F9YPJU00 | Date<br>18/05/2022 |
|---|---|---|---|
| <div> <div> From: MH.3 / To: OUTFALL<br/>Size: 225<br/> 10:56:51 18-MAY-22 1.07m </div> <div>Roots fine at joint</div> </div> <div> <div> From: MH.3 / To: OUTFALL<br/>Size: 225<br/> 10:56:54 18-MAY-22 1.58m </div> <div>Roots fine at joint</div> </div> | | | |

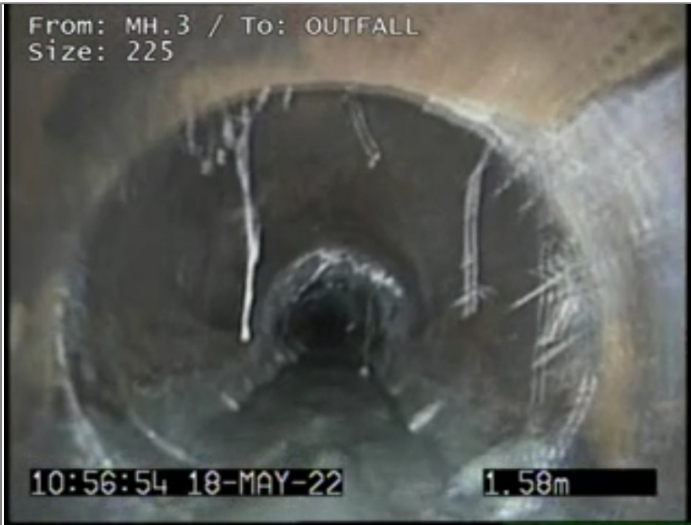
| Position | Code | Description | Photo | Type/Grade |
|---|---|---|---|---|
| 1.58 | RFJ | Roots fine at joint | 6395173 | Service / 2 |

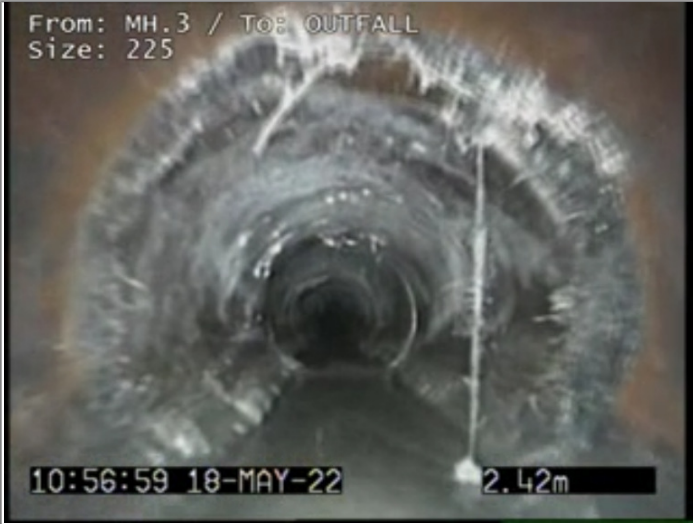
| Position | Code | Description | Photo | Type/Grade |
|---|---|---|---|---|
| 2.42 | RFJ | Roots fine at joint | 6395177 | Service / 2 |

| Job Number<br>399040 | Surveyed by (Operator)<br>Jordan Jones | Base Unit<br>X7F9YPJU00 | Date<br>18/05/2022 |
|---|---|---|---|
| <div> <div> From: MH.3 / To: OUTFALL<br/>Size: 225<br/> 10:56:59 18-MAY-22 2.42m </div> <div>Roots fine at joint</div> </div> <div> <div> From: MH.3 / To: OUTFALL<br/>Size: 225<br/> 10:57:07 18-MAY-22 4.42m </div> <div>Roots fine at joint</div> </div> | | | |

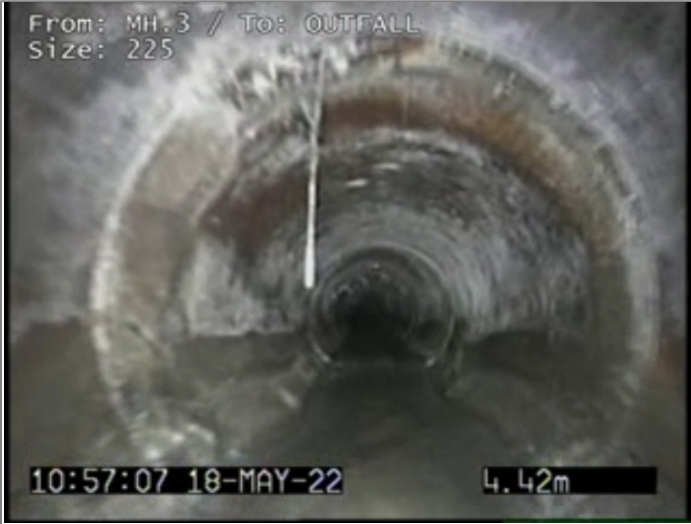
| Position | Code | Description | Photo | Type/Grade |
|---|---|---|---|---|
| 4.42 | RFJ | Roots fine at joint | 6395180 | Service / 2 |

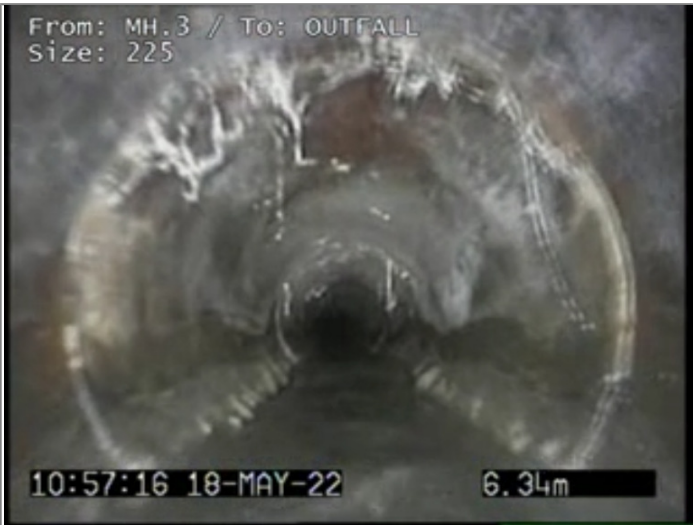
| Position | Code | Description | Photo | Type/Grade |
|---|---|---|---|---|
| 6.34 | RFJ | Roots fine at joint | 6395184 | Service / 2 |

| Job Number<br>399040 | Surveyed by (Operator)<br>Jordan Jones | Base Unit<br>X7F9YPJU00 | Date<br>18/05/2022 |
|---|---|---|---|
| <div> <div> From: MH.3 / To: OUTFALL<br/>Size: 225<br/> 10:57:16 18-MAY-22 6.34m </div> <div>Roots fine at joint</div> </div> <div> <div> From: MH.3 / To: OUTFALL<br/>Size: 225<br/> 10:57:20 18-MAY-22 7.34m </div> <div>Roots fine at joint</div> </div> | | | |

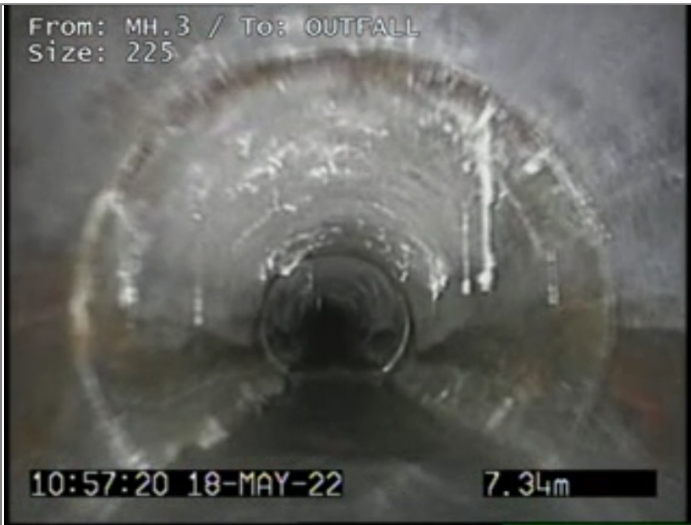
| Position | Code | Description | Photo | Type/Grade |
|---|---|---|---|---|
| 7.34 | RFJ | Roots fine at joint | 6395186 | Service / 2 |

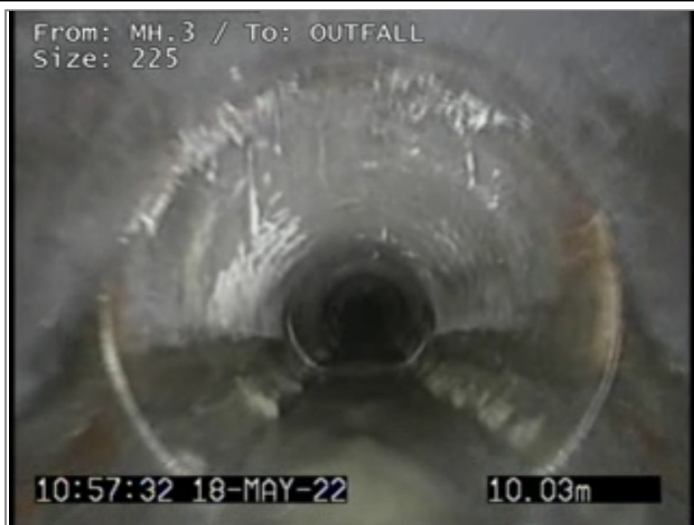
Roots fine at joint

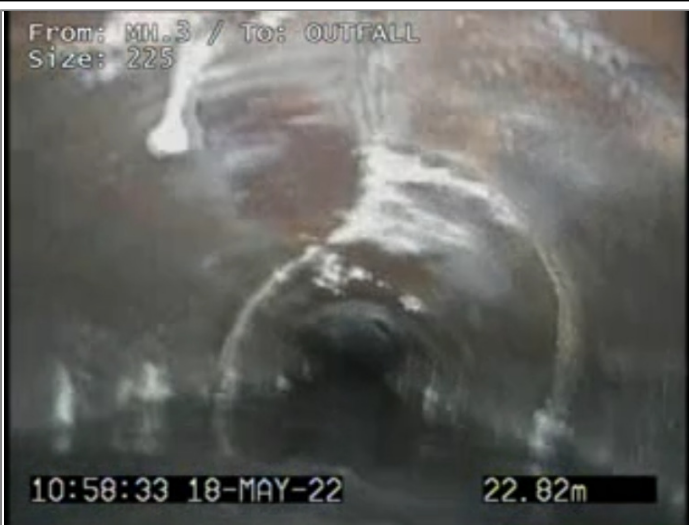
| Position | Code | Description | Photo | Type/Grade |
|---|---|---|---|---|
| 22.82 | CM | Cracks multiple from 12 to 12 o'clock | 6395195 | Structural / 3 |

Cracks multiple from 12 to 12 o'clock

| Structural Defects | | | |
|---|---|---|---|
| 1 | MH.3 X | 3 | Cracks multiple from 12 to 12 o'clock |

Grade 3; Best practice suggests consideration to be given to repair in the medium term.

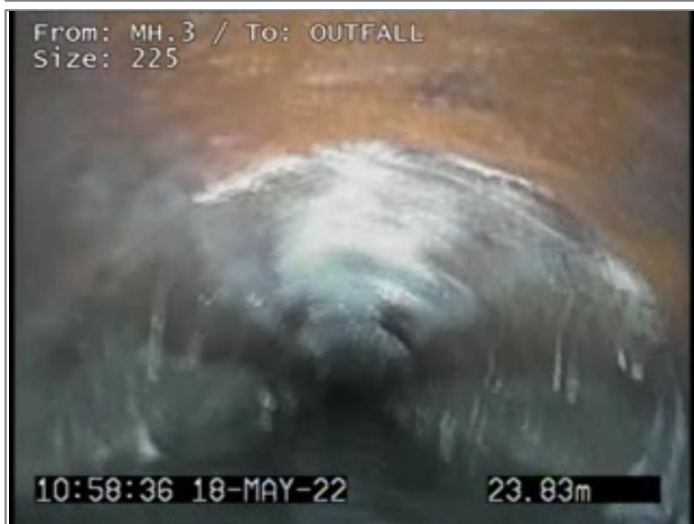
Roots fine at joint

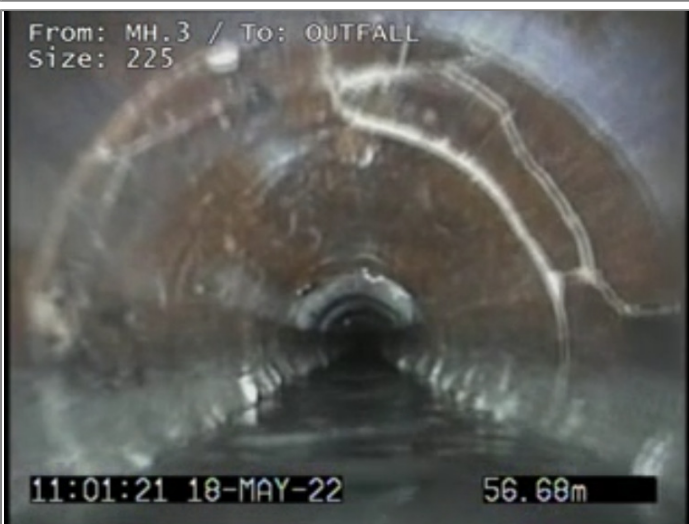
| Position | Code | Description | Photo | Type/Grade |
|---|---|---|---|---|
| 56.68 | CM | Cracks multiple from 12 to 4 o'clock | 6395220 | Structural / 3 |

Cracks multiple from 12 to 4 o'clock

| Structural Defects | | | |
|---|---|---|---|
| | | | Cracks multiple from 12 to 4 o'clock |
