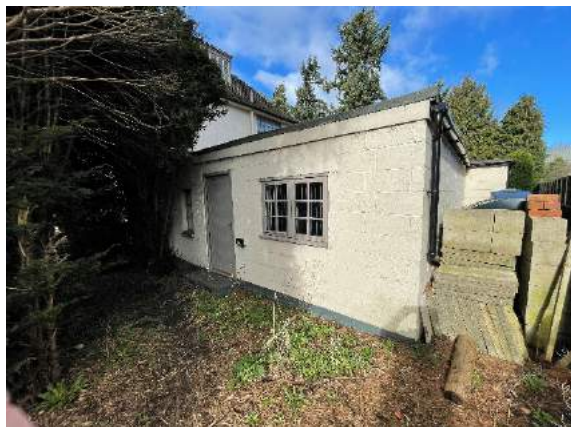
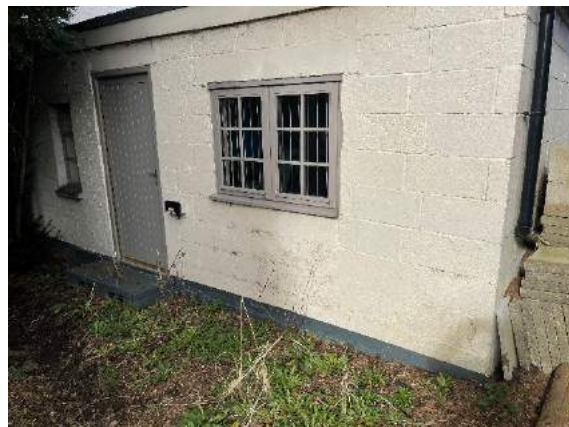
*Block forming office/ garage abuts the original brickwork forming a previous outbuilding.*

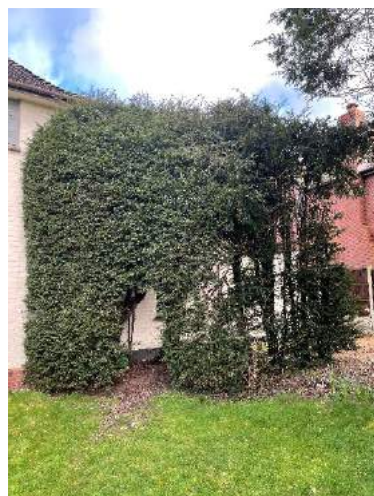
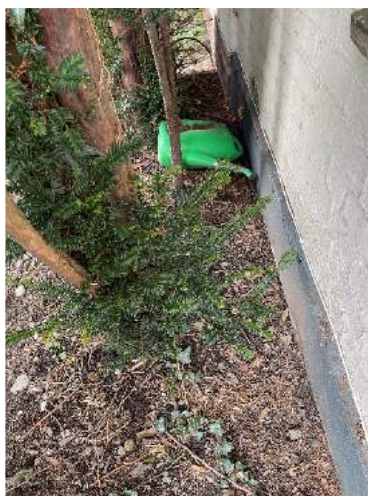
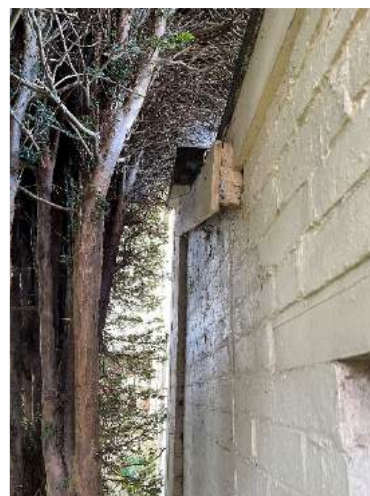
Trees are located in close proximity to the rear garage/office wall and its foundations. These trees have contributed towards the deterioration of the flat roof covering and notable gutter blockages. We cannot confirm the depth of the building foundations; however, whilst the trees are too close, there were no immediate signs of movement in the structure itself. It is recommended that you employ a tree surgeon's services in significantly cutting back or removing these trees. Should any future movement occur, following the trees removal, further investigation and remedial works will be required. You will need to seek additional guidance from the conservation officer before there removal.

*Trees are planted too close to the foundations of the building.*
